Geotechnical Evaluation Proposed North End Subdivision Dawson City, Yukon – 2016

Prepared For: Yukon Government – Energy, Mines and Resources

Date : September 18, 2016

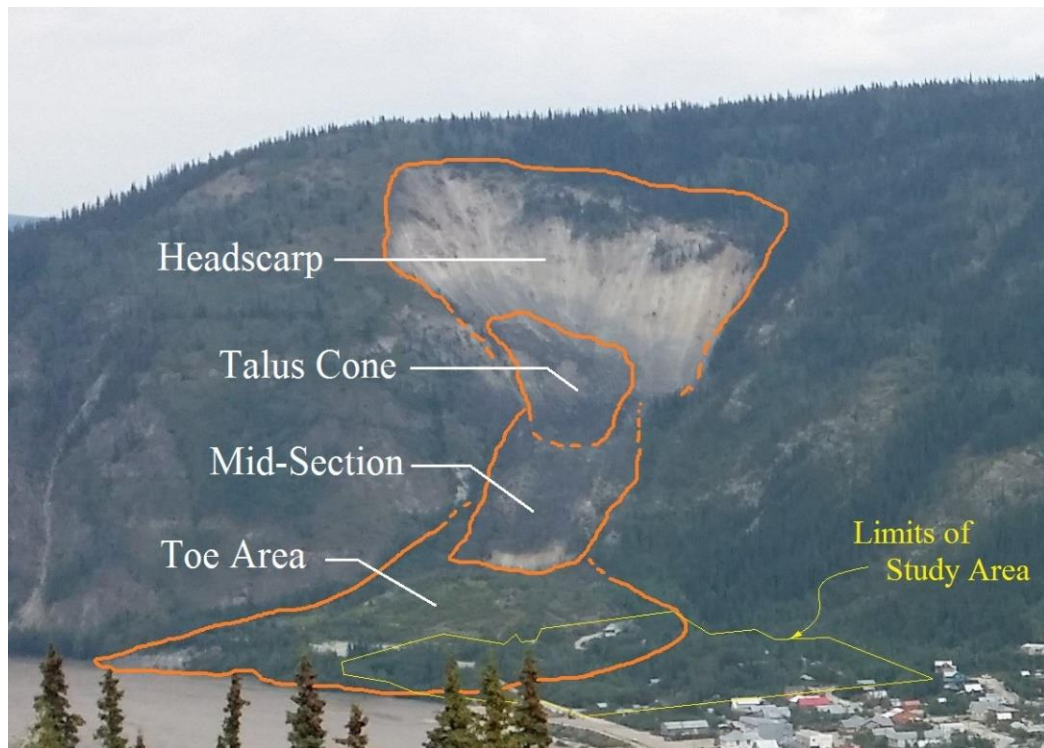
View of slide and study area facing north-east. Photo taken from road to Sunnydale in West Dawson.

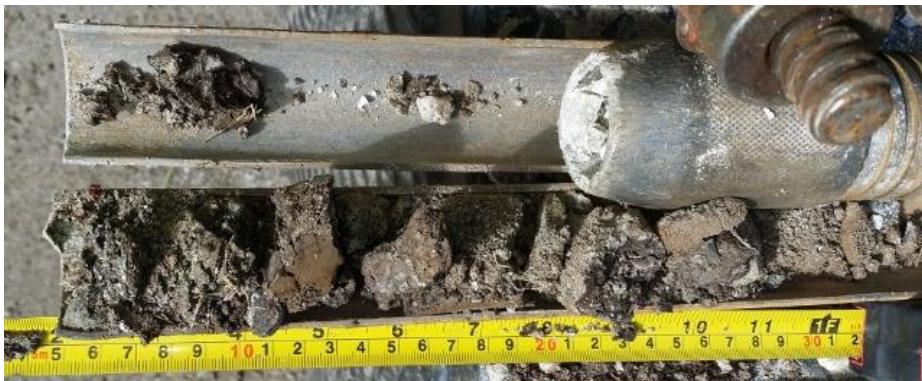
BH 4-16 - Sample No.33 – Unit # 5a Colluvial Slide Debris

The moisture content of the rubble averaged 5.8% (but varied between 2.8% and 10.1%), indicating generally damp conditions.
