**Geotechnical Evaluation  
Proposed 2<sup>nd</sup> Avenue Upgrades  
Dawson City, Yukon – 2014**

**Prepared For:** Yukon Government – Energy, Mines and Resources

**Date :** December 30, 2014

**File No:** 200-003-14

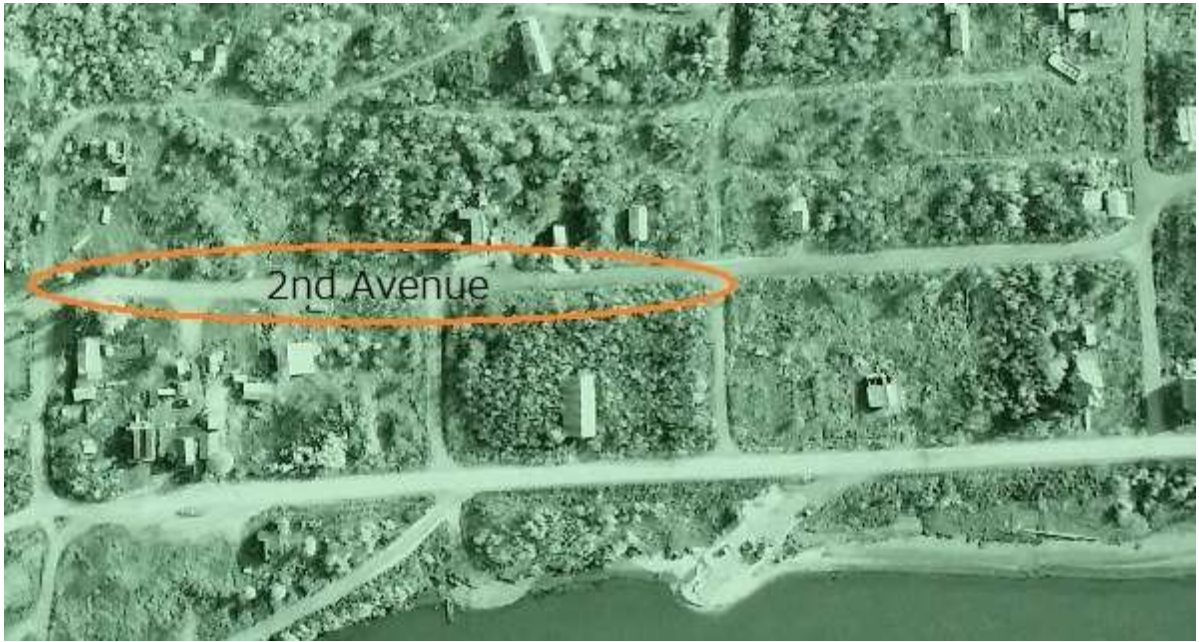
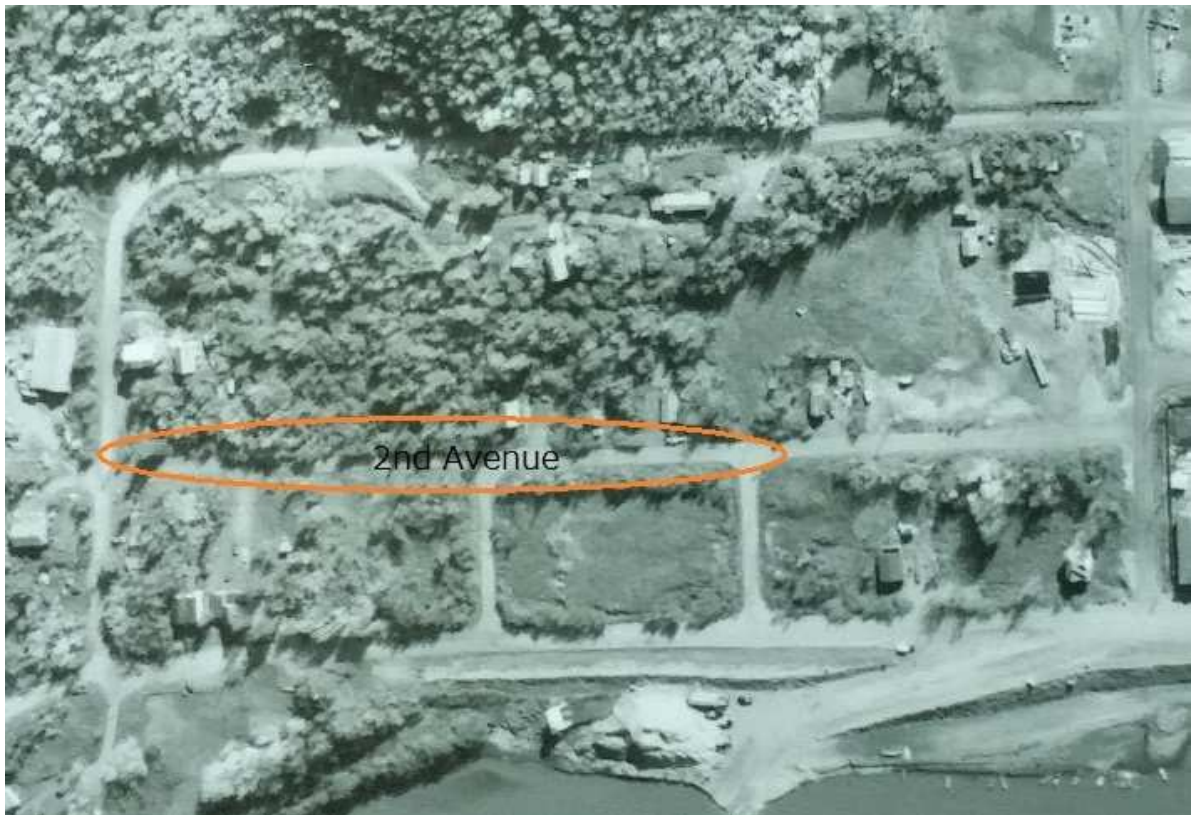
FIGURE 3 - Airphotos

Selections of the above noted aerial photographs have been attached in Figure 3. The 1993 aerial photos shows a considerable amount of clearing was conducted in the region west of 2<sup>nd</sup> Avenue and between Edward Street and George Street. This area has since become overgrown.

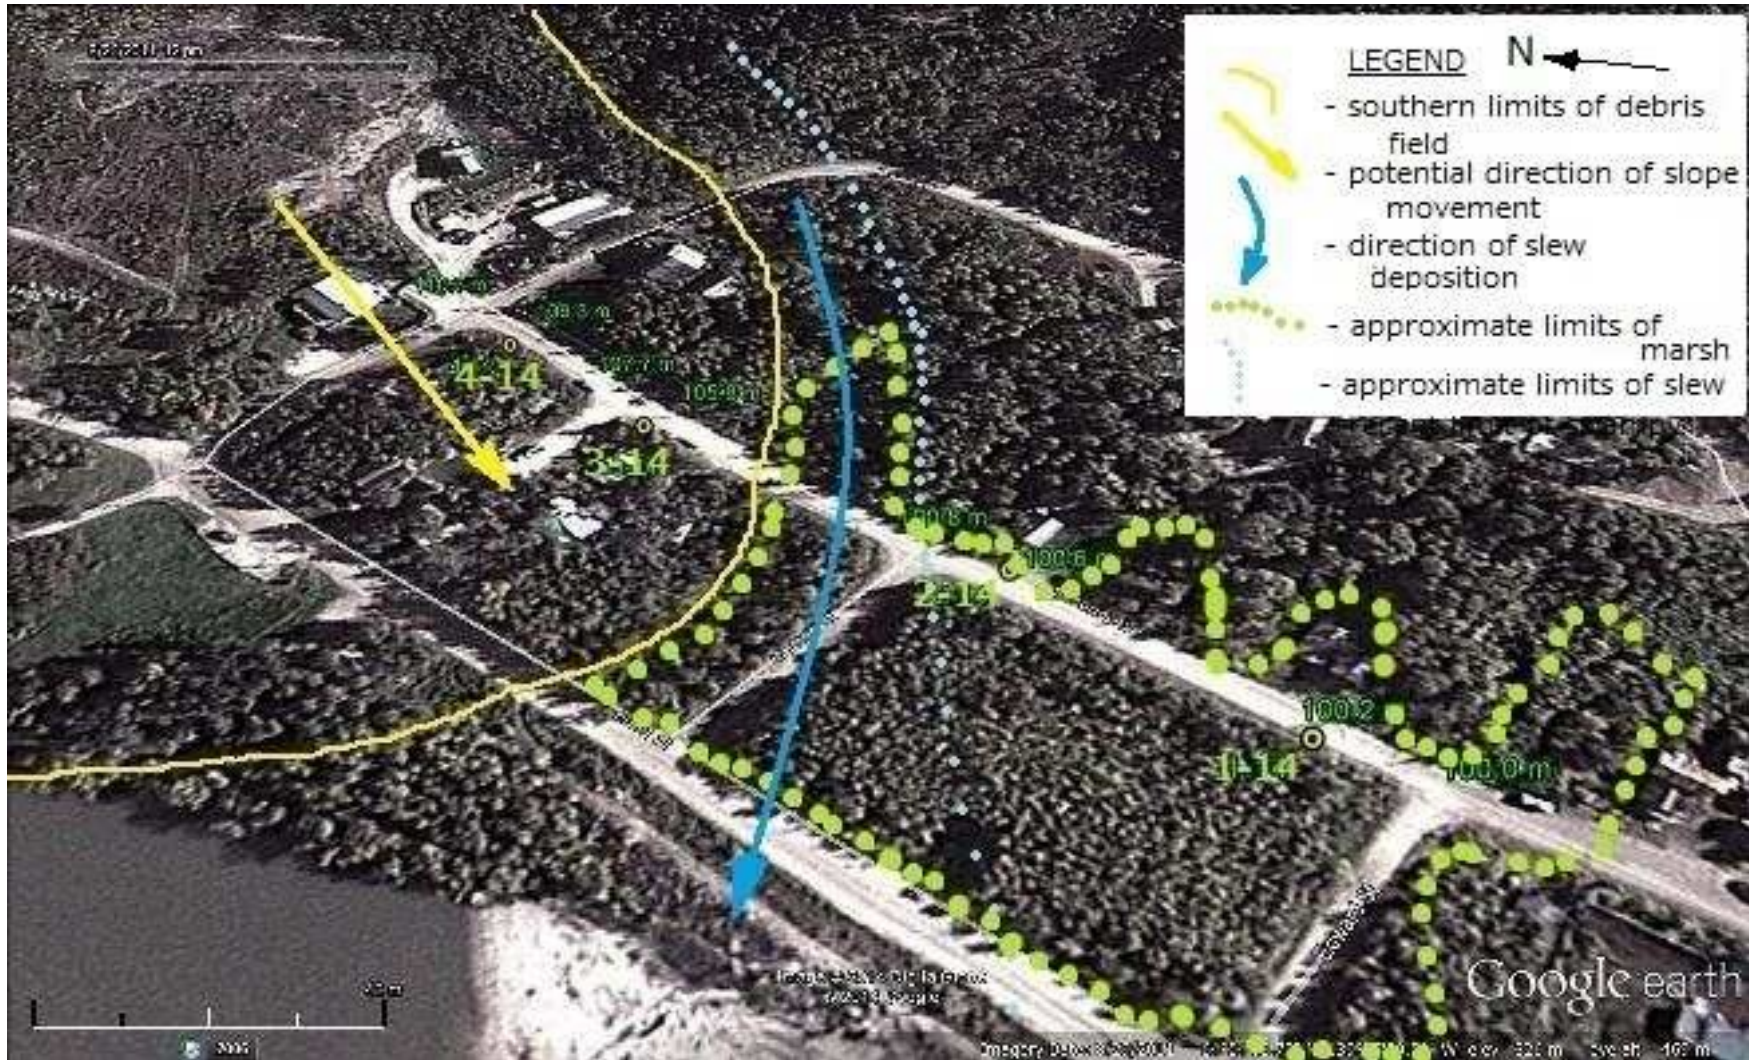
FIGURE 6 – Geomorphic Areas

The proposed development area can be separated into the approximate geomorphic areas illustrated in Figure 6. The development potential between these areas will vary dependent upon the soil and permafrost conditions. In general, the regions north of the debris field limits and other well drained areas will have reasonable residential development potential. The regions located within the marsh and poorly drained areas will be less favorable for residential development. The slew region will likely have poor development potential, particularly if thick zones of compressible organics are encountered in these areas. Larger mixed commercial/residential projects which are undertaken by private developers and/or Territorial Agencies, may provide more viable long-term development options in these regions.

As long-term creep of the soil mass is likely, the sub-surface utility design should incorporate measures to allow for generally southern to south-western movement from the regions north of the debris field limits noted in Figure 6.

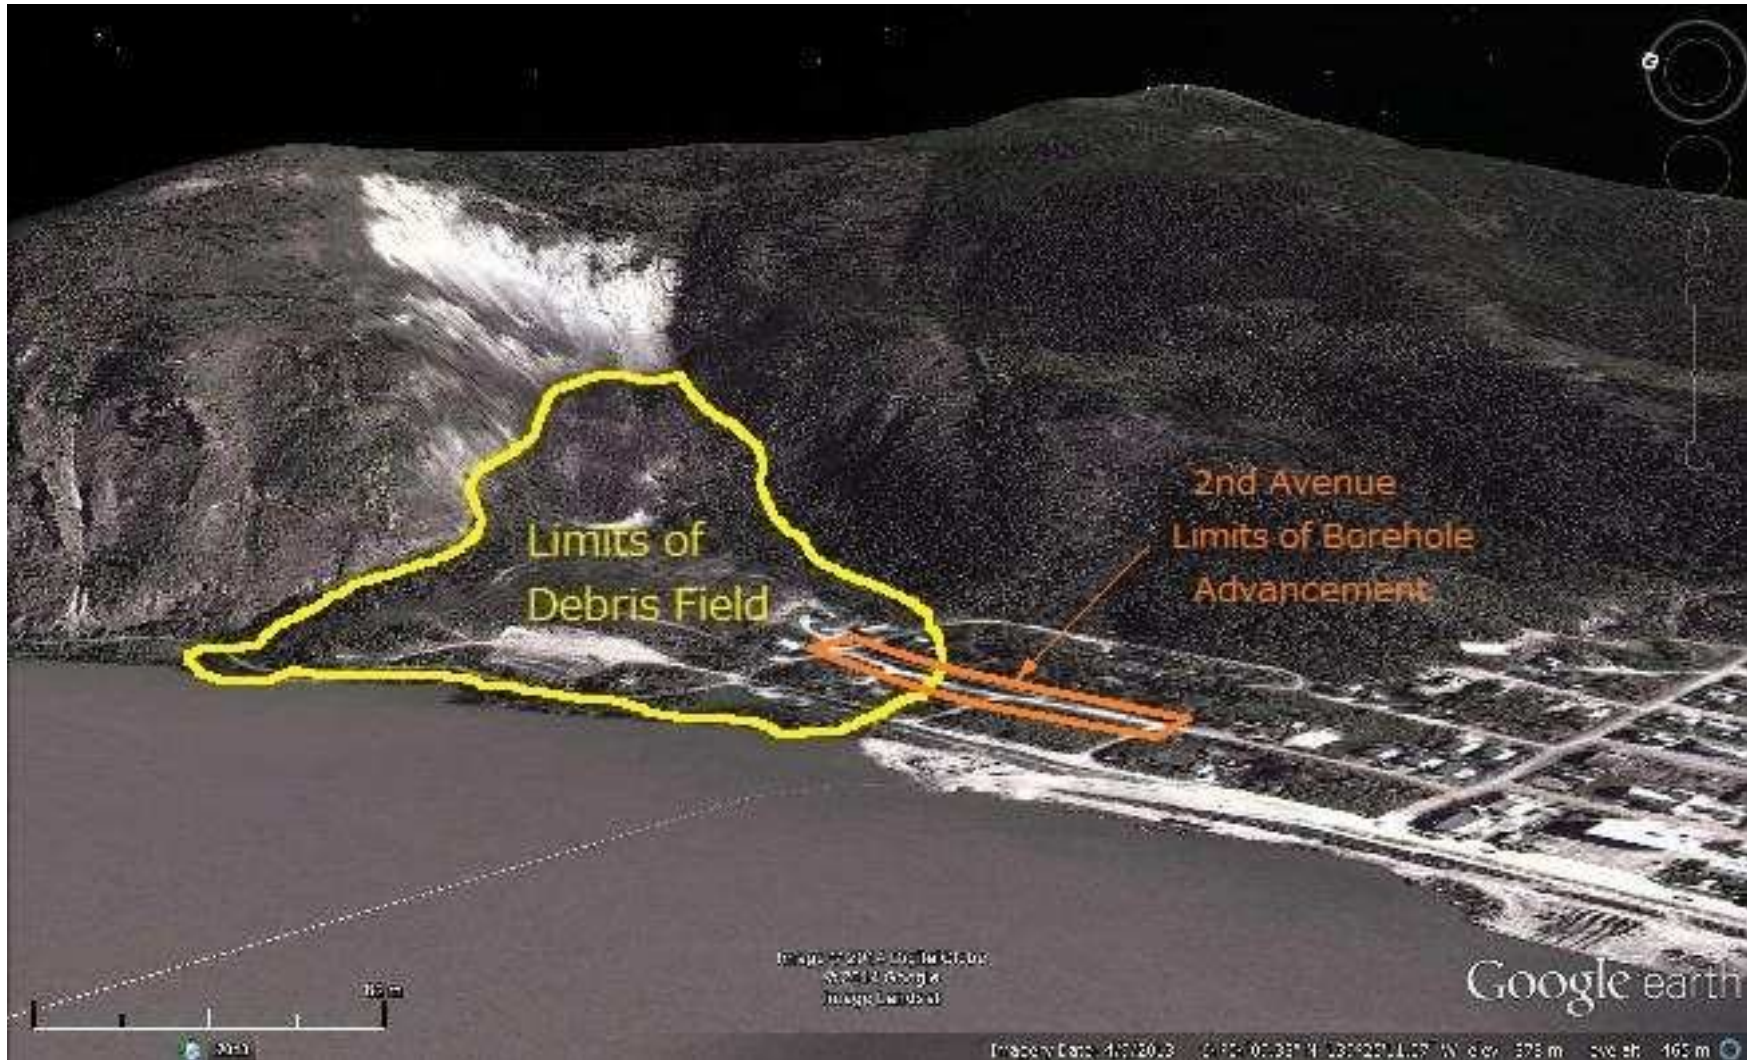
FIGURE 7 –Limits of Slide Debris Field

The site is located within the limits of a debris field which originated from a prominent slide area, the head-scarp of which is located ~ 650 meters to the north. The approximate limits of the debris field have been noted on Figure 7.

Central regions of the debris field are known to be undergoing mass wasting/creep. Creep is caused by the repeated expansion and contraction of the upper part of the regolith (weathered bedrock surface) through freeze/thaw and wetting/drying cycles. Combined with gravitational forces, this process results in slope movement in generally steep terrain, although even shallow slopes may exhibit this behavior. It is understood that central regions of the debris field are undergoing movements at a rate of up to 5 cm/year.

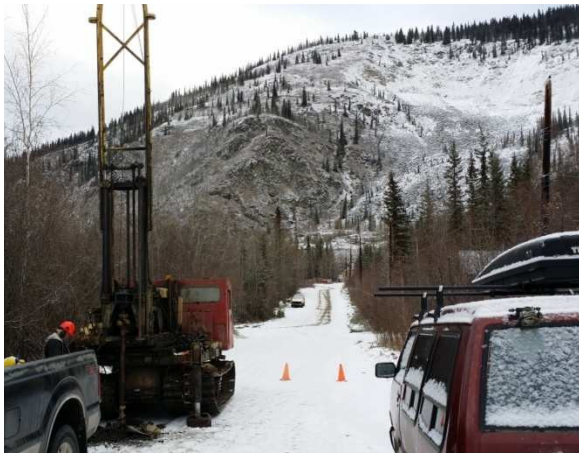
Photo # 1 (left) –BH 1-14 site conditions facing north from Edward Street.

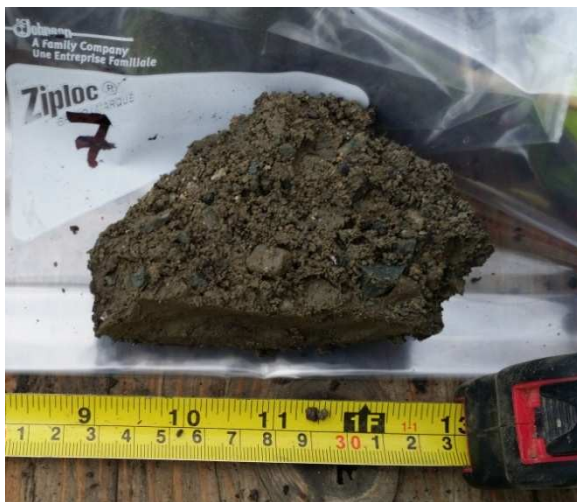
Photo # 2 (above) –BH 1-14 - Sample No.7 – Soil Unit # 4

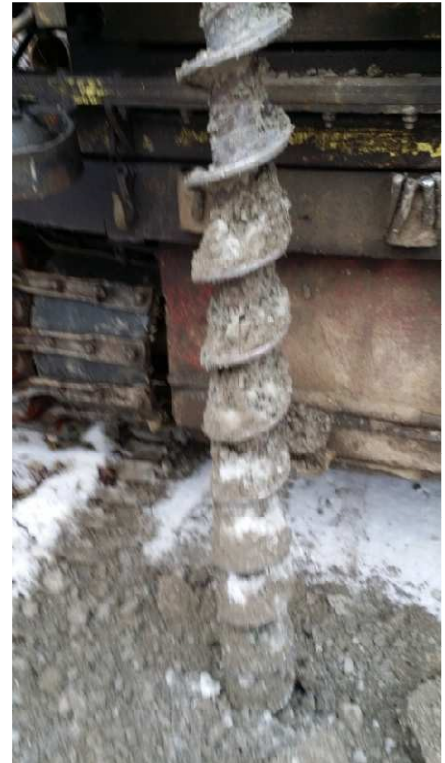
Permanently frozen soils were encountered in each of the four (4) boreholes at an average depth of 2.28 meters, but varied between 1.52 meters (BH 2-14) and 2.89 meters (BH 3-14). A granulated ice lens up to 630 mm thick was noted in BH 4-14.

Photo # 3 (above) – BH 4-14  
Ice lens @ 4.9 meters

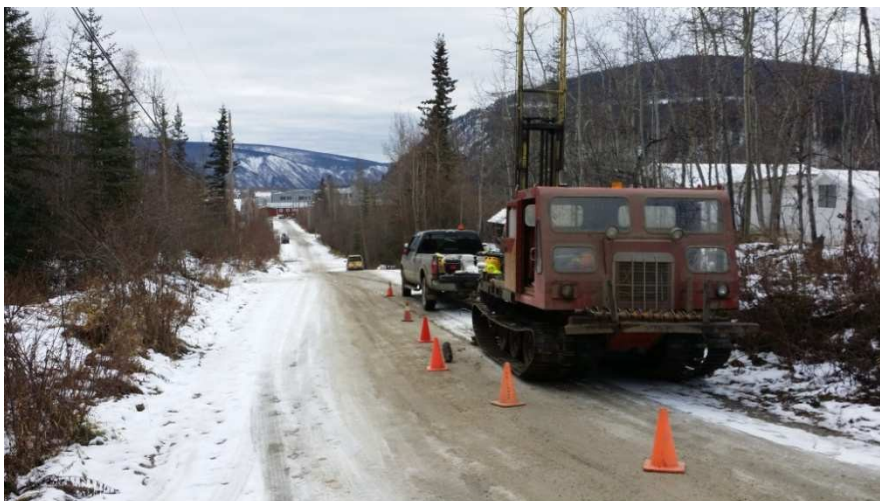
Photo # 4 (left) – BH 4-14  
Facing south from  
Judge street.
