**Geotechnical Evaluation
Geohazard Assessment
Block 4 - North End Subdivision
Dawson City, Yukon – 2017**

Prepared For: City of Dawson

Date : June 30, 2017

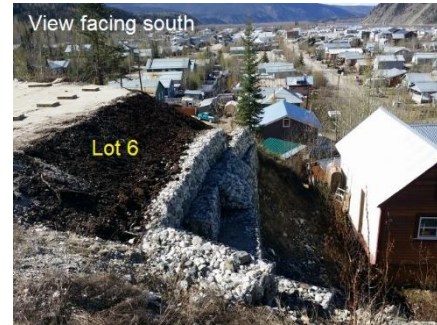
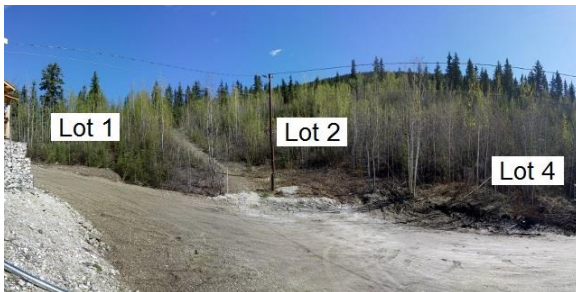
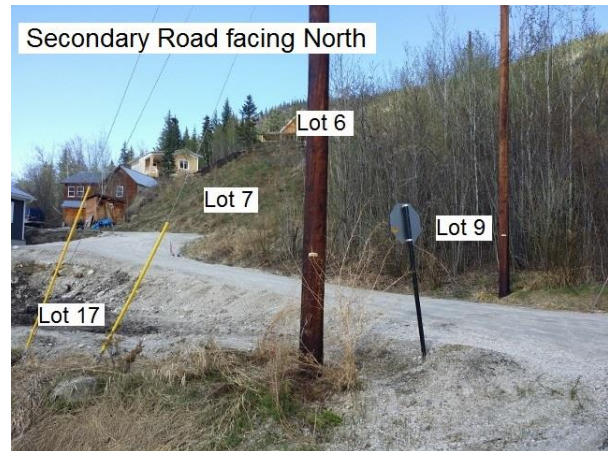
The remnants of cut-slopes which were likely created by a bulldozer were noted on Lots 2 & 4.

These lination features were oriented approximately north-south and measured in the order of 1.0-1.5 meters in height. The tree trunks in this region were noted to be slightly deformed, suggesting slope movement (possibly comprised of creep).

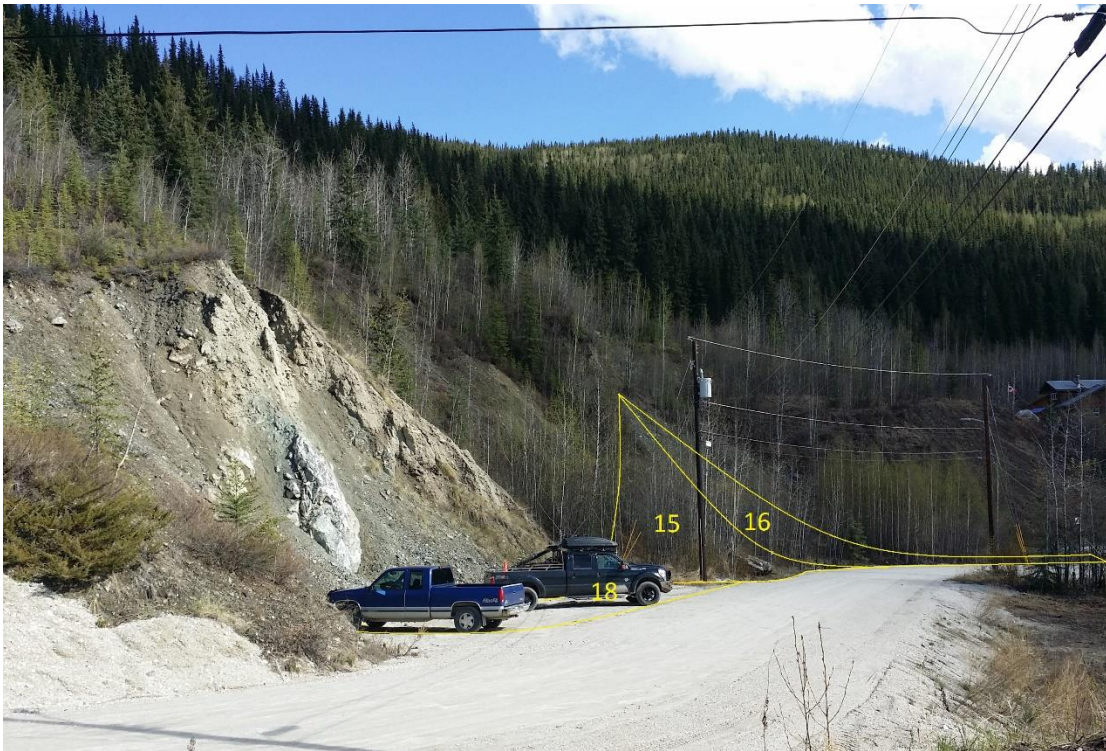
Surface drainage through the subdivision is poorly defined. Although shallow swales were established along the upper road (adjacent to Lots 3 to 6), ditches and culverts within the subdivision were not present.

Generally surface waters flow from regions of higher elevations onto regions of lower elevations towards the south-west. This surface flow is generally contained at higher elevations to rudimentary swales which are present in areas where the building lots are located at higher elevations relative to the primary road (namely Lots 1-6). Otherwise where building lots are located at lower elevations, the surface waters flow off the road shoulders onto the side slopes of the road embankment and onto the building lots. Erosion rills have formed along the roadway embankment at some of these locations (such as Lots 8 and 15).

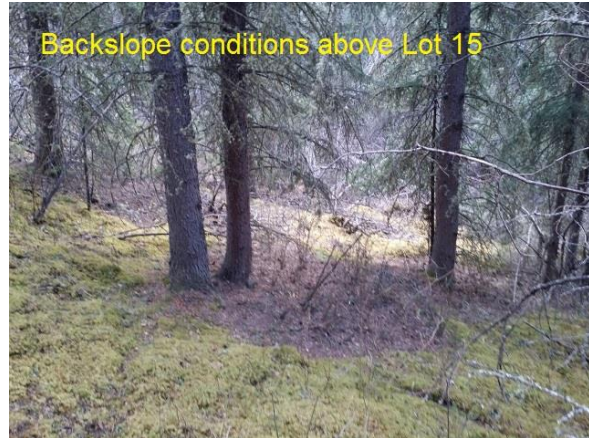
Prominent slopes lie above and extend into Lots 15 and 16. These slopes measured approximately 20 meters in height and had grades in the order of 40°. Considerably steeper slopes are located west of these lots immediately north of Lot 18. While these slopes are predominately comprised of native colluvial deposits, some regions of fill, remnant from quarry operations were noted to overlie portions of Lot 15 and Lot 18. Cobbles which had fallen down the slopes were noted along the toes of these slopes.

The 9th Avenue Trail lay directly above the steep portion of the slope and traverses the approximate north-eastern limits of the subdivision. The back-slope conditions beyond the 9th Avenue Trail alignment were dominated by a well-established forest comprised of predominately spruce trees. Thick moss and lichen were present throughout the area along with stands and lineations of willow bush.

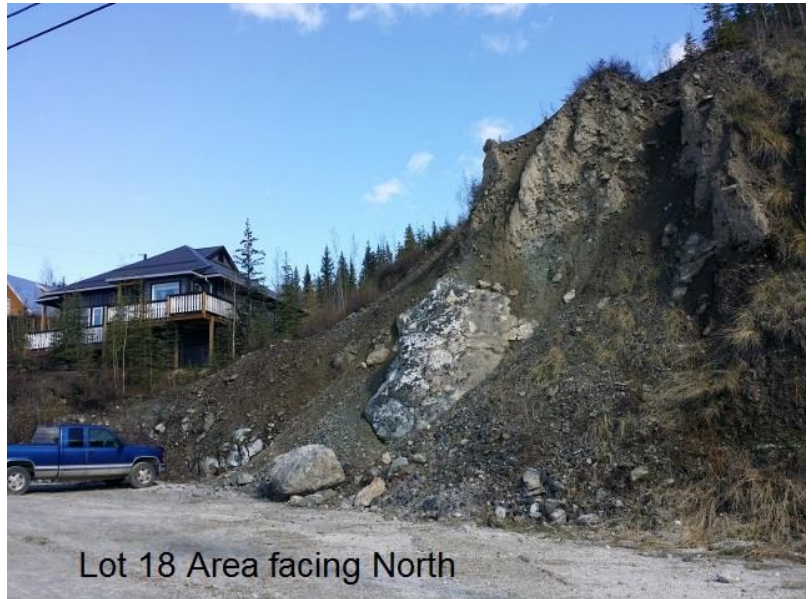
With the exception of the prominent rock feature located immediately north of Lot 18, there were no signs of competent bedrock outcrops. While we classified the rock feature as possible bedrock, it could simply be a large boulder. The terrain in regions of higher elevations within the subdivision however, is likely bedrock controlled as evidence by the composition of the exposed colluvial ground surface.

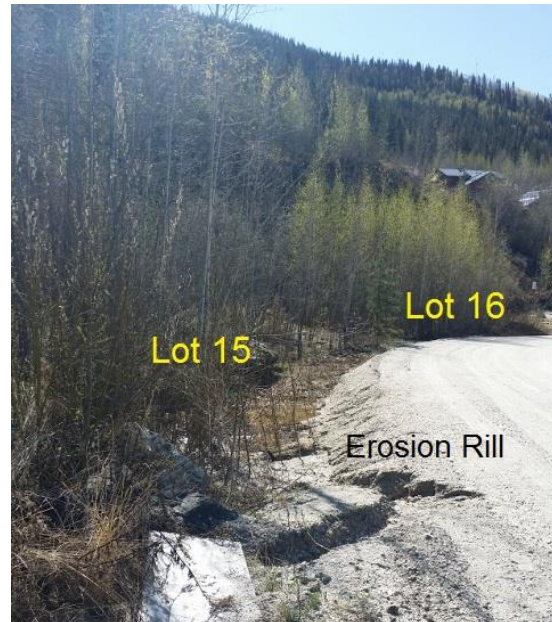
The surface drainage along some portions of the road would be considered poor, particularly where the road has been established at higher elevations relative to adjacent lots. Erosion rills were noted in the road side slopes along Lots 8, 10, 15 & 16.

As such, Lots 15 and 16 could be filled to prevent surface water from impacting the lots and road side-slopes. As the topography will not allow for this at Lots 8 and 10, the road side-slopes should instead be armored with drain rock if seeding is not sufficient to prevent erosion. The water at the base of the side-slopes in Lots 8 and 10 (amongst others) would need to be redirected and managed accordingly.

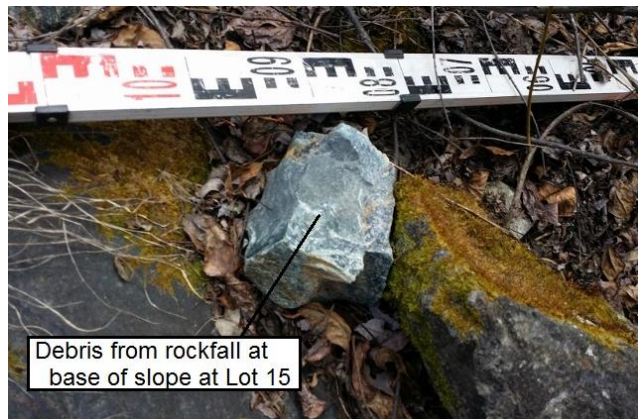
Propability of Occurance: Probable to Remote
Level of Risk: Minor to Catastrophic

Rockfall is occurring where steeper slopes are present above Lots 15, 16 & 18. Rockfall is more likely in these areas during poor weather (rain/precipitation) and the spring freshet and so exposure to regions located at the toe of these slopes should be minimized during these times. While most of the rockfall would present only a minor hazard (relative to building structures), the risk factor would increase significantly relative to the size of the rock or if people are directly exposed.

While it appears the majority of the rockfall is being restrained by the presence of trees located at the toes of the respective slopes, fences should be established along Lots 15, 16 & 18 as an added precaution. Ideally, the trees located along the toe of these slopes should not be removed given the protection they afford.

The use of fences along Lots 2, 4 and 5 should be considered on a case-by-case basis depending upon the nature of lot development.

The fences should be robust and tall enough to minimize the impacts of rockfall. Chain-link fences are commonly ideal for this purpose.

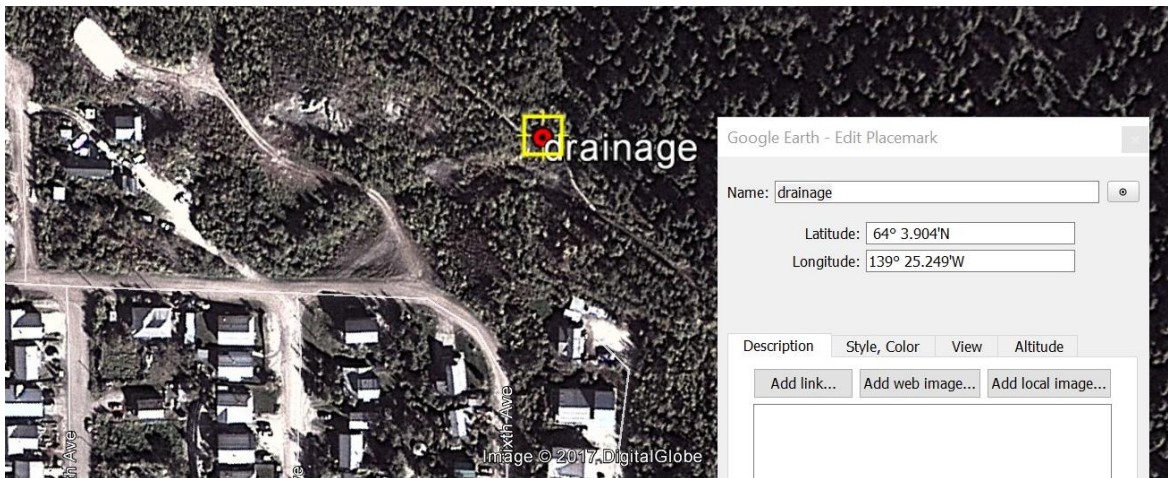
Loose fill materials which are remnants of the quarry operations were noted on the slopes which overlie Lots 15, 16 and 18. This material is unconsolidated and is undergoing erosion. As such, the lots which lie below these materials may be impacted from the downward migration of eroded materials. While eroded material will gravitate down-slope in minor amounts over time, the release of larger volumes of materials may occur and so this should be considered (see Landslides / Slope Failures below).

Portions of the 9th Avenue Trail above Lot 15 intercepted downslope surface drainage above the development and redirected the flow to the east. Future trail upgrades should consider managing this drainage accordingly to minimize down-slope impacts. This surface flow discharged from the trail at the approximate location noted below.

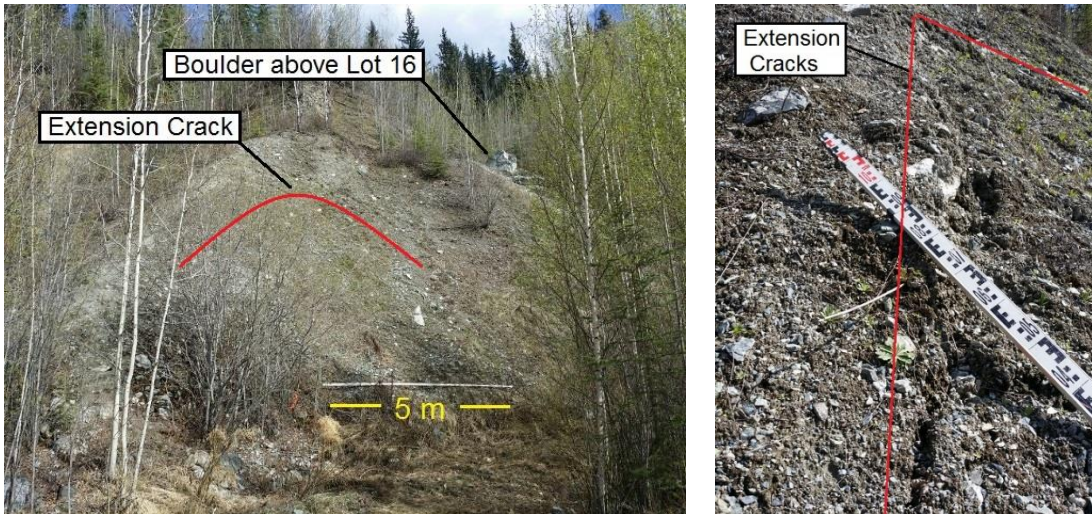
Propability of Occurance: Remote to Extremely Remote
Level of Risk: Hazardous to Catastrophic

Given the presence of steep slopes in the regions of Lot 15, 16 & 18, additional consideration will be required if these lots are to be utilized. Extension cracks (which are evidence of slope movement) are visible on the slope which lies on the boundary between Lots 15 & 16. These cracks were noted to be in the order of 3 cm wide and originate from a headscarp which measured in the order of 10 cm in height.

As such, the residences on these two lots should be carefully situated to avoid the potential runout zone as follows;

The residence on Lot 15 should be located as far to the west as possible to allow for a buffer from the lot 15/16 boundary. This buffer is necessary to reduce the potential that debris from a slope failure would impact the residential structure.

As Lot 18 is being utilized for overflow parking, a simple barrier comprised of concrete lock blocks, jersey barriers or large (1.5 m +/-) boulders should be established at the base of the slope to reduce the risks which may be associated with failure/erosion of the slope in this region.

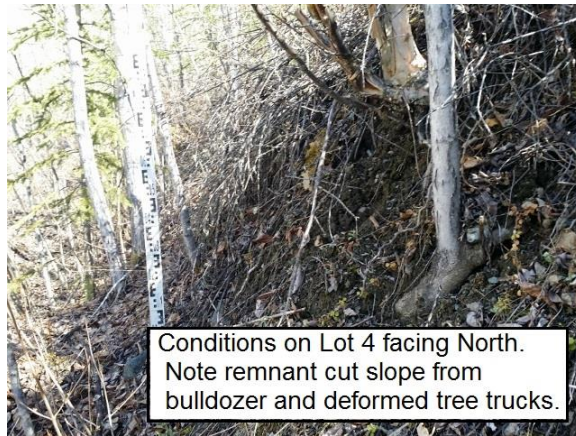
Level of Risk: Minor to Major

Creep appears to be ongoing where steep slopes are present, particularly Lots 2, 4, 15 and 16. The impacts the 1-5 cm/year rates of movement will have upon infrastructure will vary over time.

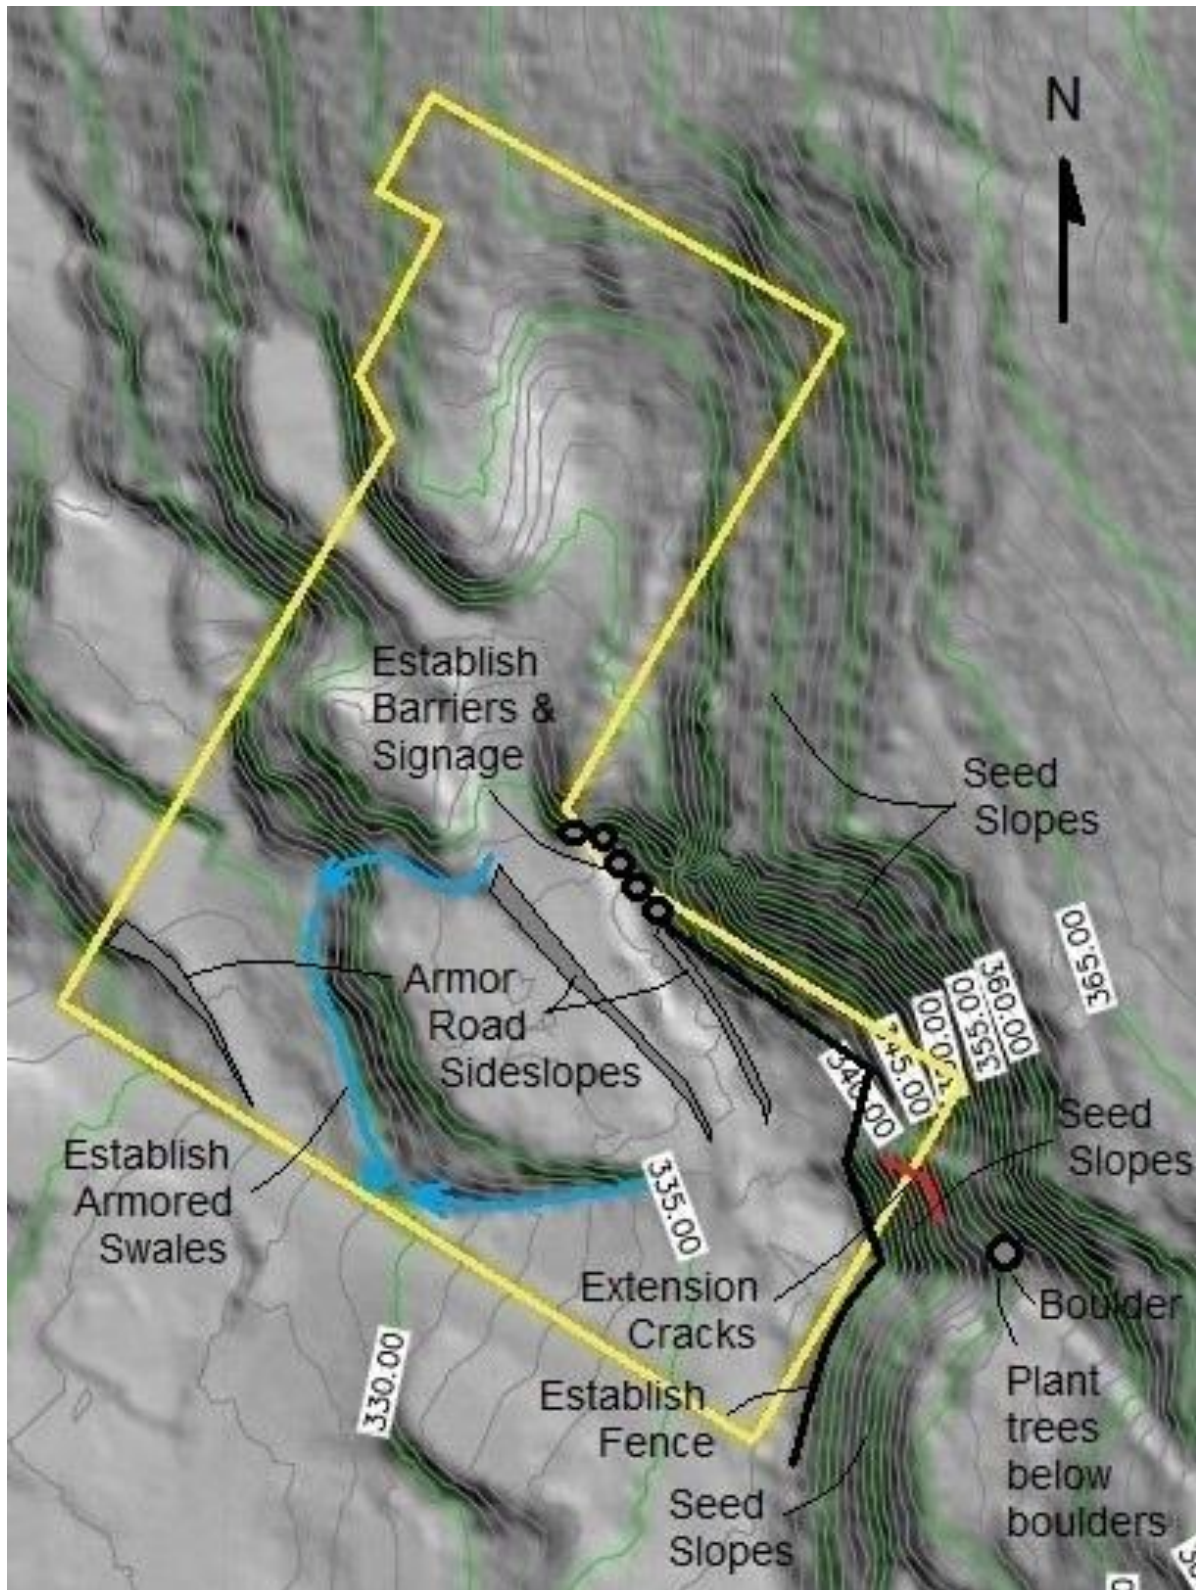
Geotechnical Evaluation – Geohazard Assessment
Block 4 North End Subdivision – Dawson City, Yukon – 2017
Figure 7 – Proposed Hazard Mitigation Plan

The location of these extension cracks has been noted in Figure 7.

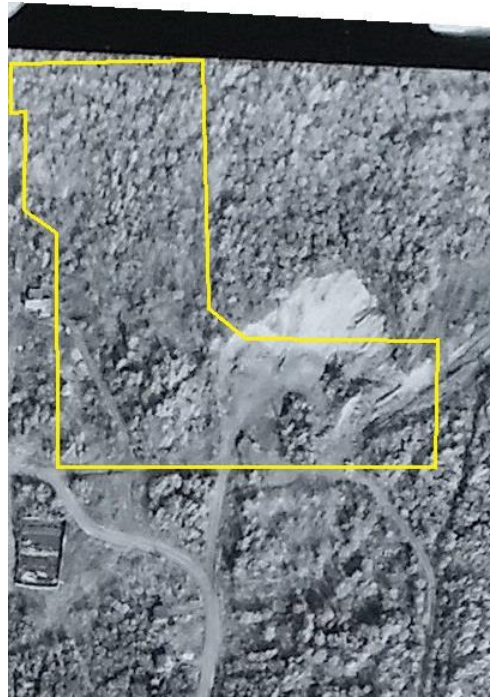
1970 – A22199 – Quarry activities can be noted within Lots 15/16 & 18. The activities appear to comprised of bull-dozer pushes which originate immediately beyond the north-east corner of Lot 15/16. A cul-de-sac trail terminates in the area of Lot 18.
