# CHILKOOT GEOLOGICAL ENGINEERS LTD.

## **Geotechnical Evaluation Lot 27 – Dredge Pond Subdivision (99-0199 LTO) Dawson City, Yukon – 2015**

**Prepared For:** Yukon Government – Energy, Mines & Resources  
**Date :** September 8, 2015  
**Project No:** 200-006-15

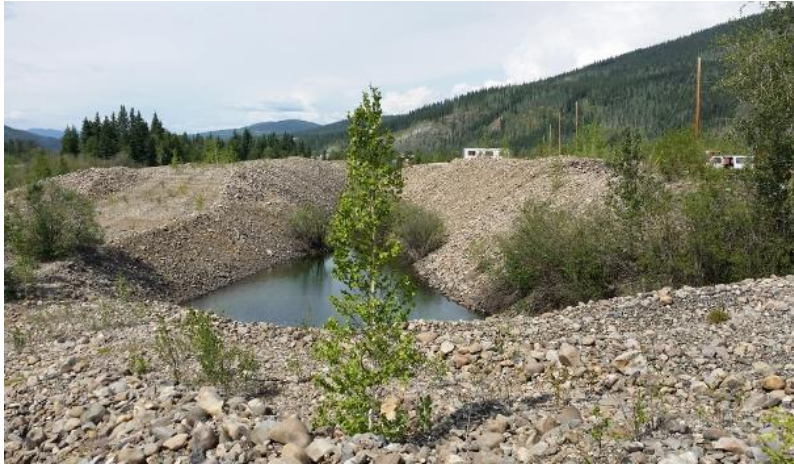
Photo # 1 – Eastern pond conditions facing west

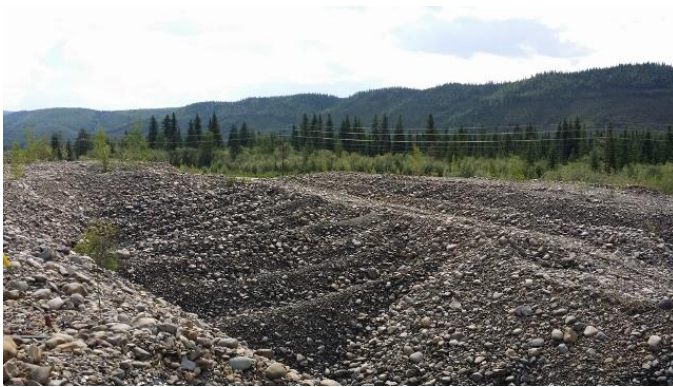
At present, although essentially undeveloped, there is a region where a portion of the tailings have been levelled and where someone has been storing a variety of derelict pick-up trucks as well as other mechanical supplies such as boat motors, engines and other similar types of automotive/boating parts. A small wooden shed, which may have at one time been utilized to store hunting meat, is also located amongst the vehicles and debris. In addition, there are two cat trails which have been advanced into the property along the southern periphery and from the west side of the property.

Photo # 2 – Site conditions facing north-west

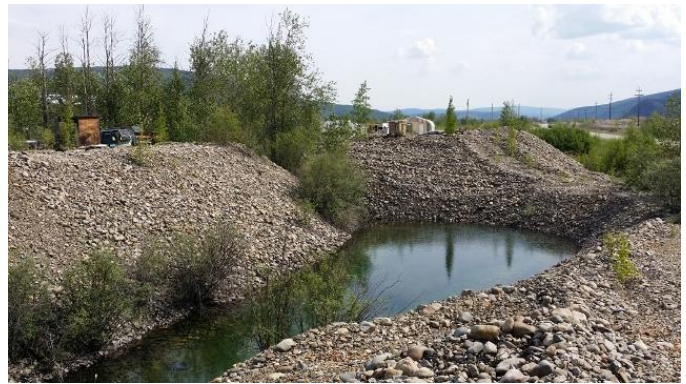
Photo # 3 – Eastern pond facing east.

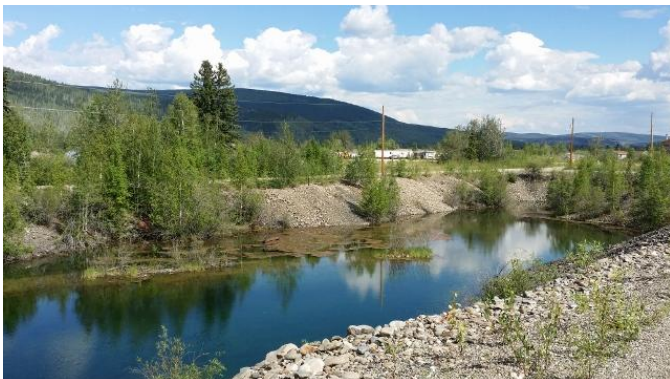
Photo # 4 - Conditions across Pay Dirt Way facing south-east

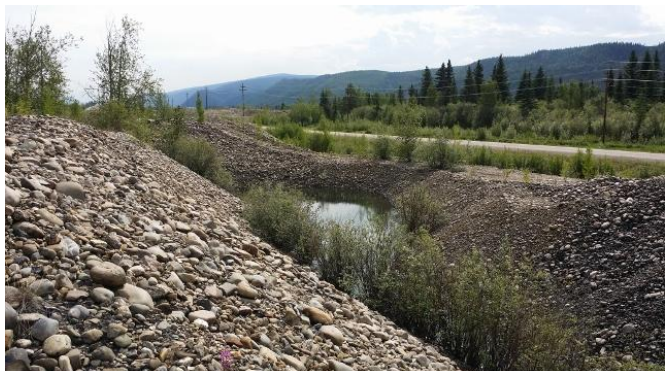
Photo # 5 - Conditions facing south-east towards Klondike Highway # 2
