CHILKOOT GEOLOGICAL ENGINEERS LTD.

Geotechnical Evaluation Proposed North End Subdivision Dawson City, Yukon – 2016

Prepared For: Yukon Government – Energy, Mines and Resources

Date : September 18, 2016

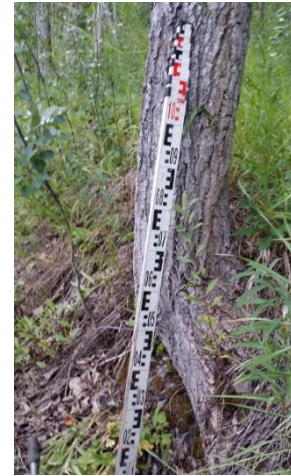
Creep is caused by the repeated expansion and contraction of the upper part of the regolith (weathered bedrock surface) or other colluvial derived materials through repeated freeze/thaw and/or wetting/drying cycles. Combined with gravitational forces, this intermittent/seasonal process results in slope movement in generally steep terrain, although even shallow angled slopes may exhibit this behavior.

Typical tree trunk deformation.

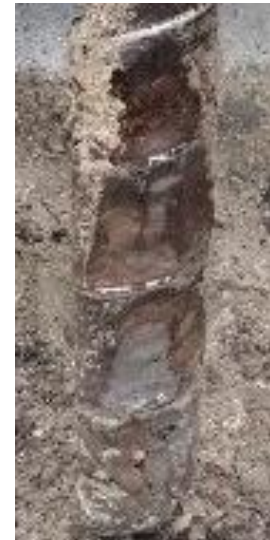
The fluvial channel deposits were comprised of sequences of fine grained non-plastic grey silts which contained varying amounts of sand and gravel or else dark grey low-plastic clayey silt to sandy silty clays. On average, the grey silts were classified as sandy silt which contained up to some gravel.

*Organics (Unit #2) over
Fluvial silt (Unit #3)*

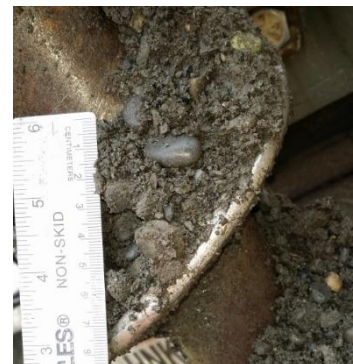
The fluvial valley deposits were comprised of clean coarse grained granular deposits which are known to contain cobbles and boulders. These deposits are extremely dense and are generally known to be frozen and thaw stable. These materials comprise a base gravel unit upon which the overlying compressible and unstable thaw susceptible (Unit # 2 and # 3) materials lie.

*Fluvial valley deposits (Unit # 4)
BH 1-16*

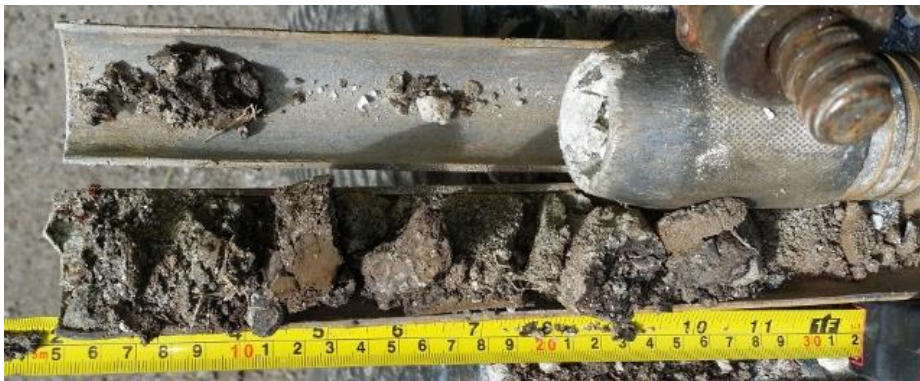
The coarse grained slide rubble was encountered in BH 4-16 through BH 6-16 immediately below Unit # 1 fill materials at an average depth of 1.02 meters.

BH 4-16 - Sample No.33 – Unit # 5a Colluvial Slide Debris

The moisture content of the rubble averaged 5.8% (but varied between 2.8% and 10.1%), indicating generally damp conditions.

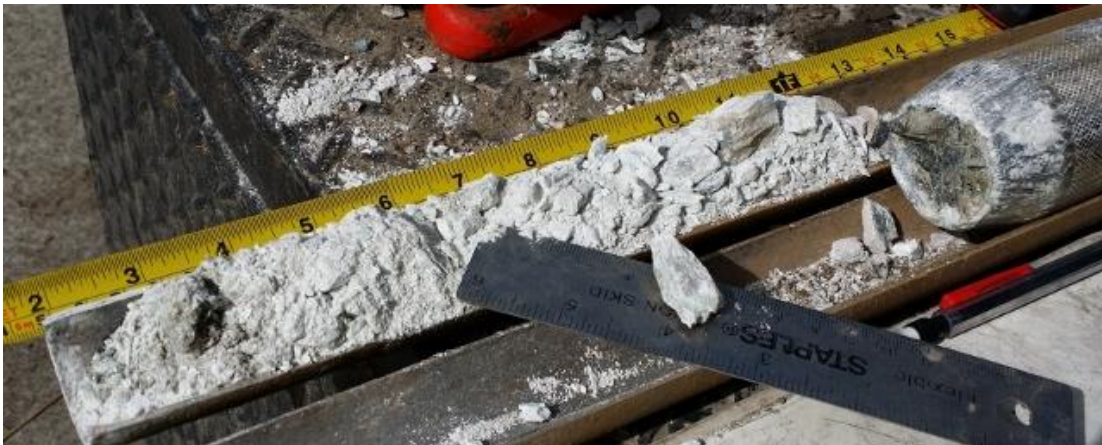
The fine grained decomposed slide rubble was encountered in BH 4-16 and BH 5-16 immediately below Unit # 5a rubble at an average depth of 4.73 meters. This is similar to BH 4-14 (advanced on 2nd Avenue) where the decomposed slide rubble was encountered at a depth of 5.51 meters.

BH 4-16 – Sample No.34 – Unit # 5b Colluvial Slide Debris

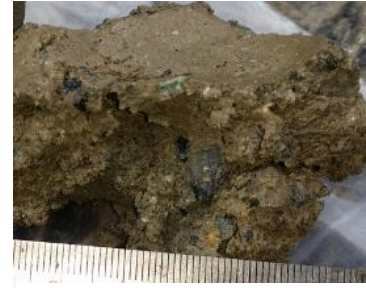
Sample No.42, which was located at the interface with the overlying coarse grained slide rubble, was a diamicton classified as a gravelly silty sand and may be remnants of colluvial apron materials which were deposited between the 1st and 2nd slide events. The depth of this sample may coincide with the base of the 2nd slide event.

*BH 5-16 – Sample No.42
Remnants of Colluvial Apron Deposits*

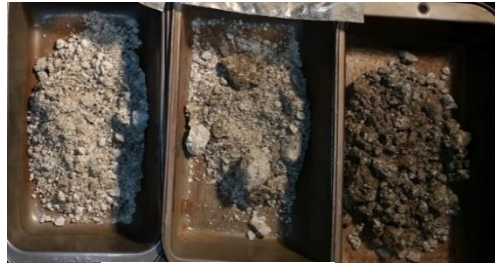
Sample No. 47, 48 & 49

Sample No. 49, which was retained from the base of BH 5-16, was classified as a silty sand with some gravel and may also be remnants of the original native deposits intermixed with the slide rubble from the 1st slide event.

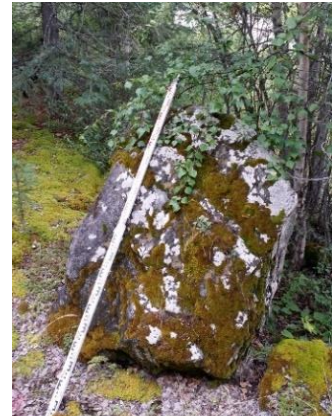
The odd surficial boulder was noted along the Yukon River (west of Front Street and north of George Street) and near Judge Street.

Boulder along Judge Street – Area 26

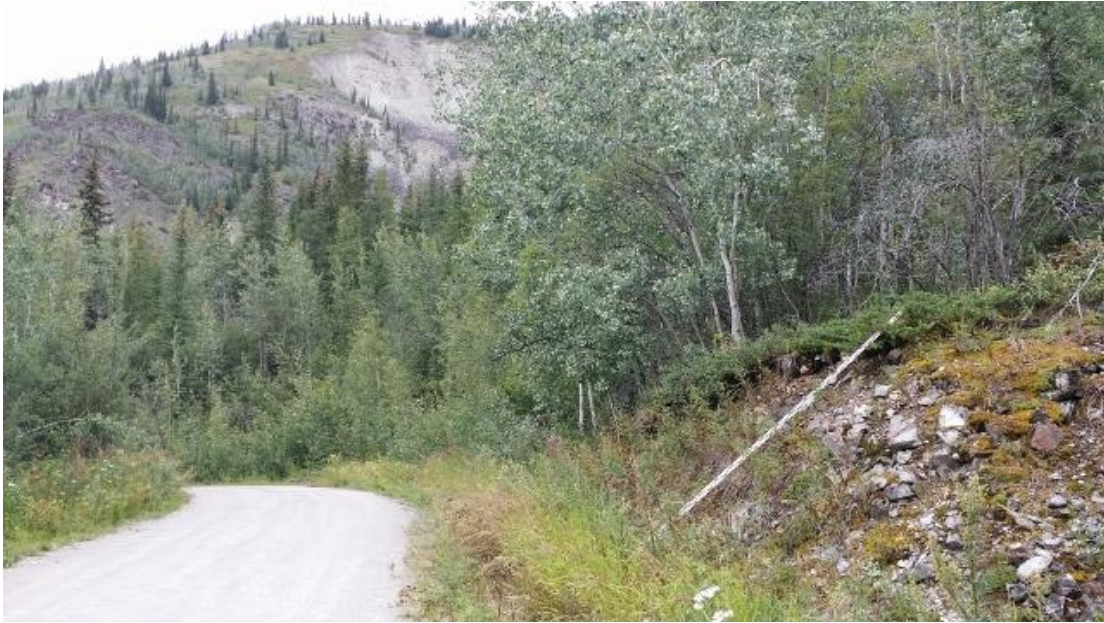
There was no indication of bedrock within any of the boreholes which were advanced. Locally however, bedrock may be present near (north-south) Judge Street where the topography appears to be bedrock controlled.

View of north-east corner of Judge Street facing north.

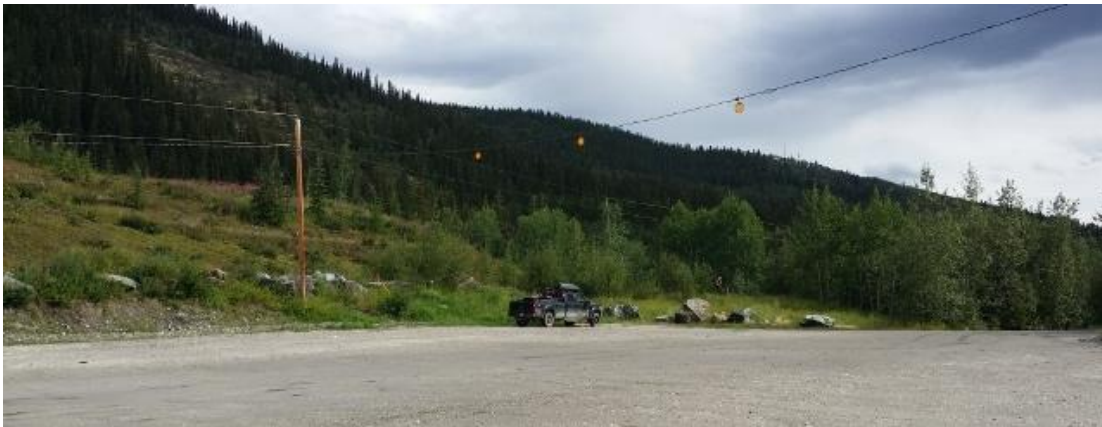
View of Area # 1 facing east and Area # 3.

This use of this area, located on the toe of slide, should continue to be utilized as an intermittent public use area. While public washrooms or storage sheds could be constructed, permanent public use structures should not be constructed in this area as it is located in a slide/rockfall run-out zone.

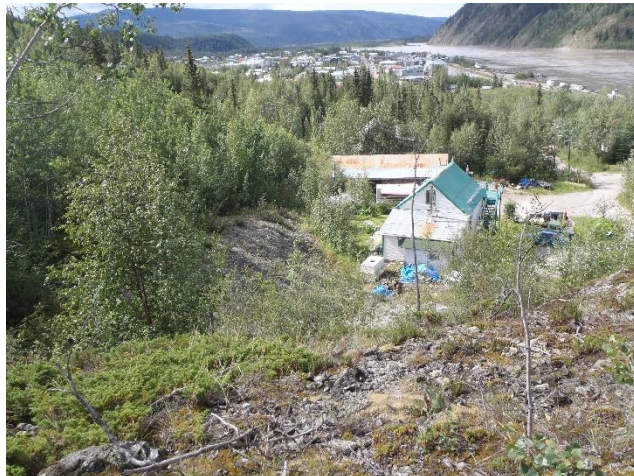
View of study area facing south-west. Area # 9 in foreground.

These areas are comprised of backslopes and should not be developed. They could be attached to residential lots located to their south to serve as lot extensions. The existing trees should not be removed as they may serve as protection from potential rockfall hazards.

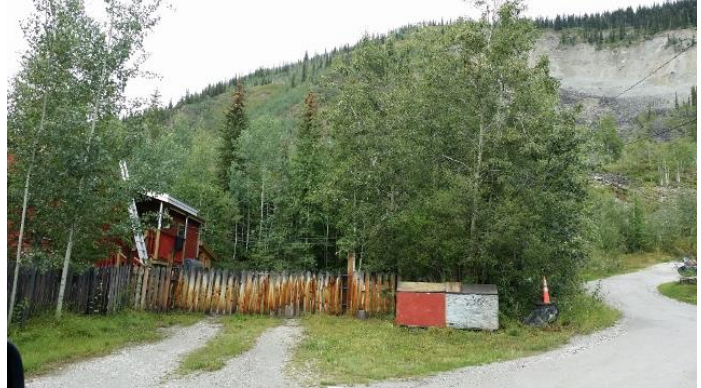
View of Area # 8 facing north.

Although this area appears to be a road extension to 2nd Avenue, it could be rezoned and utilized as a residential lot. Development should be limited to the southern realms of site as the northern realms are comprised of a backslope where rockfall hazards may exist. Additional assessment will be required to assess the use of this area as it appears to be predominately comprised of a yard belonging to a residence located to the west.

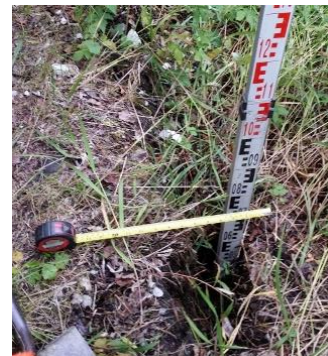
This area denotes a 30 meter wide geotechnical setback from the toe of the slide debris and Yukon River. Development should not be allowed in this region. Extension cracks and tree trunk deformation indicating active slope movement were noted along the trail which traverses the area.

Extension crack along Area # 11

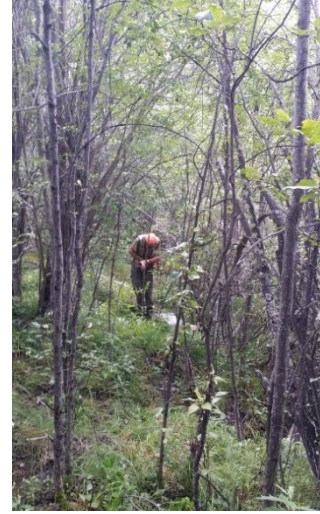
Site conditions near Auger Hole No.9

Additional consideration will be required if road access will advance through the above noted areas as a side-cut into the up-slope (east) side of the road should be avoided. A cut into the slope will increase the rate of movement of soils which are undergoing creep. If possible, the road should be constructed entirely through fill placement. The side-slopes of the roadway should be well armored to allow for the flow of surface waters as ditches should not be excavated into the colluvial deposits.

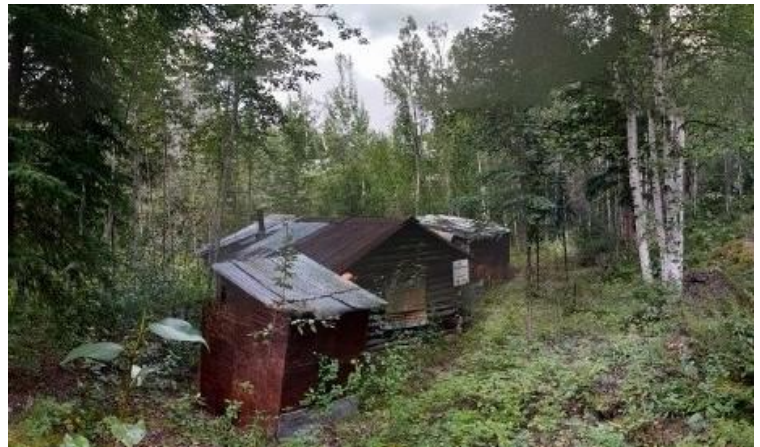
There were two cabins and an outhouse (which appeared to be of historical value) located on these lots. The western portions of the lot could allow for visitor parking from the Steele Avenue cul-de-sac described in Area 19. Lot 10 Block F in this area will otherwise be suitable for residential construction.

View of cabins in Area # 20 facing north-west.

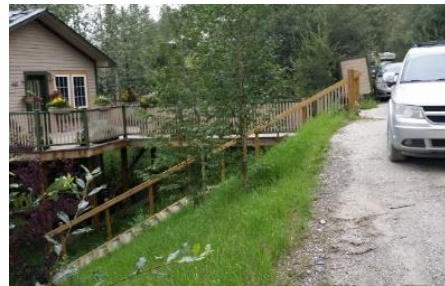
Residence access along 8th Avenue.

These lots will be suitable for residential lot development. The lots located on the east side of this area may be accessible from Judge Street depending upon residential building design and site access requirements. Several residences located in other regions of Dawson have accommodated these sloping areas through the construction of elevated walkways.

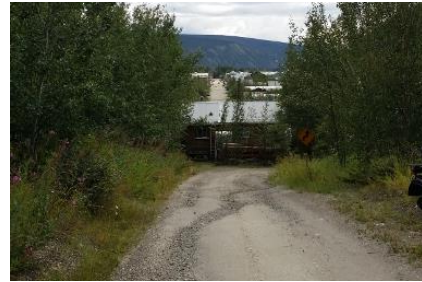
View of Judge Street facing south.

As per the other roads in the study area, Judge Street will require upgrading to residential standards. Several residences utilize this roadway for lot access.
