**Geotechnical Reconnaissance
Lot 1191 Henderson Corner (2014-0027 LTO)
Dawson City, Yukon – 2016**

Prepared For: Yukon Government – Energy, Mines & Resources
Date : August 17, 2016

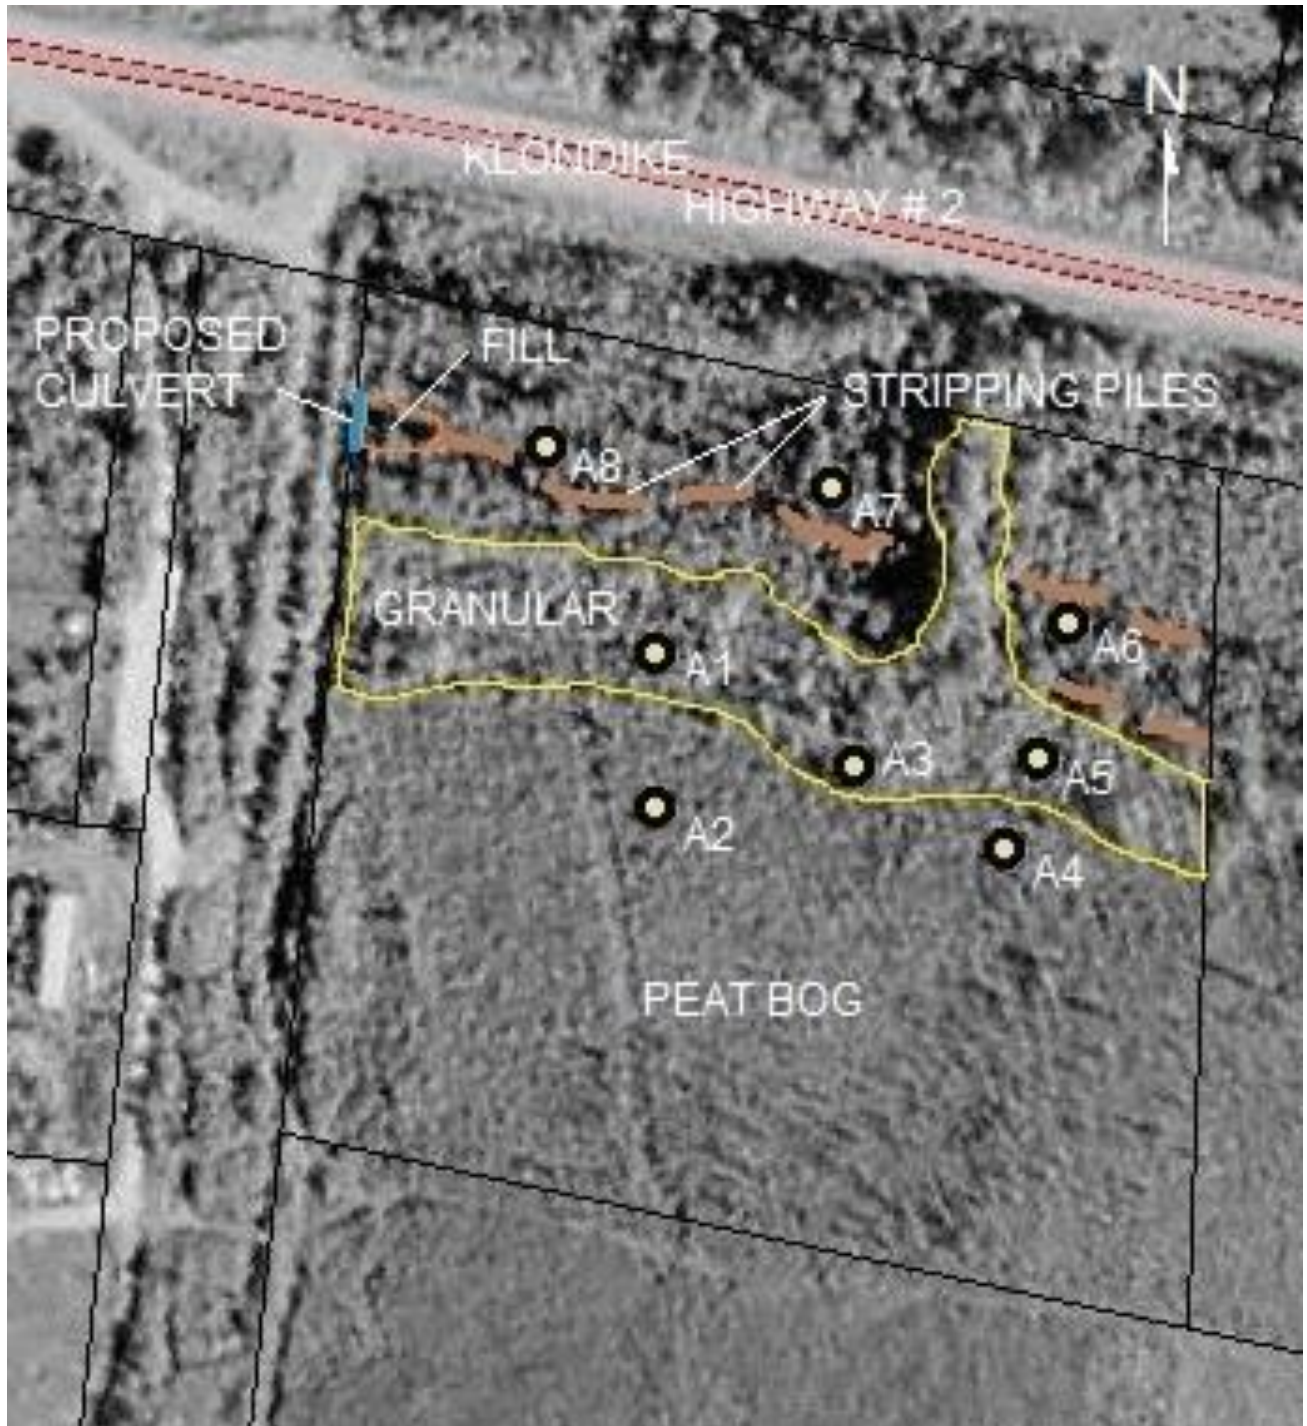
FIGURE 2 – Sampling Locations

Standing water is prevalent throughout the hummocky bog region located in the southern half of the subject property. A drainage ditch is located on/adjacent to the western side of the property. The drainage within the ditch flows to the north until it is blocked by fill located near the northwest corner of the site (as noted in Figure 2).

A series of stripping piles were observed along the northern periphery of the granular region as noted in Figure 2. These piles are likely remnants from clearing/stripping operations conducted during construction of the Klondike Highway.

A culvert should be installed at the location where the ditch (or local drainage) is blocked and at any other proposed access to the site, to allow for proper regional and site drainage.

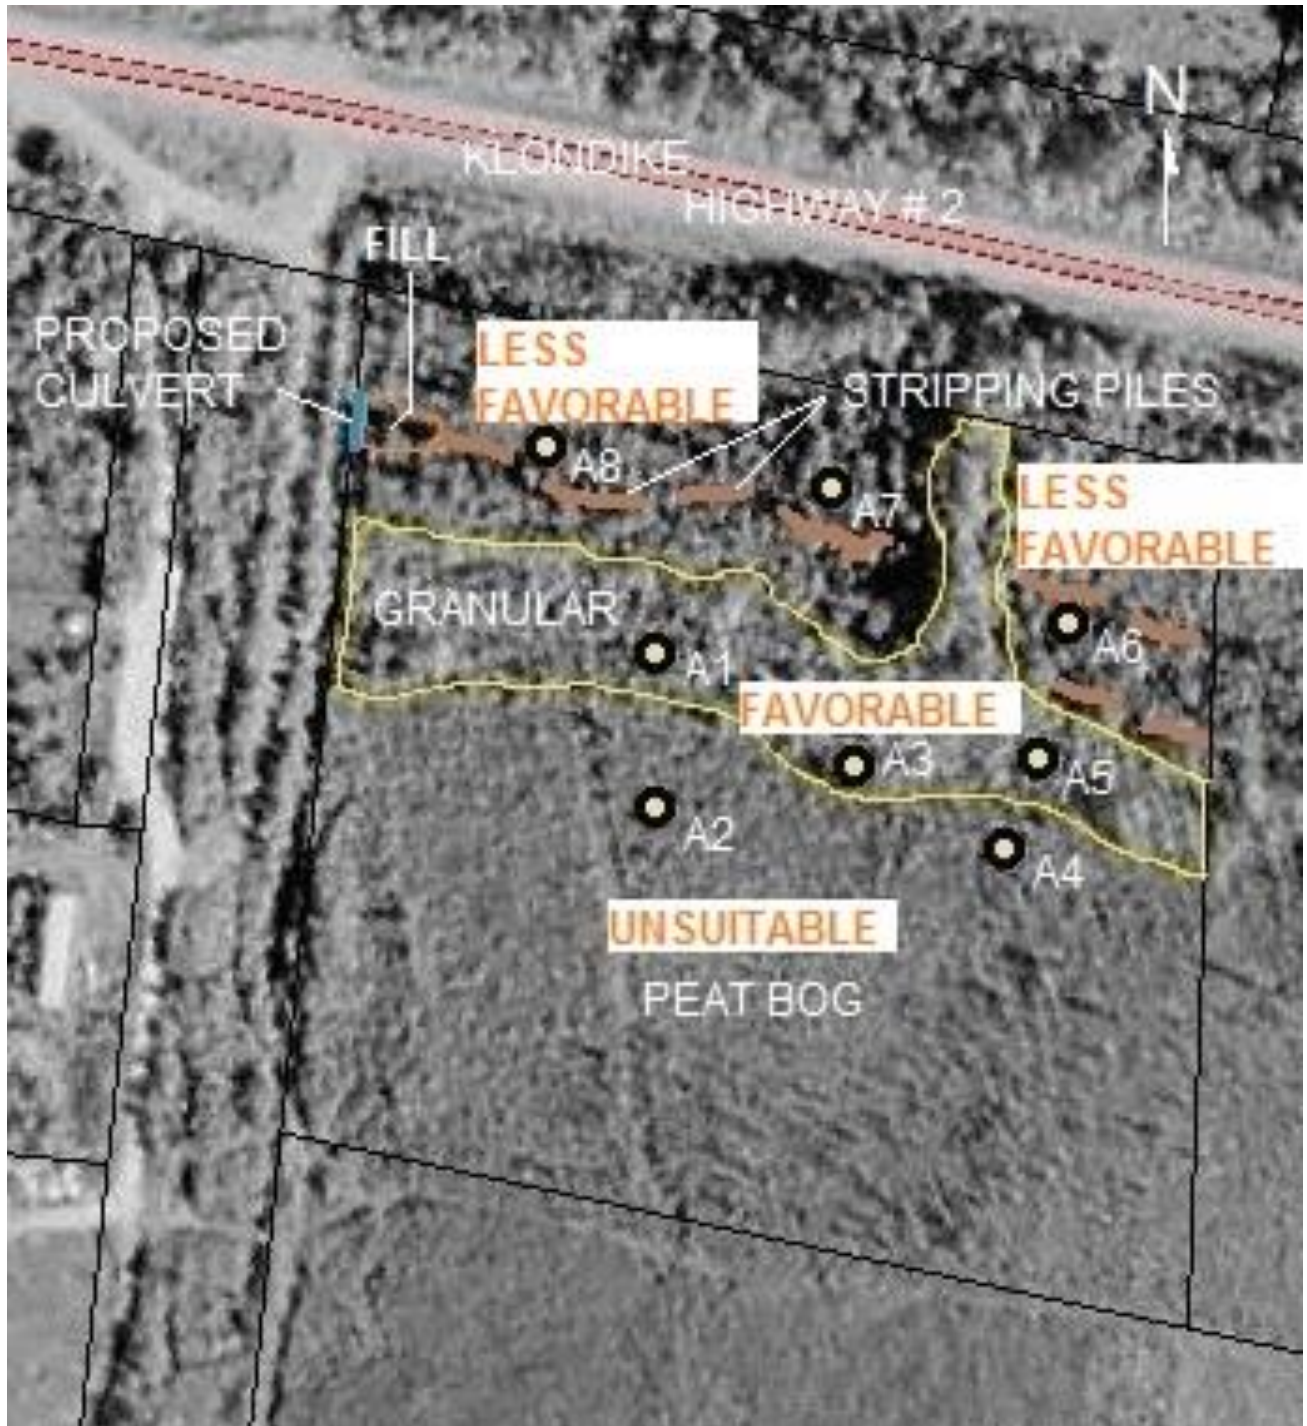
FIGURE 4 – Residential Development Feasibility

Relative to residential development feasibility, there are three distinct regions located within the subject property as noted in Figure 4.

- a central granular region where residential development would be considered favorable,
- a low lying area (located north of a central granular region), where residential development feasibility would be considered less favorable, and
- a peat bog which is unsuitable for residential development.

The central granular region (which will be suitable to allow for residential development) is in the order of 25 meters wide (\pm) and appears to span the entire width of the property (east-west). While a small region of this granular material may extend north into the low lying region, this (north-south) zone should be considered less favorable for development as it is thinner and may be discontinuous. Additional evaluation would be required to determine whether or not the granular soils will be suitable to allow for construction of a septic field as they may be frozen at depth. The use of a septic holding tank should be anticipated.

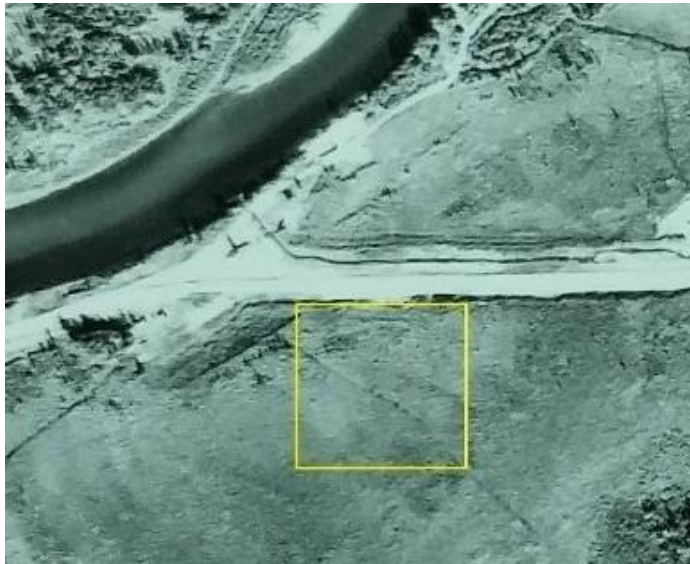
Historically, the site and much of the valley region were void of trees as noted in the 1960 and 1977 air photos. These trees would likely have been removed since the time of the Gold Rush to help fuel Dawson. The lack of tree cover would have helped to

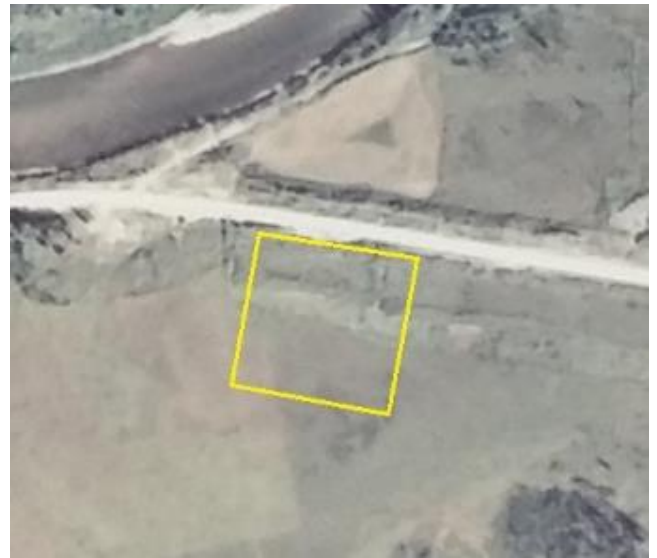
The 1960 and 1977 air photos noted that the site and much of the surrounding area was generally void of trees. A centrally located granular region traversing the site (east-west) can be seen as evidenced by the lighter colored band in the 1977 air photo.

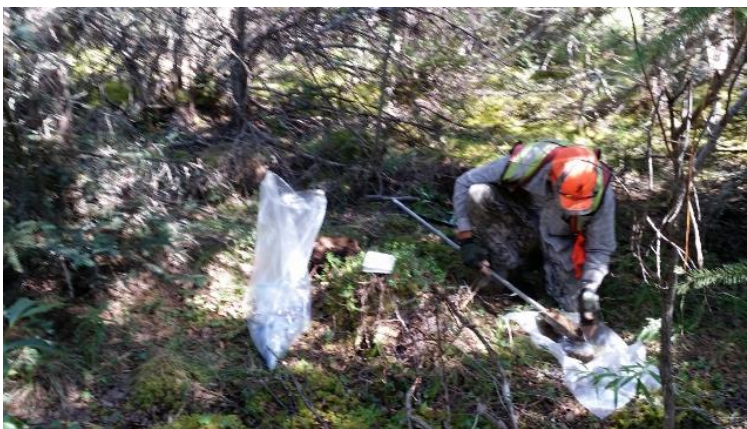
Above – Site conditions at A7.

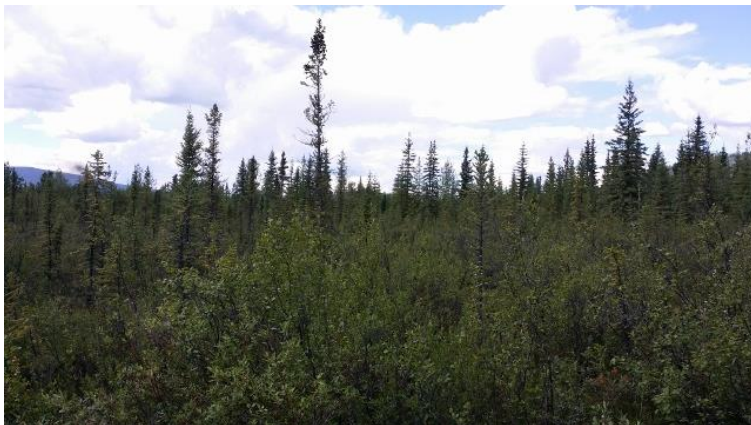
Above – Site conditions within peat bog.
Facing north towards treed granular area.

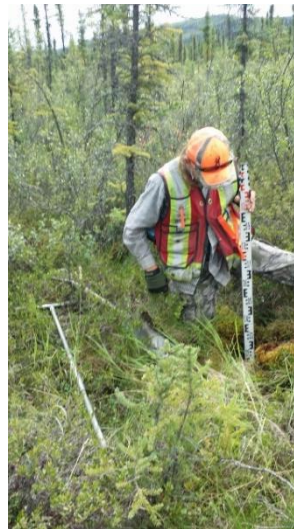
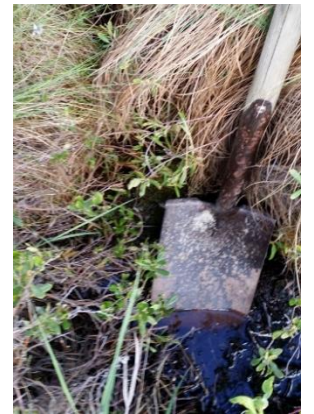
Left. Above & Below
Conditions at A2 - Bog

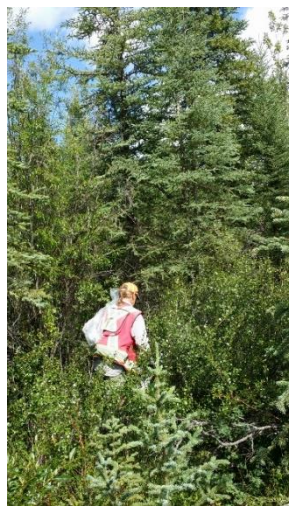
Left – Conditions @ A5
Granular area.
