## Geotechnical Evaluation – Geohazard Assessment

### Moosehide Slide Area

Dawson City, Yukon – 2017

**Date :** August 31, 2017

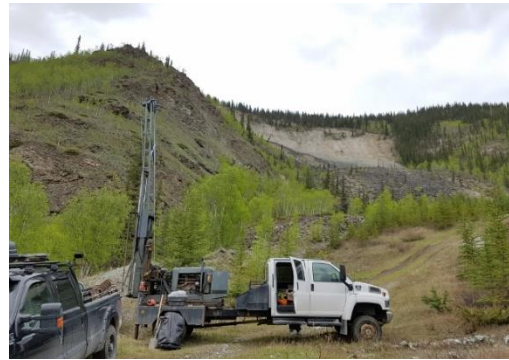
*Borehole BH 5-17 facing east*

BH 5-17 was advanced in order to install a casing and groundwater monitoring well within the slide rubble to the maximum depth allowable relative to the subsurface conditions and fiscal constraints. Both solid-stem and hollow-stem augers were utilized to attain a borehole termination depth of 15.15 meters below the ground surface. Given the coarse nature of the slide rubble, solid-stem augers were utilized to advance the borehole to a depth of 13.35 meters. The larger diameter hollow-stem augers were subsequently advanced to allow for standard penetration test (SPT) methodologies to be employed at depths of 13.41 meters and 14.94 meters below the ground surface.

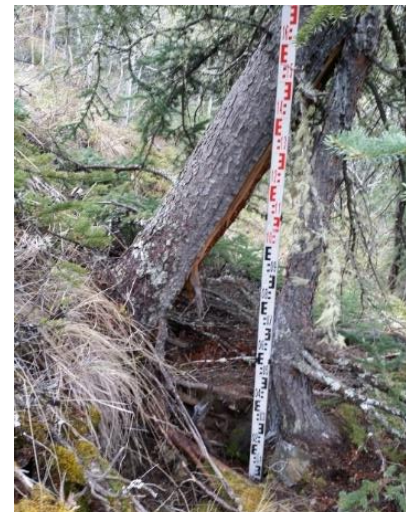
The terrace area of Alpha Block is well treed and harbors a moss and lichen forest floor under which permafrost may prevail. While the southern parts of the Alpha Block headscarp predominately measure in the order of 2 meters in height, the scarp becomes more pronounced midway through the feature as one traverses north. Relative to the prevailing elevation of the terrace area, the height of the headscarp varies from 5 to 15 meters in height. While split trees and stretched roots are present throughout the Alpha Block feature, they become less prevalent in the other blocks (Beta/Gamma/Delta) suggesting Alpha Block may be a relatively newer feature.

*May 19<sup>th</sup>, 2017 photo of split tree on Alpha Block*

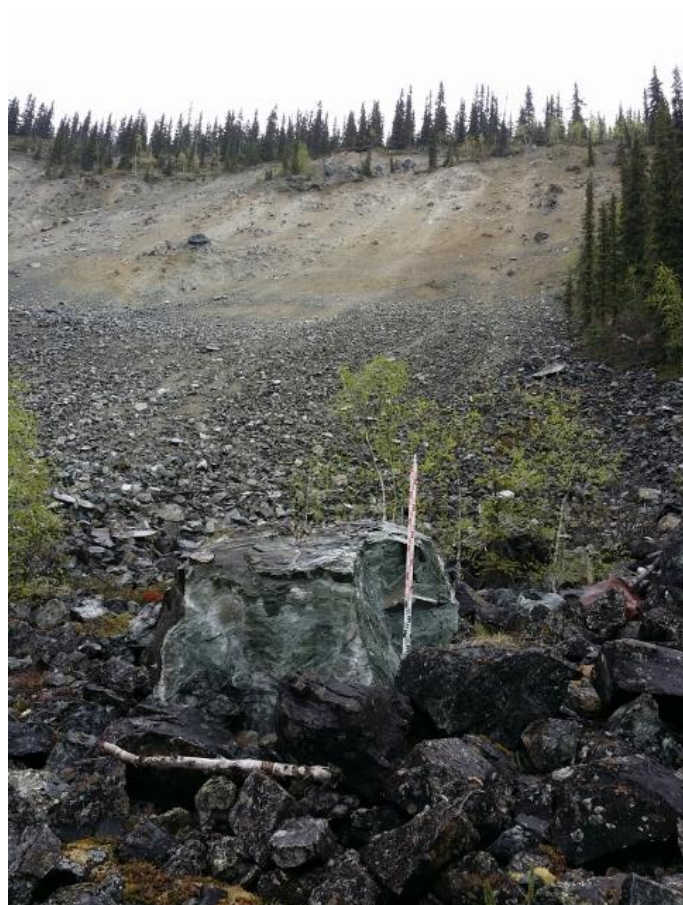
An inspection of the fall-line from where the boulders are thought to have originated noted impact marks upon other pre-existing lichen covered boulders. Shattered pieces of the parent boulders (which were predominately comprised of serpentinized rock) were clearly evident at the points of the impact.

*May 21<sup>st</sup>, 2017 – Recent boulder located in the talus cone area.*

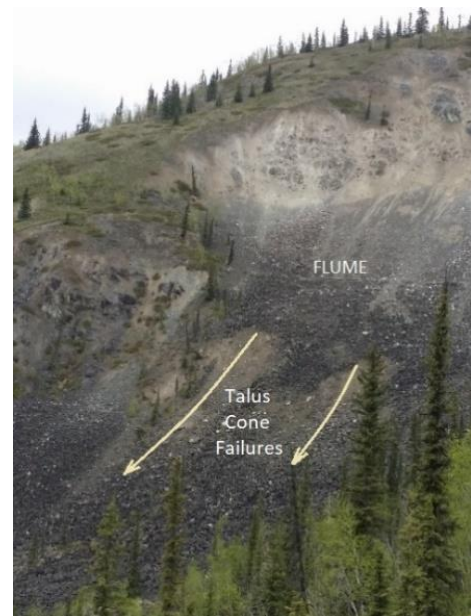
Signs of recent slope failures were noted on the west side of the talus cone immediately below the flume.

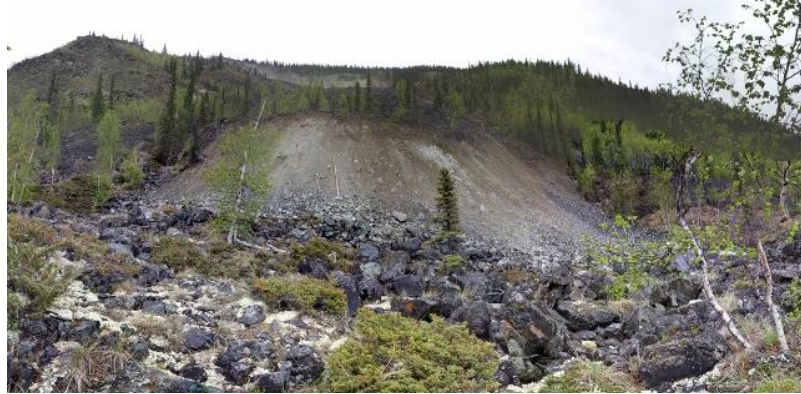
A slip-face (which is located between elevations of 360-385 meters), is located at the base of the mid-section. The composition of the materials located within the slip-face are the result of mass wasting processes whereby the overlying (mid-section) rockfall debris has essentially disintegrated. The nature of slope movement continually spawns fresh detritus and thus prevents vegetation from become established along the slip-face.

*May 21, 2017 photo of slip-face (above)*

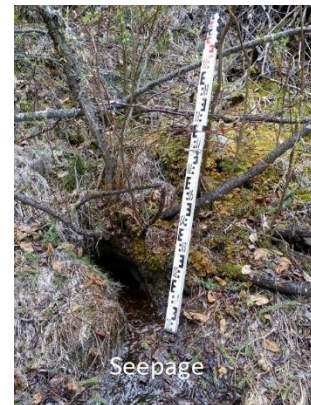
This gully was well vegetated and there were no signs of rockfall. However, seepage zones were noted when the gully was traversed on May 21<sup>st</sup>. These seepage zones were no longer visible during a subsequent traverse of the gully which was conducted on July 17<sup>th</sup>. During this time, the gully was traversed from an elevation of 490 meters to the intersection of Judge Street & 3<sup>rd</sup> Avenue (elevation 330 meters). Numerous areas within the gully were noted where tree branches had washed down-slope

and become lodged in regions where trees were more densely concentrated.

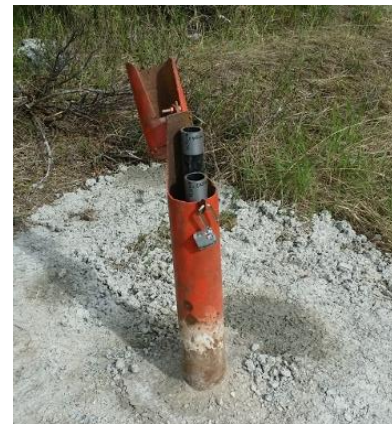
*Borehole BH 5-17 Well and Casing*

Borehole BH 5-17 was unique relative to all other boreholes which have been advanced by the undersigned and drilling sub-contractor as there were essentially no auger cuttings during the course of drilling operations. Typically, auger cuttings which are driven to the surface (due to the nature of auger advancement) need to be continuously cleared from around the drill-stem in order to maintain a clean working area. In the case of BH 5-17, the total amount of auger cuttings measured in the order of 0.1 m<sup>3</sup>.
