**KLUANE TERRAIN
HAZARD MAPPING STUDY**

FINAL REPORT

Report
to
Yukon Land Use Planning Office

Thurber Consultants Ltd.
Vancouver, B.C.

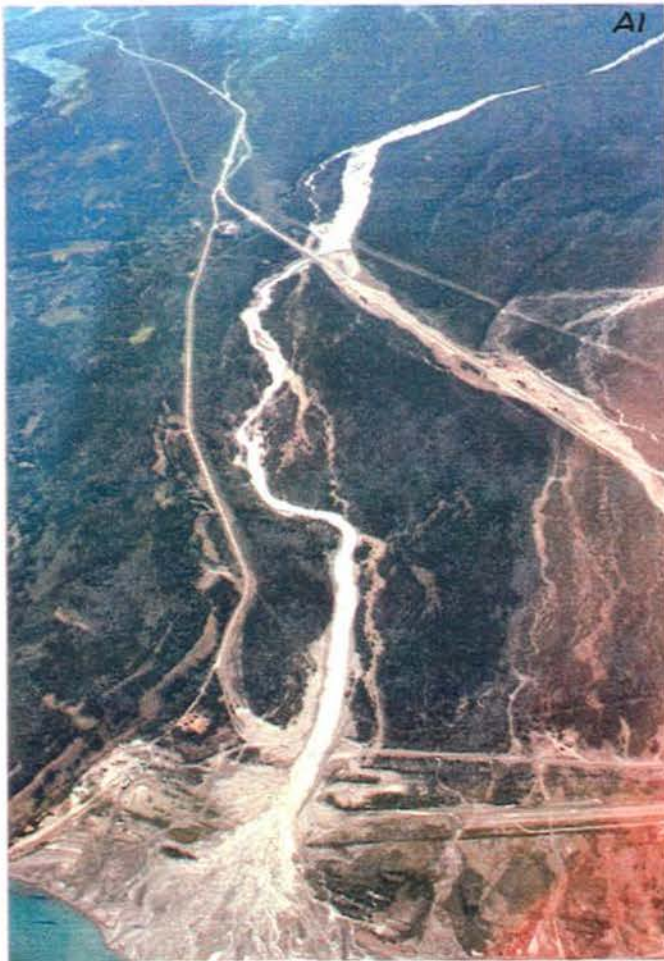
- Photo A-1 Helicopter view east showing right (north) channel of Silver Creek activated in July 1988. Silver City lies just north of the recent alluvial fan on the Kluane Lake shore. Note the recent earthworks to control the lower channel. Highway follows the active left channel in the middle distance. 07/89.

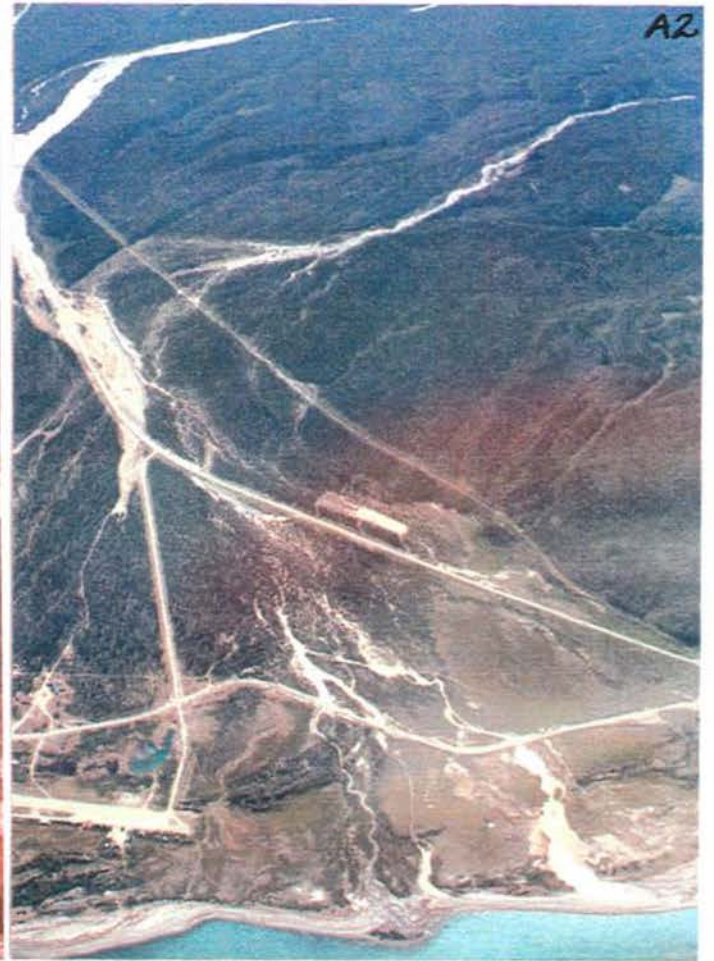
- Photo A-2 Helicopter view east showing the left (south) channel of the Silver Creek fan. This channel was also activated in July 1988. Note the un-named creek system which enters from the south and the radiating distributaries of the fluvial system below the AKH. Old slide scars (possibly permafrost active-layer detachments) are seen as light-green vegetation swaths south of the fan at the center right. 07/89.

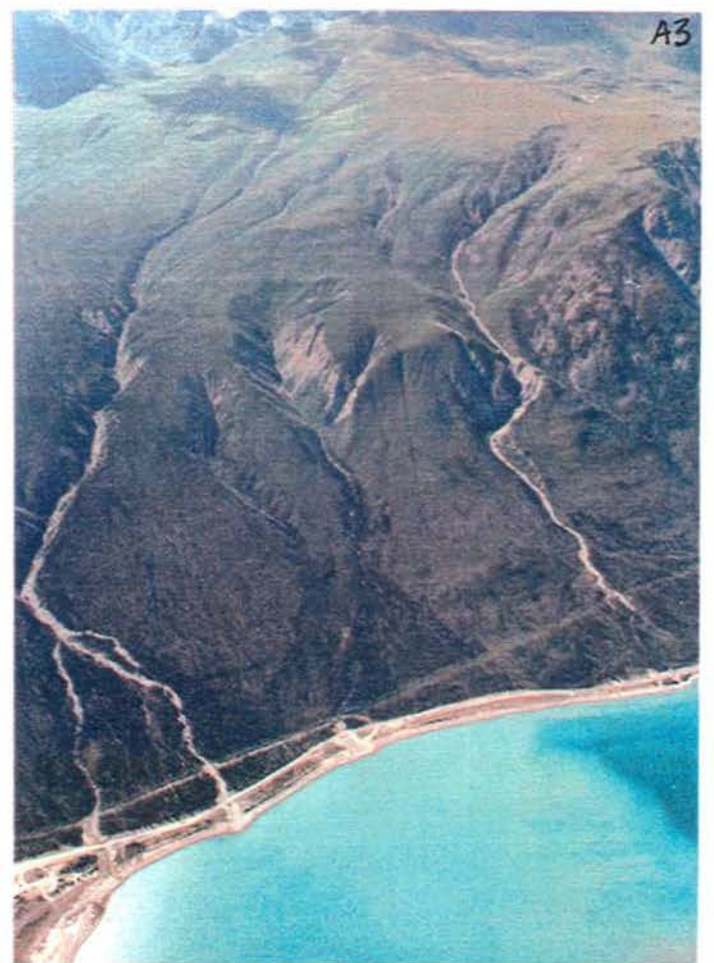
Between the west end of the Silver Creek fan and the Alaska Highway crossing of the Slims River, there is a continuous hazard from debris flows (Photos A-3 and A-4). Flows were activated in 1988 and the area has a history of such activity (Appendix B3). Snow avalanches probably also run out on the upper portions of these aprons.

- Photo A-3 Helicopter view south showing colluvial-alluvial fans just west of the Silver Creek fan at the lower left. Field of photo view A-3 lies just to the right. Kluane Lake in the foreground. 07/89.

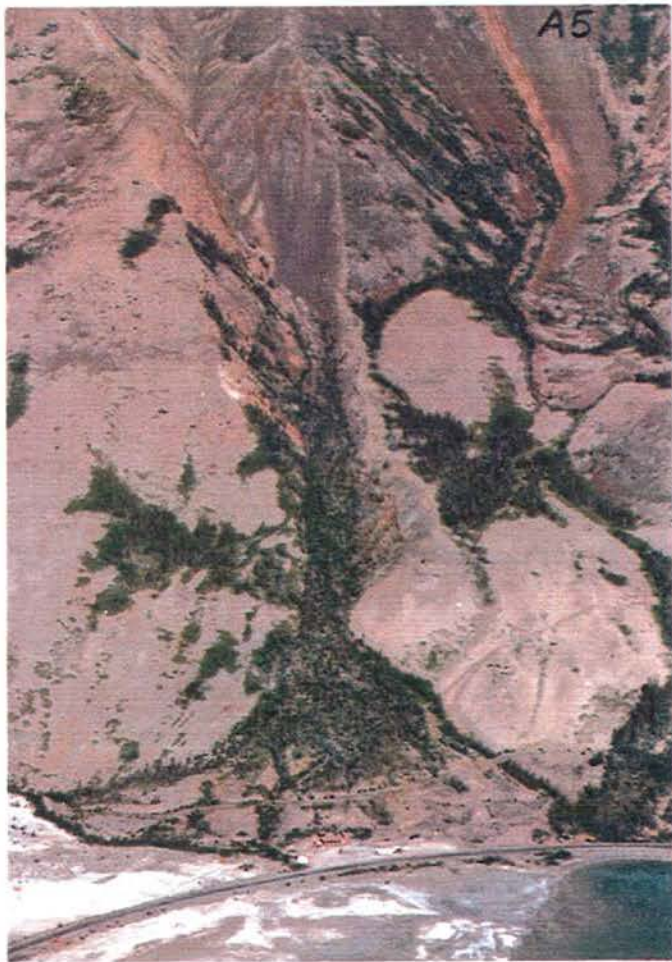
Photo A-5

Helicopter view north showing debris flow area north of the Slims River near km 1707. Note steep upper basin with well defined fan at its base. A public facility and its parking area lie along the Highway which curves right along the Kluane Lake shore. A relict rock glacier is located at the upper right.
7/89

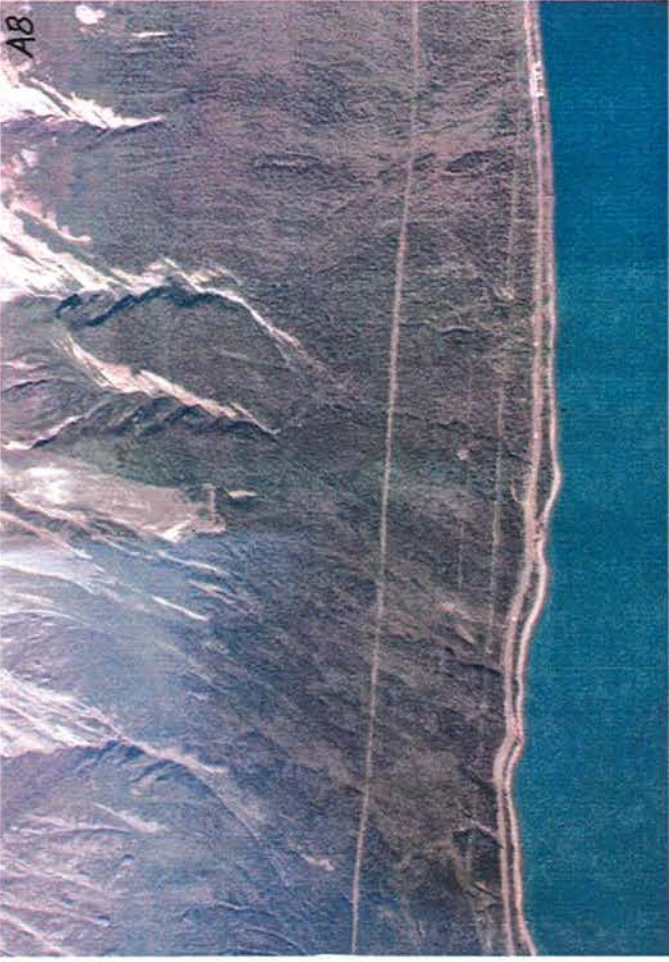
North of the bay, there are debris flow hazards on steep aprons above the Highway. Although old scars are evident, slides were not activated by the 1988 storms (Photo A-8). These hazards continue northward across the well-defined fan of Williscroft Creek (km 1716) which was activated in July 1988 (Photo A-9).

- Photo A-8 Helicopter view west showing colluvial-alluvial fans above the Alaska Highway between km 1713 and 1716. Horseshoe Bay lies just off left photo; Williscroft Creek just off to the right. Note old debris flow scars but lack of evidence of significant activity in 1988. 07/89.

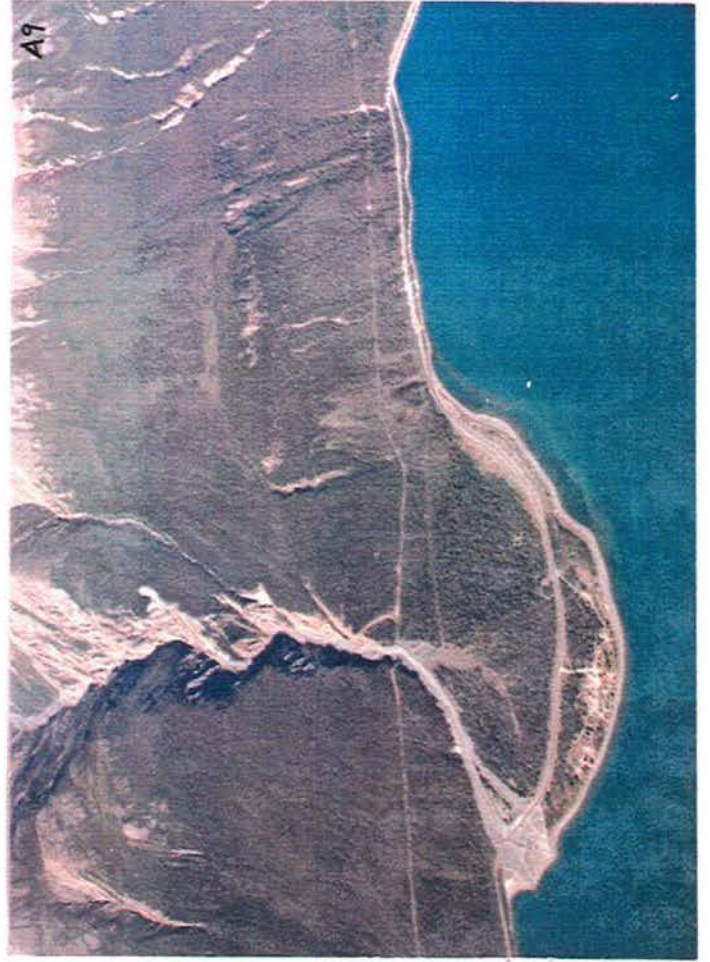
North of the Williscroft fan, a comparatively steep slope shows gullies and scarred evidence of past debris avalanches (approximate km 1717 to 1718, Photo A-9). North of the fan, two large colluvial-alluvial fans present debris flow and flood hazards as far as the right flank of the Congdon Creek alluvial fan (Photo A-10).

- Photo A-9 Helicopter view west showing fan of Williscroft Creek and the Highway at km 1716. Reforested scars on steep, gullied slope right (north) of the fan indicate past debris avalanche activity. Km. 1718 lies near right side of photo. 07/89.

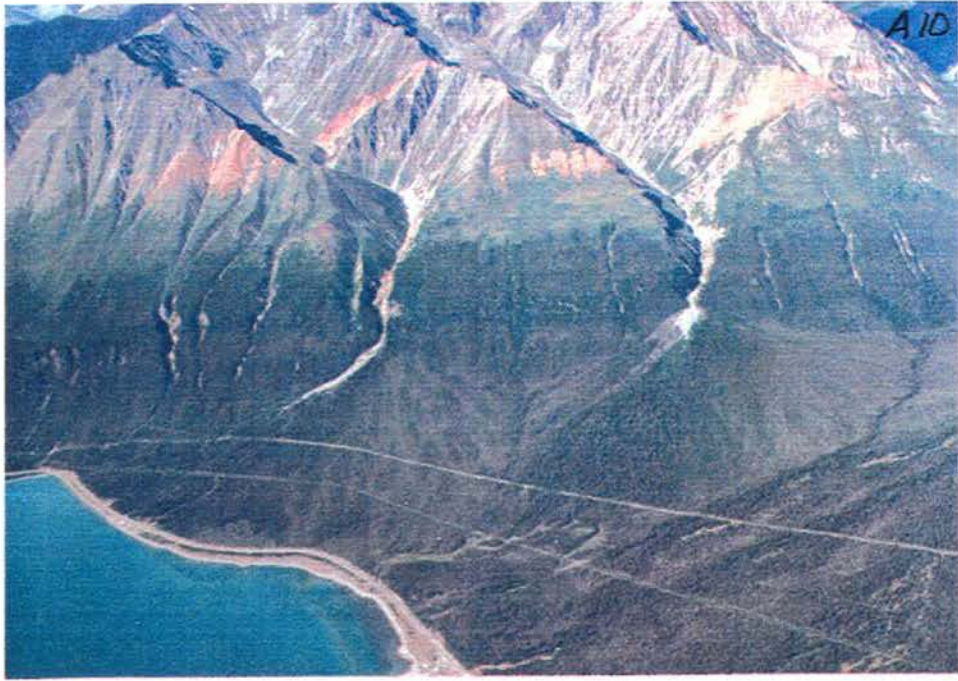
- Photo A-10 Helicopter view west showing large colluvial-alluvial fans just north of Williscroft Creek. Km 1722 and Congdon Creek alluvial fan is at lower center. Flank of this large fan extends upwards to the right. Note the steep, gullied alpine basins above each fan and lack of evidence for significant debris activity in the 1988 storms. 07/.89
- Photo A-11 Helicopter view southwest showing the enigmatic Congdon Creek deposits in the dark area extending toward Congdon Creek and the mountain front. Note the old pipe line strikes directly across the rocky surface of this feature. The Highway avoids it in the foreground. Congdon Creek is at the upper left. 07/89.
