February 19, 2016

ISSUED FOR USE
FILE: W14103698-02
Via Email: brian.crist@gov.yk.ca

Subject: Slope Stability Assessment
km 195 Robert Campbell Highway, YT

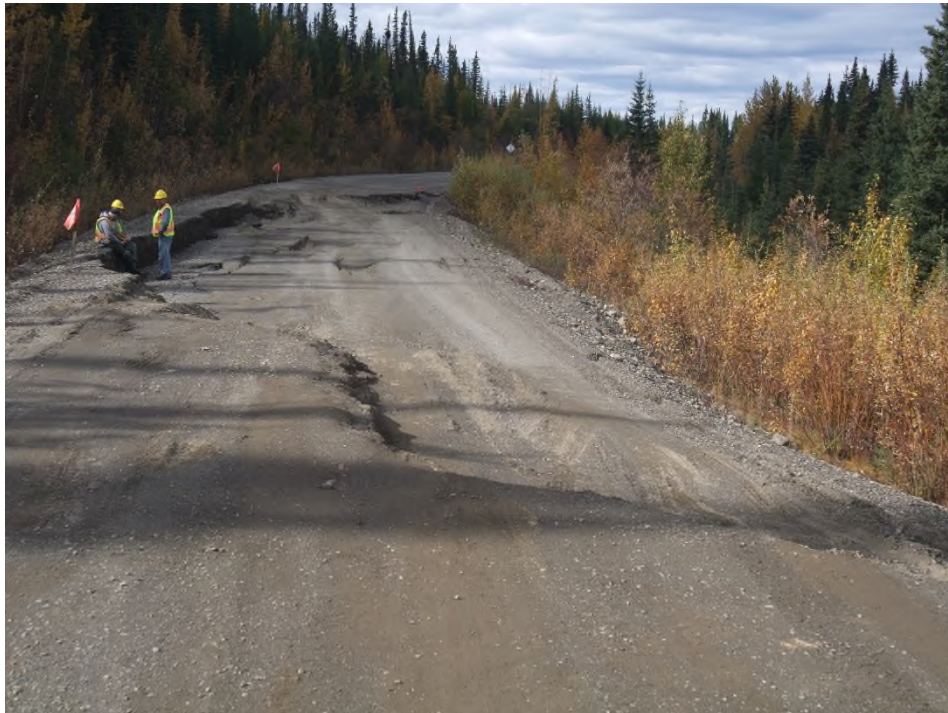
Photo 1: View at km 195 looking north towards Ross River showing slope instability affecting the highway (September 9/15)

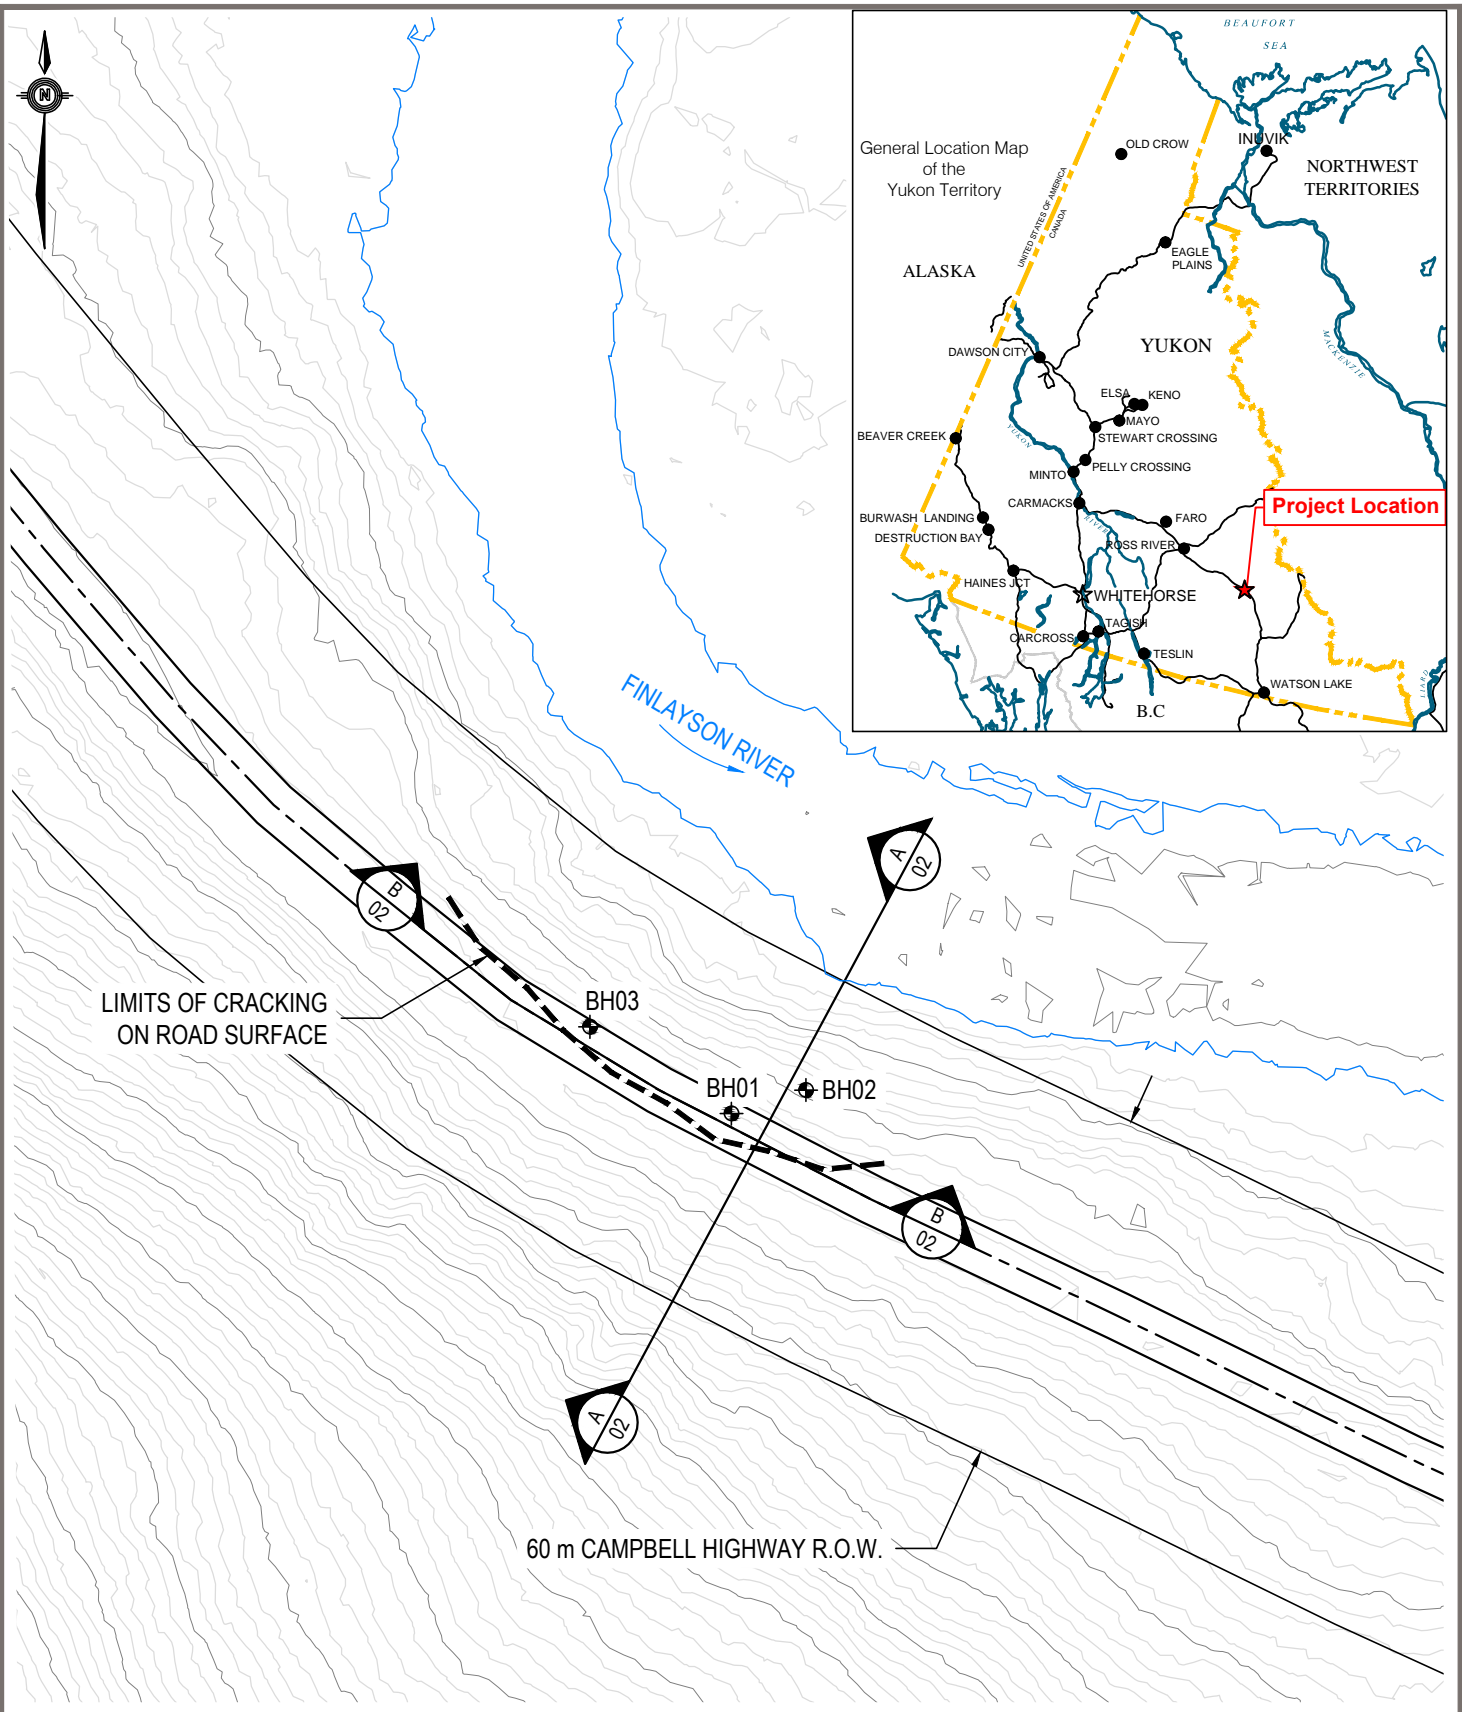
Figure 1

At the time of drilling, the road surface had been repaired and a detour established to maintain two lanes of traffic on the highway; however, cracking was still visible across most of the slope crest.

**SITE PLAN SHOWING LIMITS OF CRACKING
 AND BOREHOLE LOCATIONS**

3. The specific area with the tension cracks must be monitored regularly, and if more tension cracks develop, they must be repaired (filled in) immediately so that water does not infiltrate the subgrade.

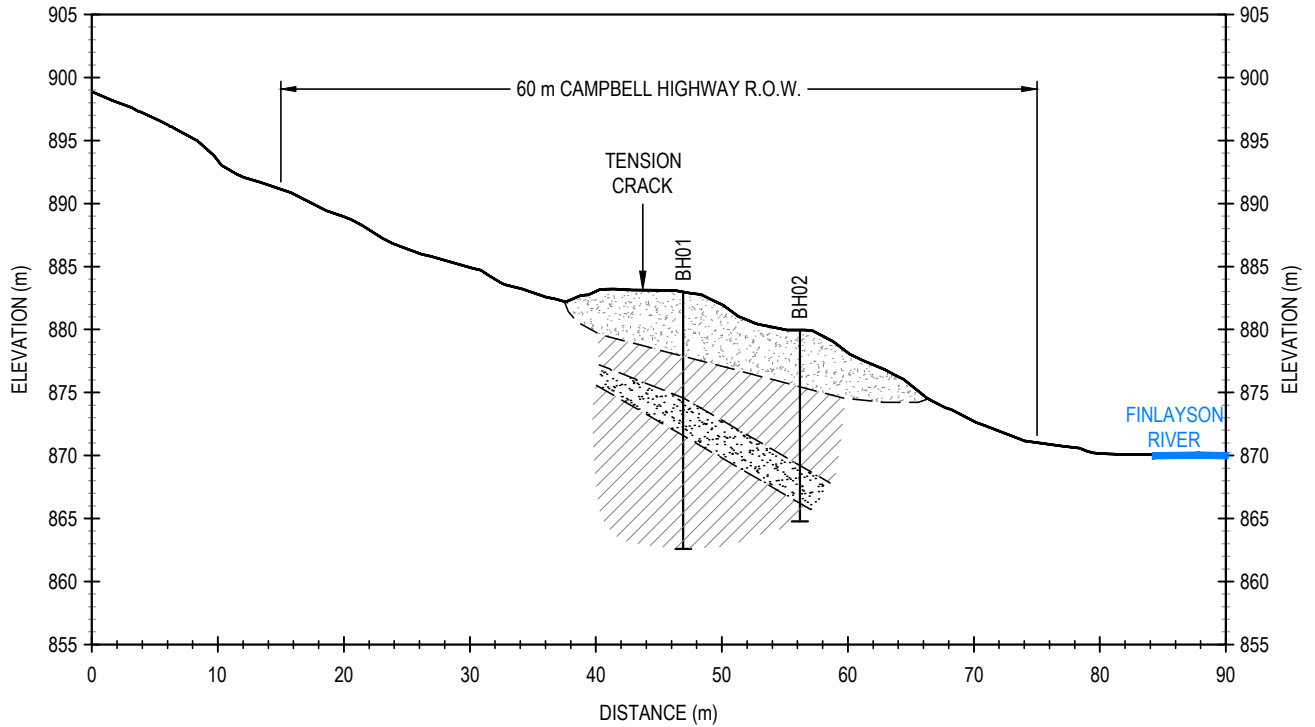
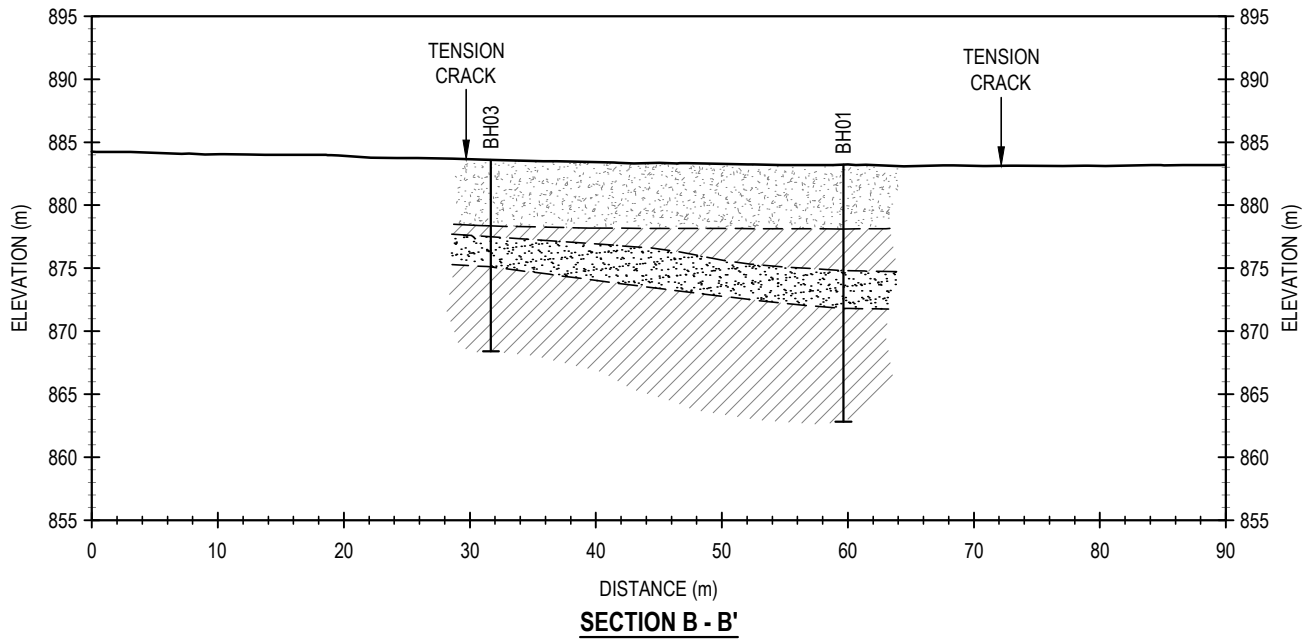
Figure 2

Similar stratigraphy was encountered at each borehole location. In general, about 5 m of loose to compact granular soil was encountered immediately below ground surface, with imported fill encountered below the road surface at BH15-01 and BH15-03 and variable mixtures of sand, silt and gravel encountered at BH15-02, which was drilled a few metres downslope from the road. The thickness of fill is likely a result of frequent fill placement to repair the

As noted above, the stratigraphy is generally consistent between each of the boreholes, particularly if the distinctive layer of gravelly sand encountered in each of the boreholes is considered to be a “marker bed”. As such, it was possible to construct cross-sections showing the generalized soil profile between boreholes in directions parallel and perpendicular to the slope, as shown on Figure 2. Based on this, it appears that the soil stratigraphy dips approximately parallel to the slope face, and also slightly from north to south.

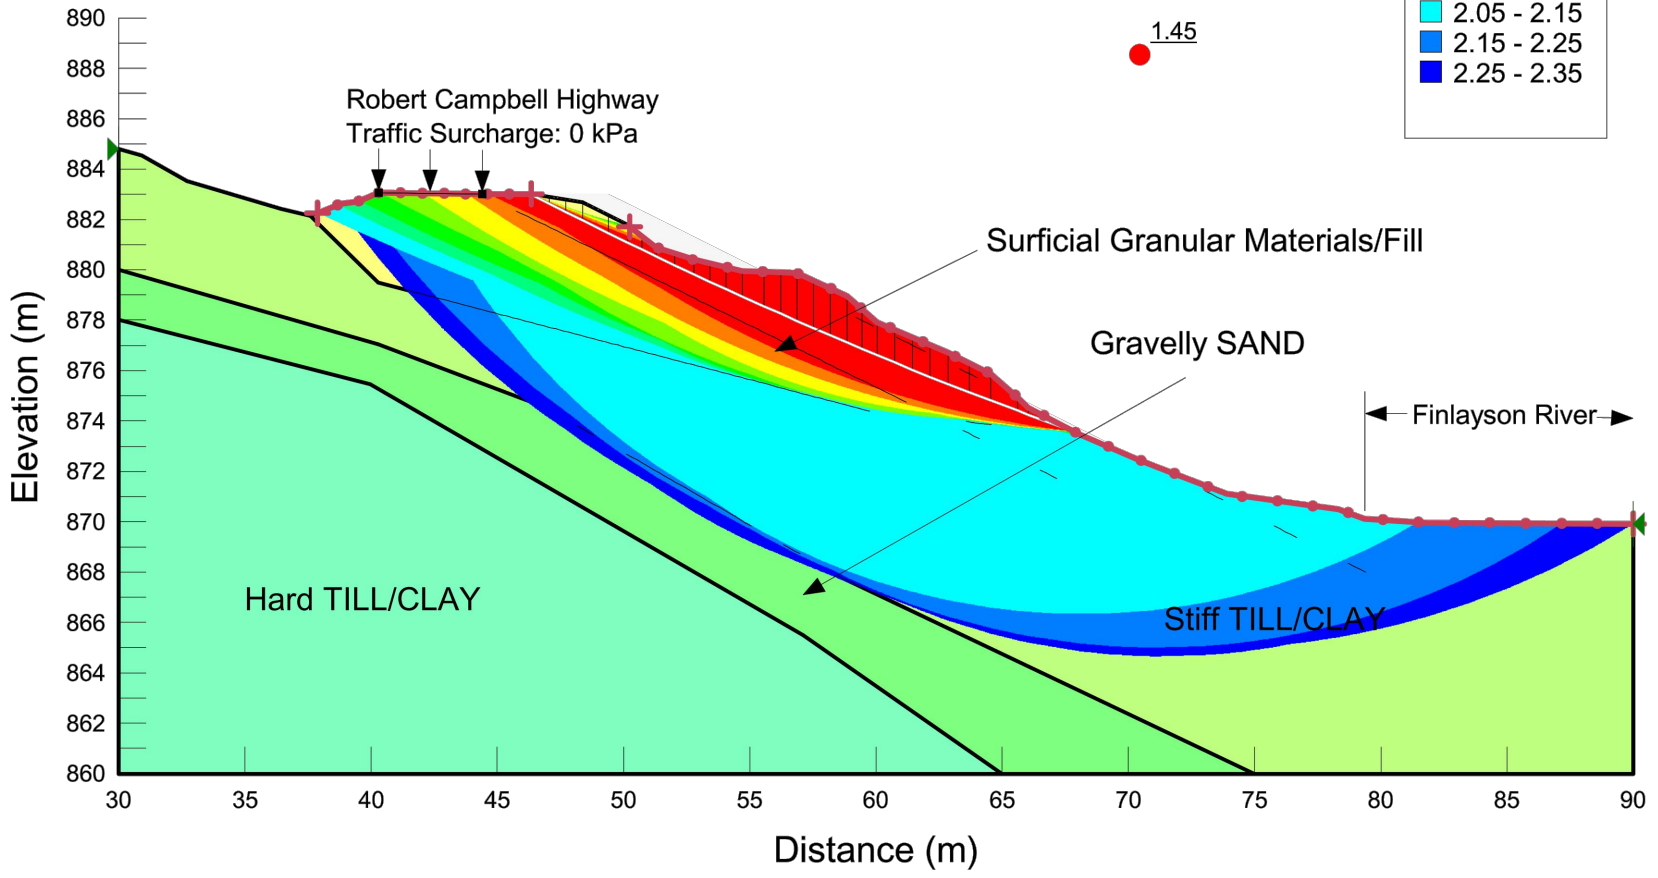
Figure 4

As shown on Figure 4, the slope appears to be stable under dry conditions, with a minimum FS of 1.45 computed by the software. However, as shown on Figure 5, elevated groundwater conditions appear to trigger instability in the slope, with a minimum FS of 0.62. Furthermore, the FS contours shown on Figure 5 suggest that instability is relatively shallow, and is contained entirely within the fill and native granular soils encountered near ground surface; no slip surface penetrating into the stiff till-like material was found to have FS less than 1.5.

**SLOPE/W RESULTS
EXISTING SLOPE - DRY CONDITIONS**

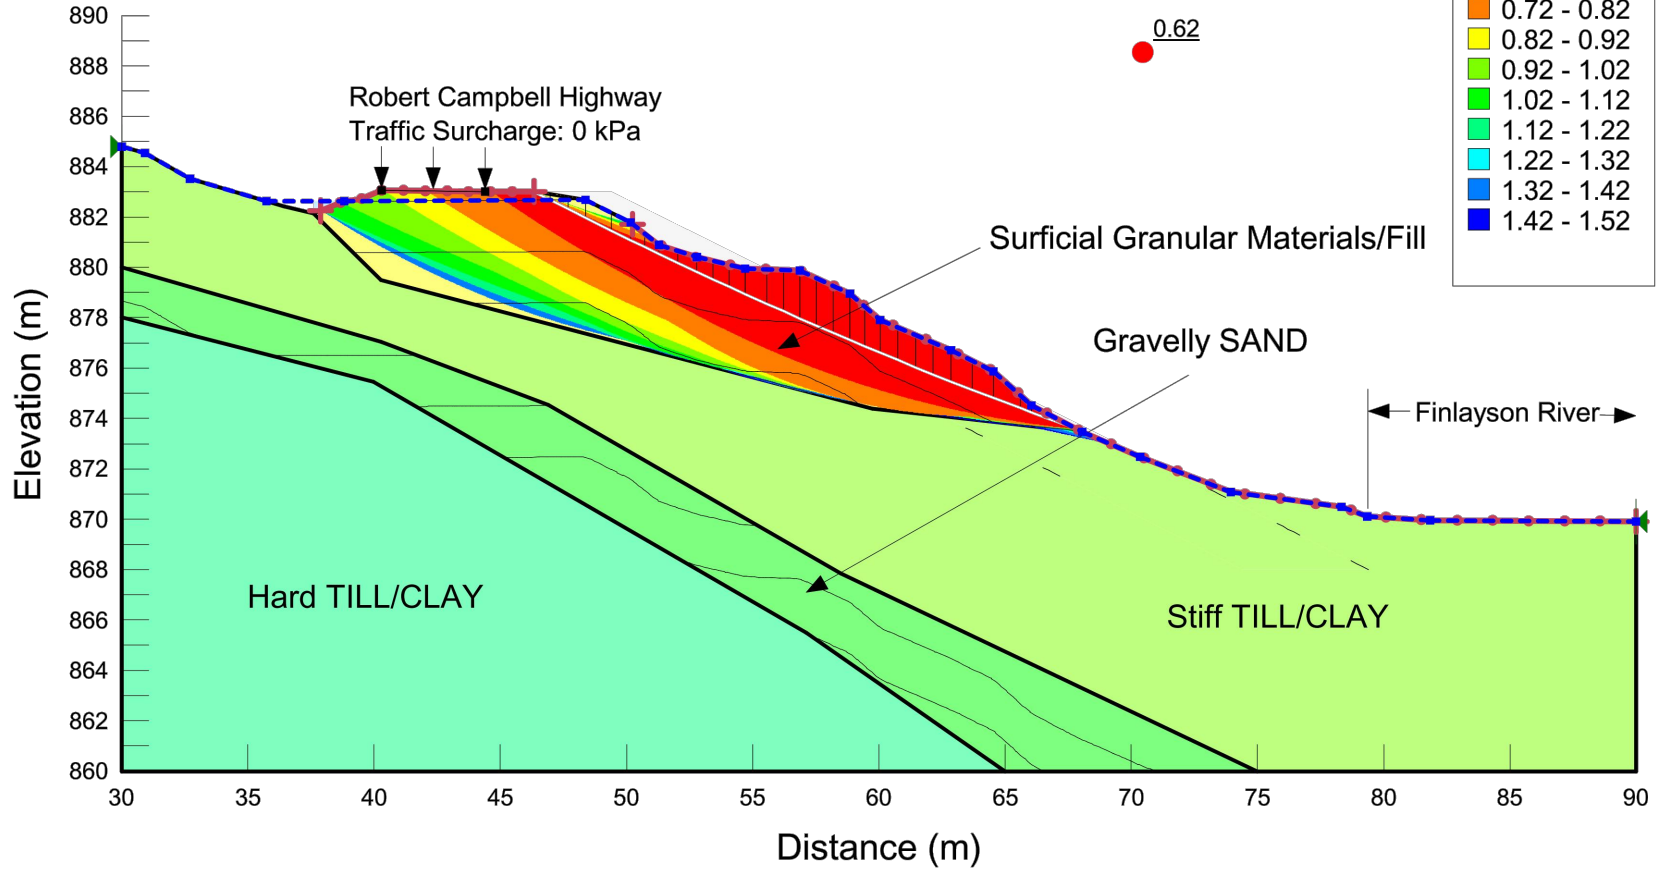
Figure 5

Based on the results of the drilling program and Slope/W modeling, and on observations of surface conditions collected during site visits, it appears that the slope movements observed at the site are localized within the surficial granular materials, and triggered by high porewater pressure caused by poor drainage in the roadside ditch, then augmented during spring snowmelt and possibly triggered by periods of heavy precipitation in the late summer and fall.

**SLOPE/W RESULTS
 EXISTING SLOPE - ELEVATED GROUNDWATER CONDITIONS**

As noted above, slope movement appears to be triggered by high porewater pressures caused by poor drainage in the roadside ditch compounded by periods of high rainfall. As such, improving drainage at the site will likely be the most effective remedial action. In order improve drainage and minimize porewater pressures in the slope, we recommend that the following items be implemented:

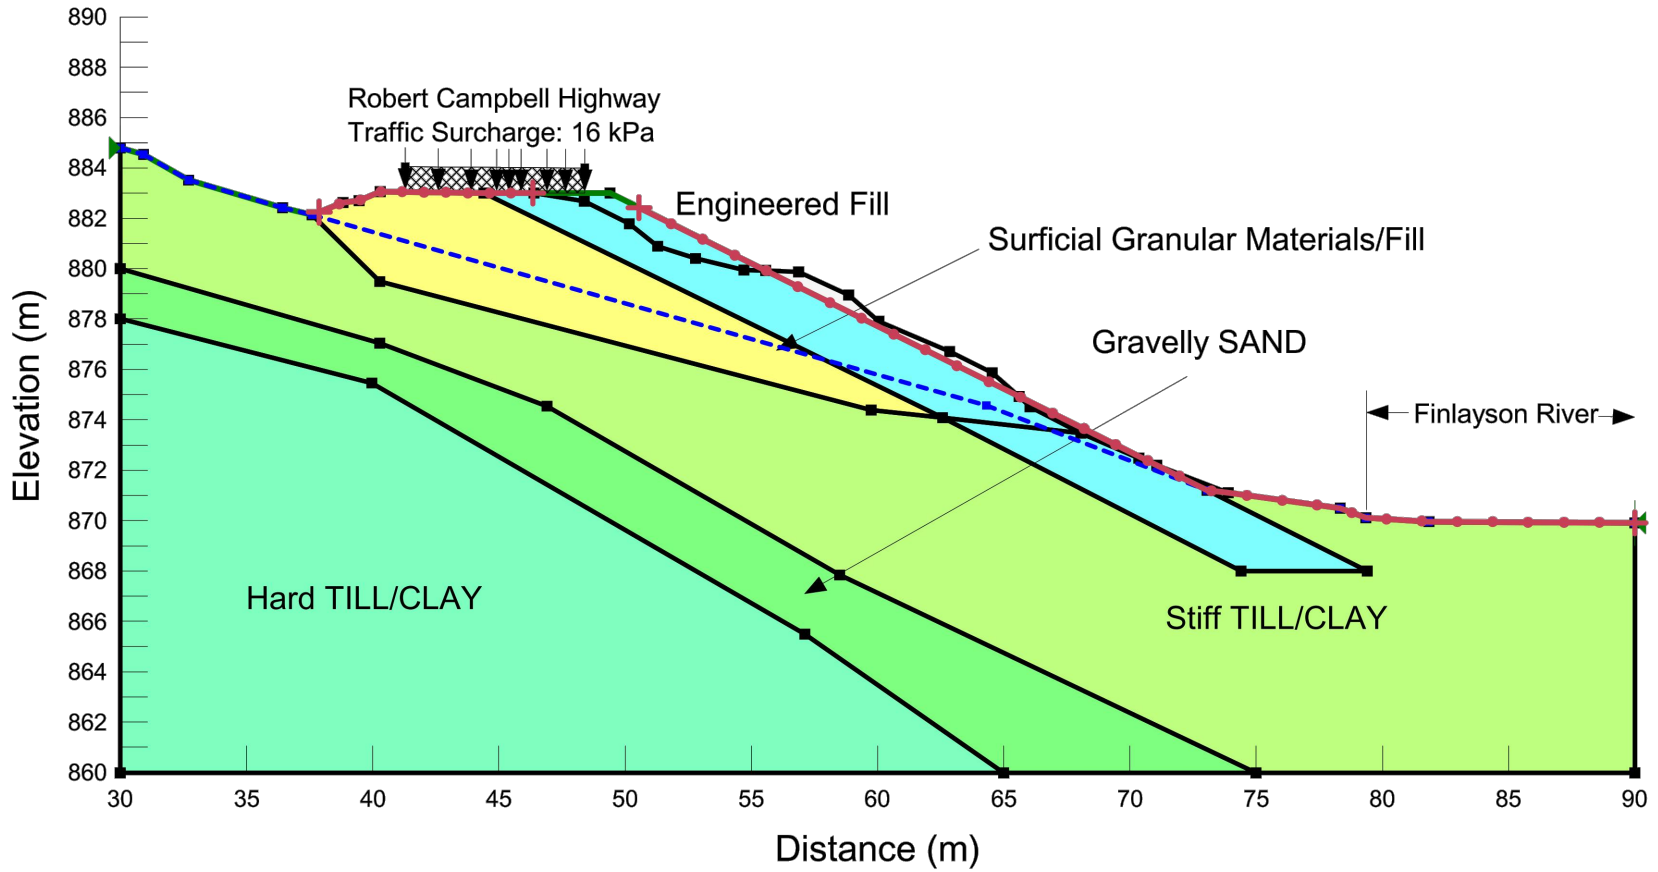
The Slope/W model used in the analysis is shown in Figure 6, for intermediate groundwater conditions as described above.

As such, in order to repair the existing disturbed slope face and mitigate against the potential for future erosion, we recommend that the slope face be reconstructed using compacted engineered fill, as shown in concept on Figure 6 and assessed using Slope/W for various groundwater conditions.

Disturbed, saturated, organic, or otherwise unsuitable materials would be removed from the slope face, and replaced with a blanket of compacted, engineered fill. A horizontal fill thickness of 5 m was used in the Slope/W model and can be considered as a reasonable preliminary estimate.

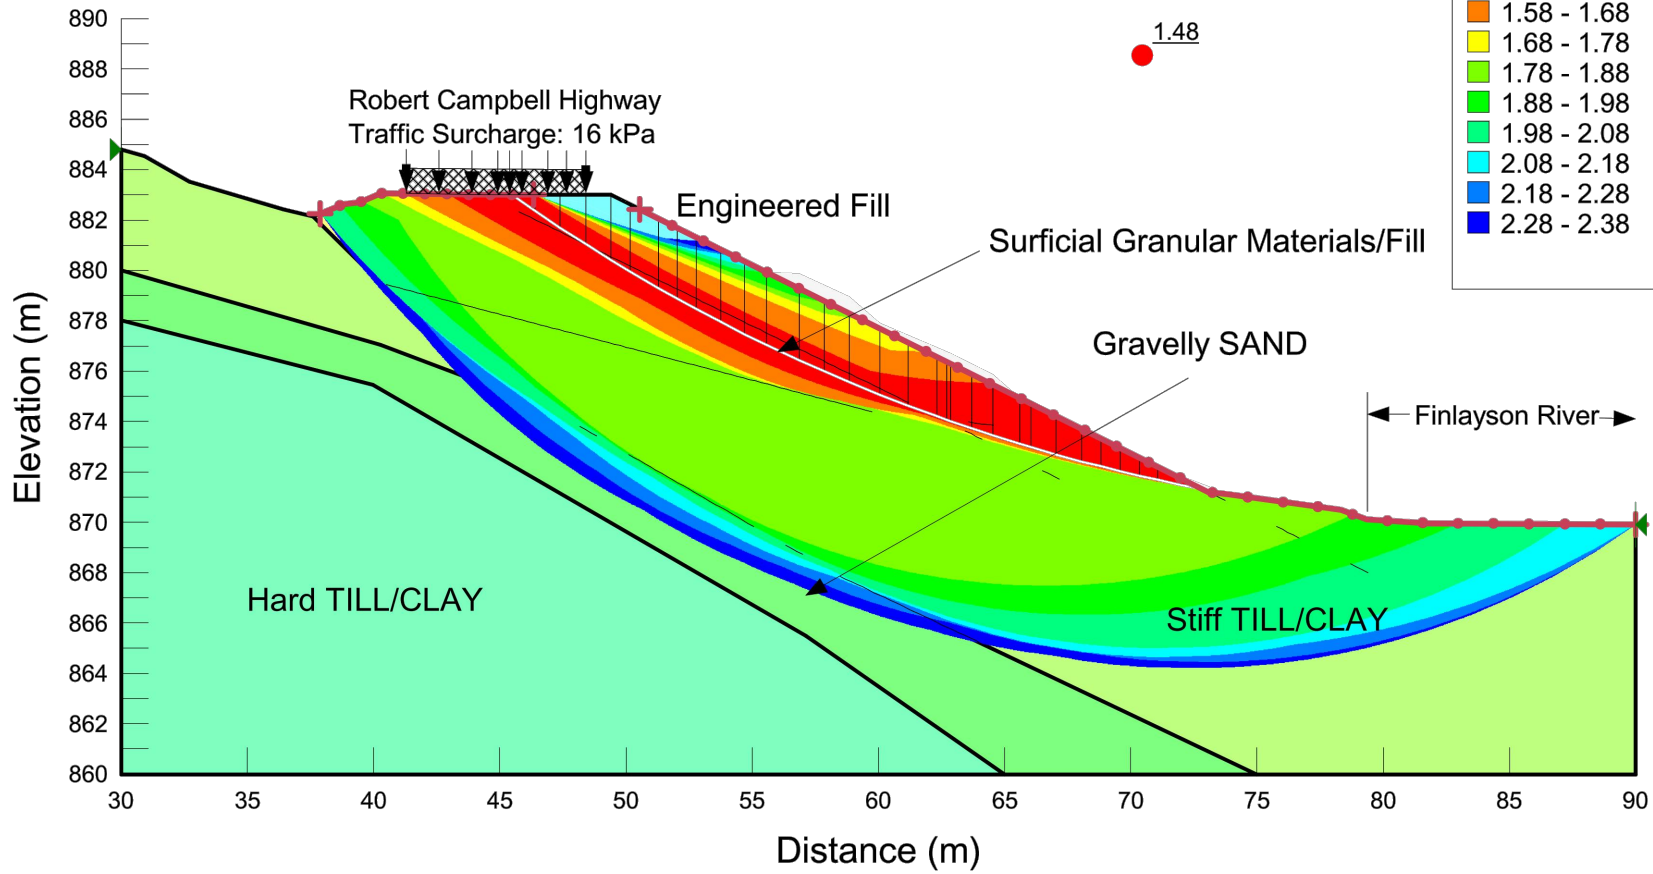
Figure 7

Results of the Slope/W analysis for the reconstructed slope are shown in Figures 7, 8 and 9 for dry, intermediate and elevated groundwater conditions, respectively.

**SLOPE/W RESULTS
 RECONSTRUCTED SLOPE - DRY CONDITIONS**

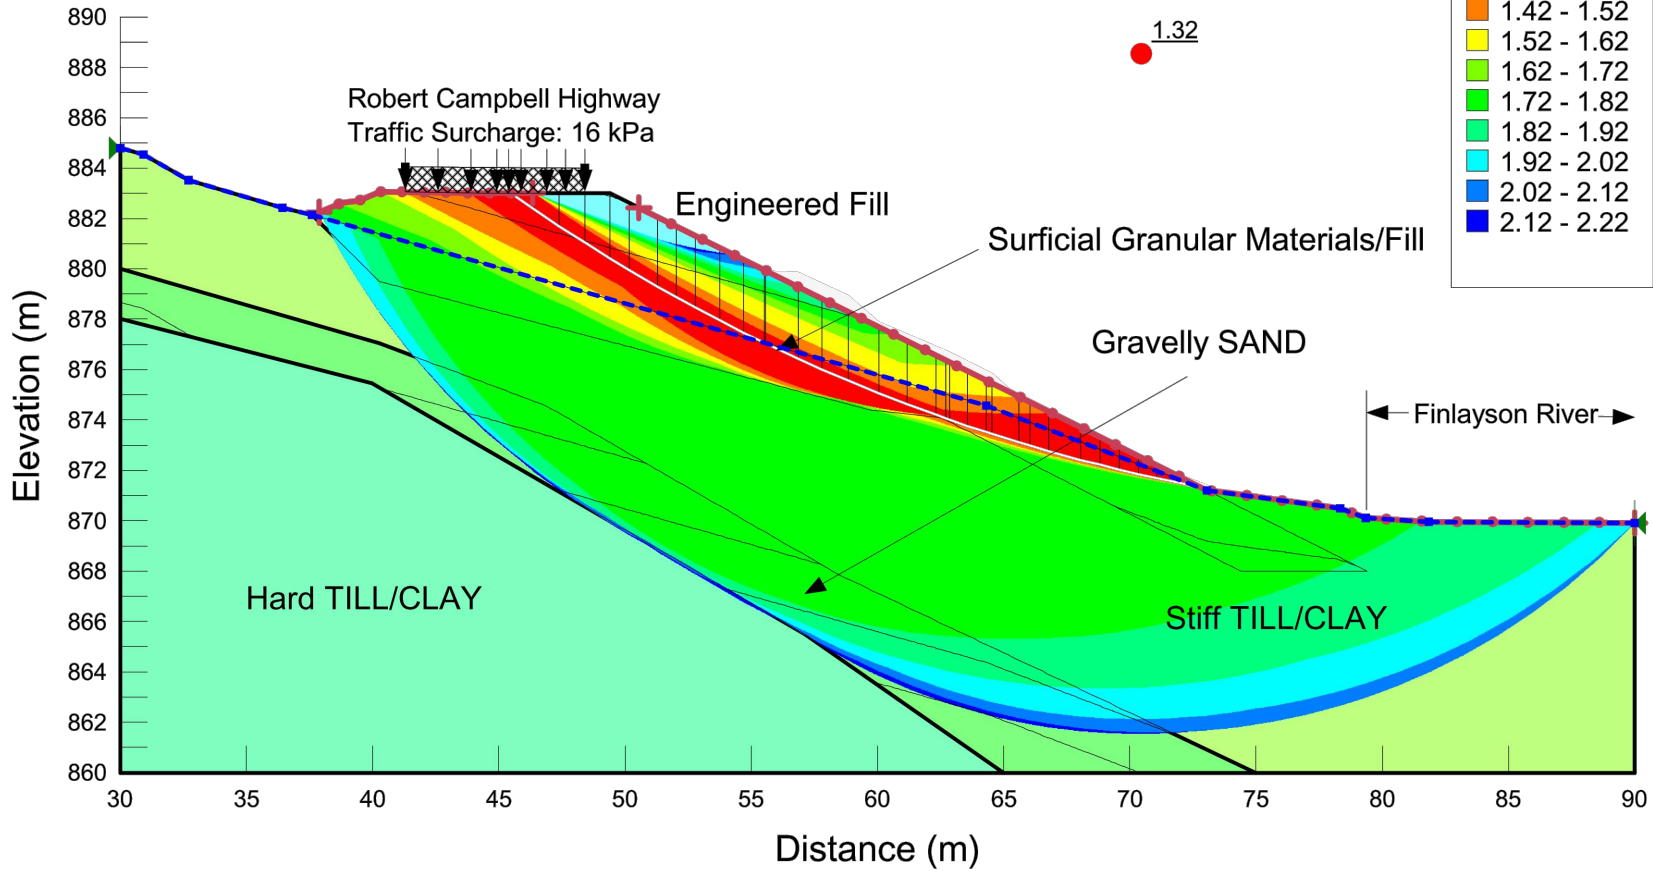
Figure 8

**SLOPE/W RESULTS
 RECONSTRUCTED SLOPE - INTERMEDIATE
 GROUNDWATER CONDITIONS**

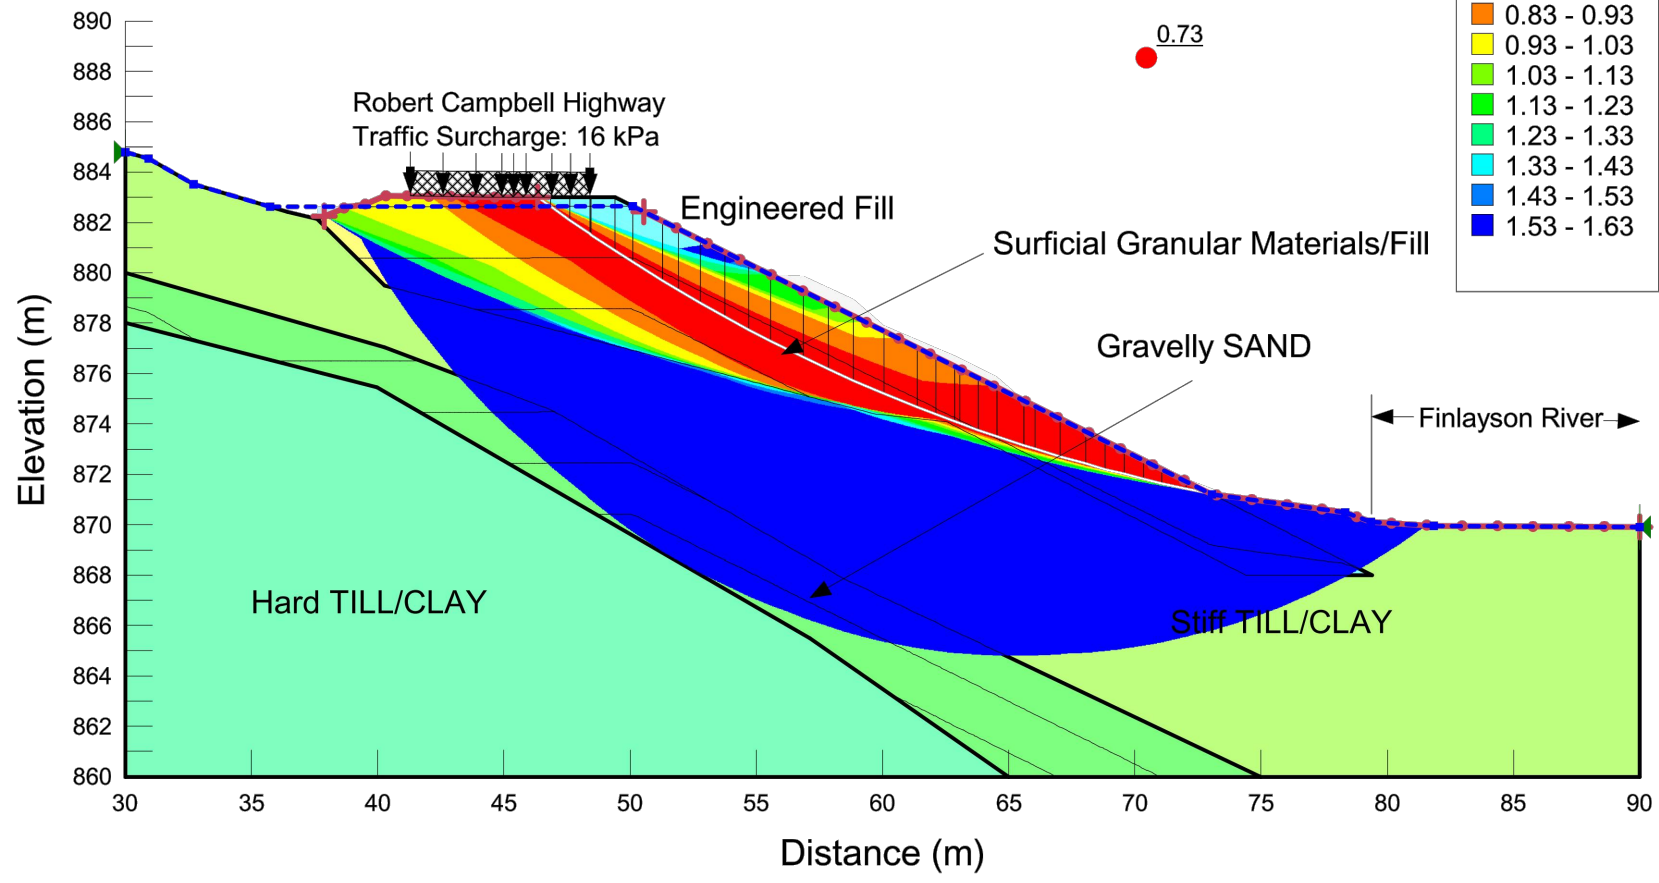
Similar to the results for the existing slope, the groundwater levels in the slope are shown to have a significant impact on slope stability; for elevated groundwater conditions, the FS of the reconstructed slope was 0.73, suggesting that groundwater is the main factor driving instability on the slope. For dry conditions and intermediate groundwater conditions, minimum FS of 1.48 and 1.32 were computed, respectively. Similar to the Slope/W results for the existing slope, in each case for the reconstructed slope the slip surfaces with the lowest FS were concentrated within the surficial granular soils.

**SLOPE/W RESULTS
RECONSTRUCTED SLOPE - ELEVATED
GROUNDWATER CONDITIONS**
