GEOTECHNICAL INVESTIGATION

DEMPSTER HIGHWAY

MILE 0 TO 78

DEPARTMENT OF PUBLIC WORKS OF CANADA

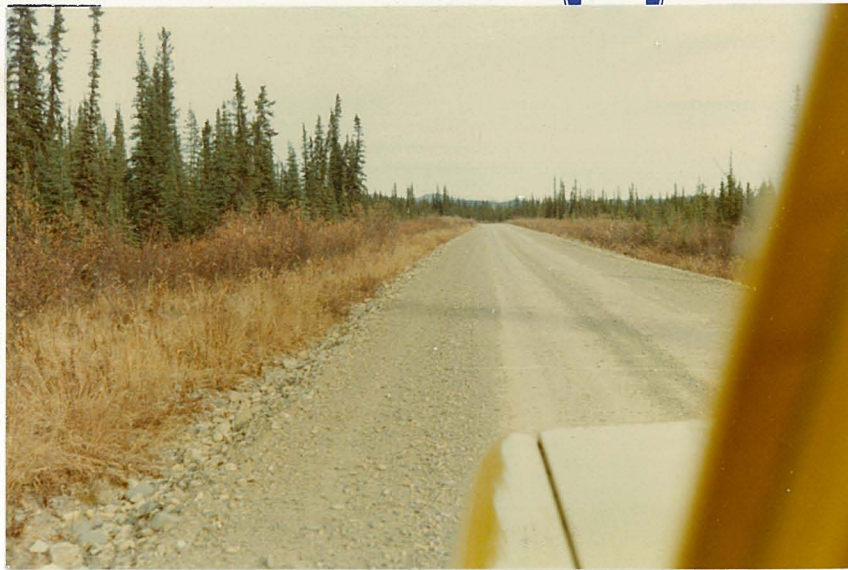
Photograph No. 3: A view of the existing grade at approximately Mile 5 looking north. Note the excellent state of this section of the highway which is typical of long stretches between Mile 0 and Mile 60. The tree cover on the left is typical for the first 43 miles of the highway. The dominant tree is white spruce.

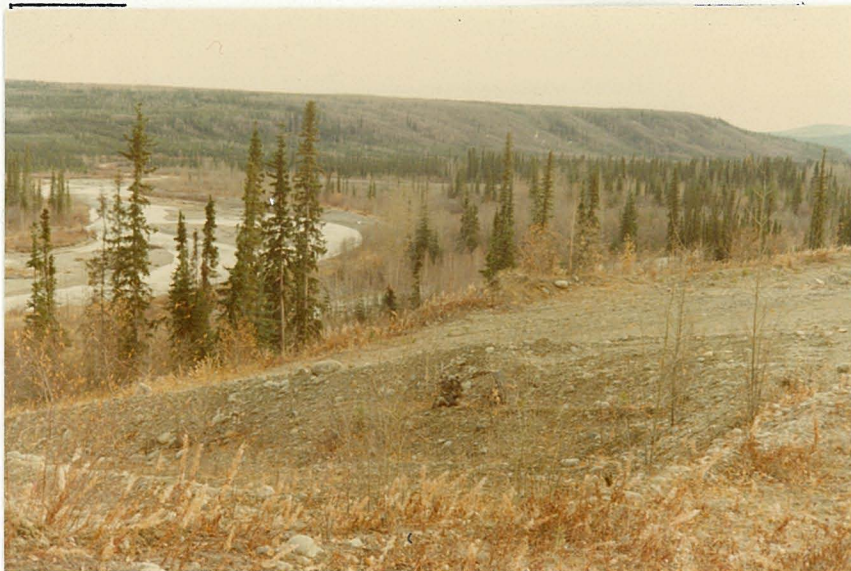
Photograph No. 4: A view from an old borrow pit looking south easterly across the existing road with the North Klondike River in the background. Note the abundance of coarse material in the borrow pit. Most of the existing borrow pits in the first 50 miles of the highway could be reopened, and extended, as required to obtain fill material.

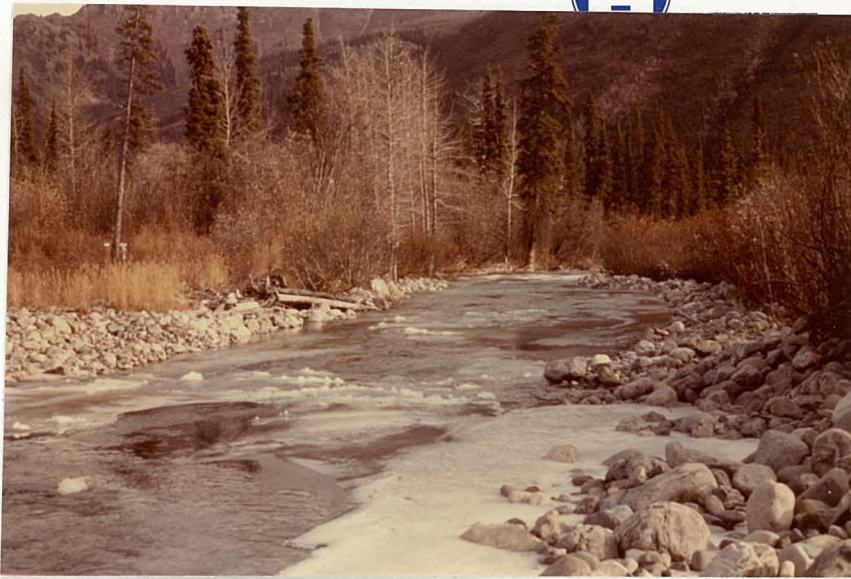
Photograph No. 5: Looking from the highway grade down Benson Creek at approximately Mile 17.8. Note the extremely coarse granular material in the stream bed.

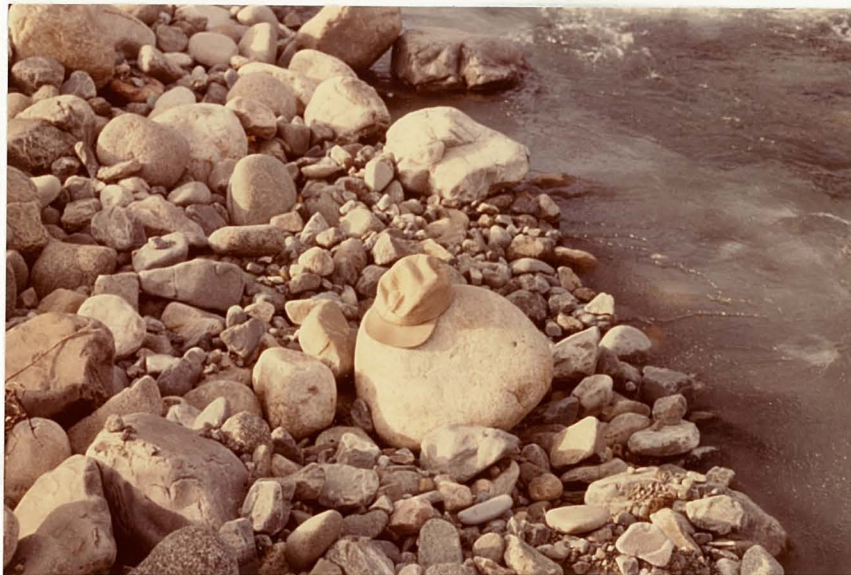
Photograph No. 6: A closeup of some of the stream bed material in the previous photograph. The cap in the foreground gives the scale.

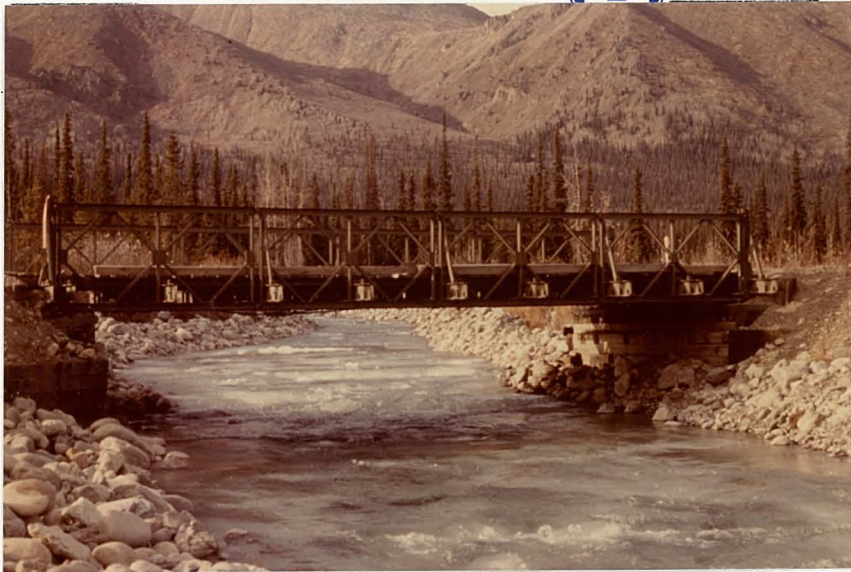
Photograph No. 7: The existing Bailey Bridge at Wolf Creek at approximately Mile 31.4, looking upstream. This Bailey Bridge has a 40 foot span and is of single-single construction. It is to be replaced with a steel beam bridge. Note the abundance of coarse granular material in the stream bed and the proximity to the mountains in the background.

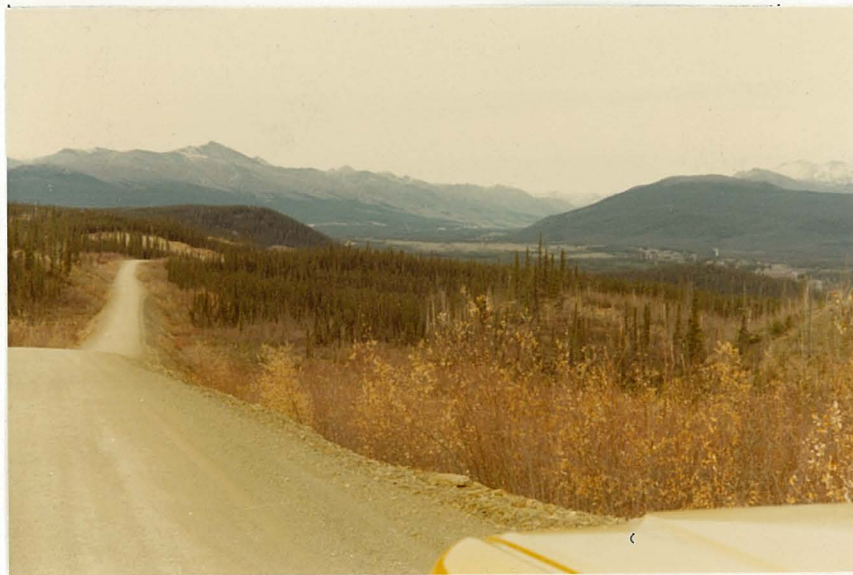
Photograph No. 8: Looking northerly from approximately Mile 30 with the valley of the North Klondike River to the right. The existing road can be observed in the centre background on the left side of the valley.

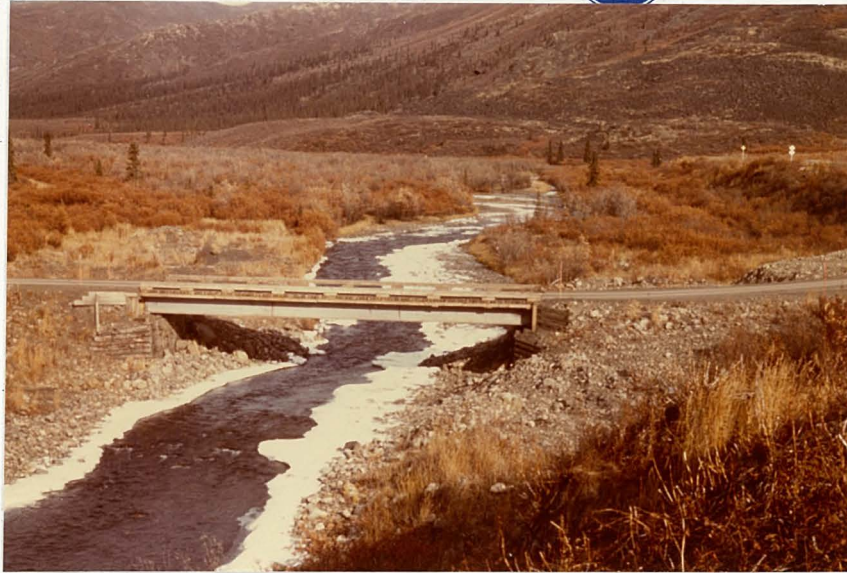
Photograph No. 9: The existing bridge where the road crosses the North Klondike River at approximately Mile 41.7. This view is looking upstream in a northerly direction. It is at approximately this point along the highway that the road passes out of the zone of thick spruce forest and into an area of scrub and alpine tundra.

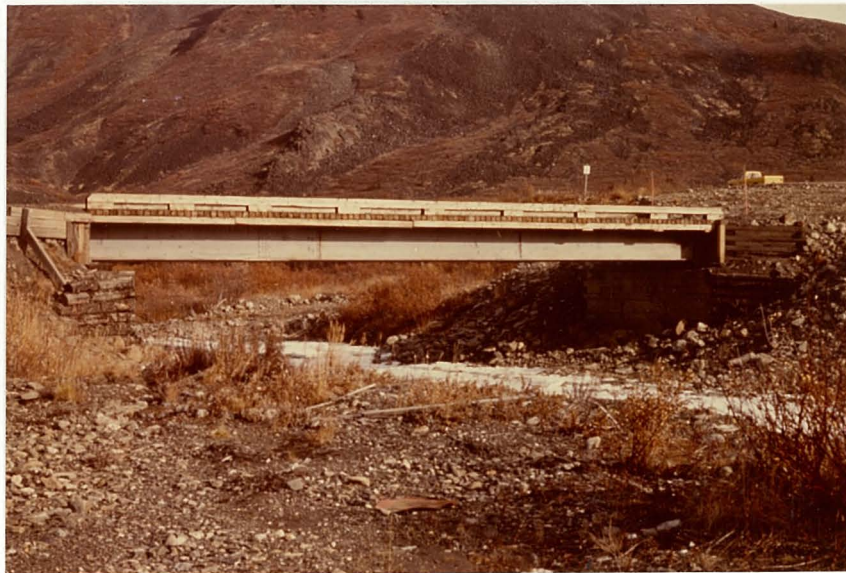
Photograph No. 10: A closer view of the existing bridge on the North Klondike River shown in the above photograph. In the background, can be seen extensive talus slopes.

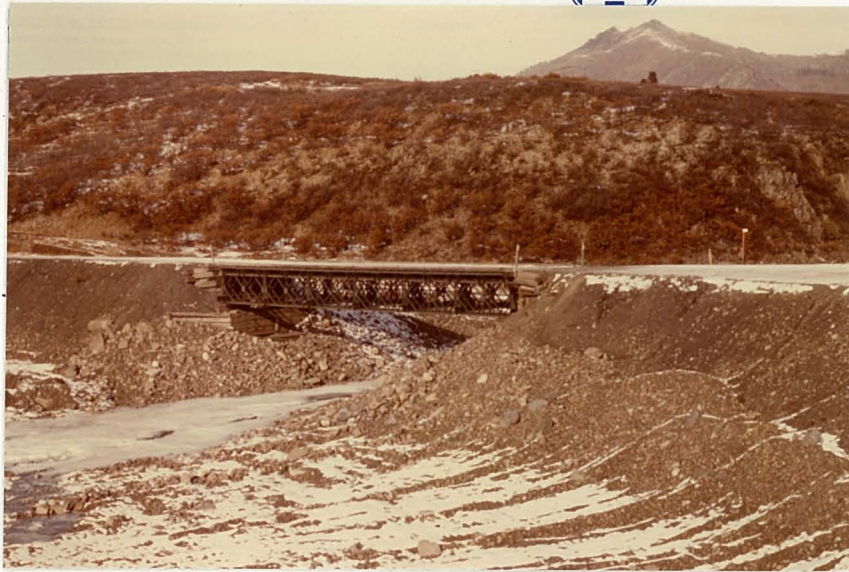
Photograph No. 11: The existing Bailey Bridge over the Upper North Klondike River at approximately Mile 47.8. Upstream is to the right of the photograph.

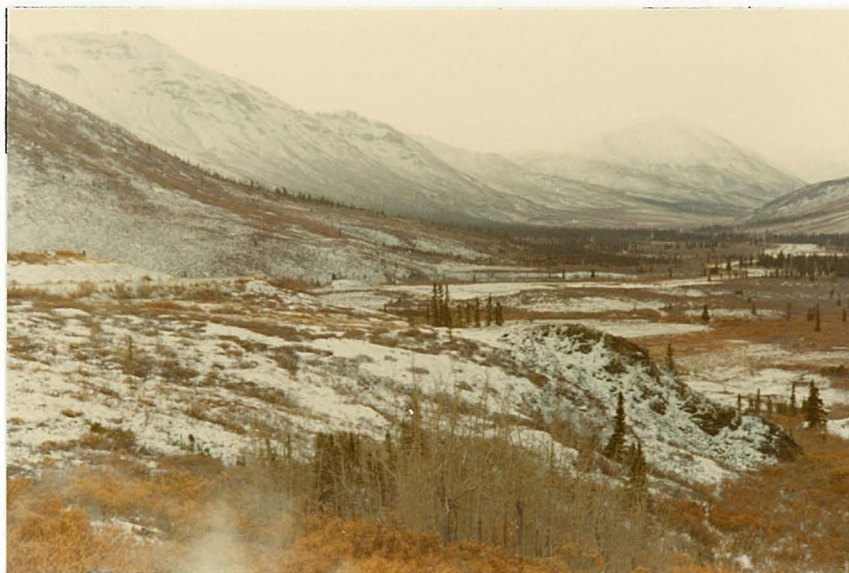
Photograph No. 12: Looking southerly from approximately Mile 58. Note the very few scattered spruce trees and the shape of the valley. The road can be observed crossing from the left foreground to the right background.

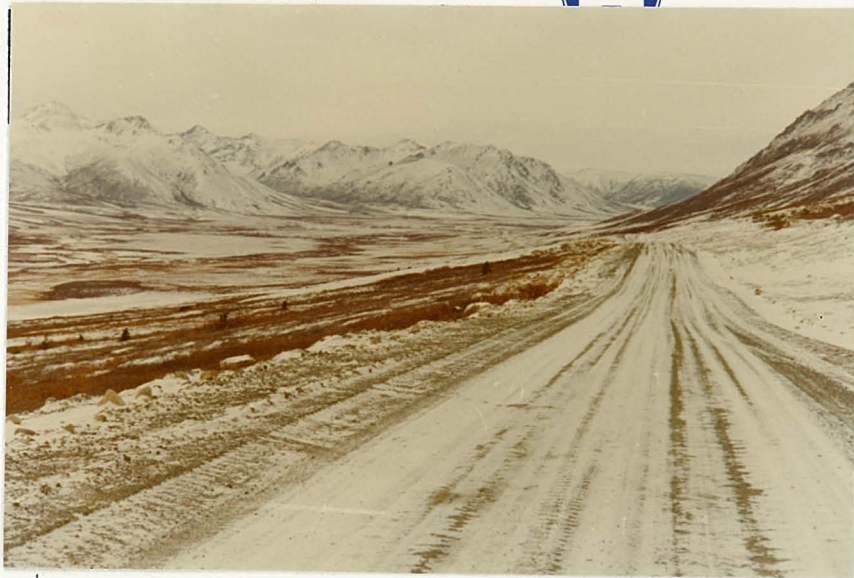
Photograph No. 13: Looking northerly from approximately Mile 50 near the "summit" which is the highest point between Mile 0 and Mile 78.

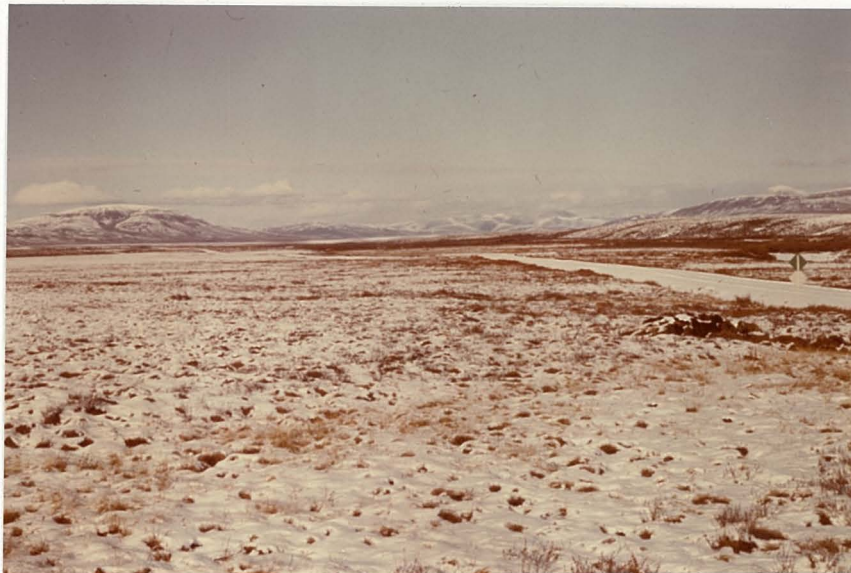
Photograph No. 14: Looking northerly at approximately Mile 75. Observe the flat bottom of the valley in this area. Drainage in this section is relatively poor with a thick peat and moss cover and a very shallow active layer.
