INSTALLATION REPORT - PREPARED BY D.P.W.

Laid M. 237.2 - Dempster Highway  
Henderwood Industries Ltd.  
"Permabed" Test Section

PUBLIC WORKS  
CANADA

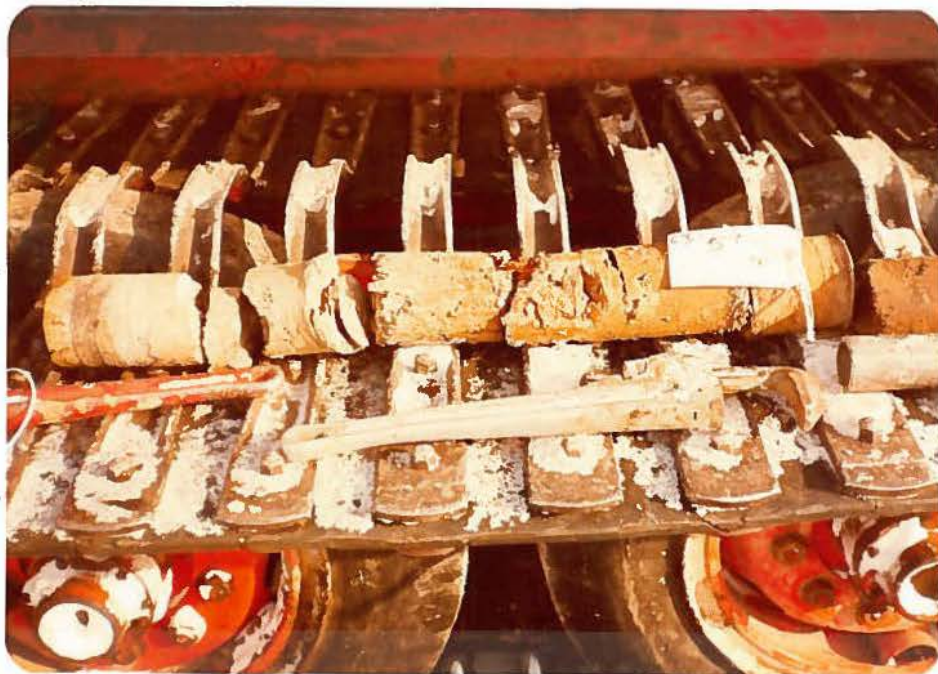
6. The core sample from Station 1023+00. The ground surface is at the left of the photo. It can be seen that the sample contains a high organic and ice content.

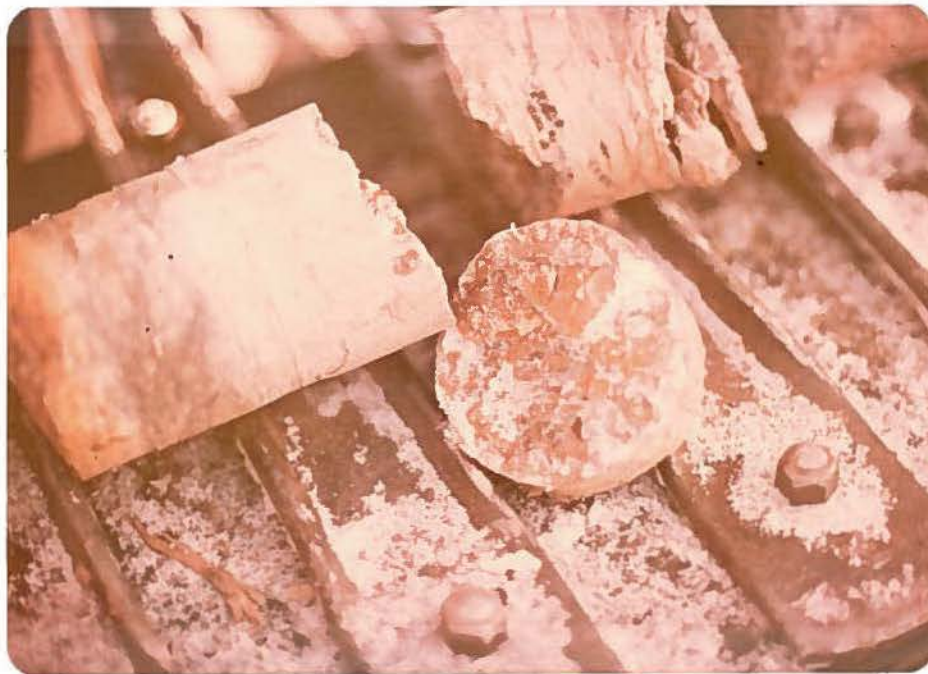
7. The ice lenses are clearly visible in the core sample at 1023+00.

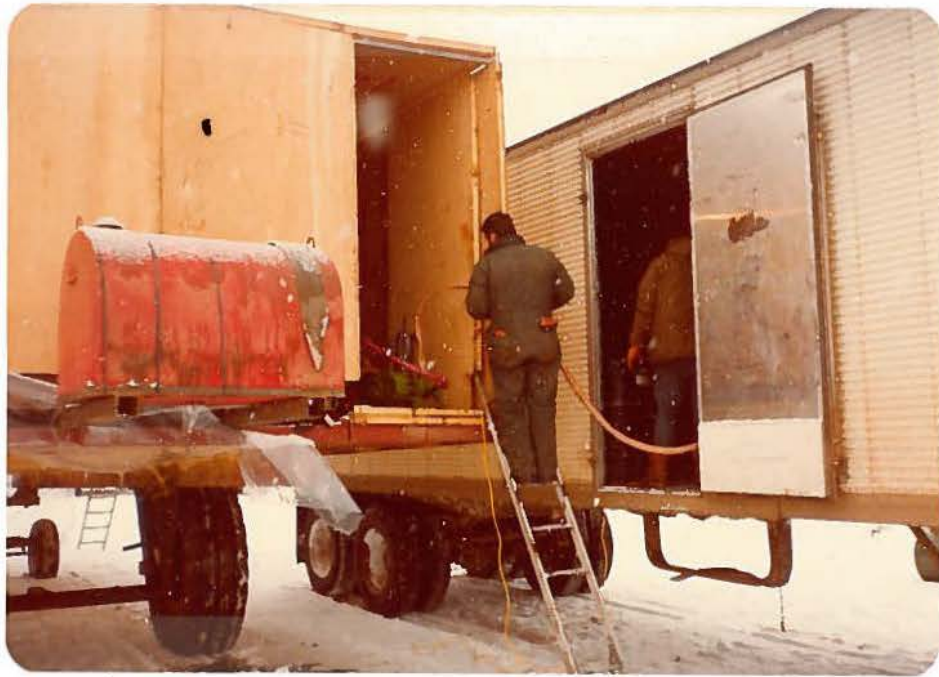
13. Pumping the foam producing liquids from 45 gallon drums to the machine. The liquids were not warm and so presented difficulty pumping.

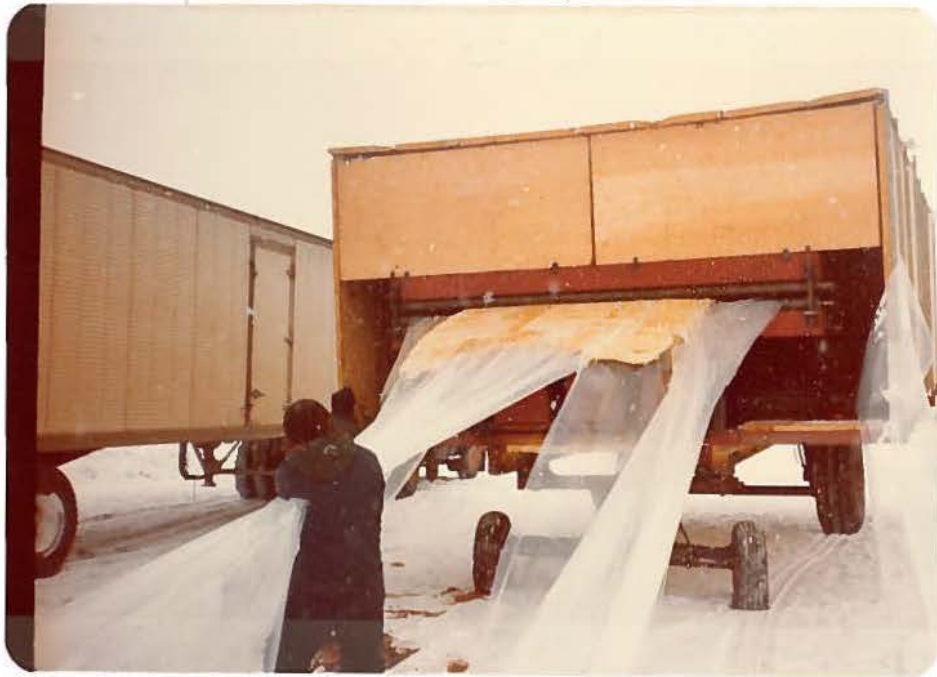
15. The first foam produced. Some difficulty was encountered in placing the foam as it was produced and this is discussed in the text. For this reason it was necessary to initially pull the sheeting from the machine.

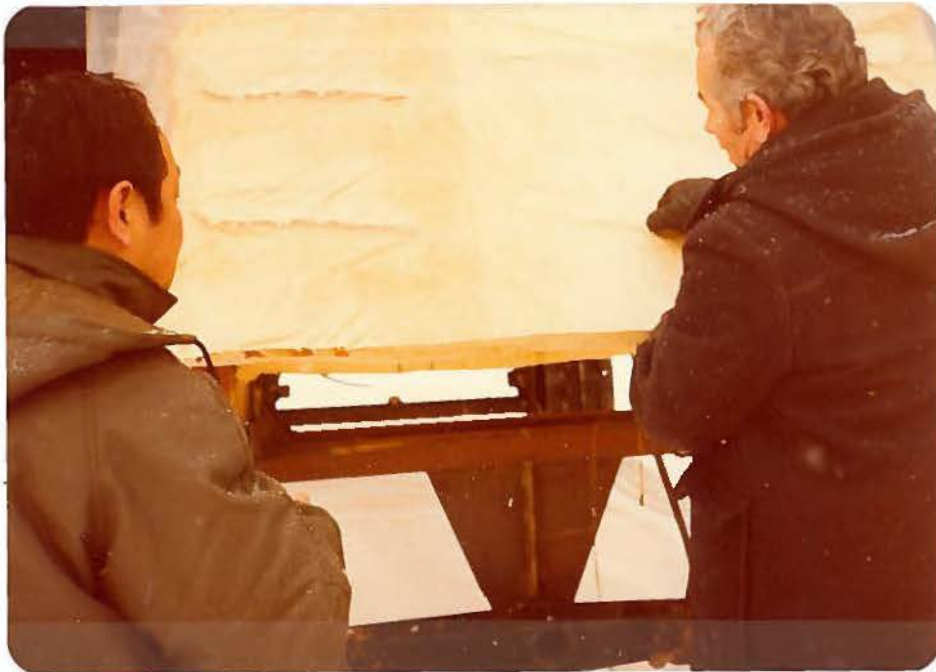
16. The non-uniformity of the first sheeting produced can be seen. The sheeting tended to have gaps at the edges where the foam had not risen sufficiently. This was later corrected.

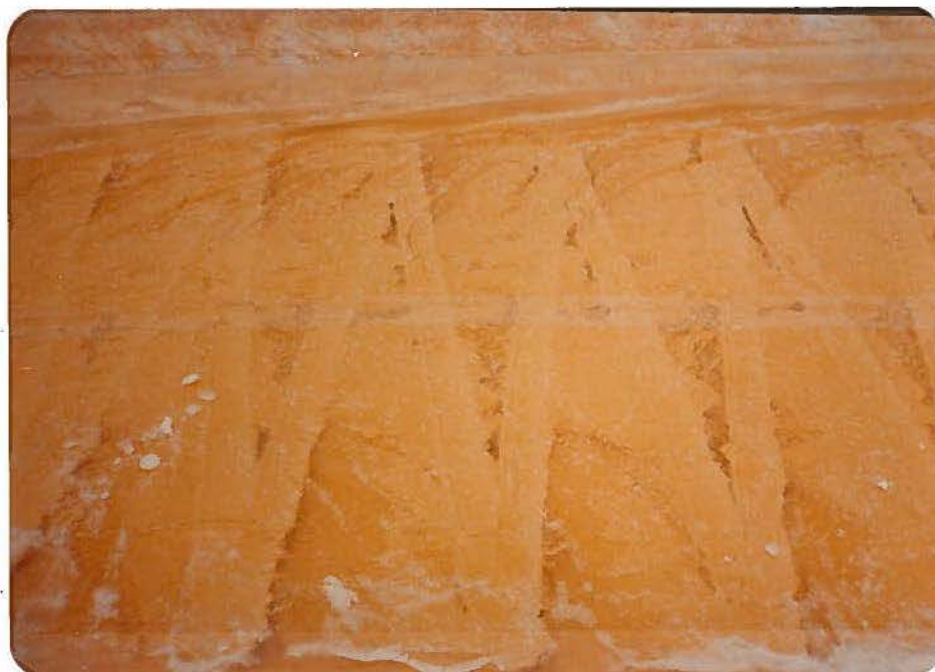
18. In the intial production of sheeting the foam was applied to produce a 3 pcf density. The foam when applied at this rate would not rise sufficiently to produce a uniform sheet. In this photo the travel of the spray nozzle is easily distinguishable in the sheet. The problem of the gaps in the foam was remedied by increasing the application rate to give a 5 pcf density.

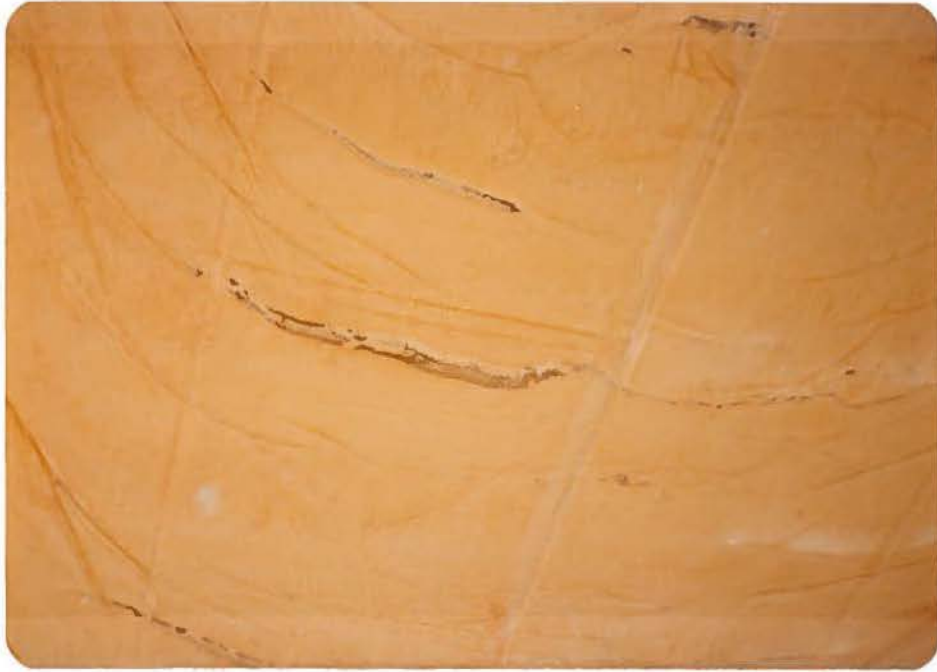
19. Even with the 5 pcf density a few gaps in the foam are present. These gaps in the foam are weak spots which could result in tearing or puncturing of the vapour barrier.

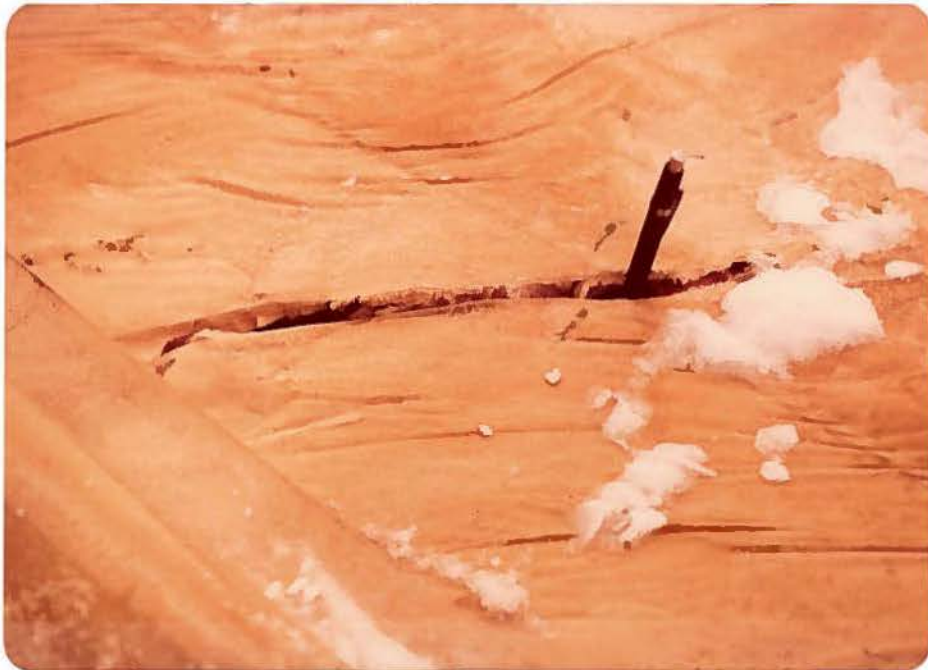
20. This is a tear in the vapour barrier created within the machine itself. It occurred at a gap in the foam and was torn by the rollers of the machine.

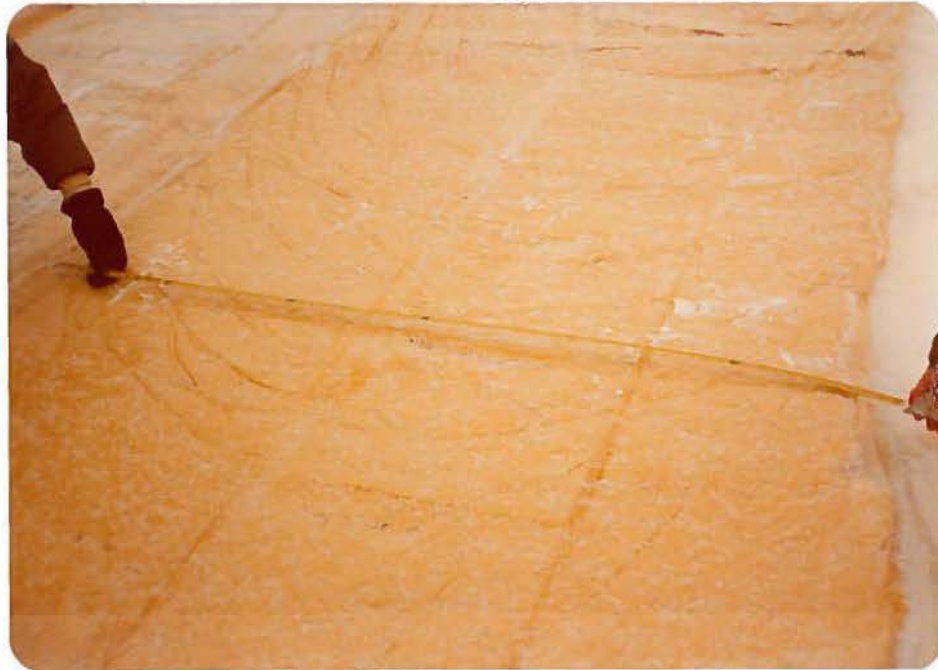
21. A typical sheet of the foam insulation, approximately 6 feet wide. The pattern impressed in the surface is from the belting over the rollers which was added during the test run. The roughness of the edges of the sheet made it necessary to overlap adjacent sheets.

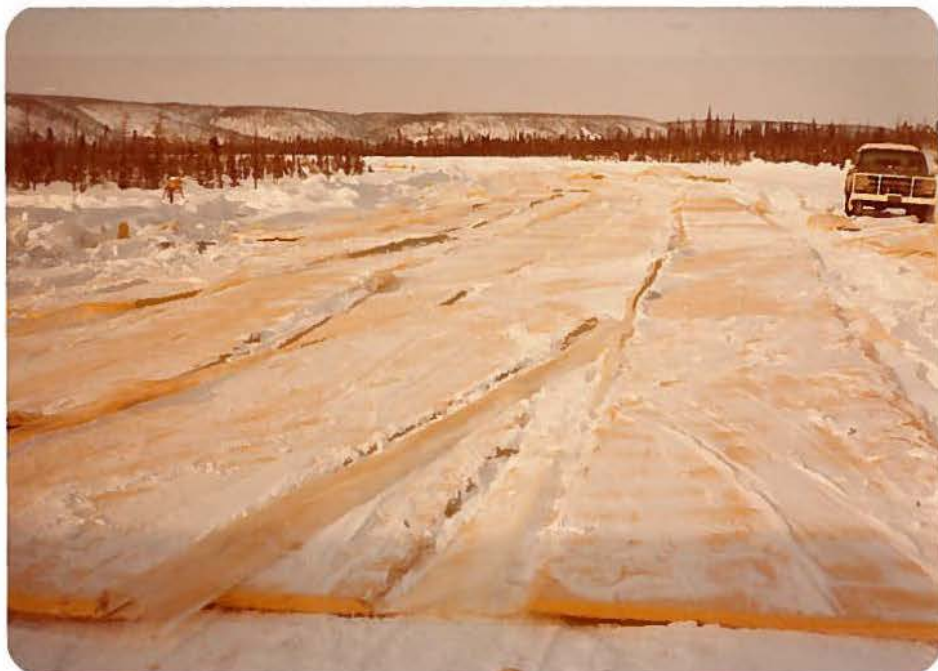
22. The test run is complete and most of the sheets are in their final location. Some minor shifting of the foam was done to reduce the gaps between adjacent sheets. The rippled appearance of the sheets is a result of the stop and start method of production used in making the sheets.

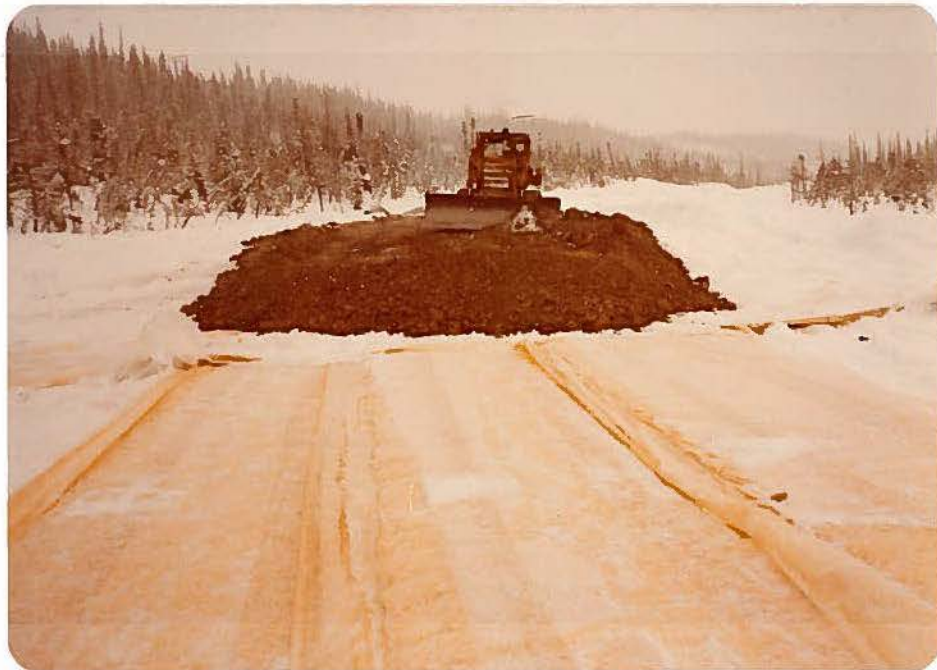
24. A small-scale backfill test was conducted for the benefit of the observers who had to leave. During this test it was noted that the sheets moved approximately 10 feet and so the main portion was tacked down before final backfilling.

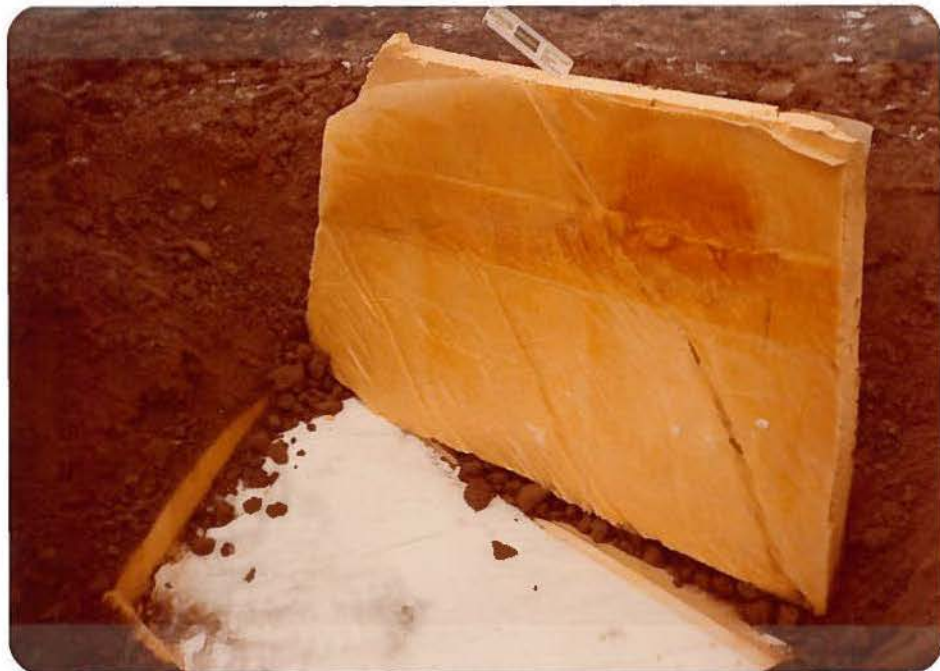
26. Both locations showed tension cracks in the polyethelene. One of these areas was completely removed by sawing through the foam into

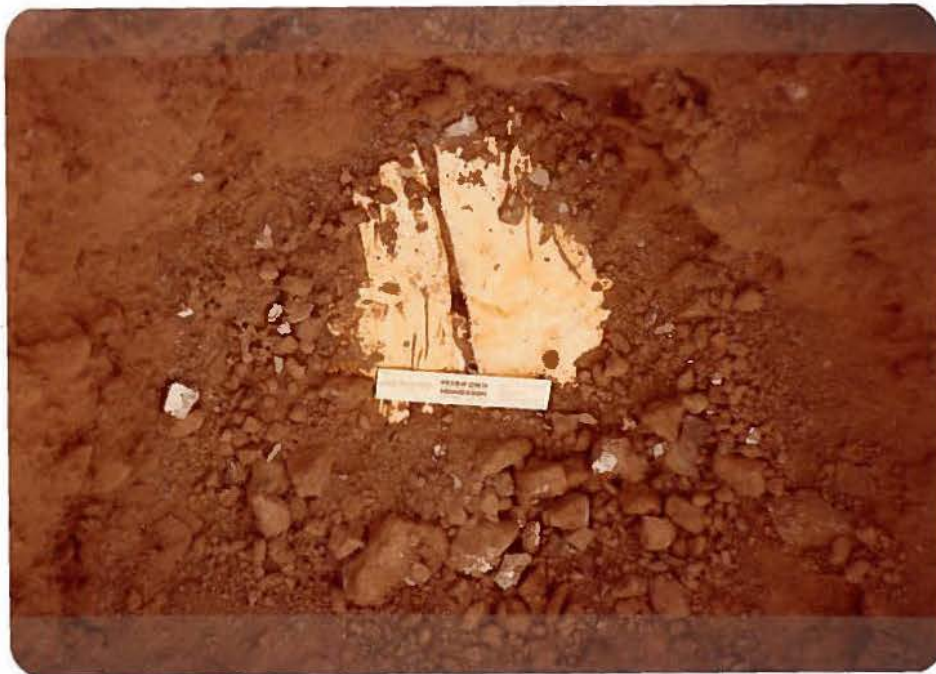
27. the underlying foam. When it was removed it showed that the foam itself had cracked.
