INSTALLATION REPORT - PREPARED BY D.P.W.

Laid M. 237.2 - Dempster Highway
Henderwood Industries Ltd.
"Permabed" Test Section

PUBLIC WORKS
CANADA

PACIFIC REGION

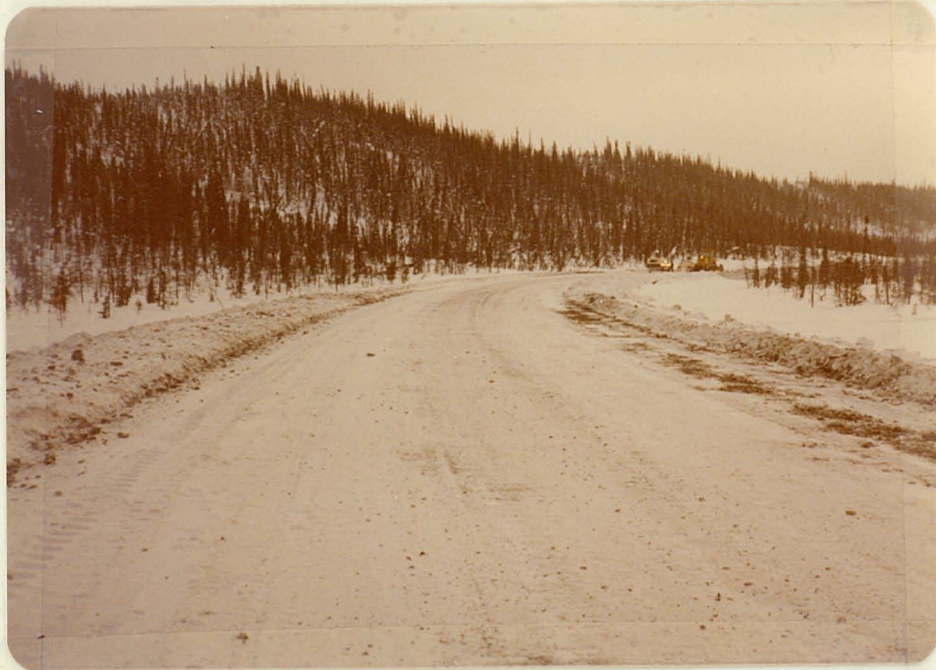
1. The insulation test section from Station 1021+00 looking east. The snow has been bladed off the surface in preparation for excavation.

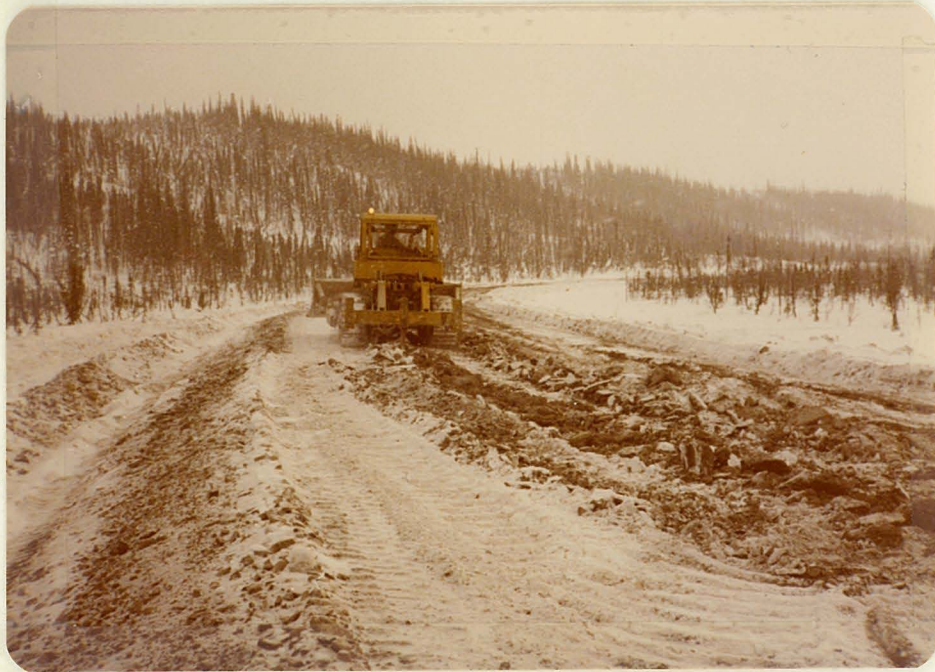
2. D/8 cat ripping Station 1020+00 to 1025+00 in preparation for removal of pad to within one foot of original ground.

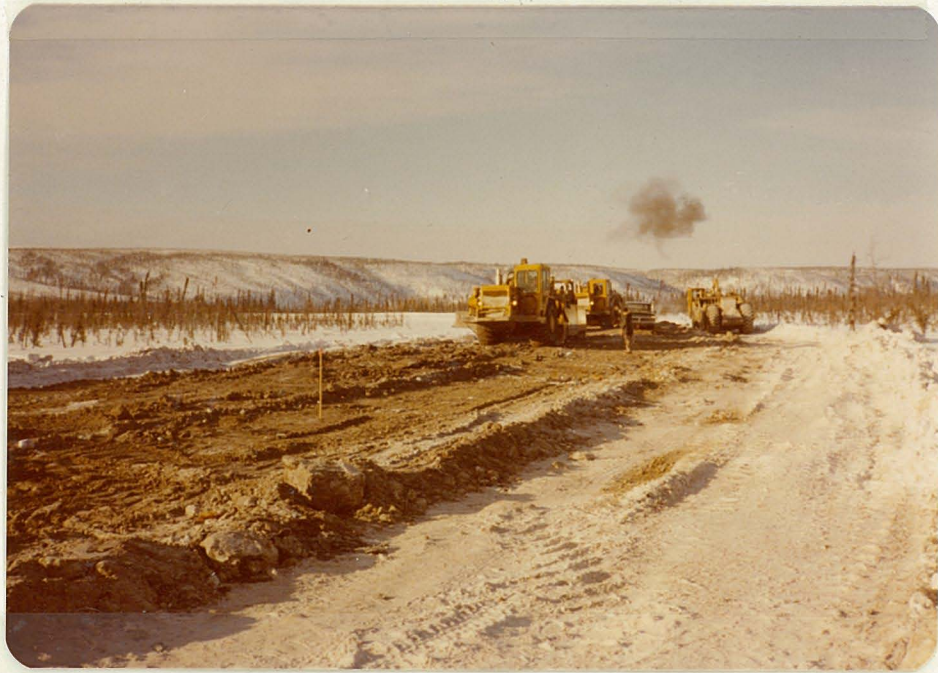
3. Excavation of test section using Cat 631-C scrapers. Photo taken looking west with the by-pass road, around the site, in the right foreground. The excavated material was stockpiled at the east end of the test section prior to backfilling.

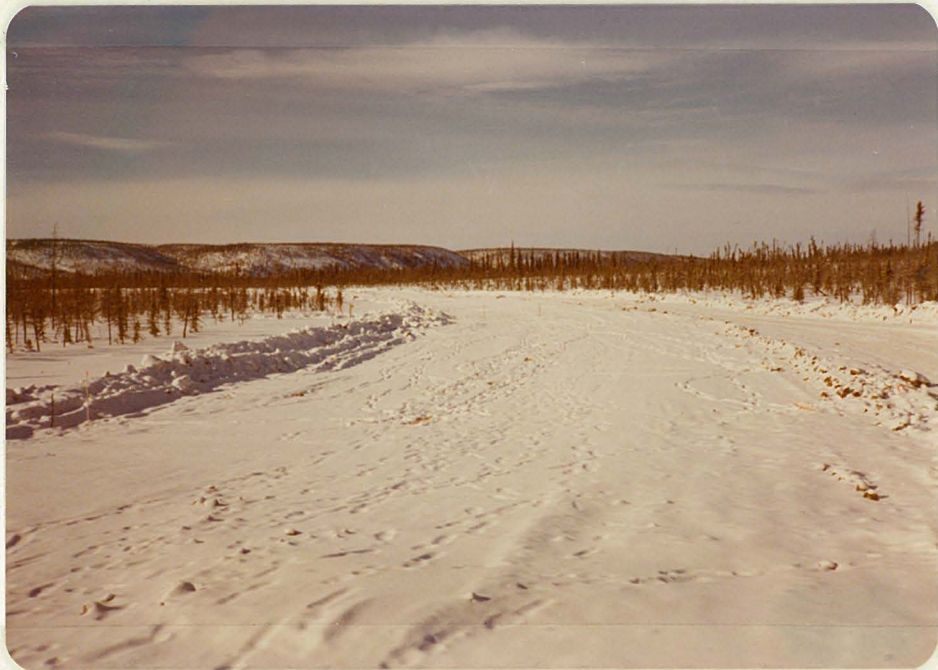
4. Test section after final blading in preparation for the foam sheeting. The sheeting was laid on the snow which had fallen after the blading.

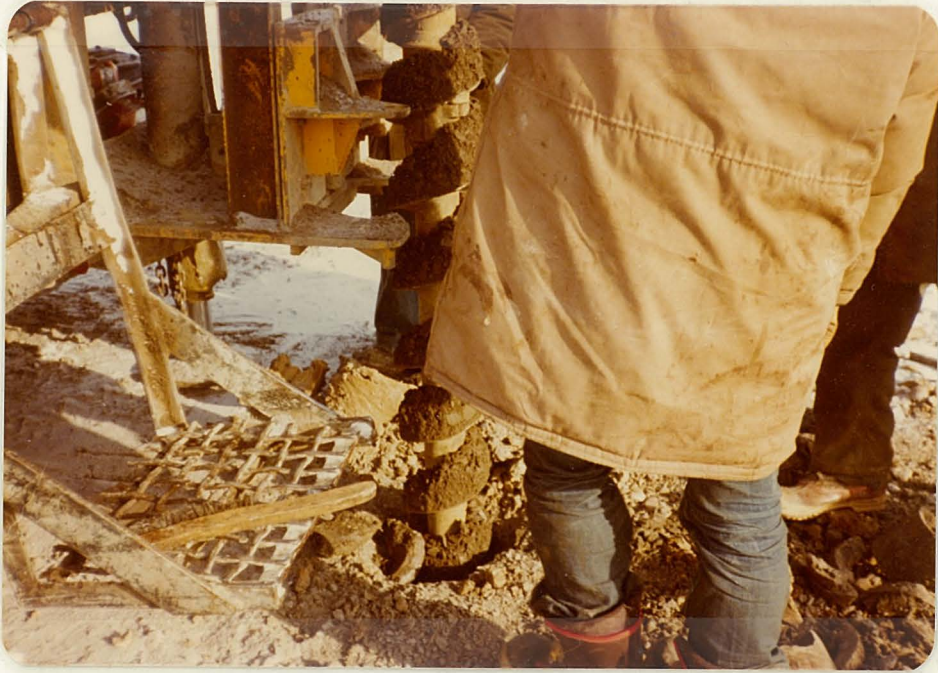
5. The D.P.W. drill crew taking a core sample at Station 1023+00.

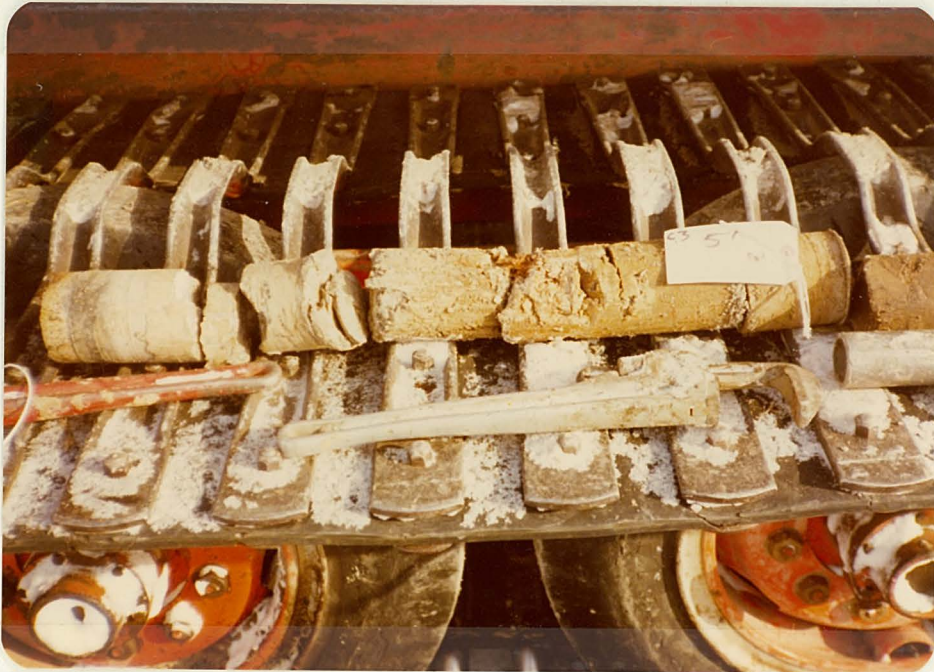
6. The core sample from Station 1023+00. The ground surface is at the left of the photo. It can be seen that the sample contains a high organic and ice content.

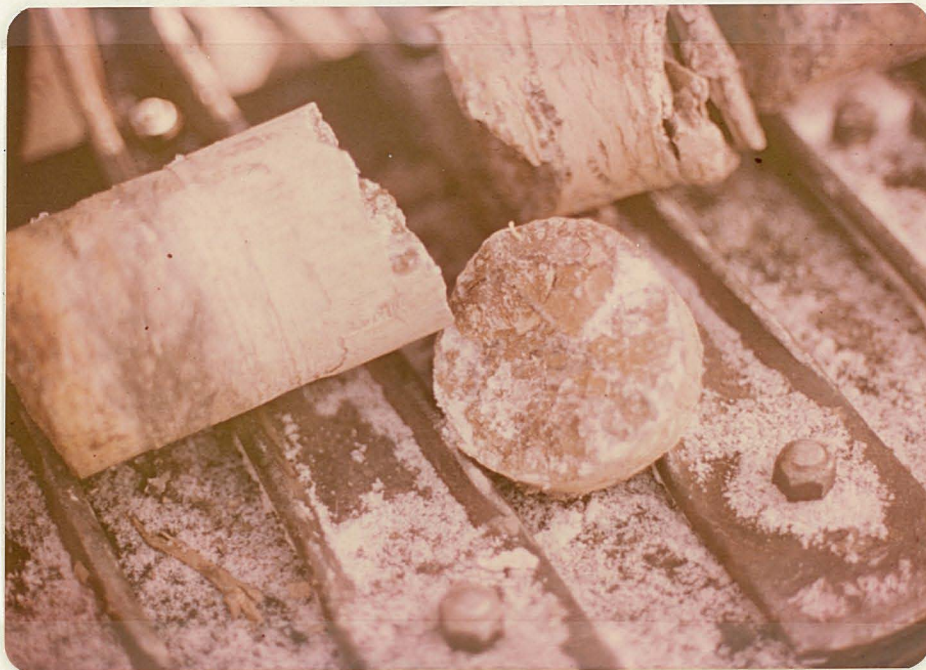
7. The ice lenses are clearly visible in the core sample at 1023+00.

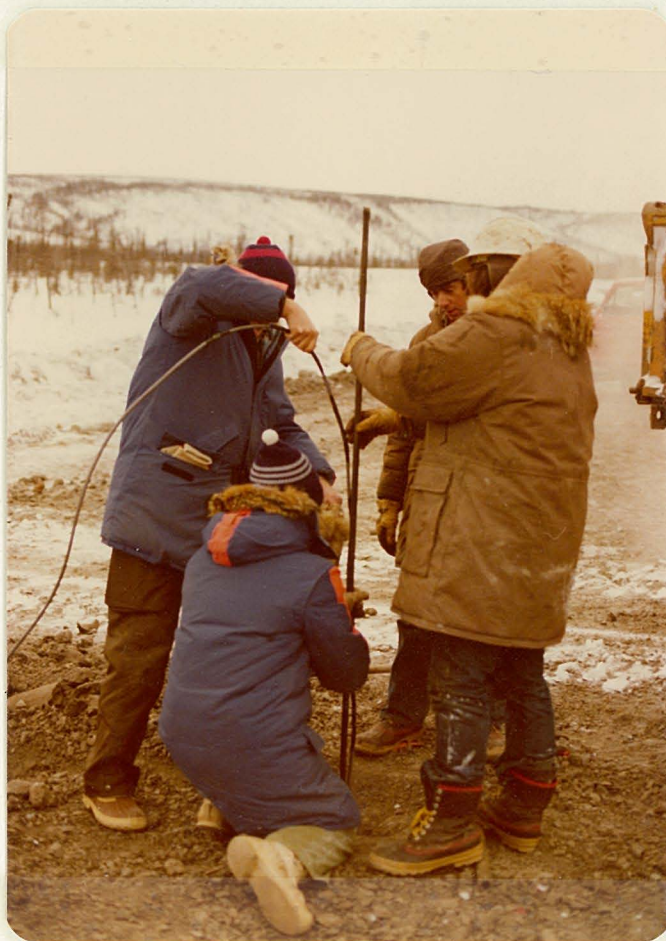
8. The installation of the monitoring system by NRC. The thermistor cables reach to a depth of about eleven (11) feet with thermistors at one to two foot intervals.

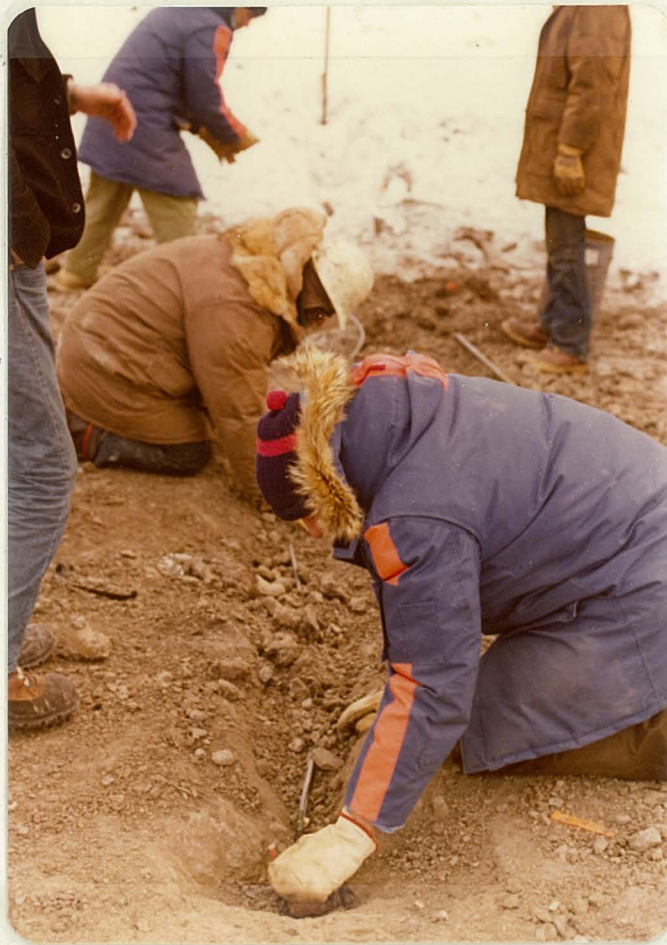
9. The thermistor cables were buried by hand to prevent damage. The top thermistor can be seen at the ground surface where it would rest at the bottom surface of the foam sheeting. The cable holes were back-filled with a dry sand.

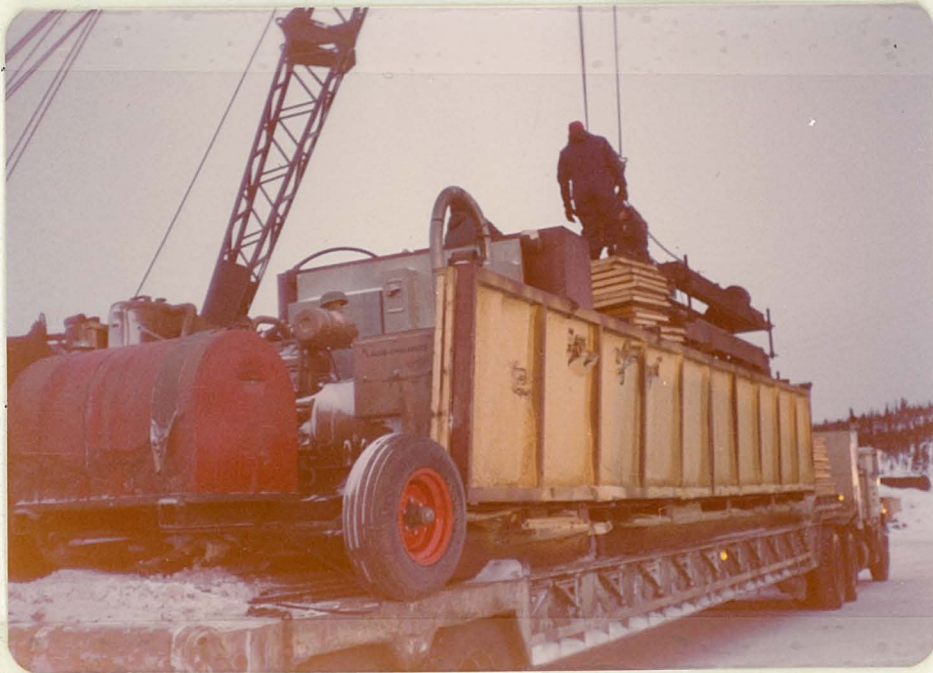
10. The foam producing machine being off-loaded from the transporting flatbed. The machine was being assembled as it was off-loaded.

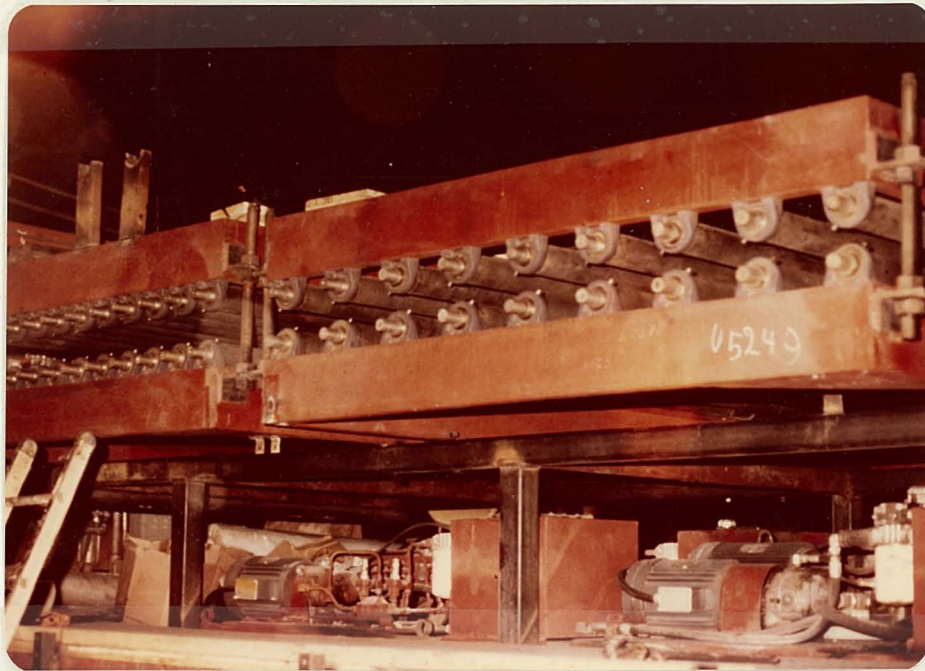
During production the only serious problem encountered with the machine was a difficulty with the roller chain drive. While the sheeting is being formed it is run through two banks of chain driven rollers. The problem occurred when the drive chain slipped off several times. With lack of the drive chain the sheeting would stop whereas the spraying of the foam liquid would not. This resulted in the foam rising excessively and jamming the rollers. The rollers also had a tendency to force gaps in the foam between the polyethelene.

11. The interior of the machine. The two banks of rollers, that restrict the rising foam and form the sheet, can be seen. Beneath the rollers are the hydraulic systems which operate the entire machine.

Both the problems, jamming and gaps were apparently solved by the introduction of belts between the rollers and the foam in the first bank of rollers where the rising of the foam takes place. Once this filed modification was implemented the quality of the foam was improved.

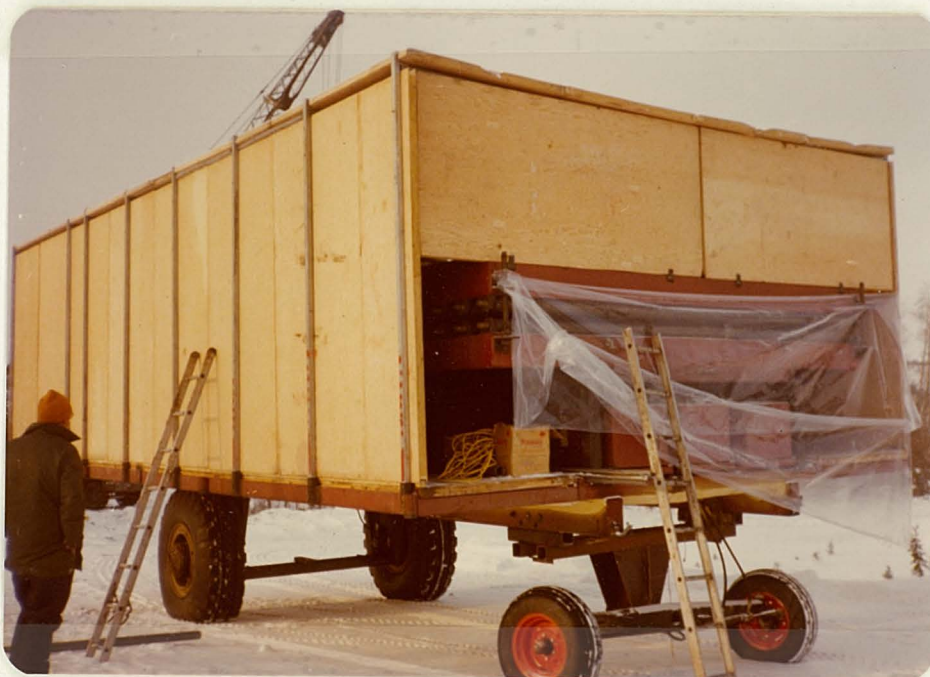
12. The assembled machine encased in urethane sheeting and plywood. Inside the final bank of rollers can be seen; beneath them are the hydraulic fluid reserves.

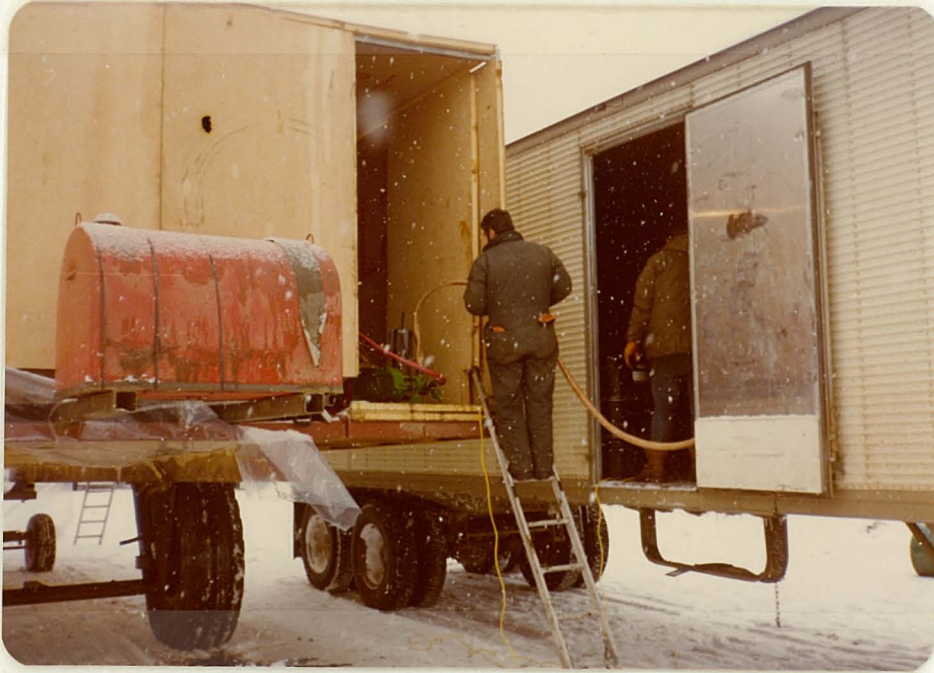
The barrelled foam liquid was stored in the semi-trailer, which was to be heated by a Herman-Nelson heater. Due to an oversight the doors to the trailer were closed resulting in the heater being extinguished. The liquids can only be pumped when warm so the cold liquids presented a few hours delay in the start of the test run.

13. Pumping the foam producing liquids from 45 gallon drums to the machine. The liquids were not warm and so presented difficulty pumping.

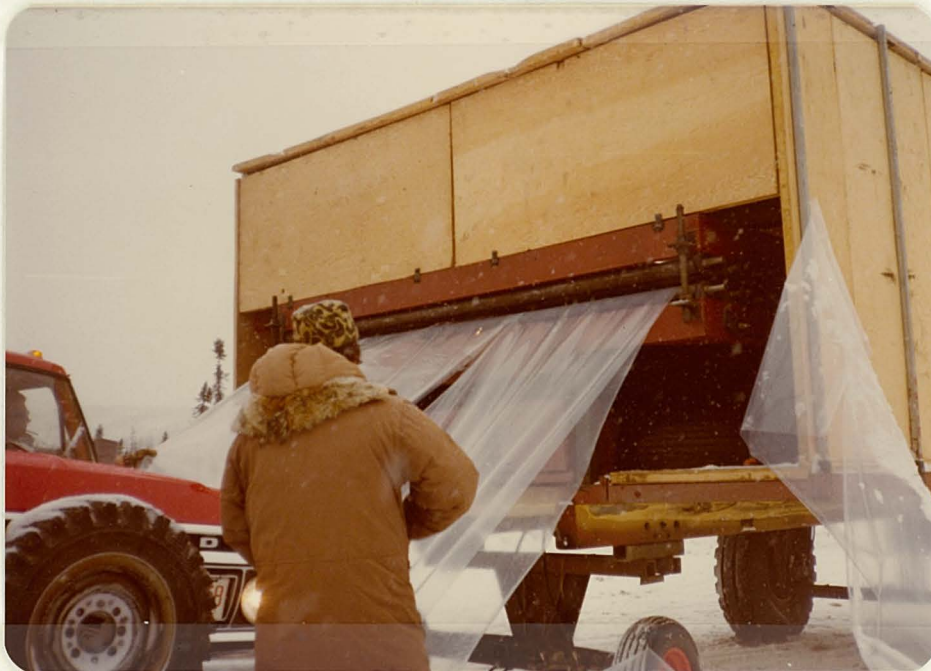
14. The polyethelene sheeting in place in preparation for production. The truck was positioned to prevent the sheeting from being dragged along as the foam was produced.

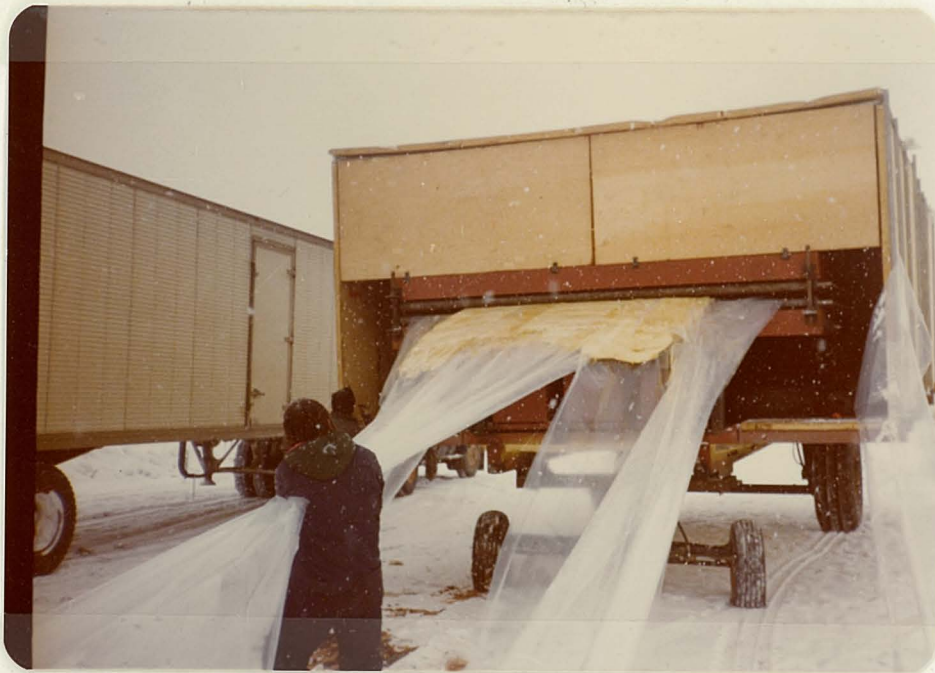
In the construction of the machine Henderwood was unable to obtain the proper sized tires, at the present time, for the large front wheels. This resulted in problems in the application of the foam sheeting. Theoretically the rate of foam production must match exactly the rate of forward movement of the machine. In this manner the foam would be laid exactly in place as it was produced. The front drive wheels being too large did not allow the matching of the speed of production with forward motion resulting in the foam sheeting being dragged along the ground.

15. The first foam produced. Some difficulty was encountered in placing the foam as it was produced and this is discussed in the text. For this reason it was necessary to initially pull the sheeting from the machine.

This difficulty was adapted to by using a steady production speed and driving the machine in a start and stop fashion. Ideally as the foam hits the ground from the rear of the machine it is still warm and flexible, cooling and becoming less flexible once it is in place. With the start and stop placement method the foam tended to cool before it was in its final site giving it a wavy surface that did not lay flat on the ground. It is possible that upon backfilling this could result in fracturing of the foam due to tension along the bottom surface.

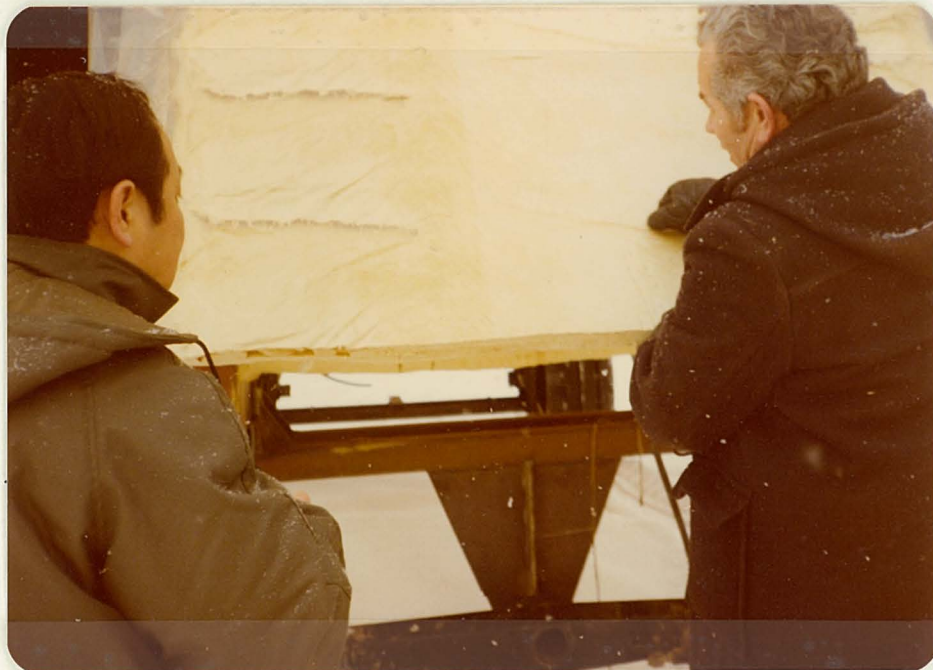
16. The non-uniformity of the first sheeting produced can be seen. The sheeting tended to have gaps at the edges where the foam had not risen sufficiently. This was later corrected.

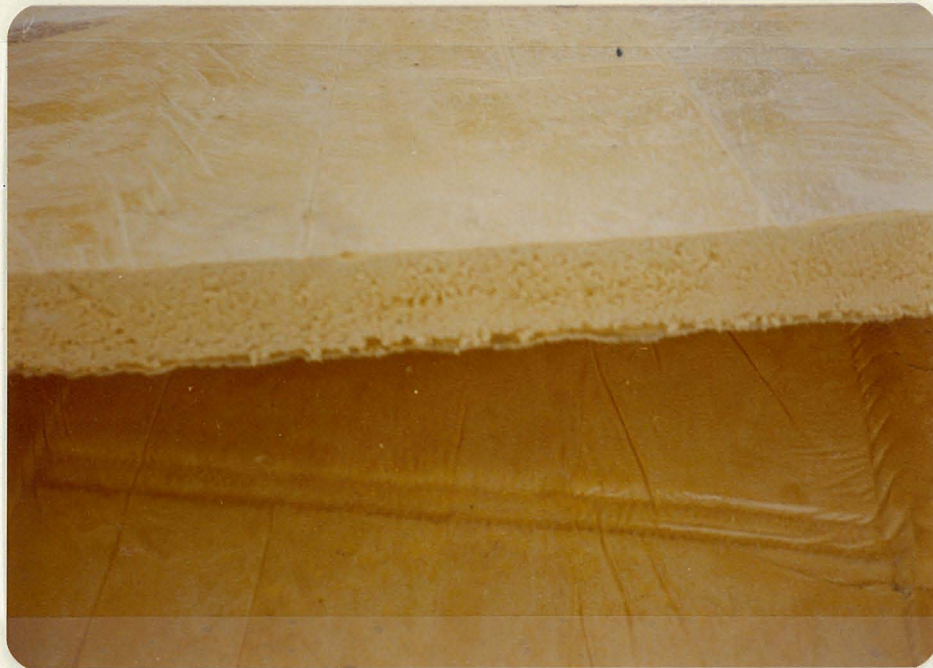
17. The porosity of the foam and the heat bonding of the polyethelene is seen in this cut off section of sheeting.

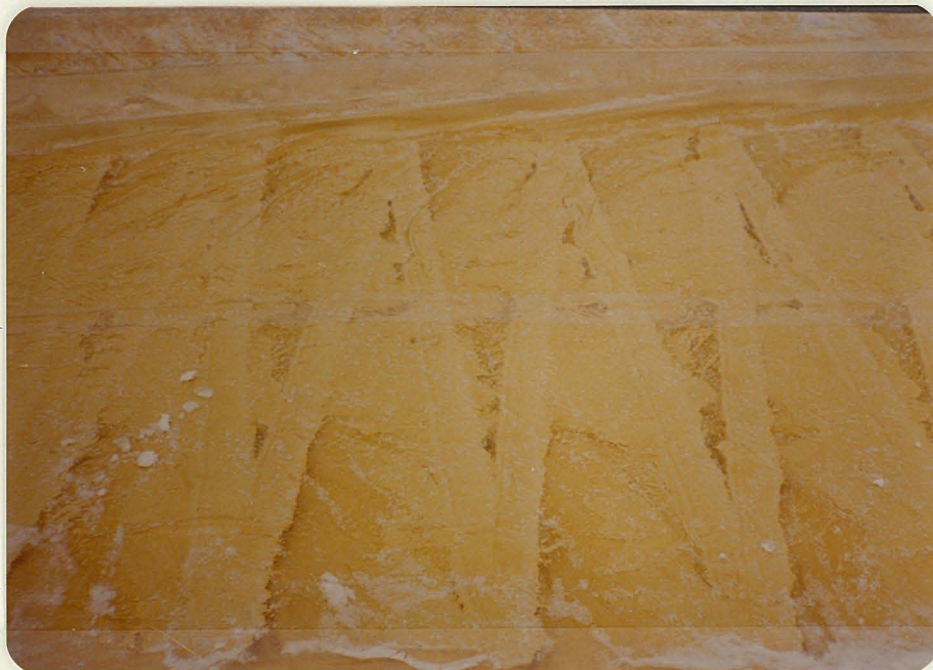
The liquid foam material was shipped to the site in 45 gallon drums loaded on an insulated semi-trailer. It was the original intension of Henderwood to manufacture sheeting 10 feet in width with a 3 pcf density of foam. The manufacturer of the foam material could not specify the density to which the foam would rise. The foam which was produced had a density of 5 pcf with a compressive strength of 110 psi instead of the intended 45 psi. Because of the increased density it was not possible to produce the intended 10 foot width as the foam would not rise sufficiently. Instead a 6 - 7 foot width was the maximum which could be obtained.

18. In the intial production of sheeting the foam was applied to produce a 3 pcf density. The foam when applied at this rate would not rise sufficiently to produce a uniform sheet. In this photo the travel of the spray nozzle is easily distinguishable in the sheet. The problem of the gaps in the foam was remedied by increasing the application rate to give a 5 pcf density.

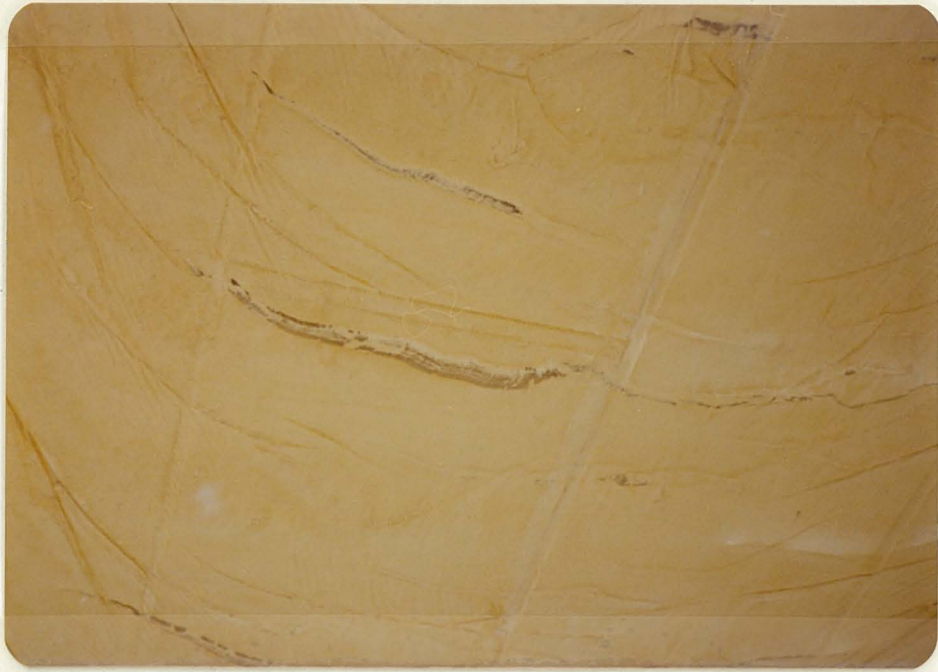
19. Even with the 5 pcf density a few gaps in the foam are present. These gaps in the foam are weak spots which could result in tearing or puncturing of the vapour barrier.

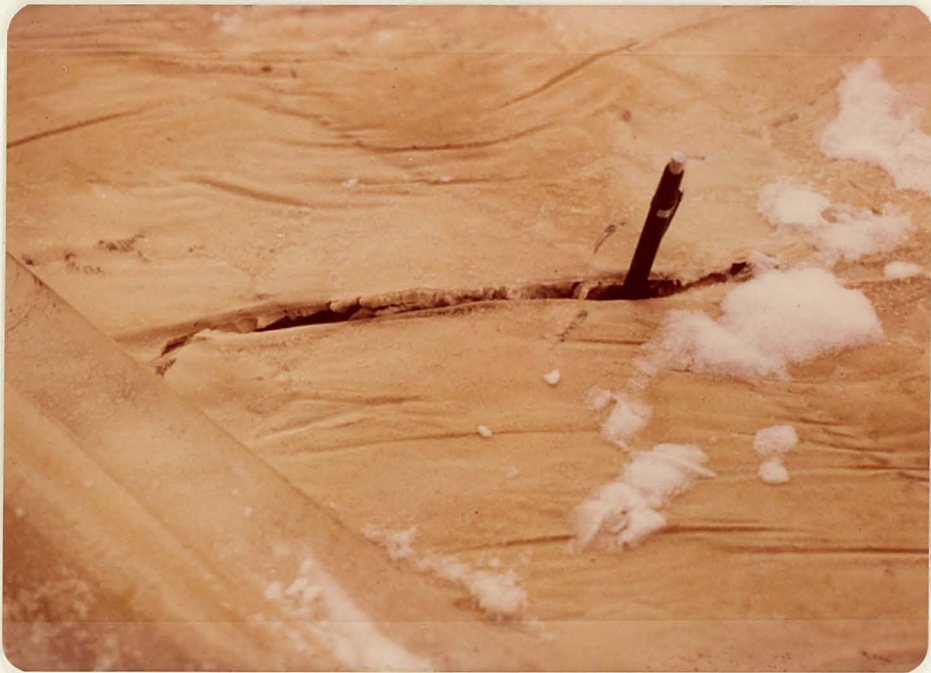
20. This is a tear in the vapour barrier created within the machine itself. It occurred at a gap in the foam and was torn by the rollers of the machine.

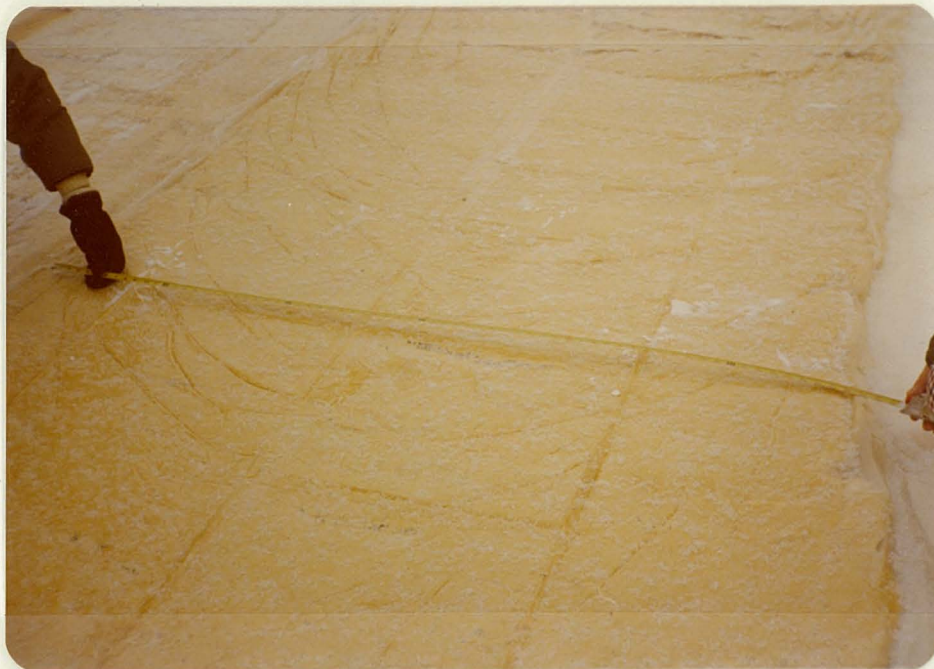
Since as the foam rises it has no edge restriction the edges tend to be of irregular shape. The sheets cannot be butted together without the introduction of gaps varying in widths up to 1½'. For this reason it was often necessary to overlap adjacent sheets. The machine could not accomplish this so the sheets were produced and then shifted into place by hand. This was quite awkward as the size of the sheets, 6 feet wide and varying from 200 - 400 feet long were fairly unmanageable.

21. A typical sheet of the foam insulation, approximately 6 feet wide. The pattern impressed in the surface is from the belting over the rollers which was added during the test run. The roughness of the edges of the sheet made it necessary to overlap adjacent sheets.

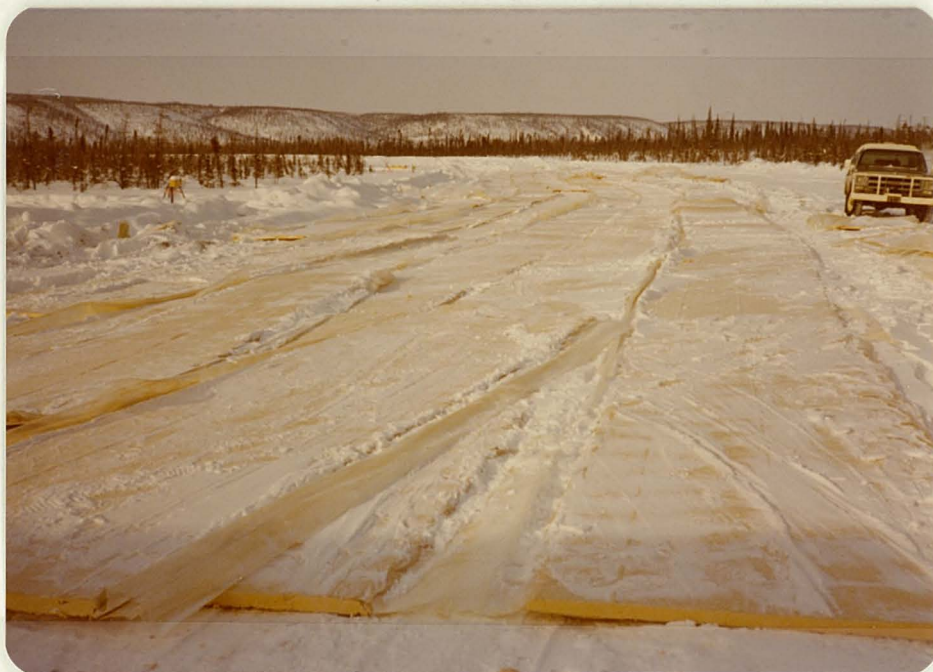
22. The test run is complete and most of the sheets are in their final location. Some minor shifting of the foam was done to reduce the gaps between adjacent sheets. The rippled appearance of the sheets is a result of the stop and start method of production used in making the sheets.

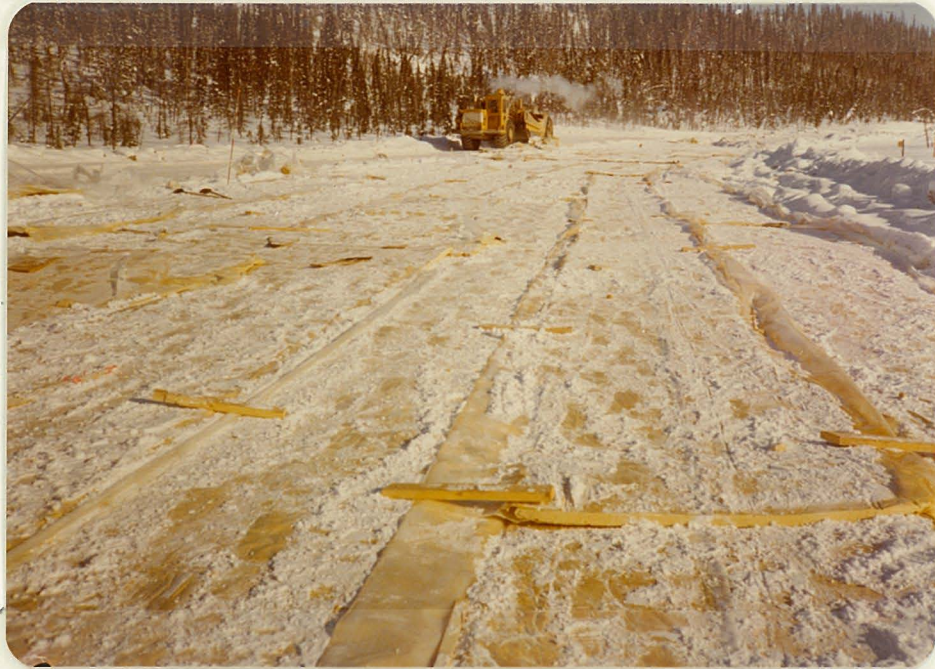
23. The insulation just prior to backfilling. The sheets have been attached together and also to the ground, with wood scraps and 8 inch spikes. This was a precaution taken to prevent movement of the sheets during backfilling.

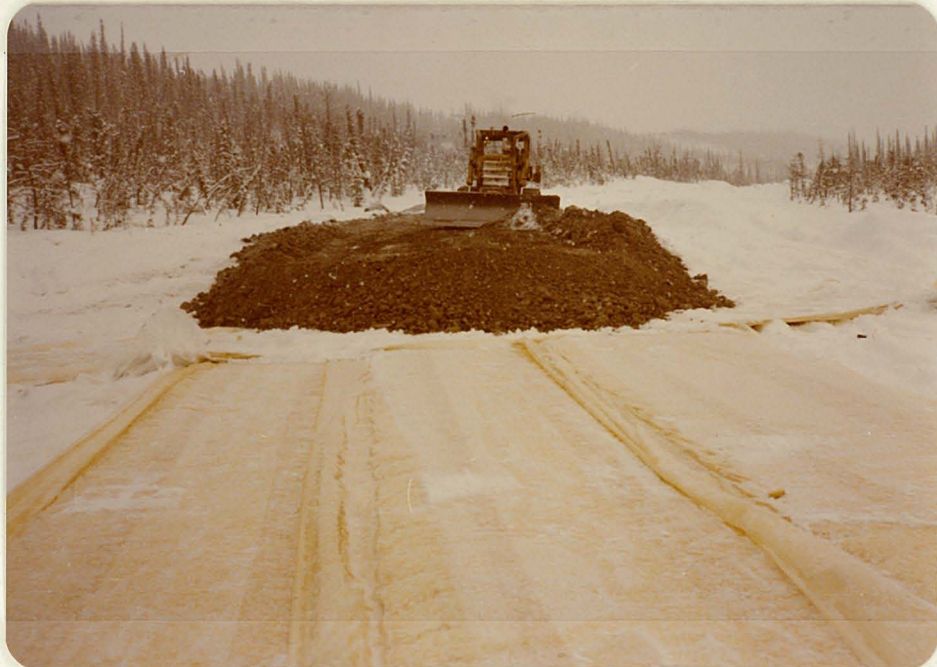
During the test run it had been snowing and thus the foam sheeting was layed over a thin layer of snow. It was found that the polyethelene when cold would slide around very easily. This greatly hampered the small scale backfill test. As the three short strips were being back-filled it is estimated they moved approximately 10 feet. To reduce the possibility of a recurrence with the final backfilling of the main portion of the urethane foam, the sheeting was nailed down with 8" spikes and wood scraps. This apparently solved the problem as no serious movement of the sheets was noted upon backfilling.

24. A small-scale backfill test was conducted for the benefit of the observers who had to leave. During this test it was noted that the sheets moved approximately 10 feet and so the main portion was tacked down before final backfilling.

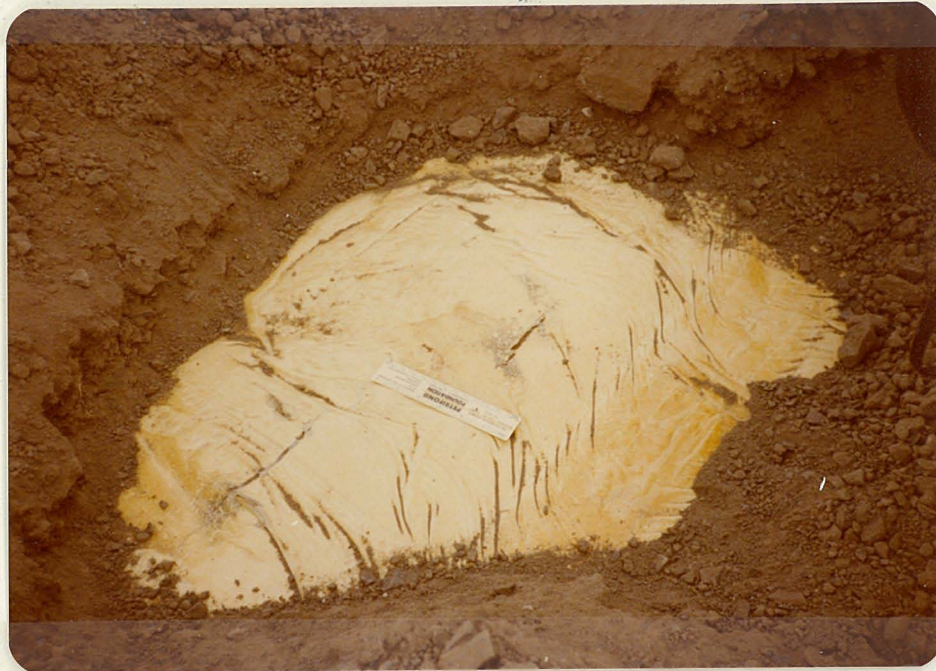
25. After the backfilling exercise two spots were randomly selected and excavated by hand to see if the vapour barrier had been punctured.

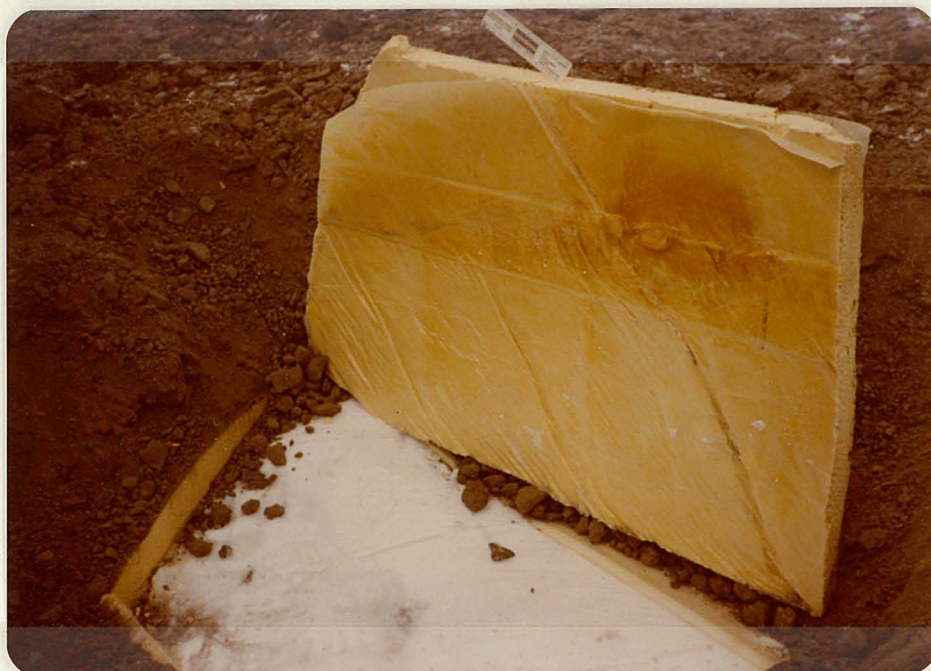
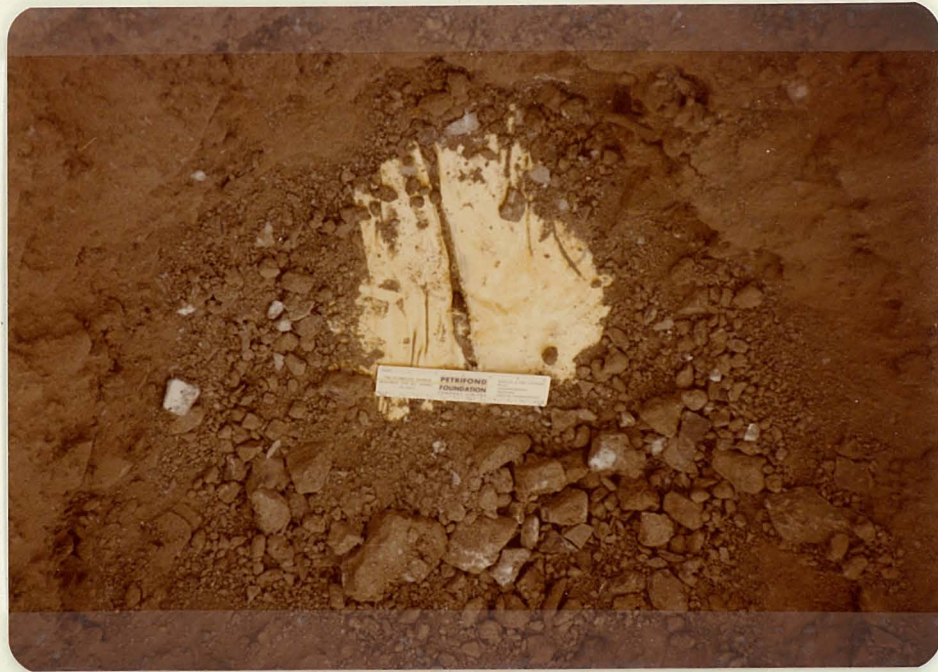
The polyethelene was not only intended as a form for the urethane, but also as a vapour-barrier since urethane is apt to absorb water, reducing its insulative properties. As a vapour barrier it was found that it tended to be weak in the longitudinal direction and was subject to tearing. This was observed in the backfilling exercise carried out. Tension cracks were observed at both sections which were excavated after backfilling. It was also found that rocks in the backfill material could puncture the polyethelene reducing its efficiency. For this reason Henderwood suggested the backfill material be of 1" minus material to reduce the possibility of puncturing the polyethelene.

26. Both locations showed tension cracks in the polyethelene. One of these areas was completely removed by sawing through the foam into

27. the underlying foam. When it was removed it showed that the foam itself had cracked.

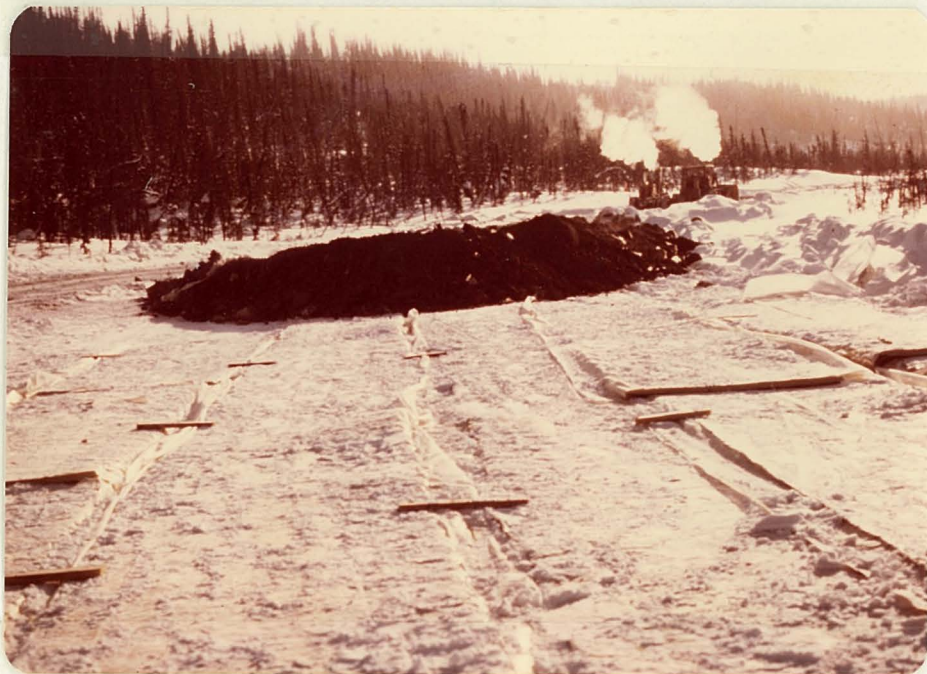
28. The final backfilling of the insulation was accomplished by pushing a two foot pad over the sheeting. The sheeting did not move during backfilling so it is believed that the tacking of the sheets was successful.

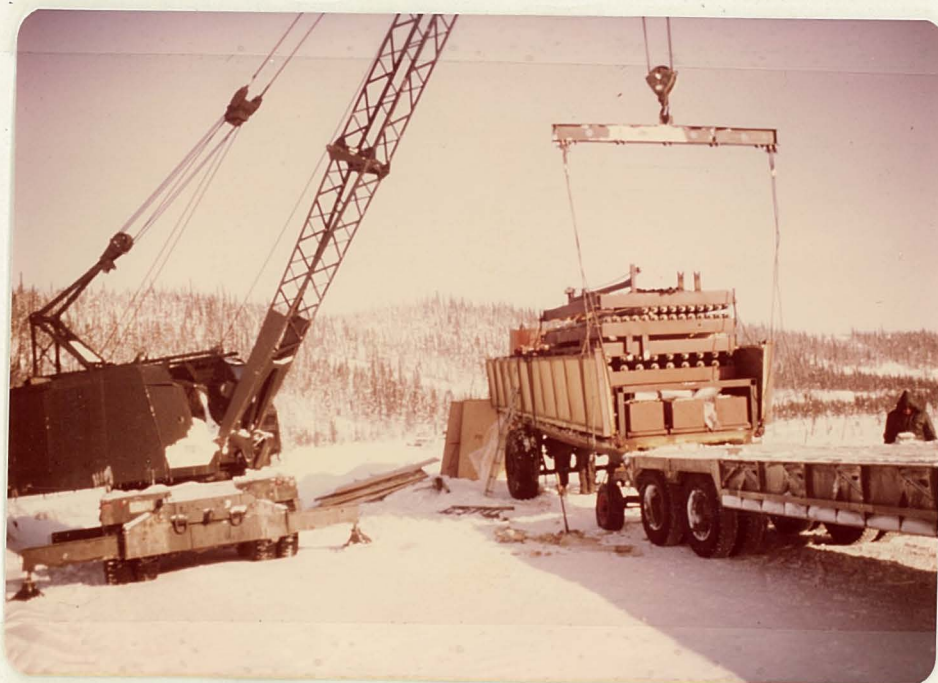
29. The loading of the machine was done at the test site with the aid of the Army's crane.
