CLIMATE CHANGE VULNERABILITY ASSESSMENT DEMPSTER HIGHWAY, YT/NT

PRESENTED TO
Government of Northwest Territories
DEPARTMENT OF TRANSPORTATION

MARCH 2015
ISSUED FOR USE
FILE: W14103156-01

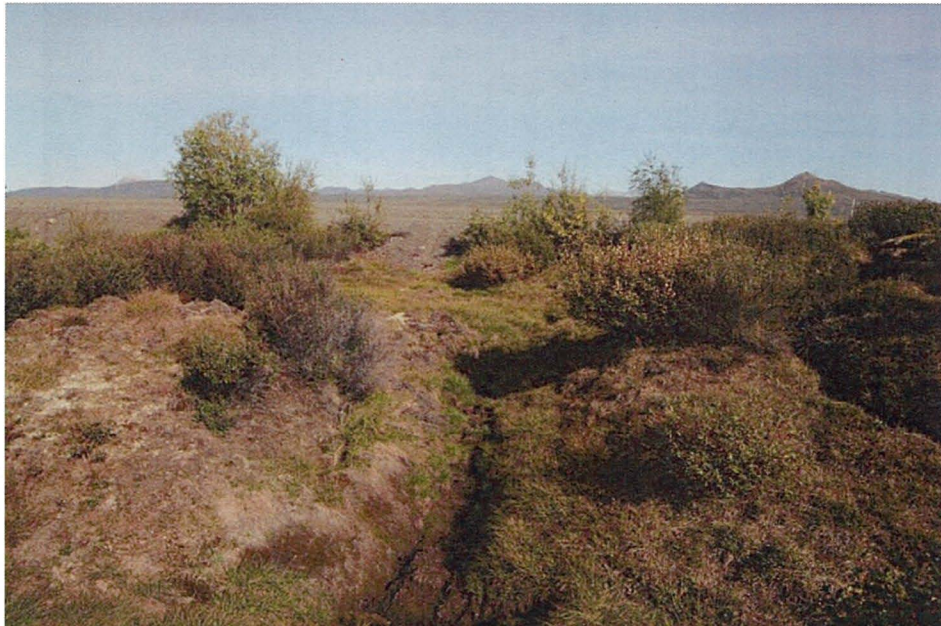
Photo 1 shows degraded ice-wedge polygons adjacent to the highway at about km 96. Natural undulations in the terrain adjacent to the highway are about 2 m and are indicative of thaw of ice-wedge polygons.

Photo 1:
Degraded ice-wedges adjacent to the highway embankment, km 96 (August 27, 2013)

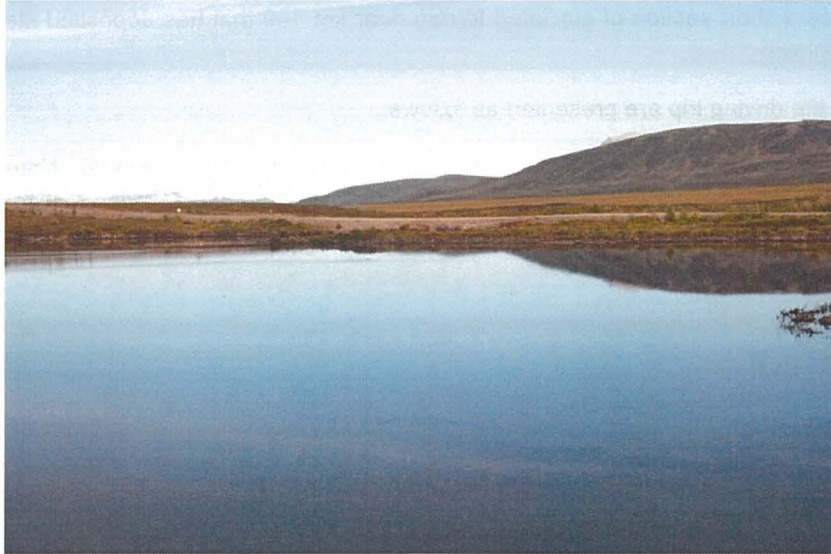
Photo 2:

Several large thermokarst lakes are also present adjacent to this section of highway – the largest being Chapman Lake and Two Moose Lake. These lakes have increased in size since the highway was constructed, and are now adjacent to and potentially encroaching on the highway embankment.

View across Two Moose Lake where permafrost thaw is threatening the stability of the road embankment (August 27, 2013)

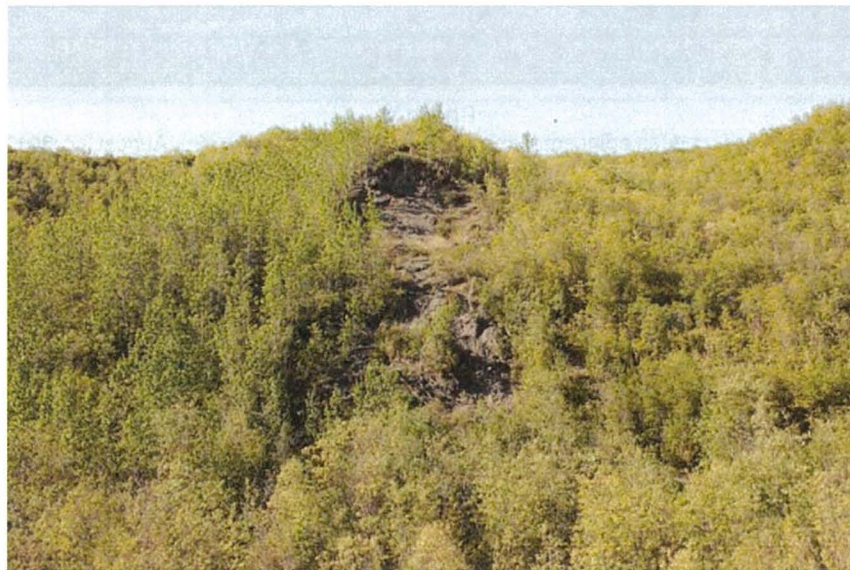
Photo 3:

The short glaciated area that the highway passes through is centered on about km 109 – the moraine in this area is ice-rich, and has recently started to exhibit minor slope instabilities (surface flow slides) related to increased active layer thickness, and possibly increased rainfall. None of these slides have affected the highway yet, but are very close to the ditches in some areas.

Shallow flowslide in glacial moraine near km 109 (August 27, 2013)

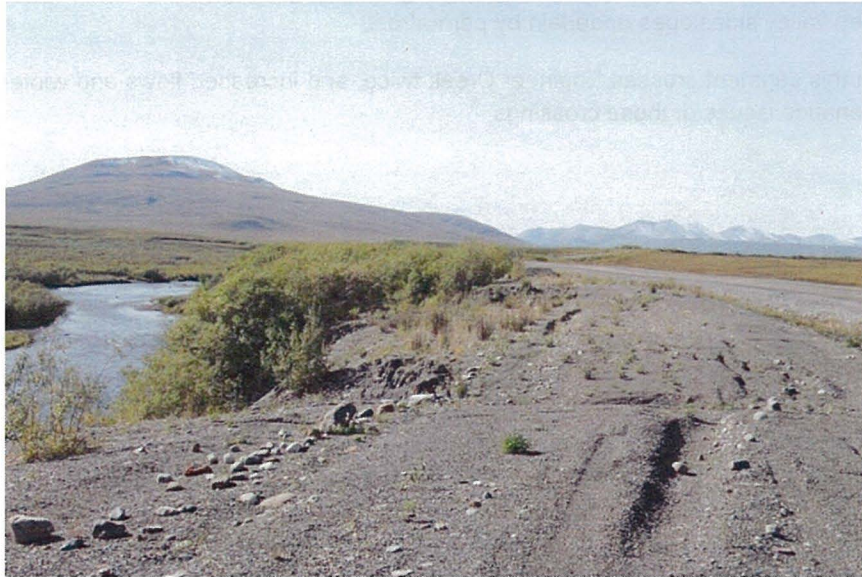
Photo 4:

Erosion from the Blackstone River has affected the highway at about km 122, necessitating a realignment. The highway was moved away from the river, but reconstruction included a minor cut section that has created ongoing permafrost thaw-settlement issues and initiated progressive instability that requires regular maintenance.

Erosion at toe of highway embankment by the Blackstone River (August 27, 2013)

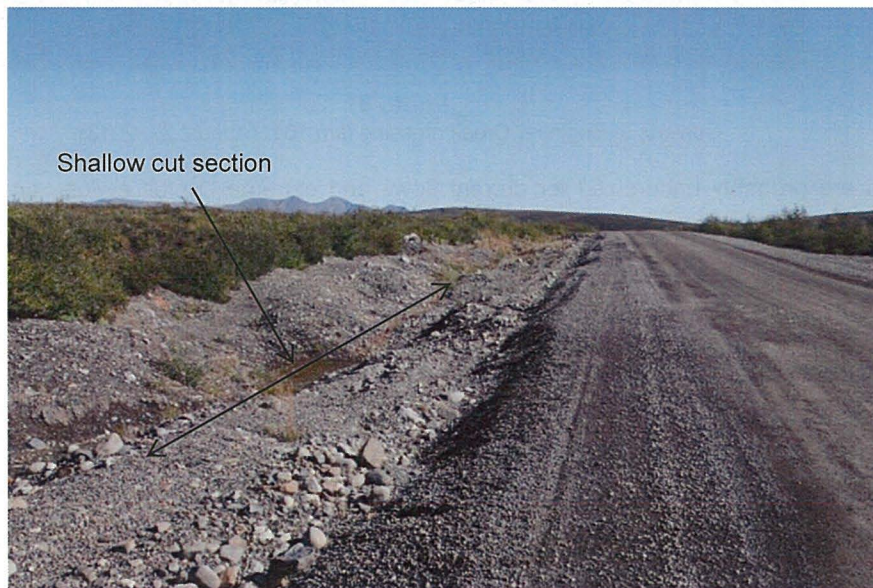
Photo 5:

New alignment further away from Blackstone River, But the shallow cut section has created thaw settlement problems in the left shoulder, km 122 (August 27, 2013)

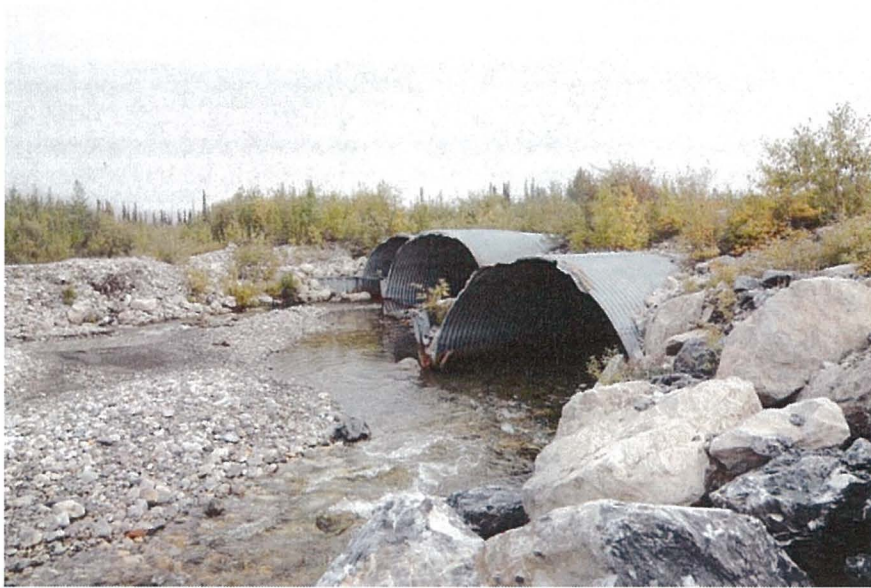
Photo 6:

Culverts at Engineer Creek crossing (km 161) (August 27, 2013)

These culverts are probably undersized for current flows and extreme rainfall events, and maintenance crews indicate that they ice up most winters. The culvert installations are not consistent with current design practice as the overlying fill is too thin to effectively dissipate the load from heavy vehicles

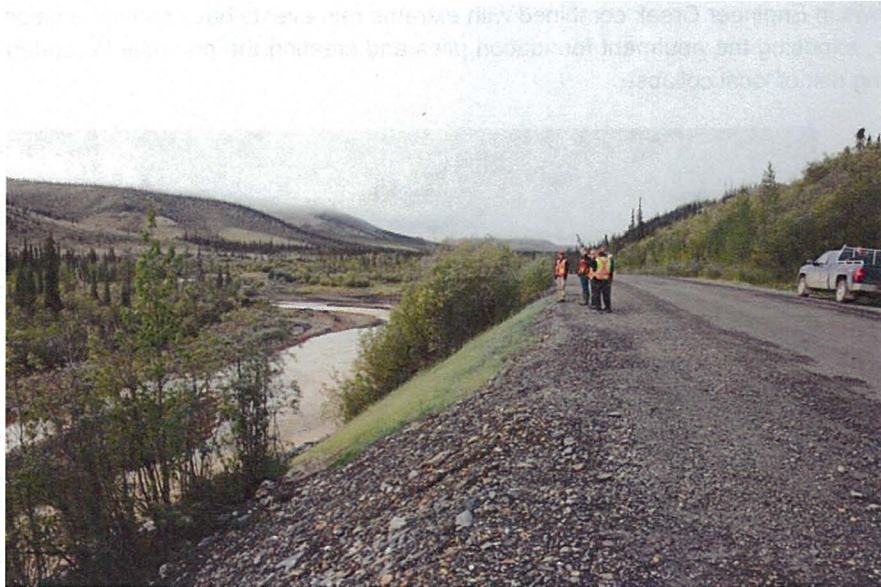
Photo 7:

Increased flows in Engineer Creek have also created highway instability by eroding the toe of the embankment. This has necessitated several repairs by highways crews after extreme rainfall events (see Photo 7).

View of successful erosion repair adjacent to Engineer Creek, km 177 (August 27, 2013)

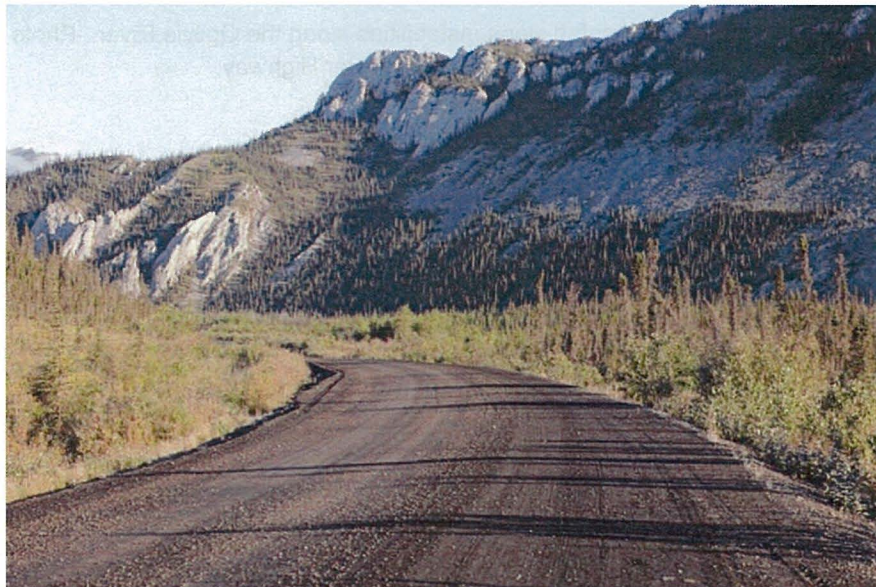
Photo 8:

The black shale used for embankment construction material has decomposed into clay minerals, and absorbed heat that has accelerated permafrost thaw and settlement.

Black shale embankment showing settlement at km 192 just south of Engineer Creek Bridge (August 27, 2013).

The original shale embankment fill has produced a matrix of fine clay and silt by freeze-thaw action. The black surface increases heat absorption, further deepening the active layer resulting in progressive settlement into the surrounding wetland tundra.

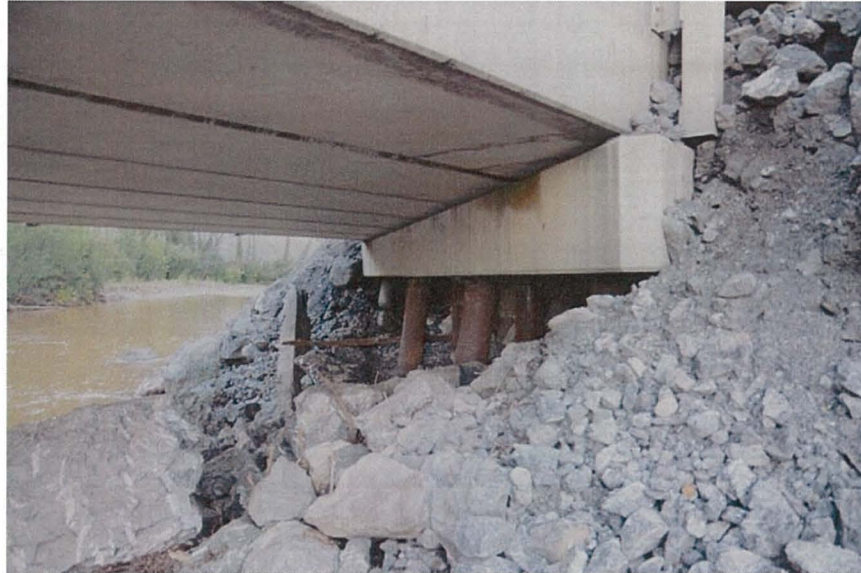
Photo 9:

Increased flows in Engineer Creek combined with extreme rain events have caused erosion of the Engineer Creek at the bridge, exposing the abutment foundation piles and creating the potential for undermining of the abutment and increasing risk of local collapse.

Erosion at abutment of bridge crossing Engineer Creek, km 195 (August 27, 2013)

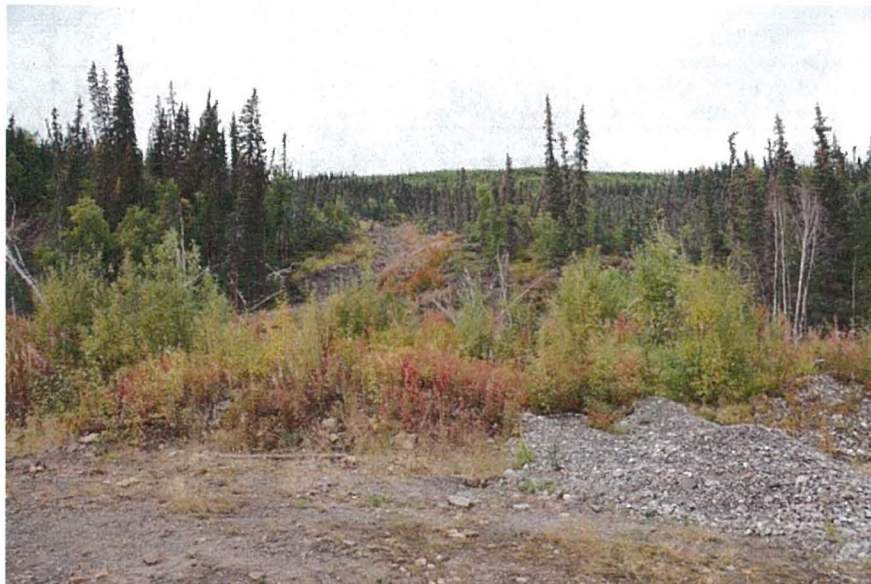
Photo 10:

Extreme rainfall events have also created slope instabilities along the Ogilvie River. Photo 10 shows a debris flow at about km 244, the toe of which came close to the Dempster Highway.

Minor Debris flow along highway beside Ogilvie River km 244 (August 26, 2013)

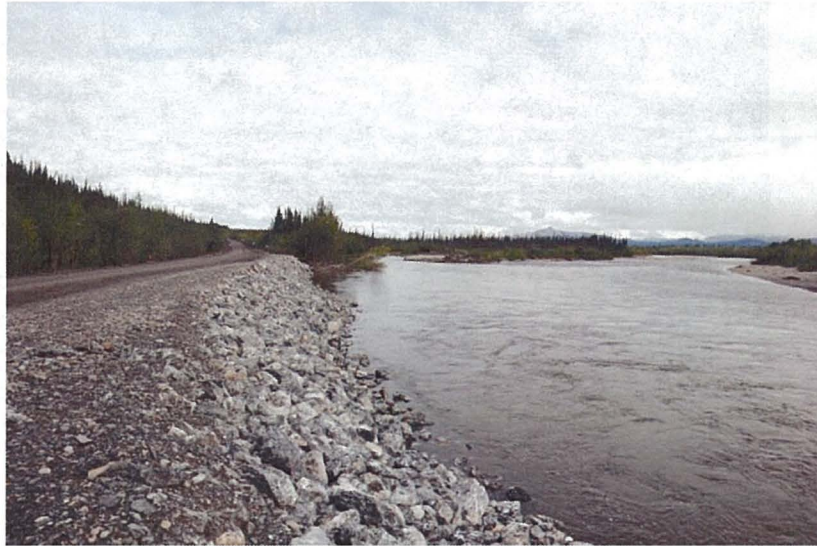
Higher flows in the Ogilvie River may also have contributed to the requirement for additional or increased riprap protection along the toe of the road embankment next to the Ogilvie River.

Photo 11:
Improved erosion protection required along Ogilvie River km 245 (August 26, 2013)

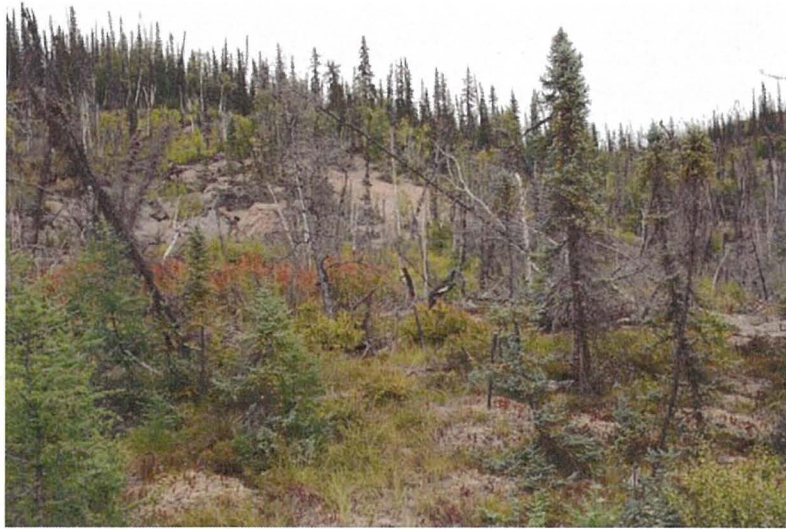
Photo 12:

Several areas of slope instability were noted on the north side of the Eagle River valley, possibly related to forest fire and/or increased precipitation, or both – see Photo 12.

Slope instability on the north side of the Eagle River Valley km 379 (August 26, 2013)

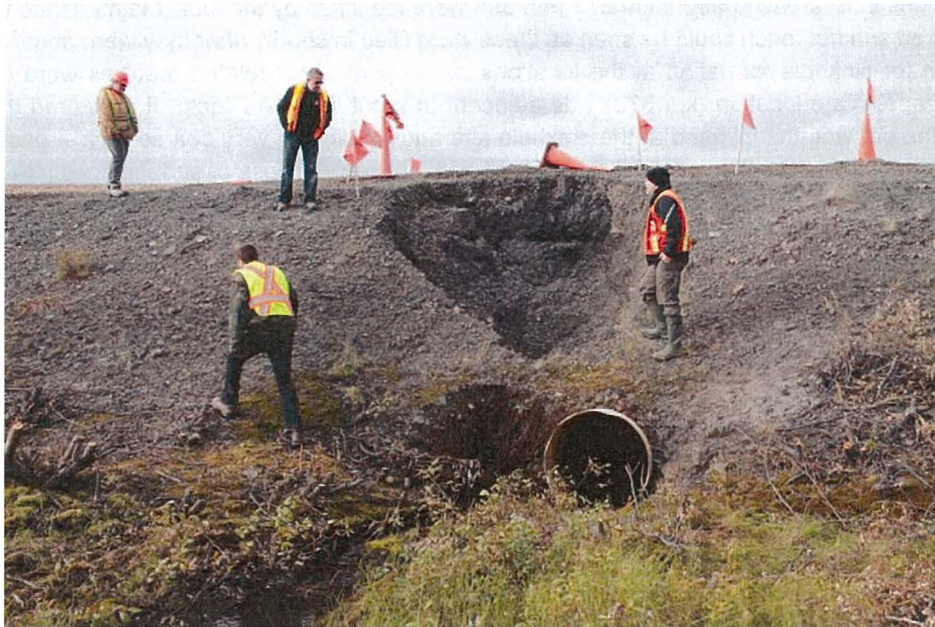
Photo 13:

Increased rainfall and possibly undersized culverts have created road instabilities through washouts adjacent to culverts in some sections of the highway. Photo 13 shows culvert distress affecting the road surface at about km 415.

Flow next to and around a culvert creating road instability km 415 (August 26, 2013)

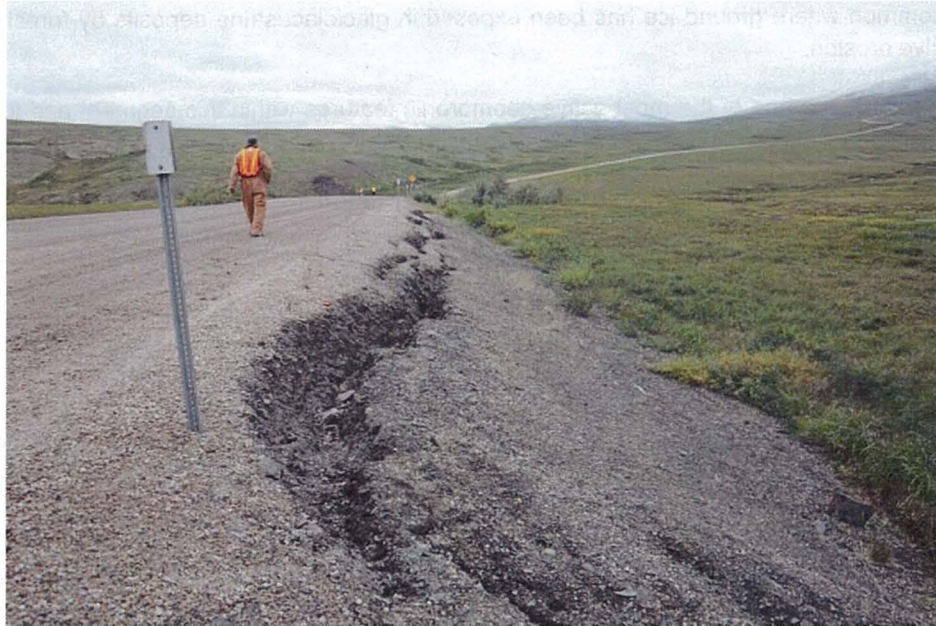
Photo 14:

The thaw of ice-wedges in the permafrost has affected the highway on the NT side in the vicinity of km 8.5 since about 1984 when there was a fatal accident at this location caused by road collapse into a thawed ice-wedge void. Photos 13 and 14 below, show continuing distress to both sides of the highway embankment at this location caused by thaw near the toe of the fill.

Ice-wedge thaw near toe of embankment creating road instability at km 8.5 NT (August 25, 2013)

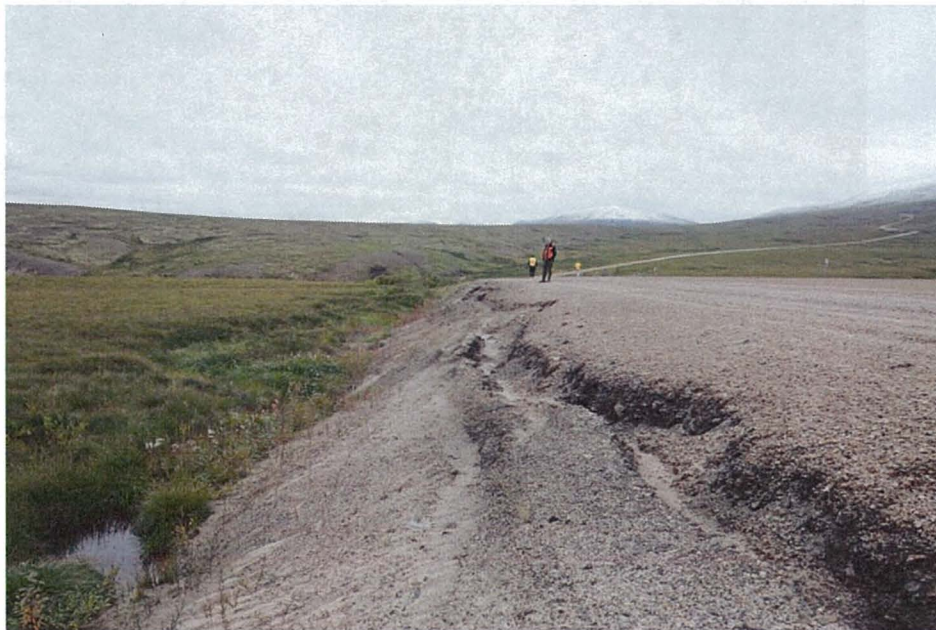
Photo 15:

Ice-wedge thaw (and ponded water) near toe of embankment creating road instability at km 8.5 NT (August 25, 2013)

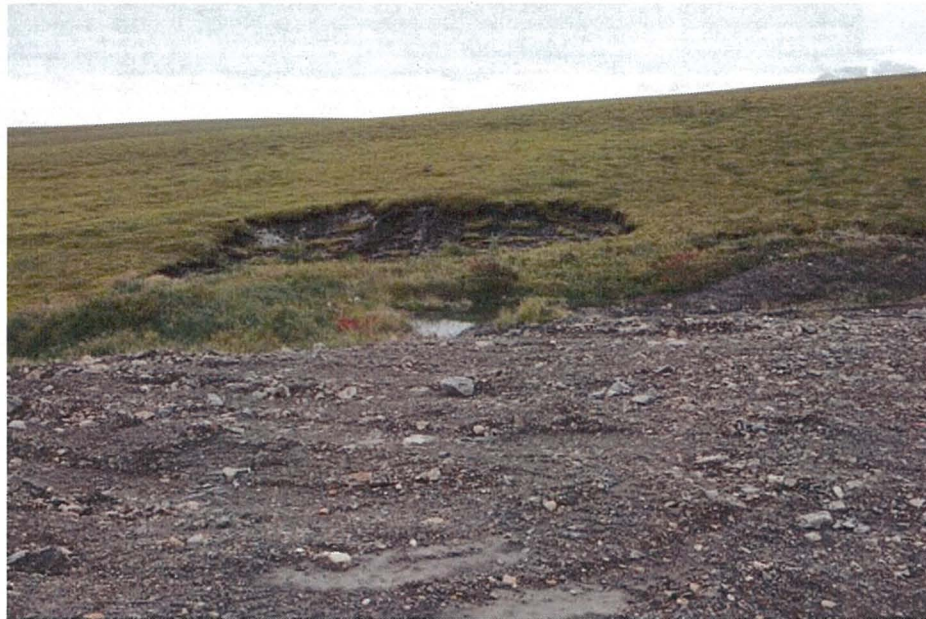
Photo 16:

The Peel Plateau is particularly susceptible to the effects of a warming climate as it contains a significant amount of ice-rich permafrost. Instability at km 27 related to thaw of ice-rich near surface soils on both banks of a surface drainage course has affected the toe of the highway embankment.

Thaw and slumping of near surface ice-rich permafrost is creating instability at km 27 NT (August 25, 2013)

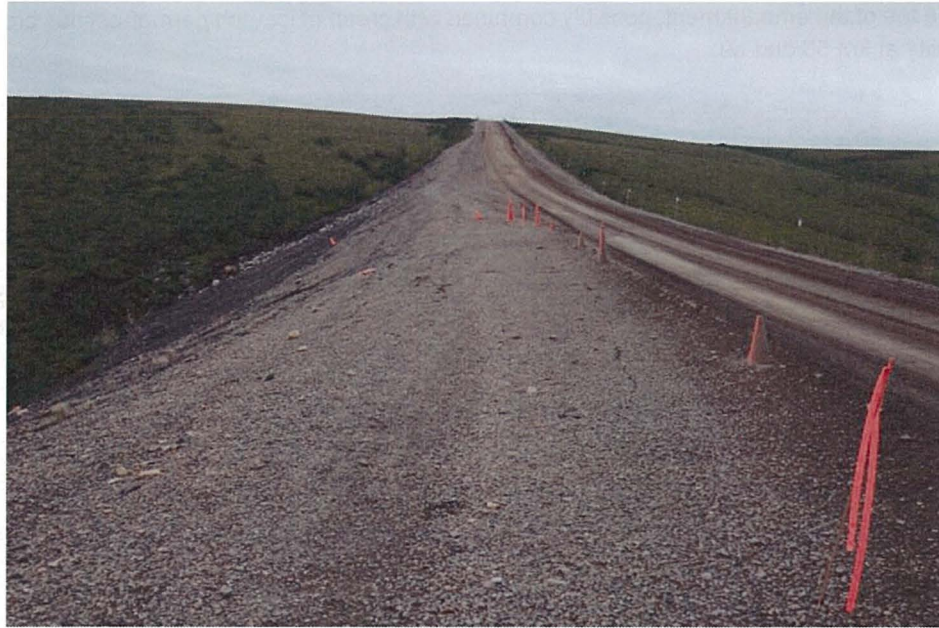
Thaw at the toe of the embankment, possibly combined with creep of ice-rich permafrost has created tension cracks and instability at km 30.

Photo 17:
Road instability related to tension cracks and slumping on a deep fill at km 30 NT (August 25, 2013)

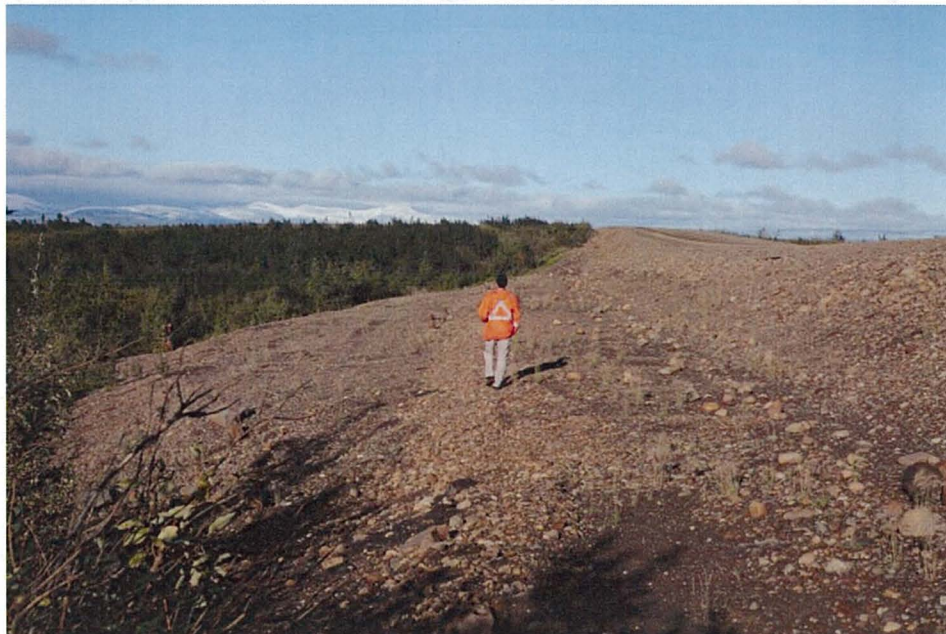
Toe berms have been used successfully at several locations to mitigate the effects of tension cracks and sideslope slumping in thick fills over culverts.

Photo 18:
Successful application of a toe berm to stabilize road embankment km 51 NT (August 25, 2013)

- Identify locations where embankment sideslopes are progressively failing and evaluate the risk of overall rapid slope failure. Adopt a proactive mitigation procedure, such as berm construction (Photo 18), that can be applied as and where required to protect the road from sudden collapse.

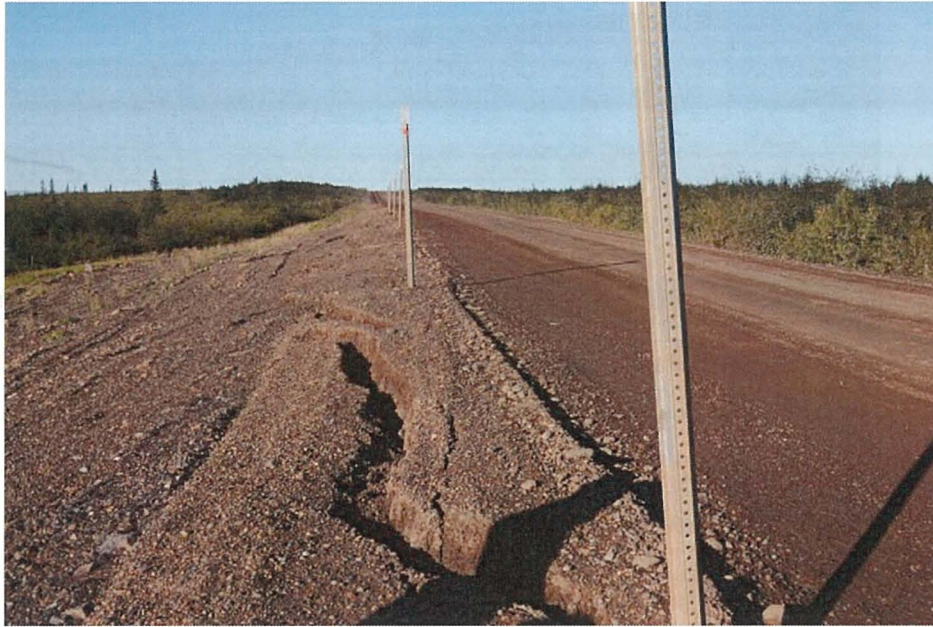
Photo 19:

Thaw at the toe of the embankment, possibly combined with creep of ice-rich permafrost has created tension cracks and instability at km 53 and 59.

Road instability related to tension cracks and slumping at km 53 NT (August 25, 2013)

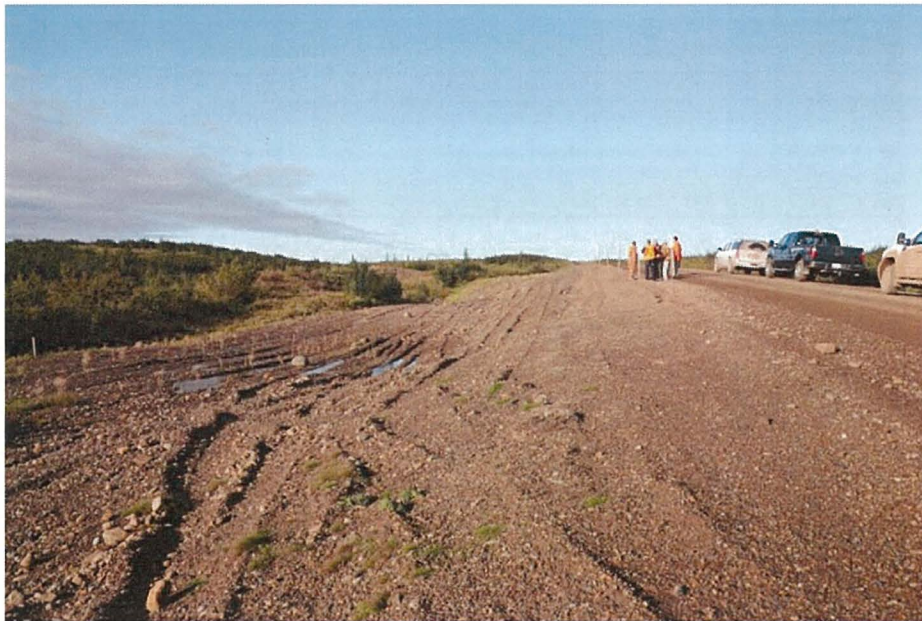
Photo 20:

Road instability related to tension cracks and slumping at km 59 NT (August 25, 2013)

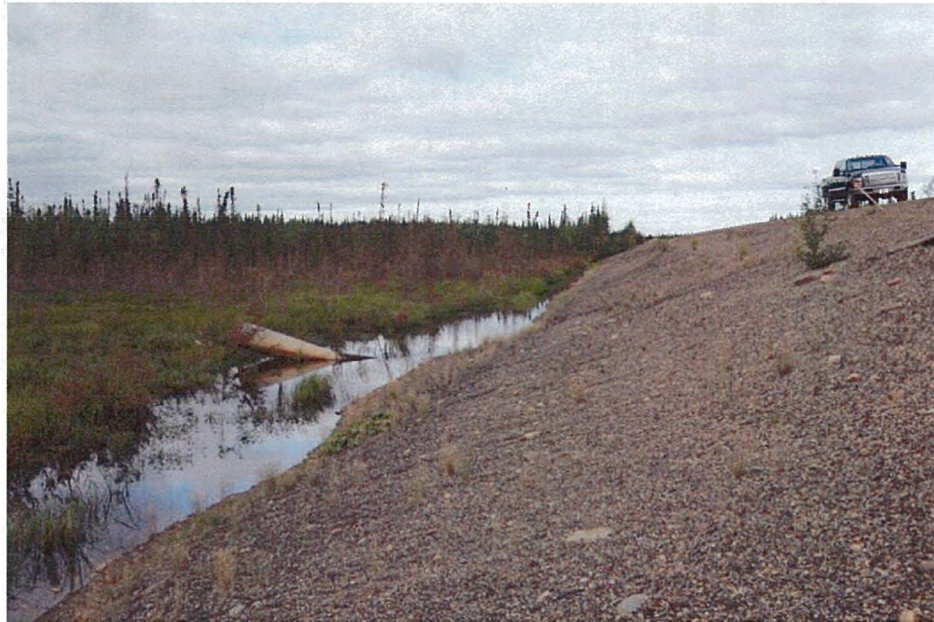
Photo 21:

This section of highway from the Peel River to Inuvik is generally flat and contains significant areas of standing water (swamps) connected by small drainage courses. In general, the swamps are shallow and freeze to the bottom every winter, preserving the permafrost. In some sections of the highway, ponded water combined with significant embankment settlement has created deep water that probably doesn't freeze every winter. This has created ongoing permafrost thaw and resulting culvert and highway distress.

Ponded water has created permafrost thaw, culvert distress, and road instability at km 90 NT
(August 24, 2013)

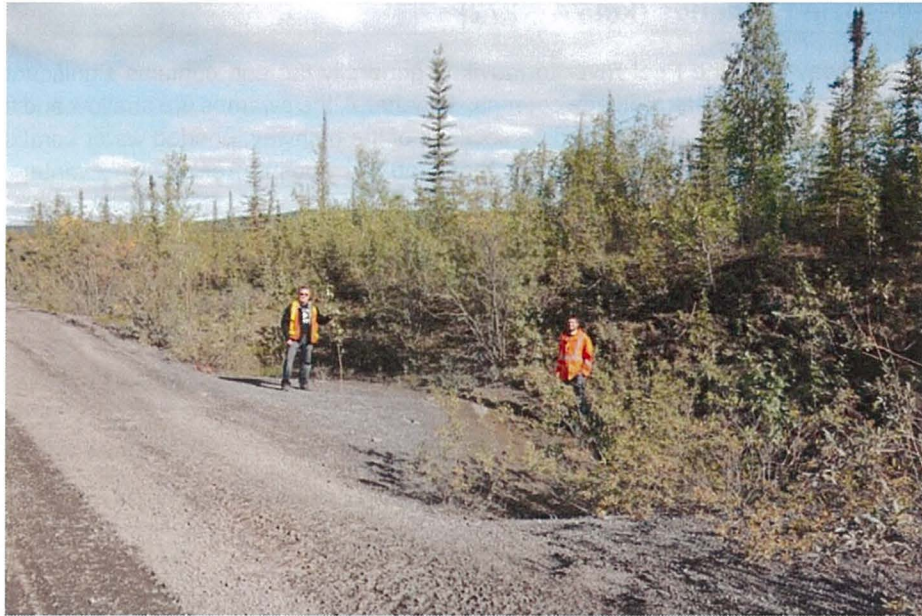
Photo 22:

Some sections of the road in this area are through shallow cuts, sometimes exposing ice-rich permafrost at depth. One of these cuts at km 227 just south of Inuvik exhibits a large thaw settlement depression requiring the addition of fill to keep it from becoming a hazard.

Thawing ground ice in permafrost adjacent to highway at km 227 NT (August 24, 2013)

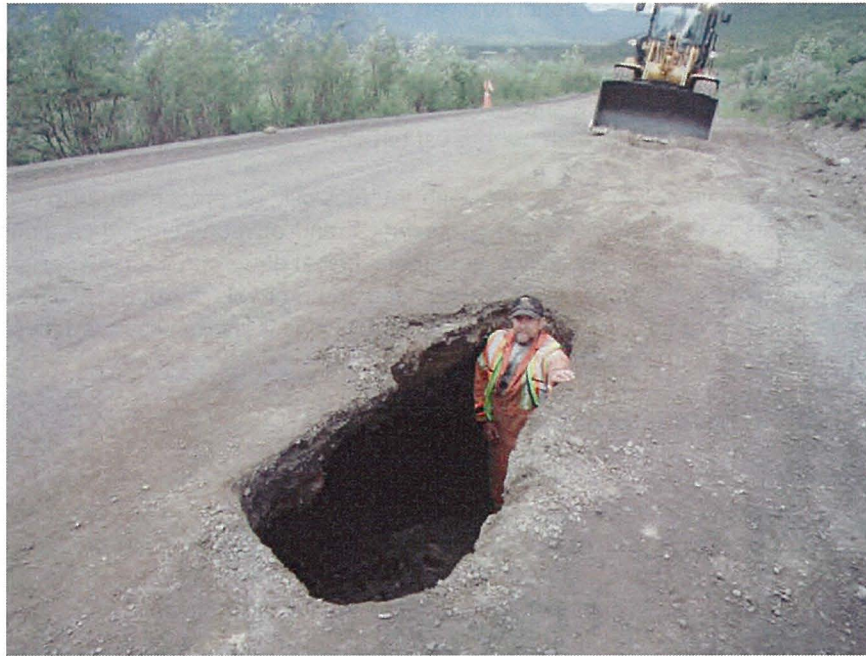
Photo 23:

A road shoulder collapse/sinkhole development at km 82 in Yukon is shown in Photo 23.

Sinkhole development near road shoulder at km 82 YT (June 2013, YG Photo)
