**AIRPORT IMPROVEMENTS
DAWSON CITY AIRPORT
DAWSON CITY, YUKON
1998**

REPORT NO.: 8002-252

PROJECT: Airport Improvements

LOCATION: Dawson City Airport
Dawson City, Yukon

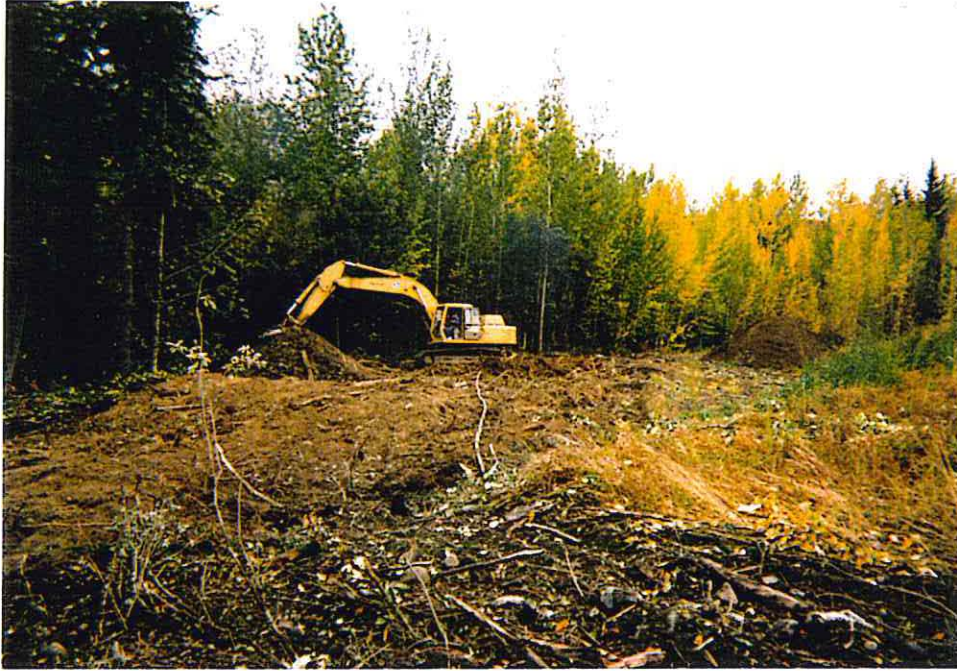
PHOTO # 1 – New Vehicle Parking Area – Clearing and Grubbing Operations

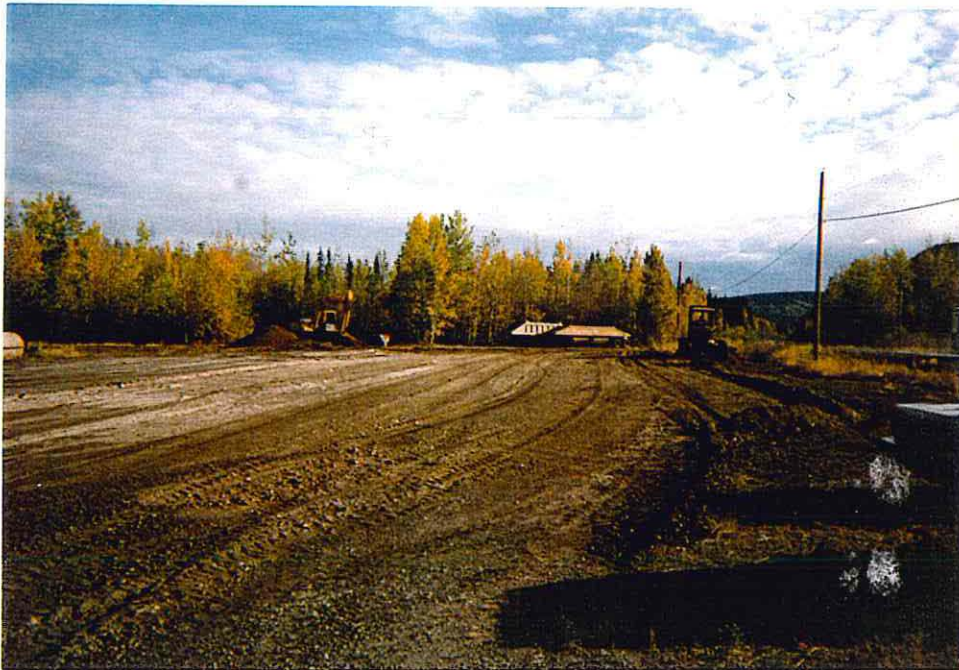
PHOTO # 2 – Existing Vehicle Parking Area – Grading Operations

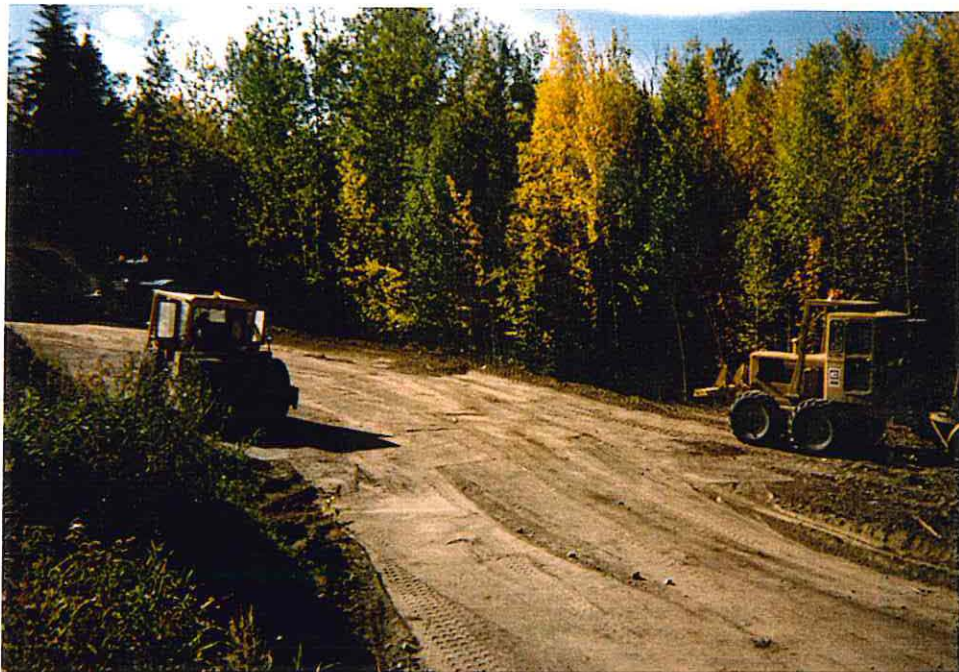
It should be noted that due to the sensitive nature of the material being used as the parking lot sub-grade, care was taken in compacting the material by using the Dynapac CA-250 Packer without engaging the vibrator.

In addition, it should be noted that inclemental weather (rain) was encountered on September 6, 7, 11, 12, 13 & 14. This extra precipitation increased the moisture content of some of the deleterious materials above optimum moisture content, creating a loss in strength and difficulty in obtaining a fully workable material near the completion of the project. As such, some locations within the newly created parking lot were in less than ideal condition upon completion.

PHOTO # 3 – New Vehicle Parking Area – Construction of Subgrade (Southwest corner)

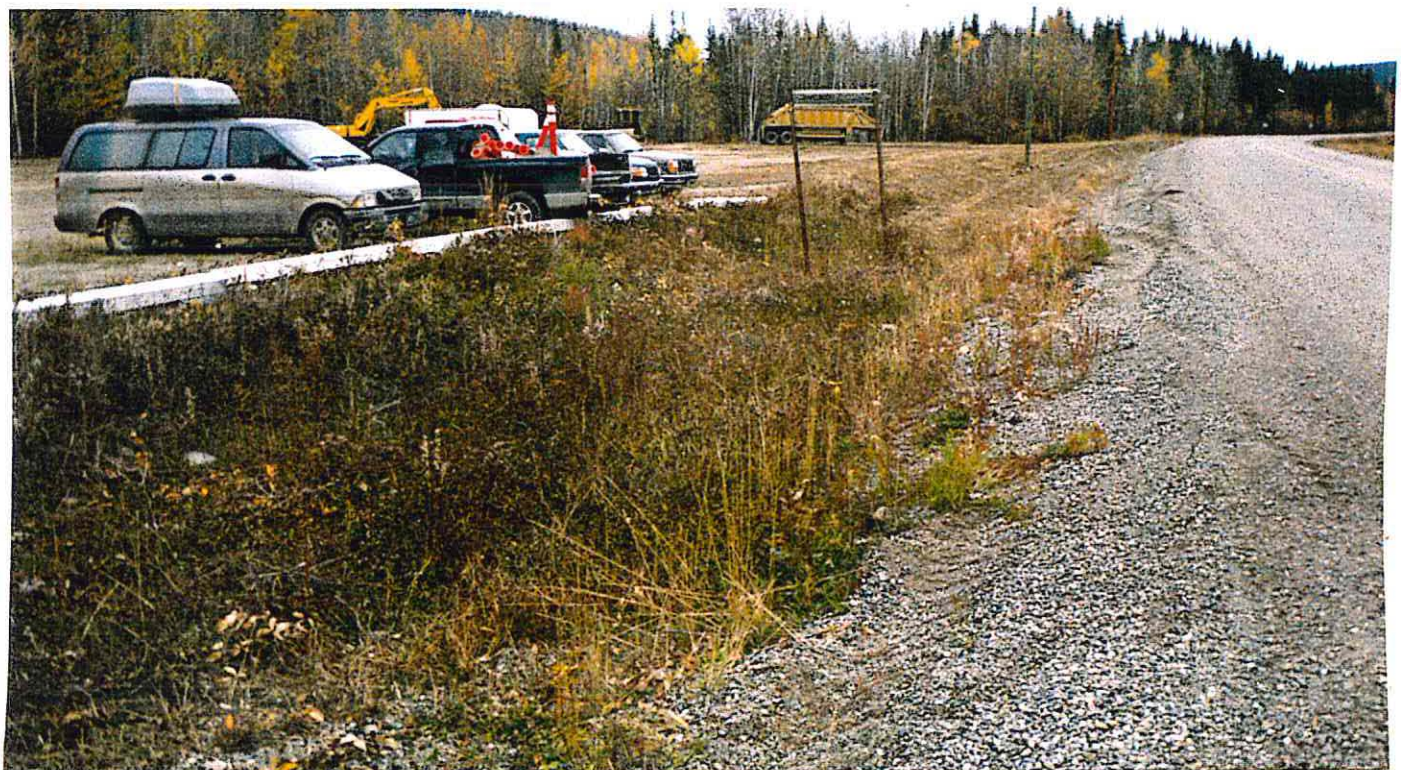
It should be noted that a portion of the existing vehicle parking lot and ditch, in the southwest corner, could not be worked due to the presence of vehicles stored in long term parking. The situation was discussed with Mr. D. Stilwell and it was decided that because the area was very close to design grade and due to the liability involved in moving the vehicles, grading of the area would not be required.

PHOTO # 4 – Existing Vehicle Parking Area – Note ditch conditions

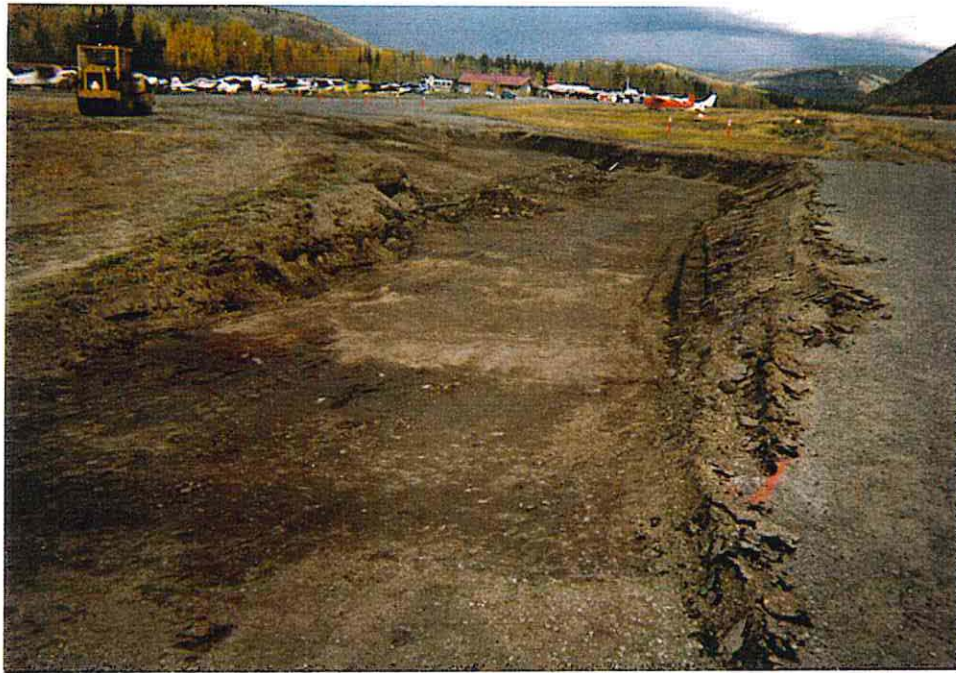
The VASES system cable (aircraft landing approach system) for the south end of the runway was severed during the excavation of repair area 1. Dawson Airport air traffic control was immediately notified of the break and a NOTAM was entered into the air traffic system. Upon completion of the excavation, Y.T.G. personnel were on-site to splice the severed cable and install a plastic conduit to run the length of the excavation.

PHOTO # 5 – Repair Area 1 – Excavation Base Note location of VASES cable

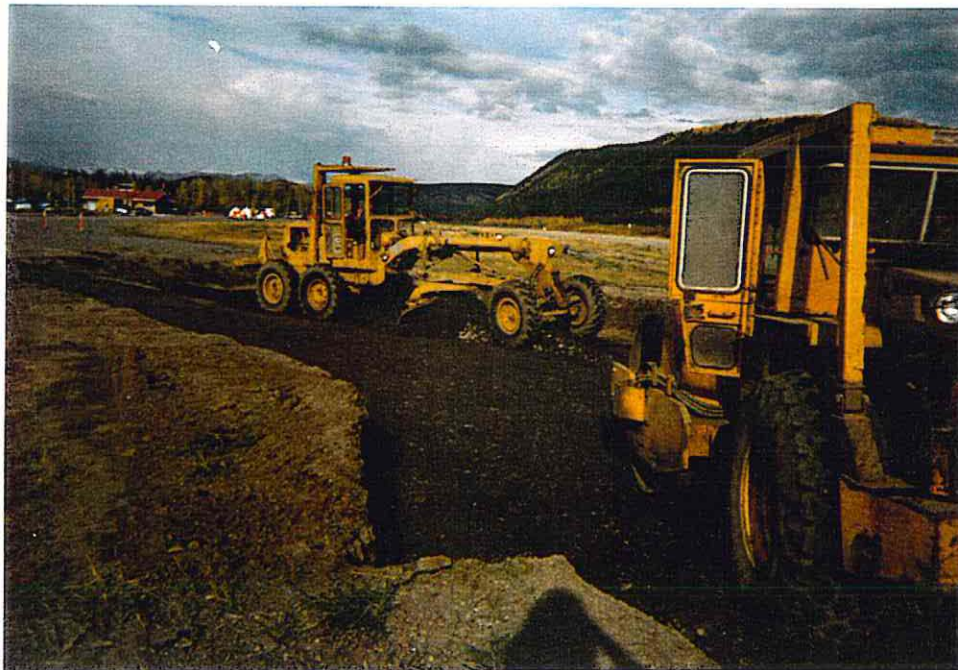
The gradation of some of the Granular E material used for backfill was coarse in nature with low sand content. More coarse areas were reworked in an effort to mix the coarse material with underlying fines. No excessively large oversize was noted in the backfilled material. No excessive amount of silt content was noted.

PHOTO # 6 – Repair Area 1 – Granular E Backfill Operations

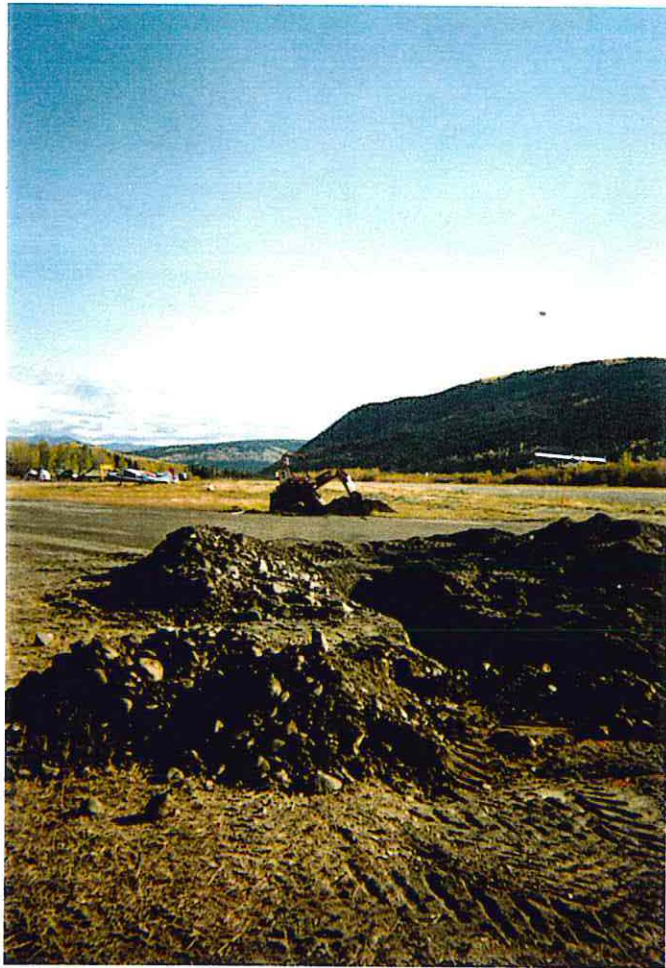
PHOTO # 7 – Repair Area 1 – Additional Repairs to VASES Cable

Upon completion of cable repairs, an additional load of Granular A material was required in order to restore the surface to design grade. This final grading and compaction was completed on September 10, 1998.

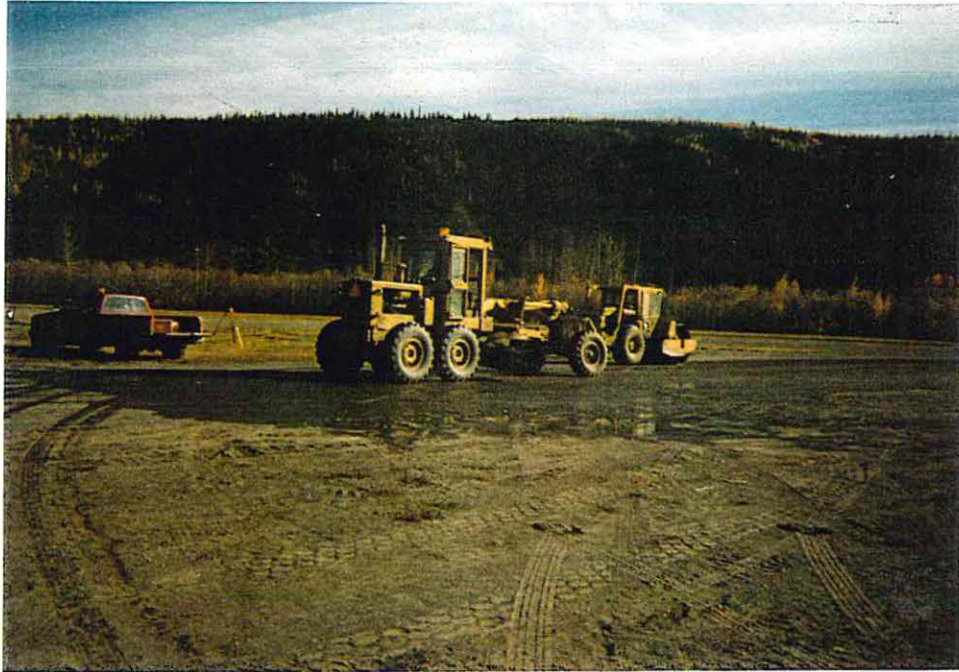
PHOTO # 8 – Repair Area 1 – Final Grading and Compacting

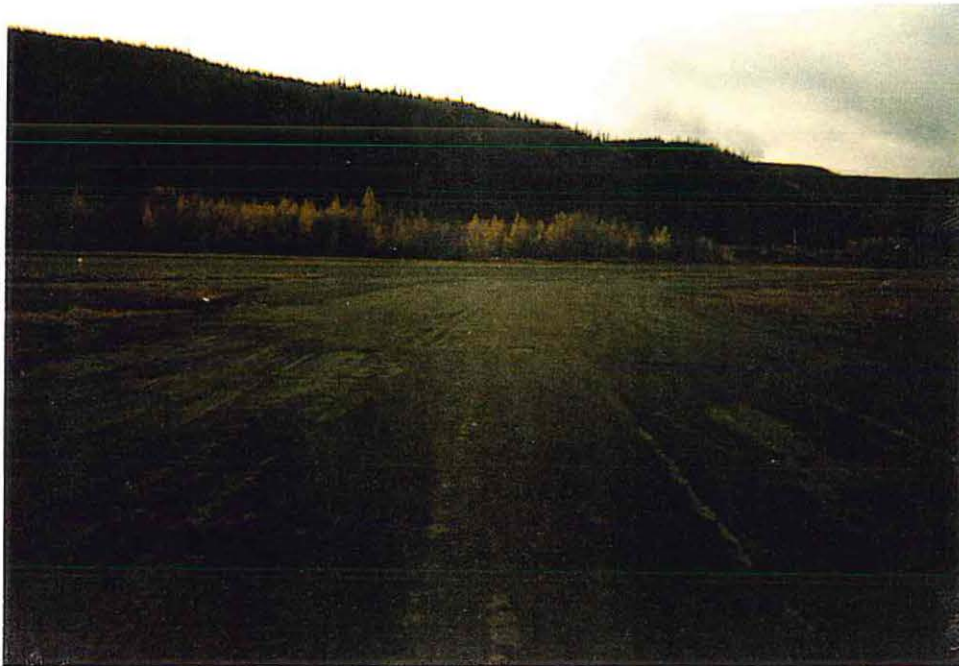
PHOTO # 9 – Repair Area 1 – Final Grade – Note the runway location in the background.

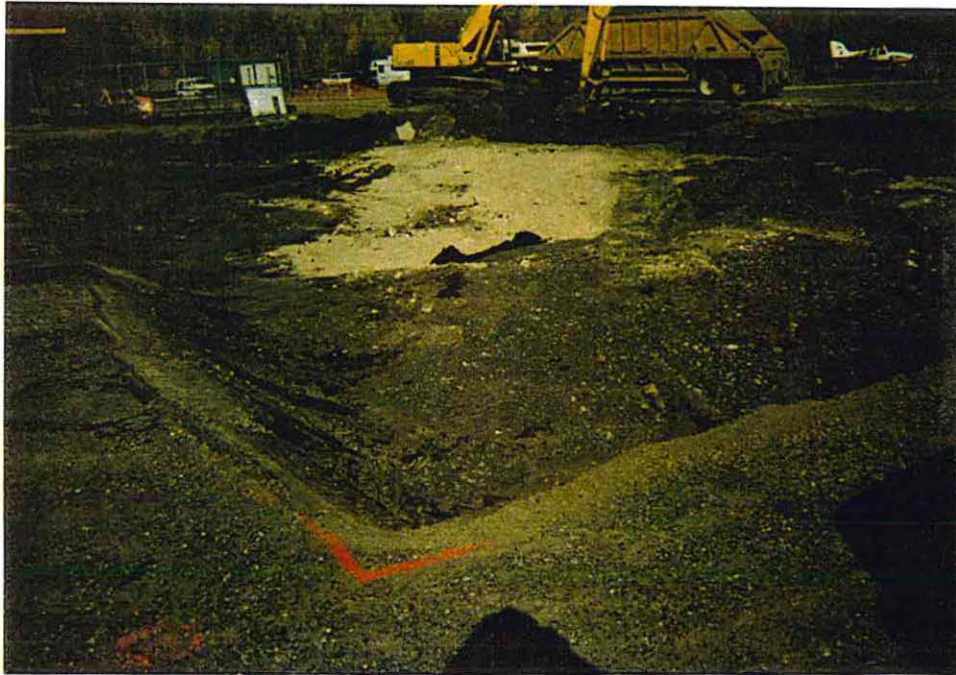
PHOTO # 10 – Repair Area 2 – Excavation Base

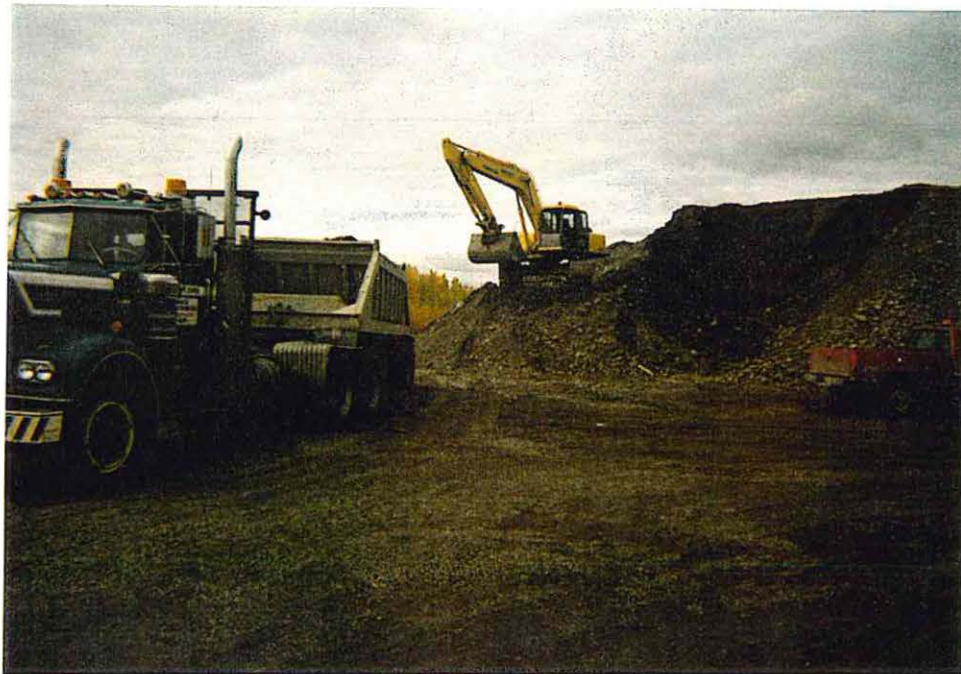
PHOTO # 11 – km 688.7 – Loading of Granular E material from existing stockpile.

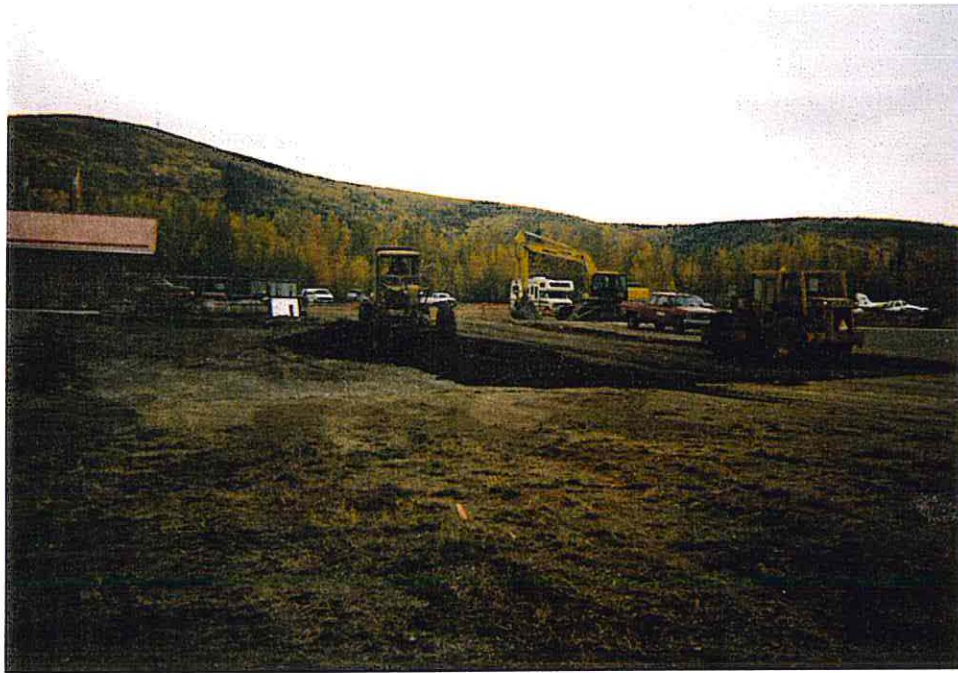
The gradation of some of the Granular E material used for backfill was coarse in nature with low sand content. More coarse areas were reworked in an effort to mix the coarse material with underlying fines. No excessively large oversize was noted in the backfilled material. No excessive amount of silt content was noted.

PHOTO # 12 – Repair Area 2 – Granular E Backfill Operations

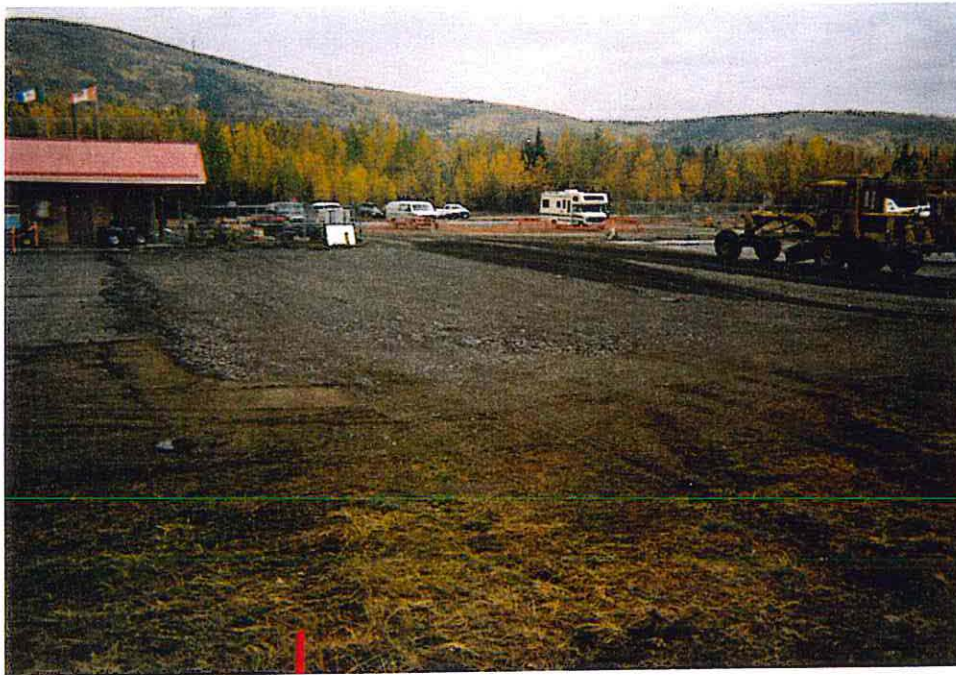
PHOTO # 13 – Repair Area 2 – Granular A Grading and Compaction

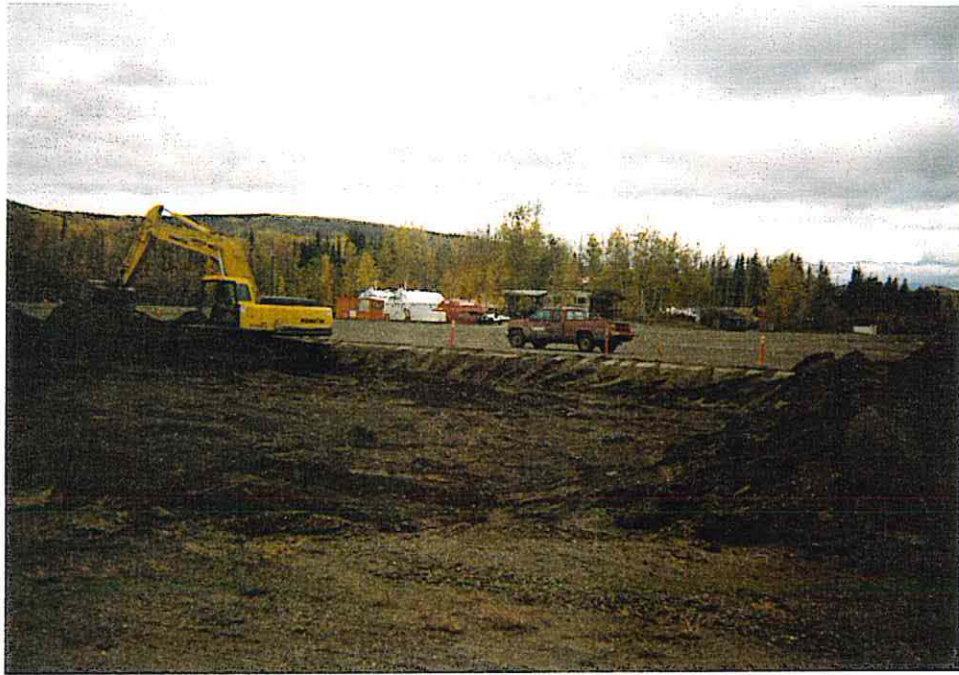
PHOTO # 14 – Repair Area 3-1 – Excavation Base

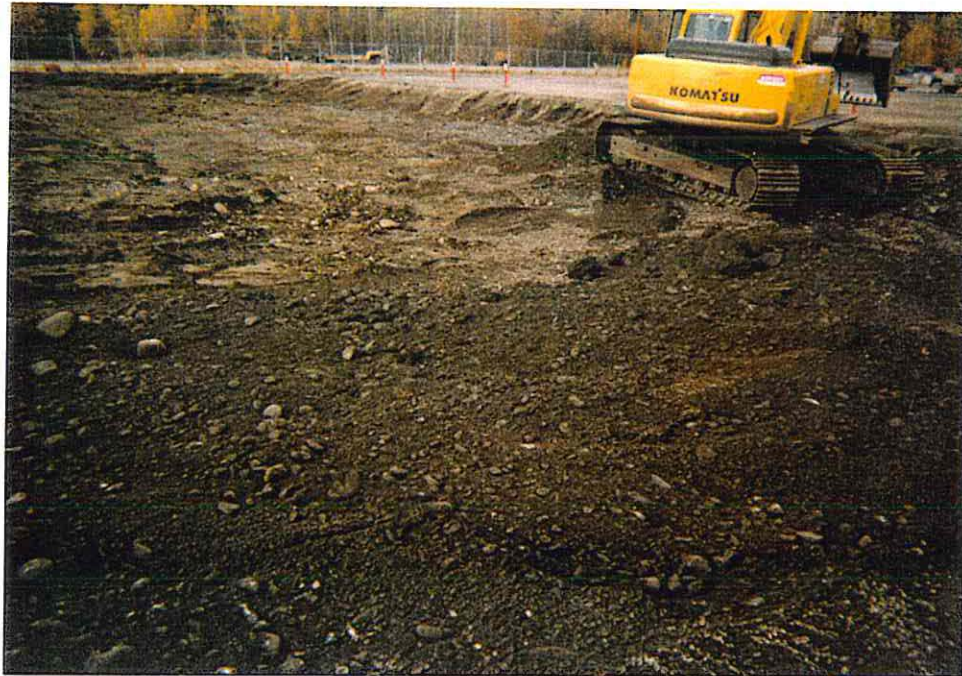
In general, operations consisted of excavating material from within the area identified during the project start-up meeting and proceeding as in Repair Areas 1, 2 & 3-1. The final excavated area was cut with vertical slopes in areas adjacent to the Area 3-1, and with side slopes of approximately 1 vertical to 2 horizontal along the Southwestern and Northeastern edges (adjacent to the existing aircraft apron). These angled side slopes were constructed in an effort to provide a transition between newly reconstructed areas and existing apron/taxiway areas with deleterious materials. Deleterious materials were encountered at all margins of the completed excavation. It should however, be noted that along the southern extent of the excavation, the strata of deleterious materials was in the order of 0.3 meters to 0.5 meters thick (as opposed to the anticipated 1.2 meters).

PHOTO # 14 – Repair Area 3-2 – Excavation Base

Due to the relatively shallow depths that the underlying granular stratum was encountered, (and relatively low amount of excavation common) the limits of the Northwestern side was extended 15 meters to the northwest.

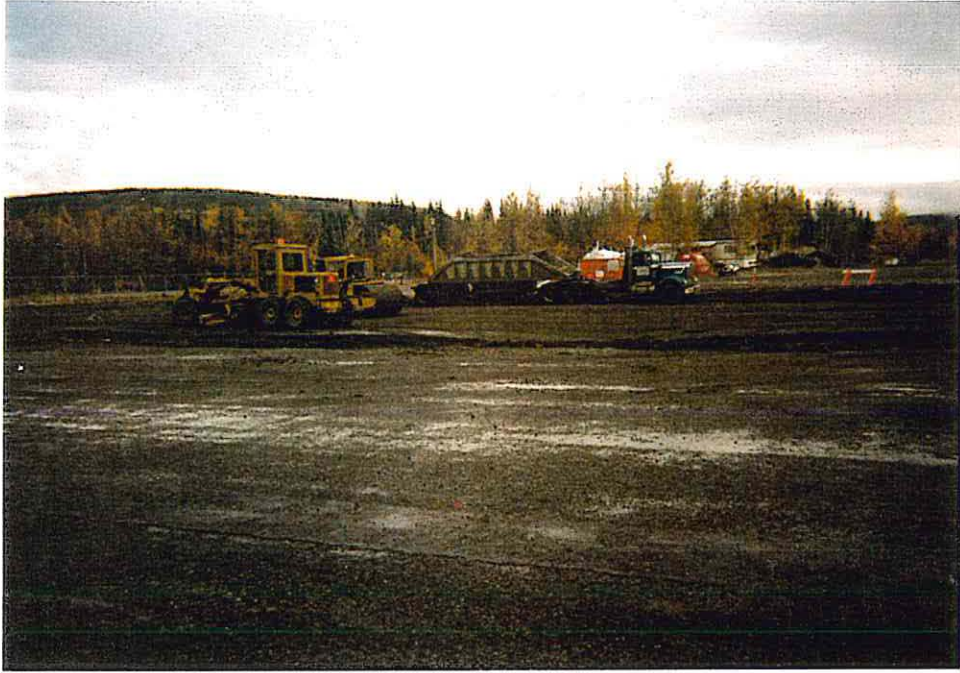
The gradation of some of the Granular E material used for backfill was coarse in nature with low sand content. More coarse areas were reworked in an effort to mix the coarse material with underlying fines. No excessively large oversize was noted in the backfilled material. No excessive amount of silt content was noted.

PHOTO # 15 – Repair Area 3-2 – Granular E Backfill Operations

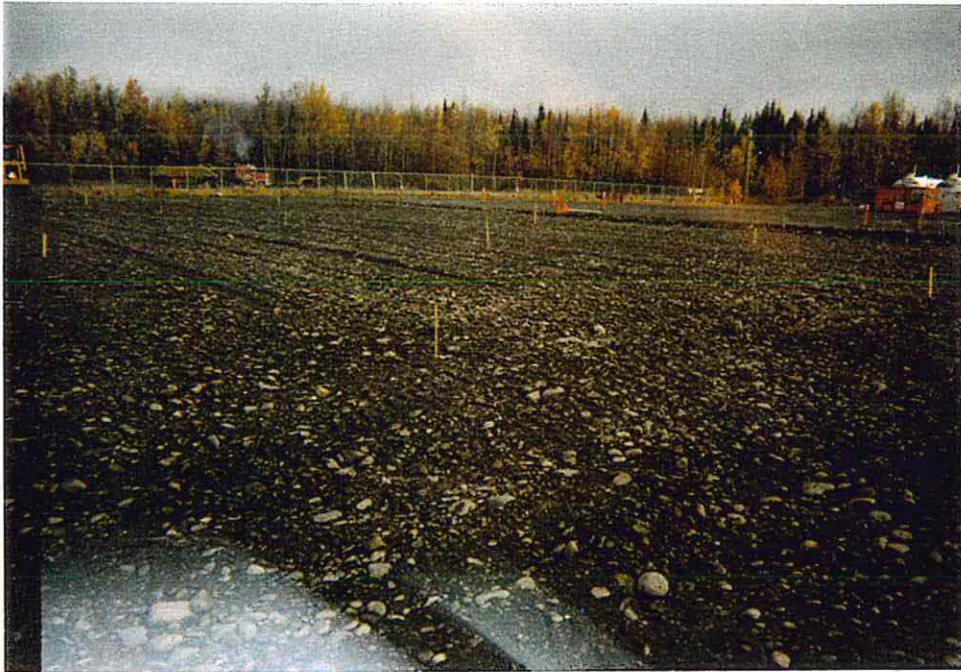
PHOTO # 16 – Repair Area 3-2 – Preliminary Grading near top of Granular E

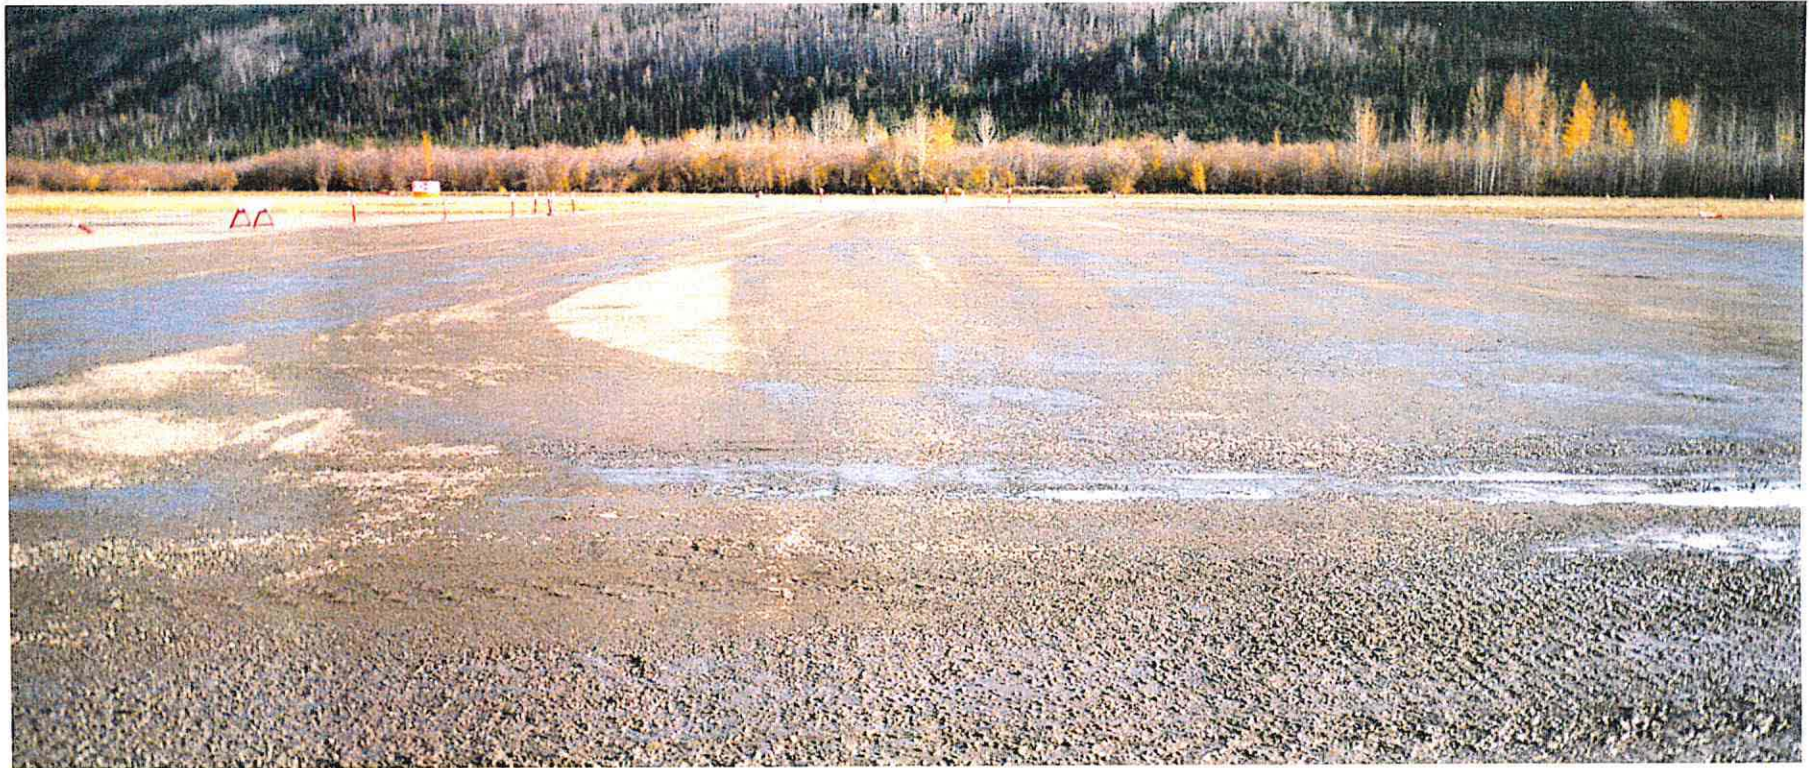
PHOTO # 17– Repair Area 3 – Near completion of final grade
View to the Southeast – Note the runway in the background
