# Desktop Study - Sinkhole Site Characterization, Dempster Highway, Yukon Territory

SRK Consulting (Canada) Inc.  
1CG023.002  
November 2014

Project No: 1CG023.002

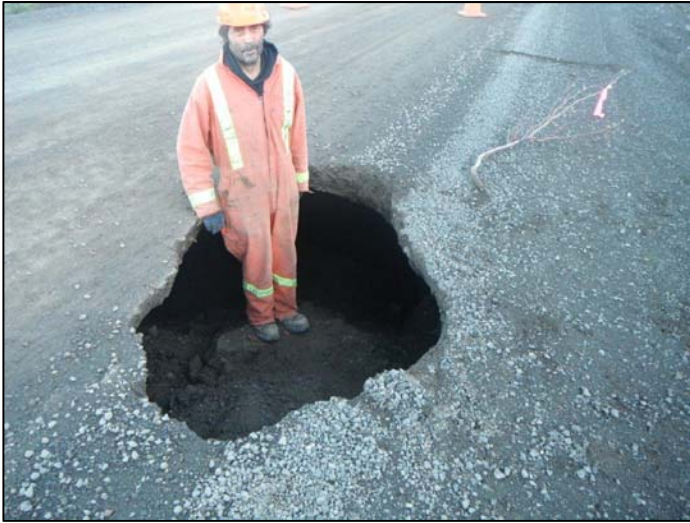
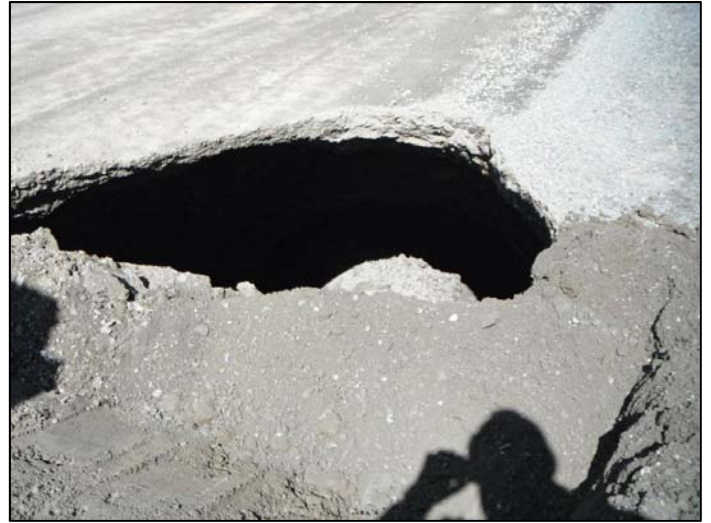
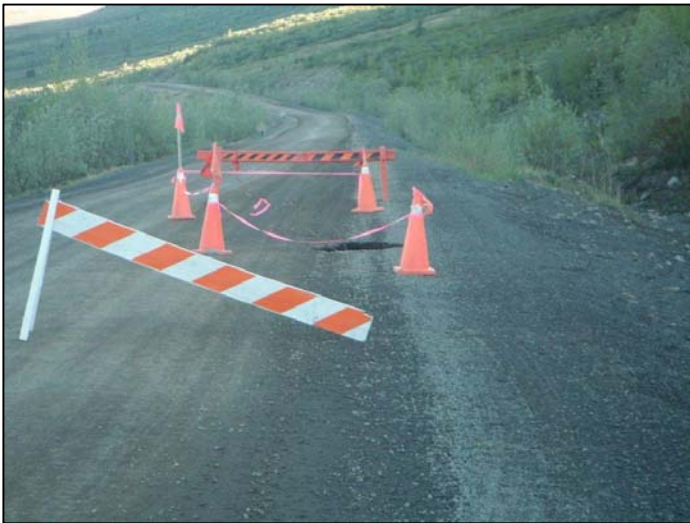
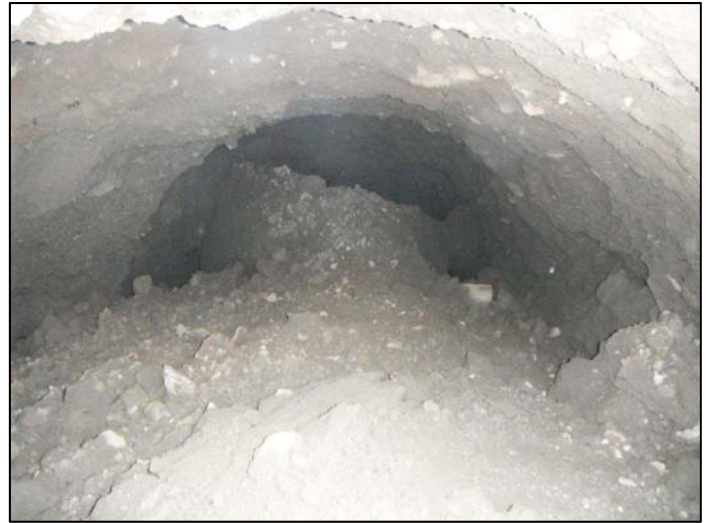
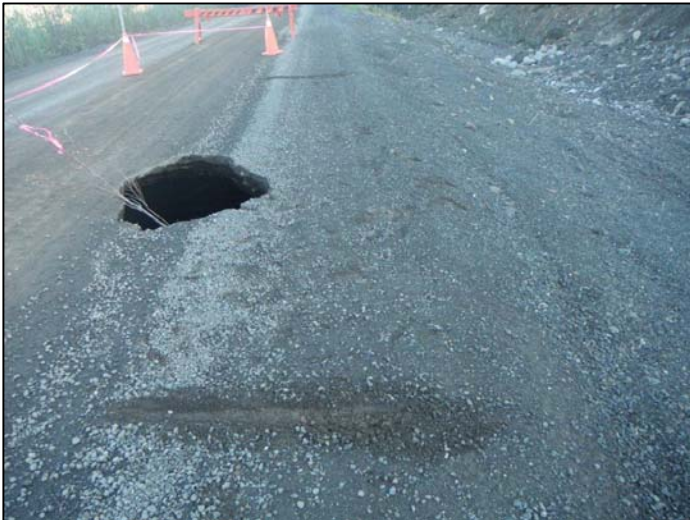
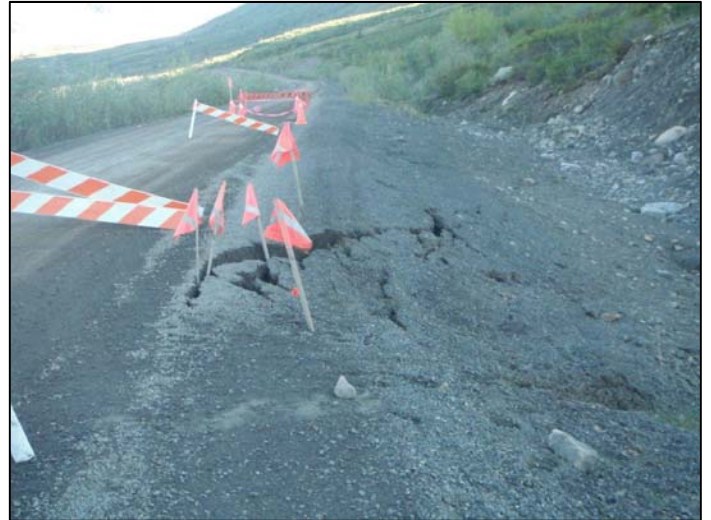
**A-1**

Figure A-1 shows a sinkhole discovered by HPW maintenance crews on June 22 of 2014. During the excavation of the void, the sinkhole was estimated to be 7.5 m long, 4.5 m wide, and several metres deep. The surface opening of the sinkhole is estimated from the photographs to be approximately 0.4-0.6 m wide at the surface (Figure A-1). The elongated dome-shaped void was located within the embankment is reported to be filled with dry to moist soil. Water was not observed in any of the photographs taken on June 22<sup>nd</sup>. Shallow surface collapse of the embankment was observed several metres from the sinkhole adjacent to a drainage ditch (Figure A-1).

1. Photographs taken on June 22, 2014 near km 82 of the Dempster Highway, Yukon Territory
2. Sinkhole was measured by maintenance crews to be approximately 7.5 m long, 4.5 m wide, and several metres deep
3. Sinkhole was filled with 32 cubic metres of pit run and 16 cubic metres of crush during a temporary repair

Highways and Public Works maintenance crews estimate the sinkhole shown in Figure A-1 was filled with approximately 32 m<sup>3</sup> of "pit run" material and 16 m<sup>3</sup> of "crush" material during a temporary repair of this site.

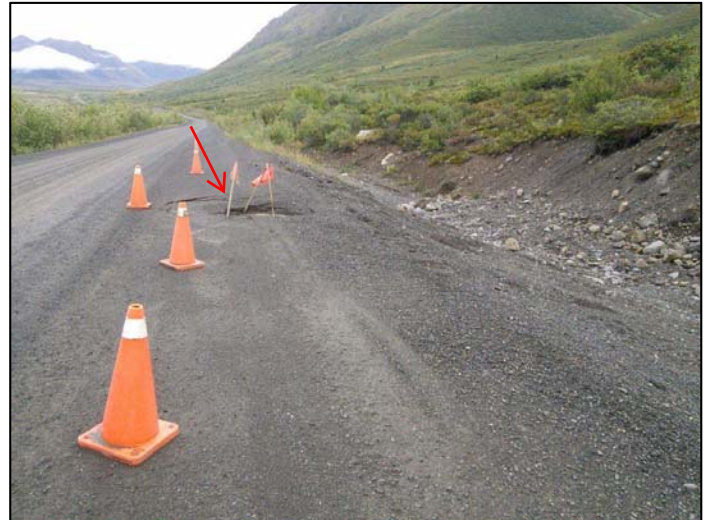
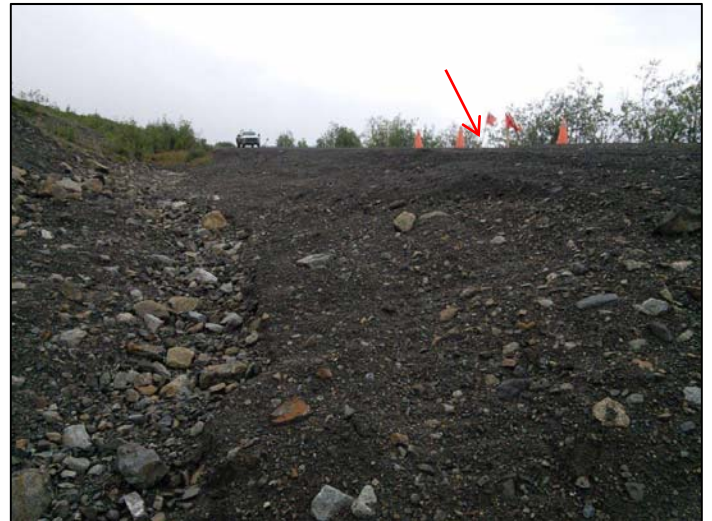
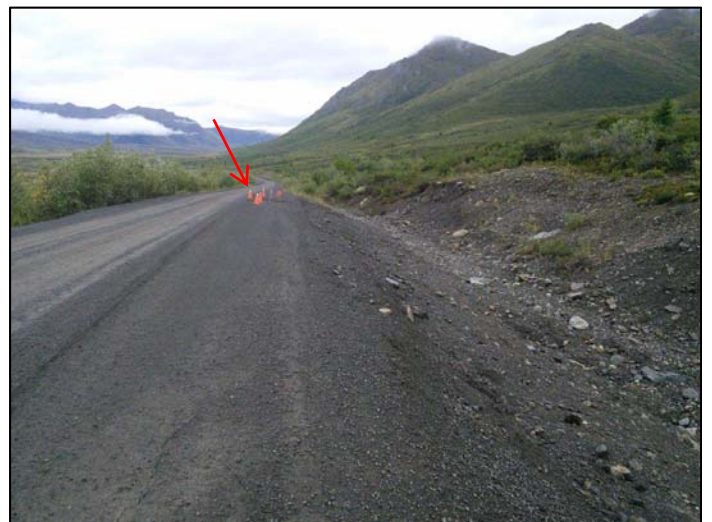
<p>Date: Sept. 12, 2014</p>	<p>Approved:</p>	<p>Figure: <b>A-2</b></p>

Appendix A-2 shows a sinkhole discovered on August 14 of 2014 during field inspections conducted by HPW. It can be inferred from photographs that the sinkholes observed in June (Figure A-1) and August (Figure A-2) formed within very close proximity of each other. The location is observed to be adjacent to the highway drainage ditch. Figure A-3 also shows evidence of highway instability near km 82 that dates back to August of 2009.

1. Photographs taken on August 14, 2014 near km 82 of the Dempster Highway, Yukon Territory

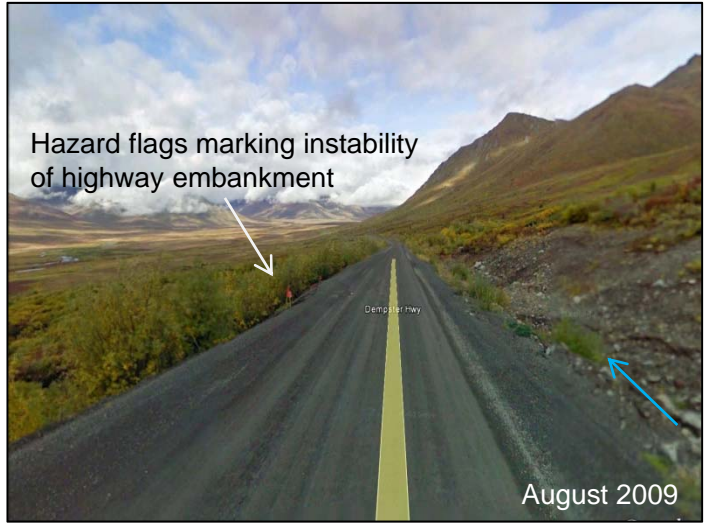
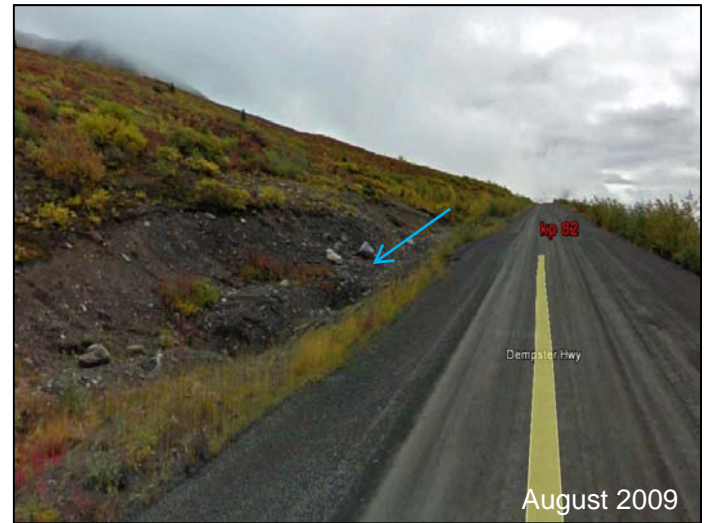
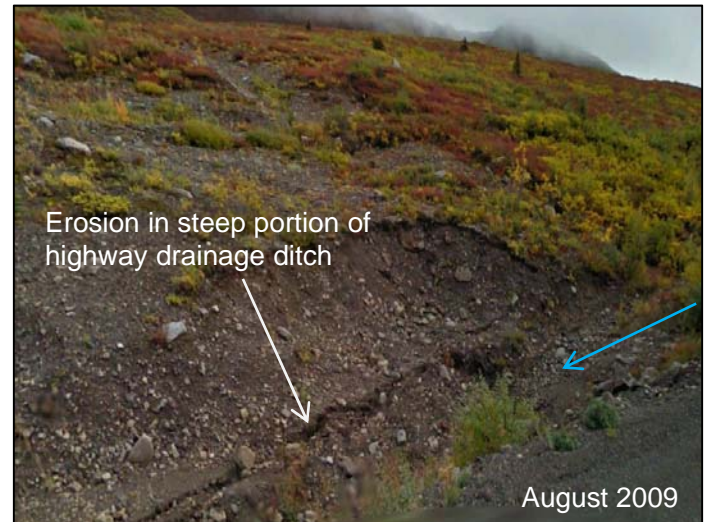
<b>Dempster Highway,</b> <b>Highway km 82</b>		
Job No: 1CG023.002 Filename: Sinkhole Photographs_Unknown Date_km 82		Date: July 15, 2014	Approved:	Figure: <b>A-4</b>

Figure A-4 shows an additional sinkhole discovered near highway km 82. The date of the photograph is unknown, but pre-dates sinkholes shown in Figures A-1 and A-2. Vegetation surrounding the site suggests the photograph was taken sometime between June and August. The surface opening of the hole is estimated from the photograph to be 1.5-2.0 m long, 0.4-0.5 m wide, and 1.2-1.5 m deep. The extent of the void in the subsurface may be greater than the observed surface opening.

1. Photographs taken on August 14, 2014 and August of 2009 near km 82 of the Dempster Highway, Yukon Territory
2. Photographs from August of 2009 taken from Google Earth Street View
3. Blue arrows indicate direction of surface water flow within drainage ditch

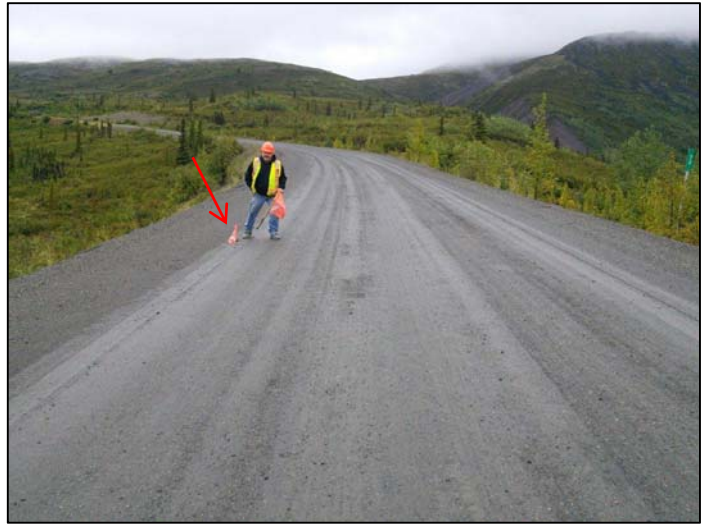
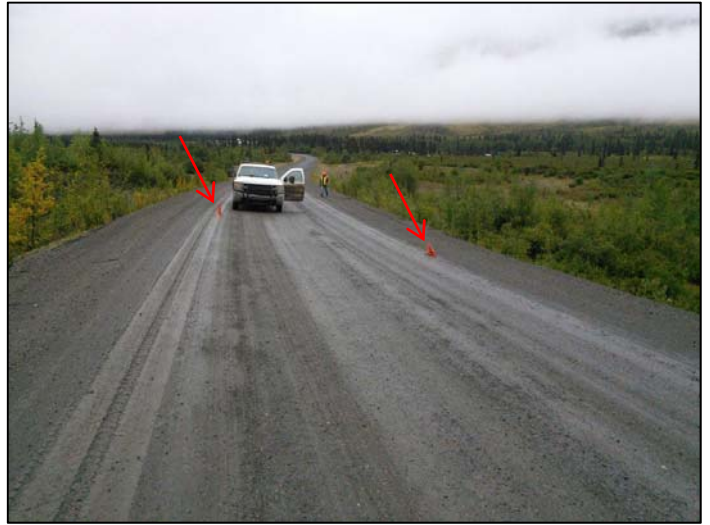
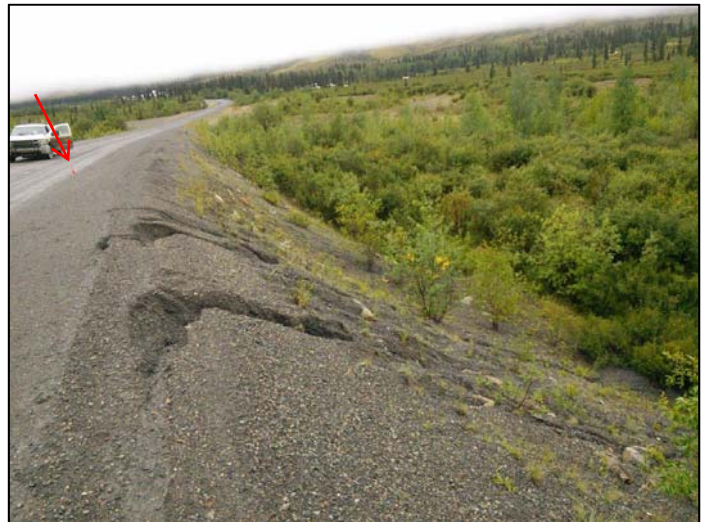
**A-5**

Figure A-5 shows evidence of several sinkholes observed on August 14 of 2014 near highway km 72. Surface erosion of the embankment is also observed in the photograph, suggesting surface water runoff and erosion occurred at the site.

1. Photographs taken on August 14, 2014 near km 72 of the Dempster Highway, Yukon Territory
2. Red arrows indicate location of sinkholes

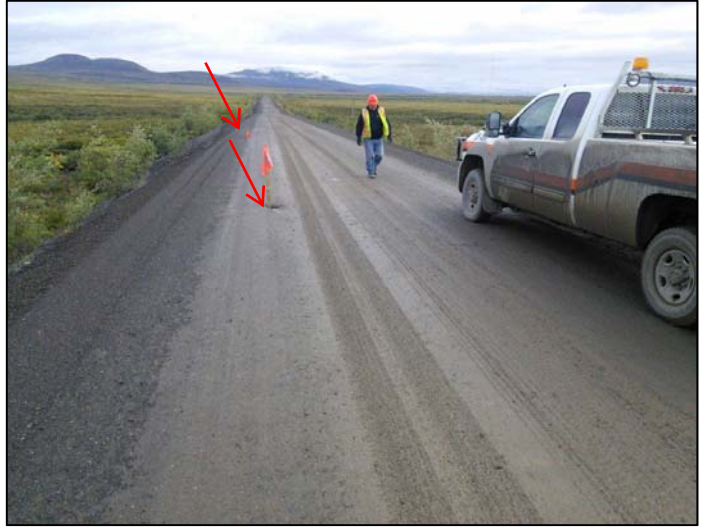
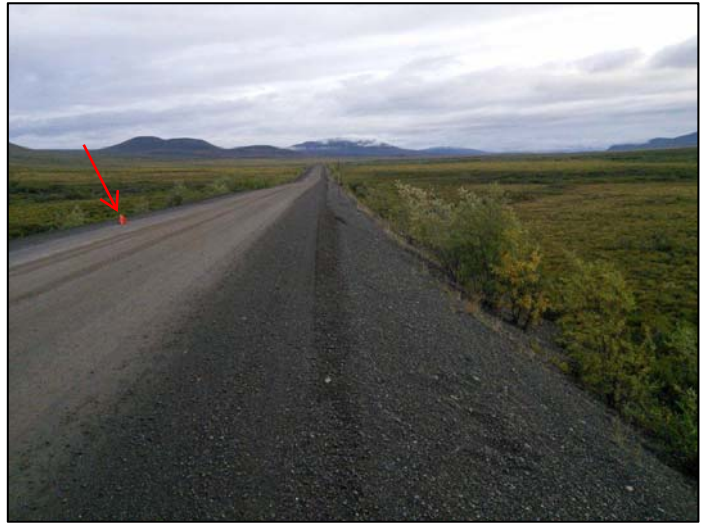
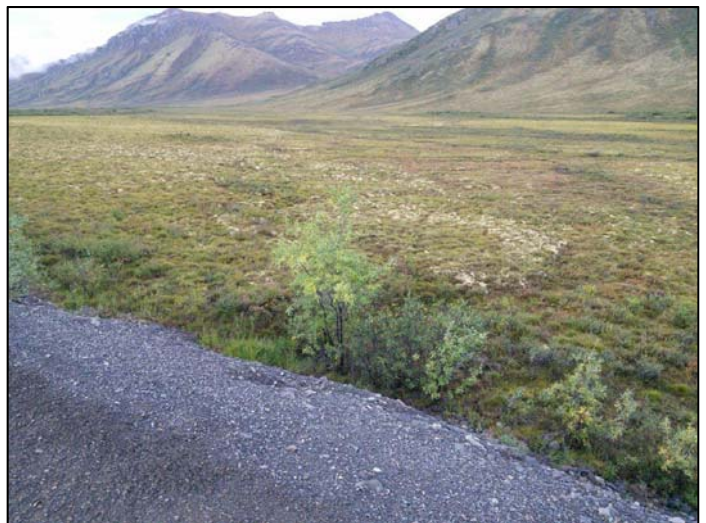
**A-6**

1. Photographs taken on August 14, 2014, South of Chapman Lake along the Dempster Highway, Yukon Territory
2. Red arrows indicate location of sinkholes

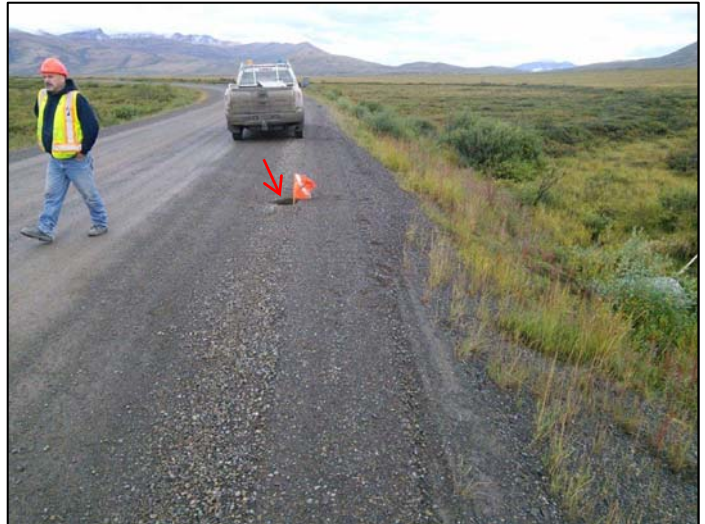
**A-7**

1. Photographs taken on August 14, 2014 near Two Moose Lake along the Dempster Highway, Yukon Territory
2. Red arrows indicate location of sinkholes

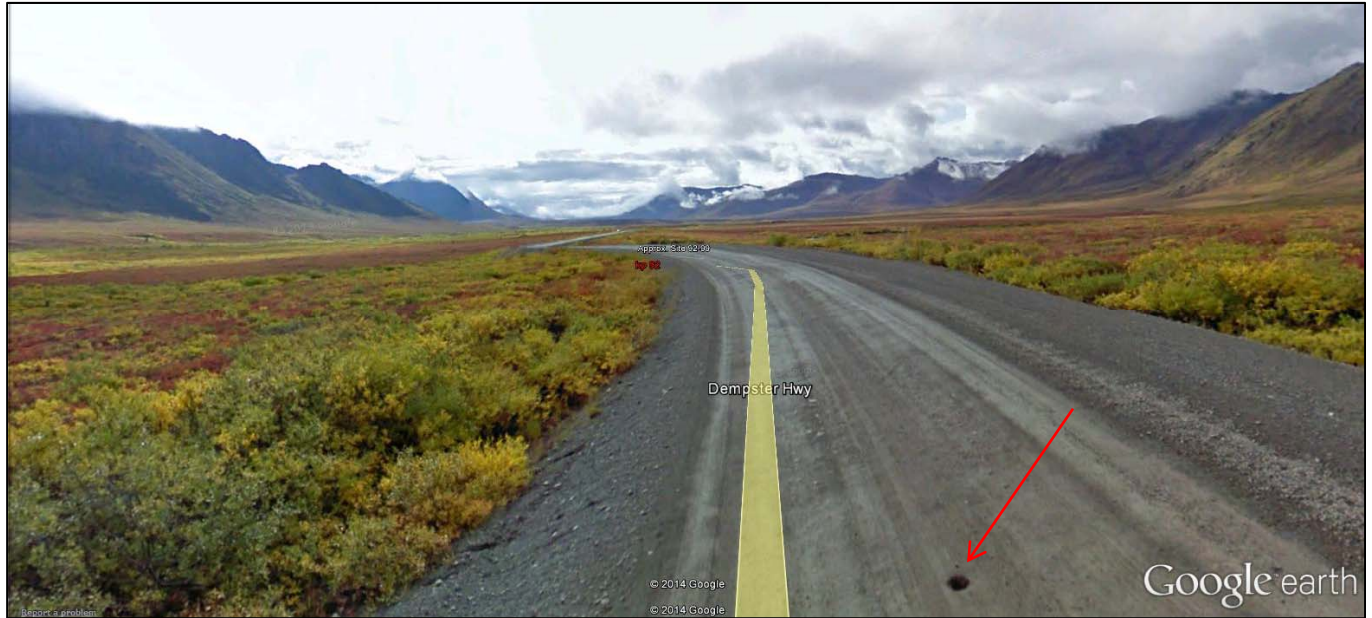
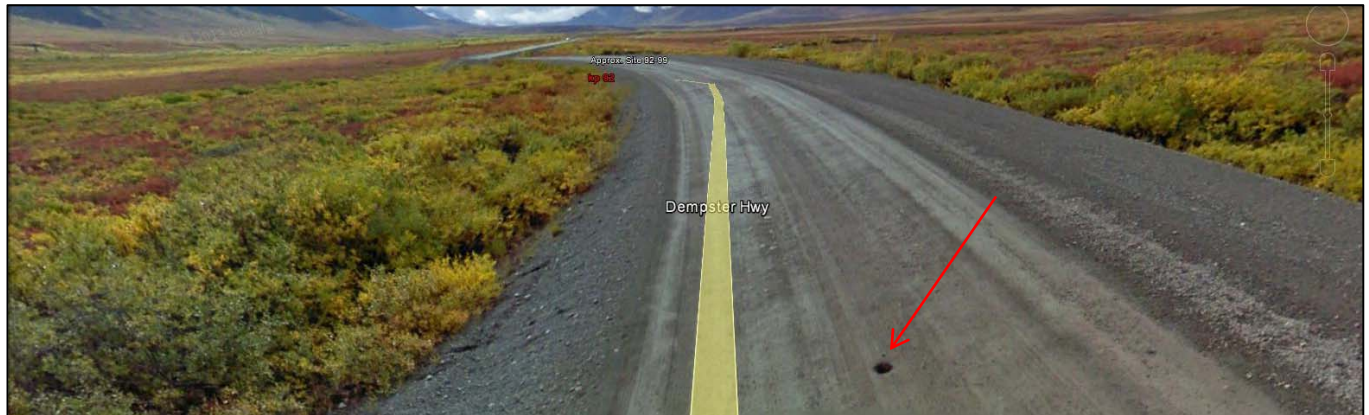
1. Dark circular hole (indicated with red arrow) is interpreted to be the surface opening of a sinkhole near highway km 92
2. Photographs acquired from Google Earth Street View
3. Photograph data reported to be August of 2009
4. Sinkhole location: UTM Zone7N, 624724.0 E, 7172583.0 N
