GEOTECHNICAL EVALUATION OF ROAD SETTLEMENT HAMILTON BOULEVARD SECTION 4+640 TO 4+860, WHITEHORSE, YT

INTERIM REPORT

DECEMBER 24, 2013
ISSUED FOR USE
EBA FILE: WI4103046-02

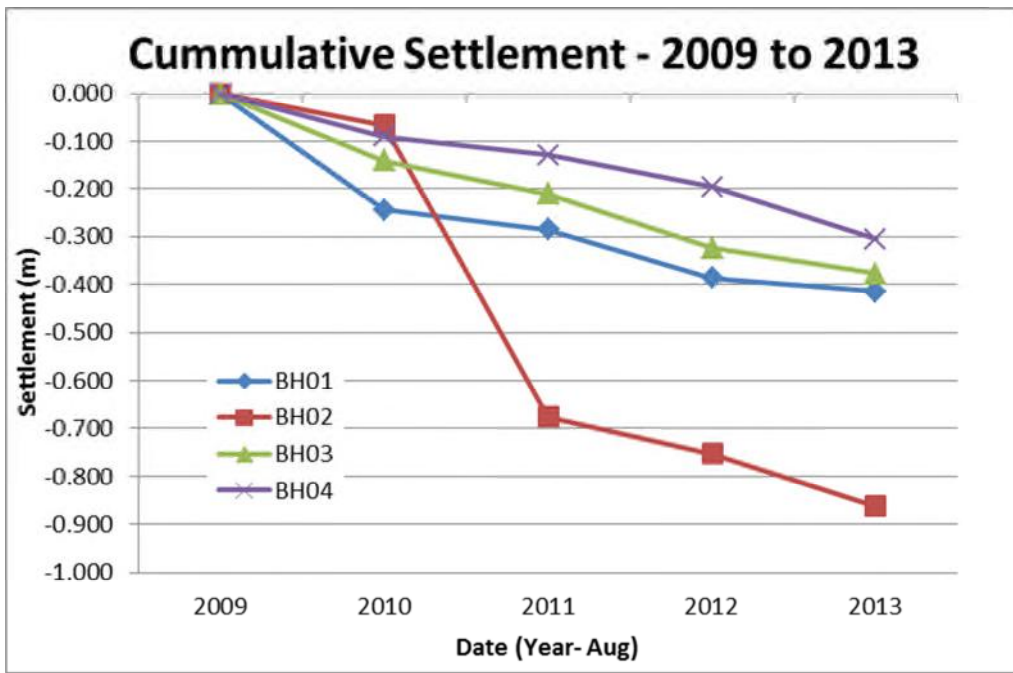
Graph 1: Cumulative Settlement

As for monitoring of the settlement that has already occurred, CS-IDB was able to provide roadway surface survey data that has been collected randomly throughout the spring, summer and fall months since October 2009. The surface elevations were collected from set stations along the alignment and EBA has determined that some of the actual locations showing signs of greatest settlement (EBA borehole locations) were not surveyed. The following Graphs 1 and 2 show overall and rate settlement, at the borehole locations. Some of the elevations were determined from break lines between two known points and only in close proximity to the actual borehole locations. The actual elevations of the borehole locations may have settlement values greater than what has been shown on the following Graphs 1 and 2.

The results indicate that there may be a slight decrease in the rate of settlement but EBA has determined that data is not very accurate and the collection of more survey data over the next 5 to 10 years will be required to better determine when settlement will stop.

- Continue to regularly monitor future settlement as compared to original design grades of Hamilton Boulevard. A benchmark and survey monuments should be established at select areas (present borehole locations) that will monitor the greatest settlement, and surveys completed prior to and after annual repair work to monitor settlement rates. The survey monuments should be positioned in locations (outside the protective guard rail) where they will not be disturbed during ongoing annual repairs. In the interim the post tops of the perimeter guard rails could be surveyed until the guard has to be replaced or other survey monuments have been installed.
- Continue with monthly monitoring of the GTC in Borehole BH03 to assist in monitoring the rate of permafrost thaw.

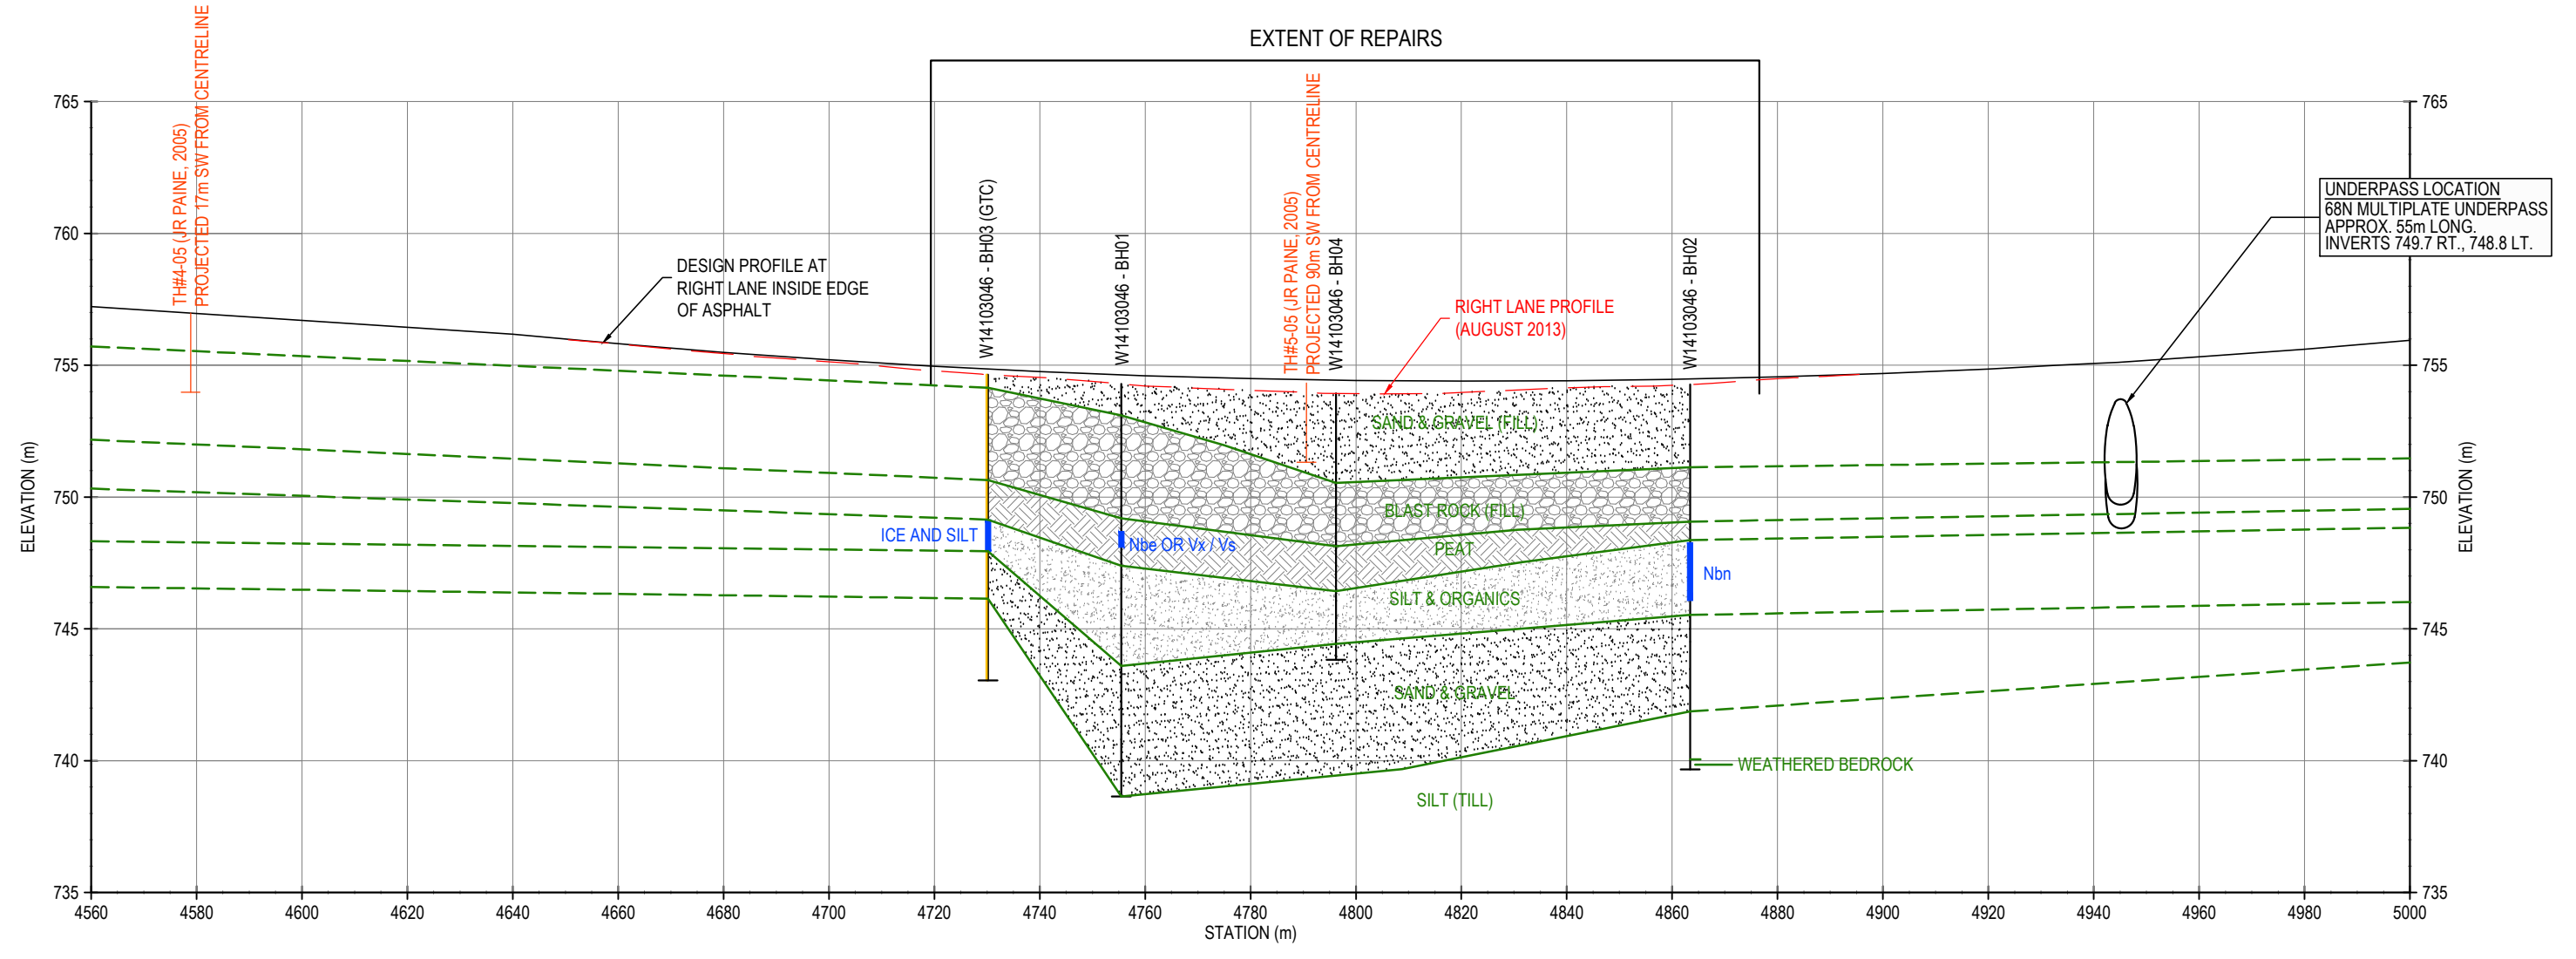
<p>CLIENT</p>		<p>GEOTECHNICAL INVESTIGATION HAMILTON BOULEVARD - WHITEHORSE, YUKON</p>		
		<p>CROSS-SECTION A - A'</p>		
PROJECT NO. W14103046-02	DWN CB	CKD CPC	REV 0	<p>Figure 2</p>
OFFICE EBA-WHSE	DATE October 18, 2013

Figure 2 presents the profile of soil stratigraphy, subsurface conditions encountered, and instrumentation installed. The elevations are manually interpreted from profiles provided by CS-IDB. Some variation in elevation can be expected. The stratigraphy shown has been interpreted from borehole logs and superimposed to the profile of the inside right lane of the roadway, with some engineering judgement applied.

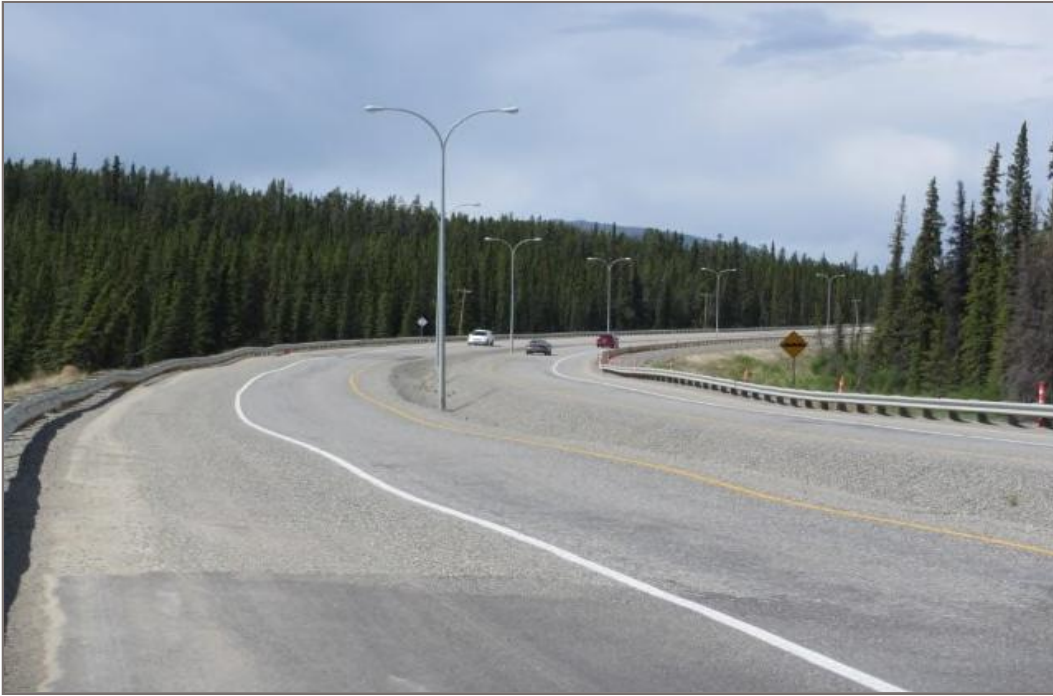
- Uneven settlement, specifically along the south bound lane (Photo 1);
- Standing water collecting in the ditches (Photo 2); and
- Tension (longitudinal) cracking at the toe of the southwest facing slopes (Photo 3) of the embankment fill. Such cracking is indicative of the underlying foundation soils settling more rapidly than the surrounding soils.

Photo 1: Hamilton Boulevard, aspect NW, June 11, 2013

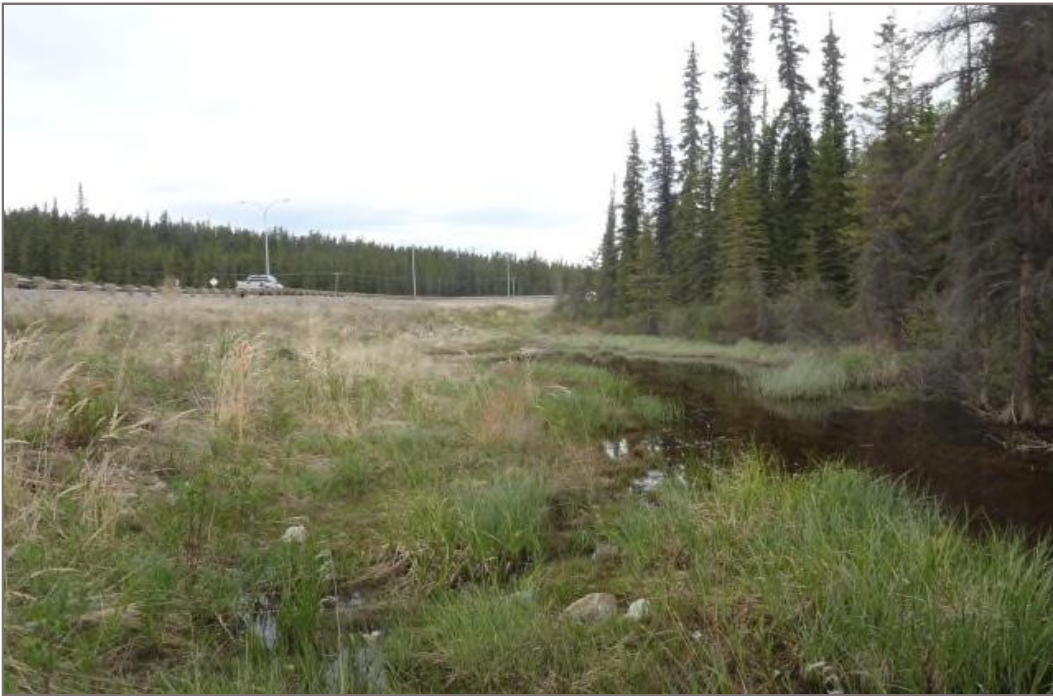
During the site visit EBA personal also noted that the area west of the Hamilton Boulevard is a localized dip in topography. Terrain inclines to the northeast and declines gently to the south and east. The site is poorly drained by natural means to the east. The road embankment appears to be damming surface water runoff from the northeast slope. No drainage paths have been constructed to successfully manage surface water.

Photo 2: Ponded water along north bound lane, aspect NW, June 11, 2013

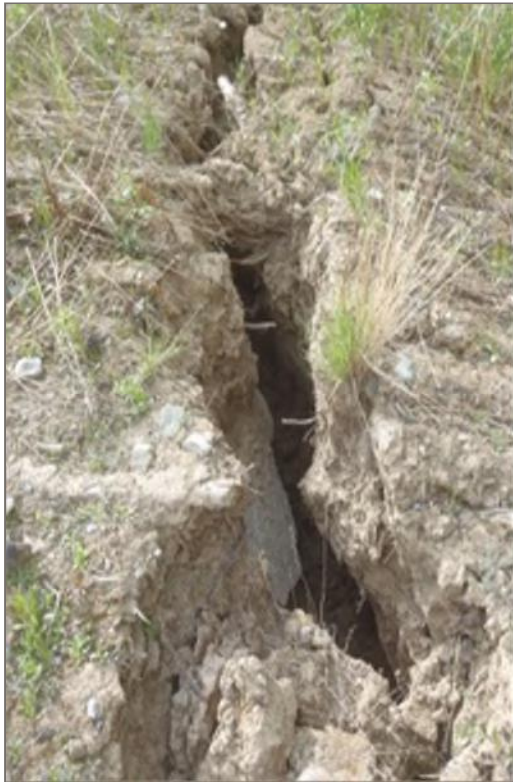
Photo 3: Longitudinal cracking in embankment atBH01, June 18, 2013

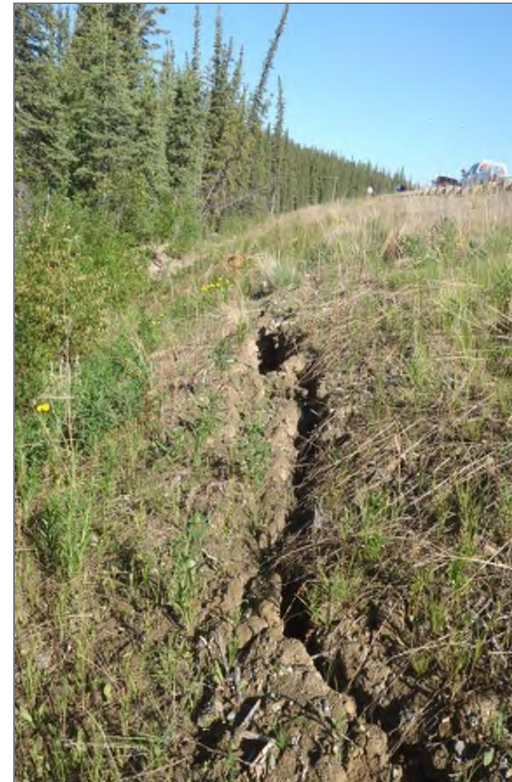
Photo 4: Longitudinal cracking along south bound embankment, aspect NW, June 18, 2013

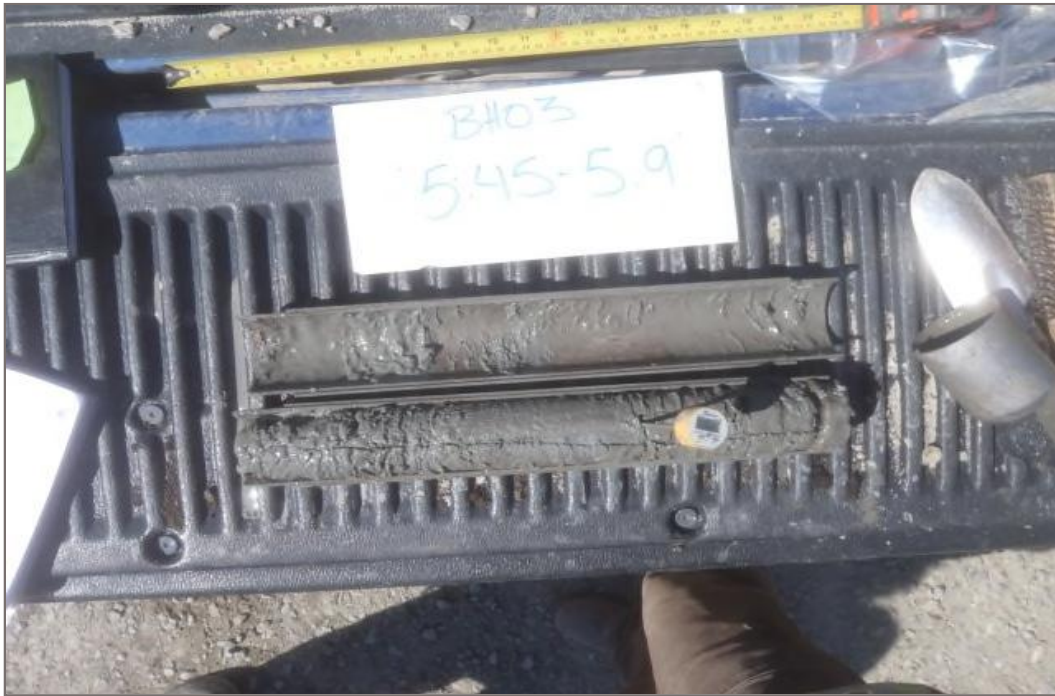
Permafrost was encountered in three of the four boreholes advanced, within the underlying PEAT and SILT. The thickness of permafrost varied from 0.8 m of frozen PEAT in Borehole BH01, 2.0 m of frozen SILT in Borehole BH02, and 1.4 m of ICE and frozen SILT in Borehole BH03. The PEAT in Borehole BH01 had an moisture content of 178% (by weight), the frozen SILT in Borehole BH02 contained 27% moisture content (by weight), and the ICE and frozen SILT in Borehole BH03 contained 60% moisture content (by weight). No permafrost was encountered in Borehole BH04.

The main cause of the settlement that Hamilton Boulevard experiences at section STA 4+640 to 4+860 is the thawing of ice-rich silt and peat beneath the quarry rock fill. It appears that the original geotechnical investigation¹ may not have included subsurface testing in this specific area.

Photo 5: Ice rich SILT in BH03 (5.45 m – 5.9 m)

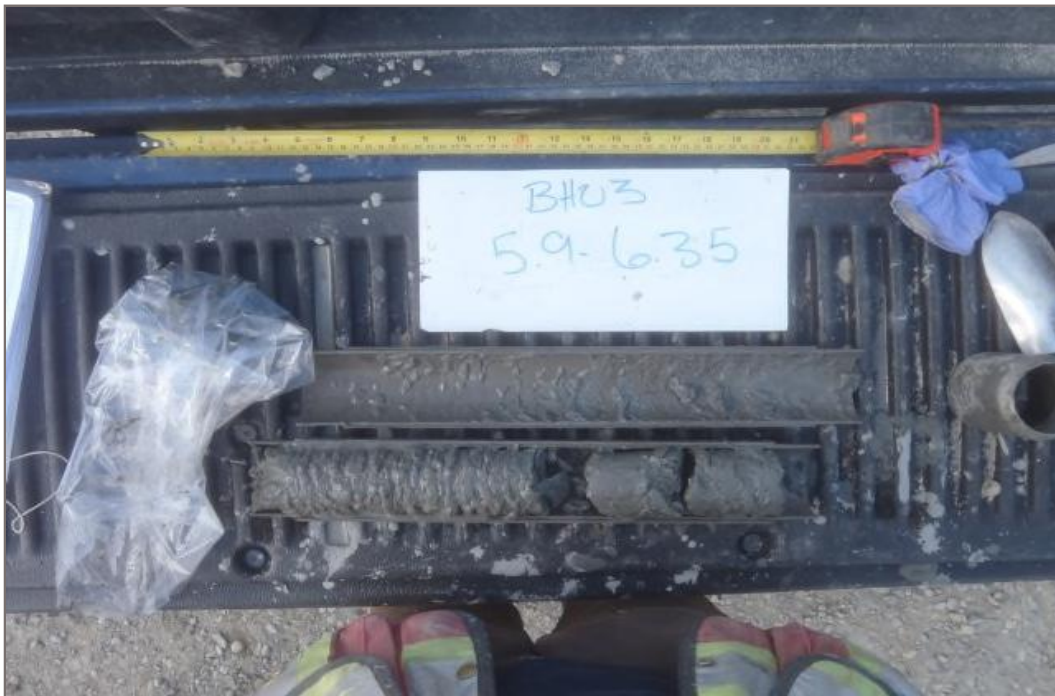
Photo 6: ICE and SILT in BH03 (5.9 m – 6.35 m)

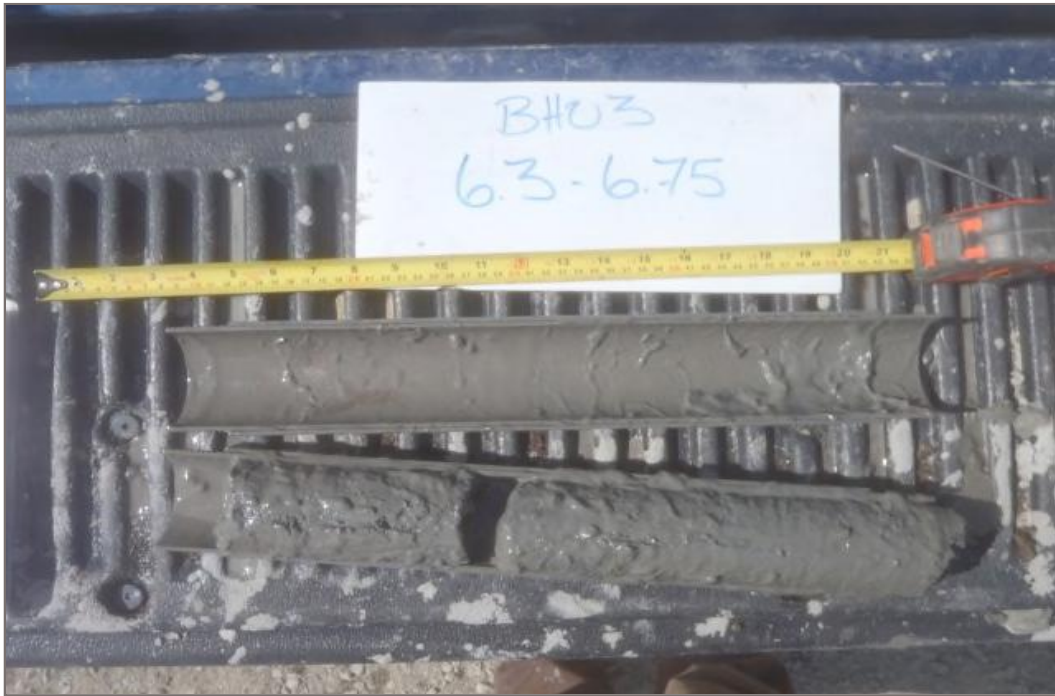
Photo 7: ICE and SILT in BH03 (6.3 m – 6.75 m)
