# Yukon Government Rural Land Development

## Grizzly Valley Road Preliminary Assessment

**August 2015**

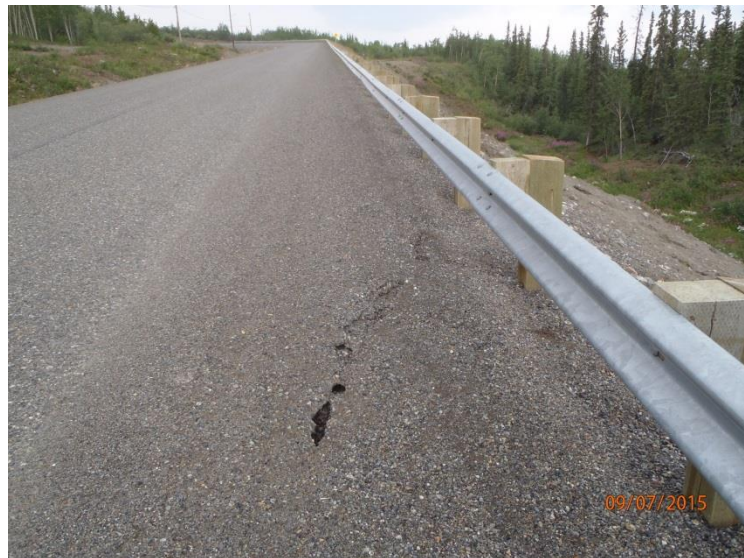
All large embankment fills, generally those greater than 6 m in height, in the subdivision showed signs of instability. This can be attributed to material placed in excessively thick lifts during construction, relatively steep side slopes of approximately 1.5 horizontal to 1 vertical, minimal compactive effort and lack of vegetation growth on side slopes. Tension cracking on embankment side slopes and BST road surface were observed at the following locations: from Sta 0+800 to Sta 1+100, Sta 2+060 to Sta 2+300, Sta 5+200 to Sta 5+320, Sta 5+900 to Sta 6+600.

**Picture 3-1 Tension cracking extending up the fill embankment and into the BST surface at 0+850 on the right hand side.**

Reconstruction of the four large road embankments fills as a high priority to stabilize the slopes and mitigate further damage. Reconstruction should take place in the following order:

Construction methodology should follow the recommendations provided by Tetra Tech EBA in their assessment found in Appendix A. In general, the embankments should be reconstructed to a 2H:1V slope by importing fill material and benching into the existing side slope starting at the toe. Material similar to the original subbase should be placed, moisture conditioned and compacted in lifts of a maximum of 300 mm depth. Removal and re-installation of guiderails will be required.

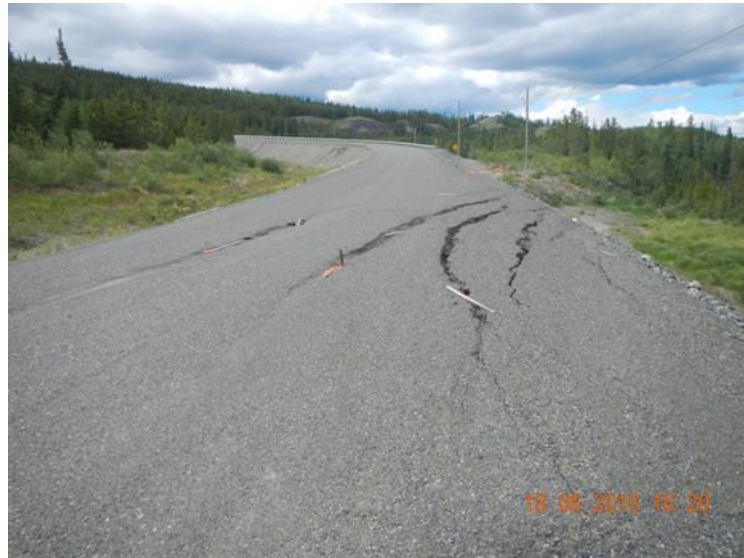
The sub grade failure near the north entrance was localized to approximately 100 metres of the roadway. This section of road was built on wet ground unsuitable for the road embankment constructed and has subsequently failed. Pondered water was observed at the toe of the embankment.

The stretch of road from approximately Sta 6+750 to Sta 7+100 was constructed on the historic drainage channel of a pond located on the south side of the road at 7+100. The water level of this pond has increased since the fall 2014 site visit based on observations from the 2015 site visit. Shrubs and trees previously not exposed to standing water on the edge of the pond appeared to be dying. This section of road was bounded by bedrock on either side. No significant damage to the road was observed along this section, however there is potential for future degradation if the water level continues to rise and drain along the toe of the road embankment.

Picture 3-2 Localized failure of the road subgrade at 6+670.

- Reinstall concrete barricades at the north subdivision access and ensure the road is secure from public vehicle access.
- Further geotechnical investigation of the subgrade soils between 6+650 and 6+750. Tetra Tech EBA suggested drilling two test holes through the road embankment in the area to assess the soil characteristics and investigate the possibility of ice-rich permafrost presence.
- Reconstruct road between Sta 6+650 and 6+750 based on the findings of the geotechnical investigation.
- Monitor the retained water level at 7+100 for increasing water volume. If the road is acting like a dam a permanent drainage solution may be required for this historic flow path.

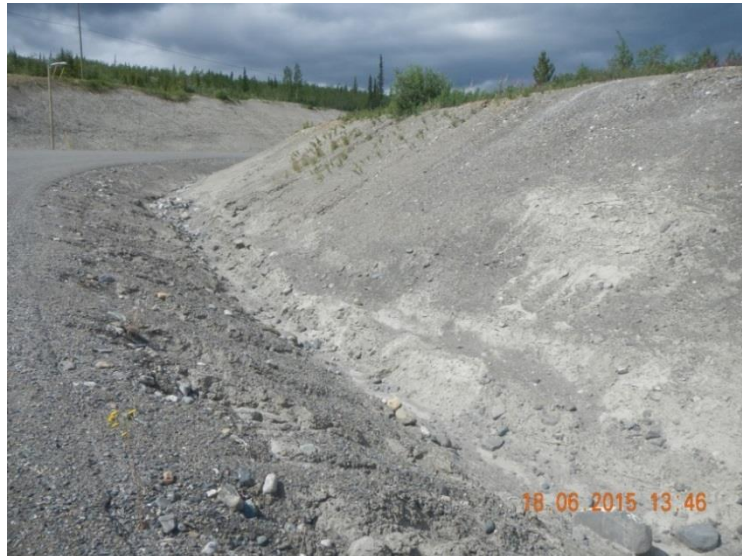
Large erosion rills have developed and led to damage of the BST road surface, guide rails and ditches. Relatively steep side and back slopes of approximately 1.5H:1V, constructed using native soils susceptible to erosion, have contributed significantly to the erosion. No measures to direct and control runoff were installed along the embankments. Ditches and slopes showed little sign of revegetation since original construction and no root mass was present to stabilize the slope. Poor compaction of road sub-base, observed by TT EBA field staff during original construction, may have contributed to extensive scouring as the material on the surface of the road side slopes would be unconsolidated. The embankments on the inside of superelevated corners were eroded significantly more than the outside embankments on the same corner due to the additional catchment area from the road surface.

**Picture 3-3 Located at approx. 0+500 on the right hand side of road.**

Re-vegetation of side and back slopes is recommended to mitigate erosion and transportation of fine grained material. Re-vegetation should be done in conjunction with ditch and culvert remediation work to maximize the effectiveness. Methods of re-vegetation for road side and back slopes are discussed in section 4.3.4 of Tetra Tech EBA's assessment report. In areas requiring embankment reconstruction, re-vegetation should be conducted following the embankment reconstruction work. Re-vegetation should be conducted in the following locations: Sta 0+000 to Sta 1+460, Sta 1+900 to Sta 2+500, Sta 4+530 to Sta 4+770 and Sta 5+130 to Sta 6+750.

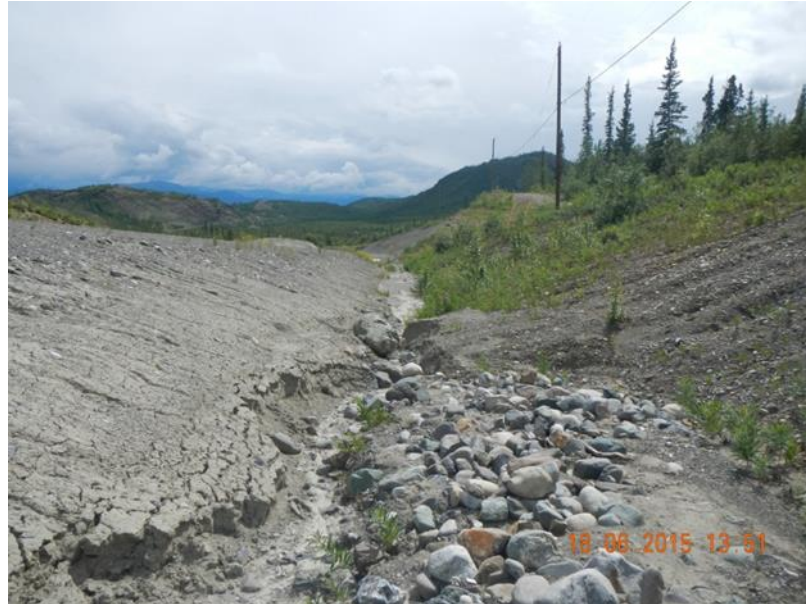
The topography of the Grizzly Valley Subdivision has resulted in long relatively steep ditch runs. No erosion protection measures were installed during original construction. As noted by TT EBA in their assessment, all ditches in excess of 3% were scoured with material deposited downstream in areas with a relief in grade. The extent of damage ranged from minor to severe.

Picture 3-5 Ditch scour and downstream deposition around 0+800 on the left hand side.

Culvert remediation work should be conducted in conjunction with ditch line remediation as their function complements each other. Damage to ditches from erosion of fine grained material was an extensive problem throughout the subdivision where grades exceed 3%, as outlined in Tetra Tech EBA's assessment report.

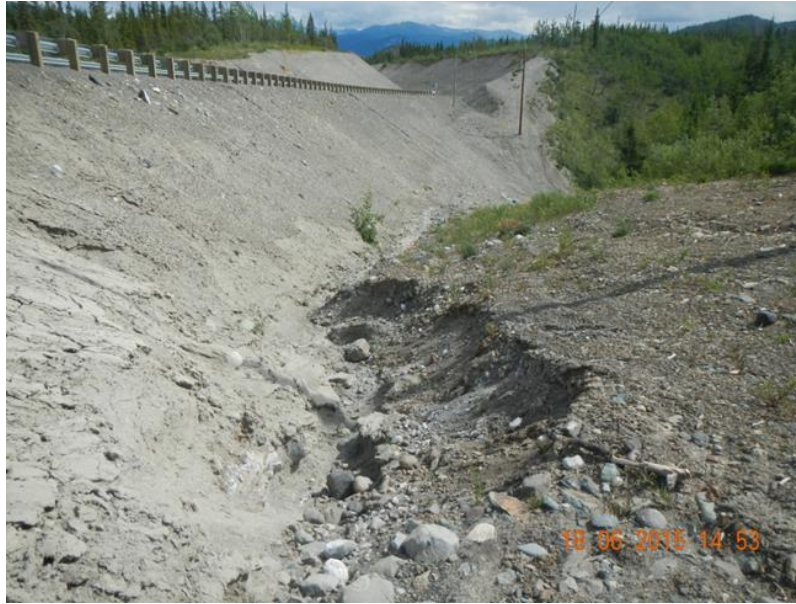
Areas where the road embankment transitioned from cut to fill often resulted in an increase in grade in the ditch. These locations experienced the most severe damage from scouring.

**Picture 3-7 Major scouring located in a transition from cut to fill on the right hand side of road 5+140.**

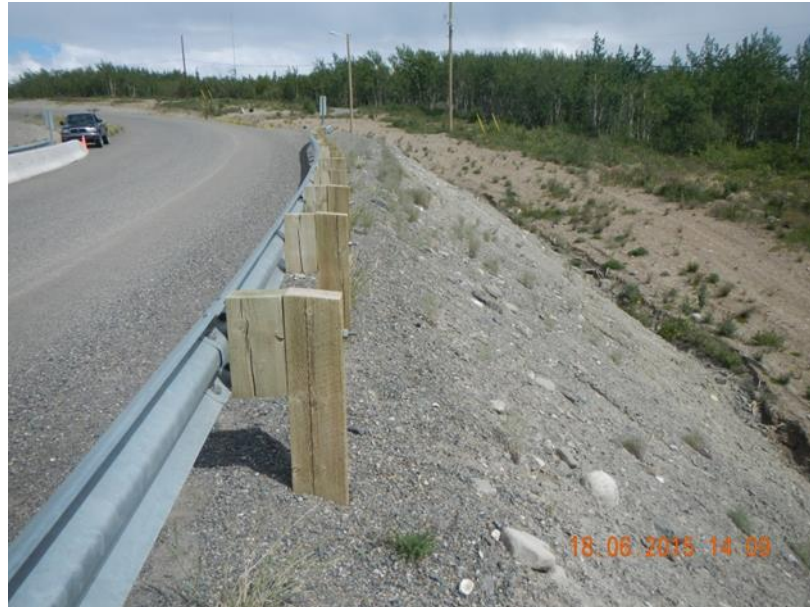
The guiderails throughout the subdivision were consistently installed too close to the top of embankment slopes. Typical installation would have one metre from the back of the guiderail posts to the top of the road embankment slope to provide a solid foundation. Poor compaction around the concrete abutments at the end of each guiderail was noticed and water had infiltrated and eroded the road subbase.

**Figure 3-9 Guiderail installed in the embankment slope at 2+100 on the left hand side. Also note the scouring in the ditch bottom.**

- Alternatively, concrete jersey barrier curb could be installed along these embankments in replacement of the guiderails. These barriers would serve as a safety barrier and a curb to direct runoff water. A barrier with a gap in the base should be installed at regular intervals to allow water to flow onto the embankment slope.

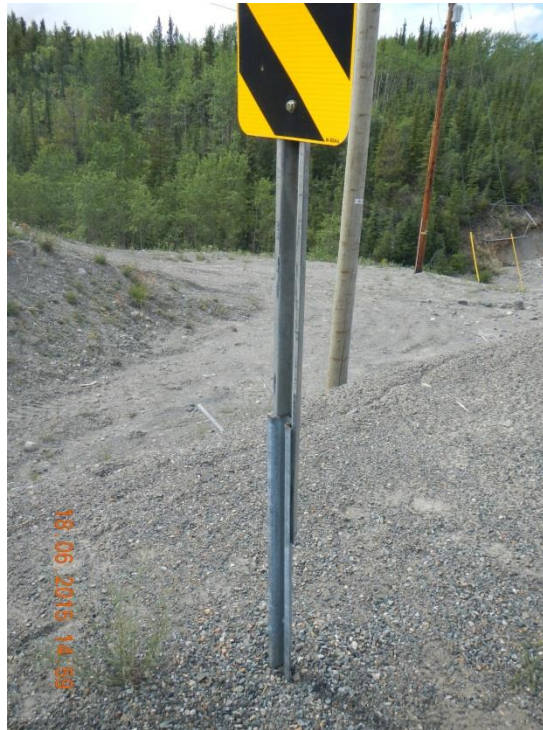
All road signs were installed incorrectly. The post anchors extended far above the ground surface and no breakaway was installed. This has resulted in posts breaking at station 1+390, 4+780. The sign at 1+480 is missing.

Picture 3-11 Typical sign post installation, long anchor and no breakaway.

The reinstallation of road signs throughout the subdivision is the lowest priority of the repair work to be done. All road signs were installed incorrectly and should be removed and replaced with proper anchor posts and breakaway mechanisms. Some road signs will be required to be removed and replaced during embankment reconstruction, at such time, these signs should be reinstalled with proper anchors and breakaway mechanisms. The sign posts at 1+390, 4+780 were broken and should be replaced. The sign at 1+480 is missing and should be replaced.

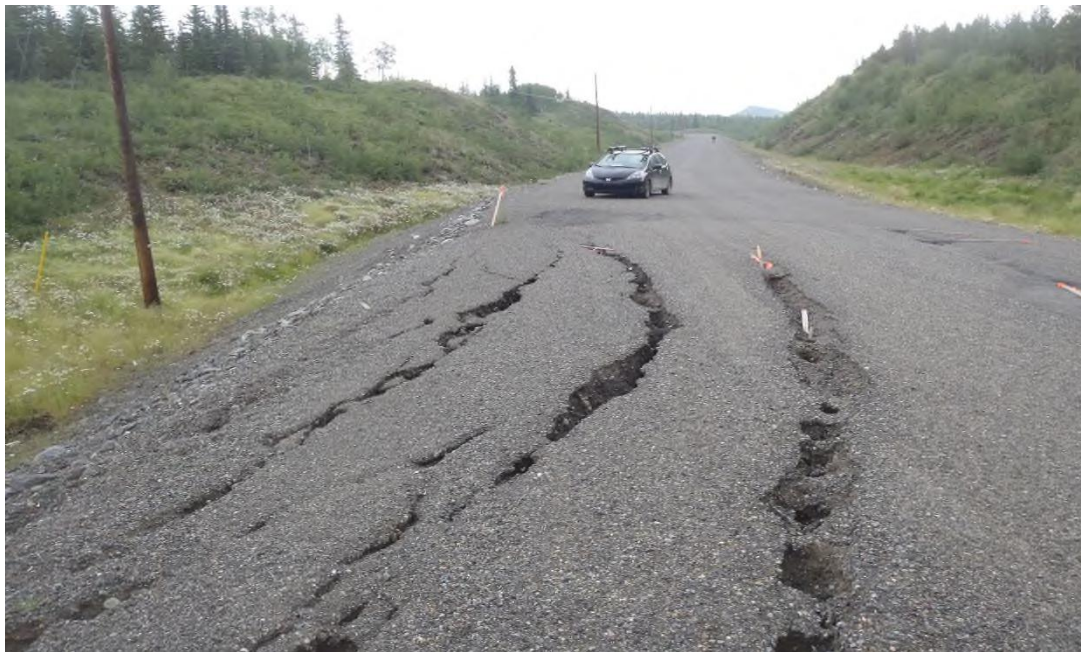
**Photo 1:** July 9, 2015 - Subgrade Failure at Sta 6+670

- It should be noted that the culvert at Sta 6+660 is badly damaged and will require replacement as well.

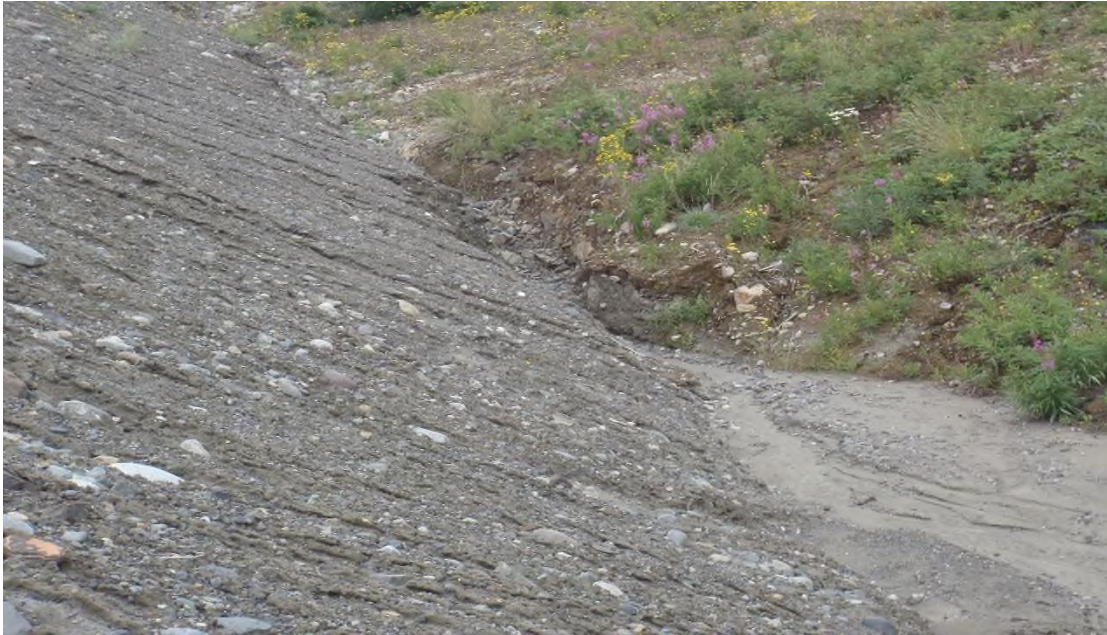
**Photo 2:** July 9, 2015 – Ditch Scour at Sta 6+320 (greater than 3 m at some locations)

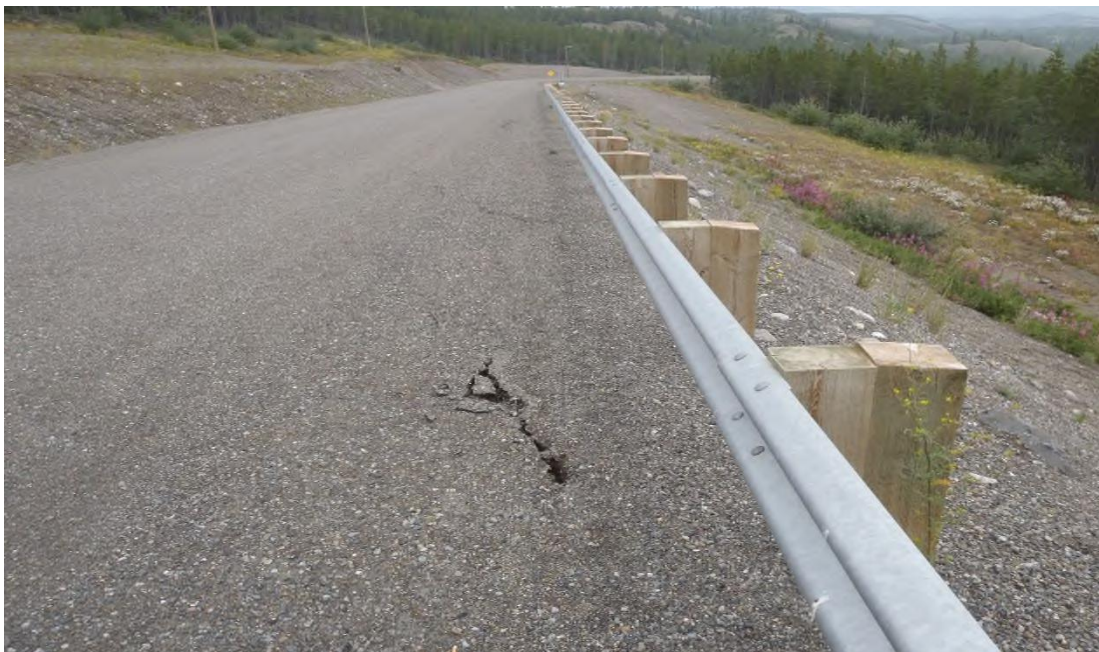
**Photo 3:** July 9, 2015 – RHS Embankment Instability North Of Sta 6+100
