21.0 BUILDING 3957: DESTRUCTION BAY HEALTH CENTRE

SMALL PUBLIC WATER SYSTEMS ASSESSMENT
 WESTERN REGION

DESTRUCTION BAY HEALTH
 CENTRE BUILDING # 3957
 SITE LOCATION DIAGRAM
 WELL ID: 3957

SMALL PUBLIC WATER SYSTEM ASSESSMENT

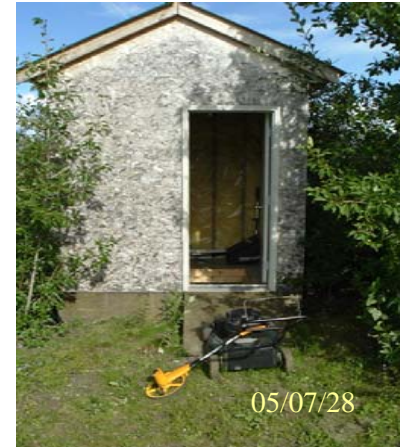
Unauthorized access by humans? Yes No
Pumphouse is unlocked

Entrance by animals? Yes No
Evidence of mice, squirrels, and insects

Photo 0595: 3957 Well house

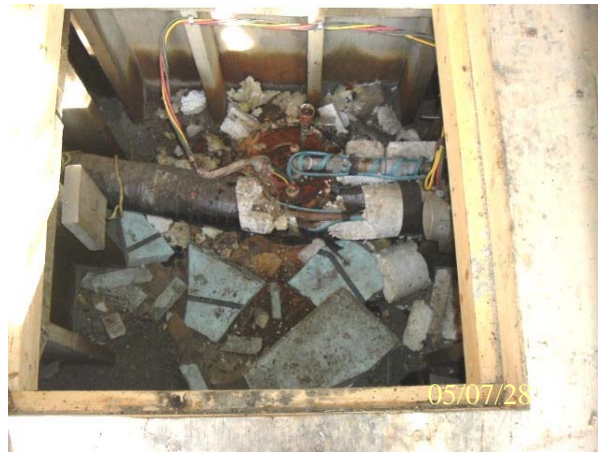
- Poor surface completion of the well (located in an enclosure below grade);
- There is no surface sanitary seal (grout or bentonite seal as required by the Canadian Groundwater Association's Guidelines for Water Well Construction;
- By definition of the Draft Yukon GUDI Assessment Guideline, the well is potentially under the direct influence of surface water because does not meet the requirements of the Guidelines for Water Well Construction;
- The well is located approximately 60 m downgradient from a community septic field; and,
- There is no disinfection system.

- i. Is the well head below grade? describe in detail ~ 0.35 m below grade
- ii. Are there signs of ponding on the enclosure(e.g. water stains, etc.)? Yes No
rust on casing
- iii. Is the wellhead enclosed by fiberglass insulations? Yes No *styrofoam*
- iv. Any evidence of rodents? Specify Mice and Squirrels
- v. Does the well casing have a proper seal cap? Yes No

If no, describe condition split gasket cap modified for artesian well

Photo 0594: 3957 Wellhead in pit below floor at well house

Priority 2 upgrade options to mitigate long-term risk and meet the proposed regulation would include standard wellhead improvements consisting of a pitless unit installation, extending the casing to at least 500 mm above grade, and retrofitting of a surface sanitary seal (grout or bentonite to at least 3 m in depth).

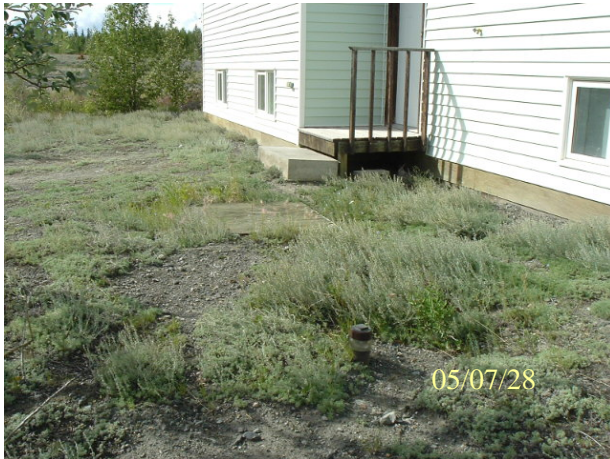
In addition an abandoned well is located on the property. The closest portion of a septic system to the well is a septic field located at 65 m.

Photo 0597: 3957 Abandoned well nursing residence # 2 (back)

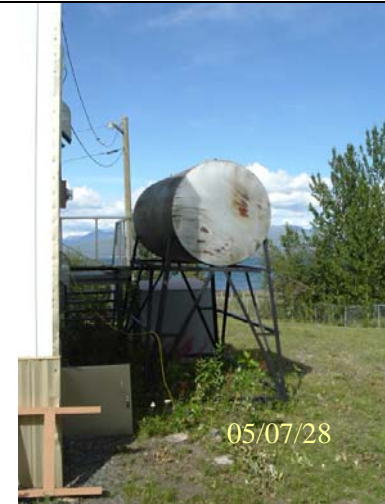
- The well is within 30 m of an above ground fuel storage tank located in Nursing Residence #1, however, since the well is 26 m away and in a building, it is considered to pose minimal risk;
- The well is located approximately 36 m downgradient from an underground fuel storage tank;
- The arsenic concentration, although not in exceedence of the current MAC, has consistently been in exceedence of the proposed new CDWQG MAC of 0.005 mg/L. The most elevated reported concentration was 0.0148 mg/L;

Photo 0591: 3957 Above ground fuel storage tank

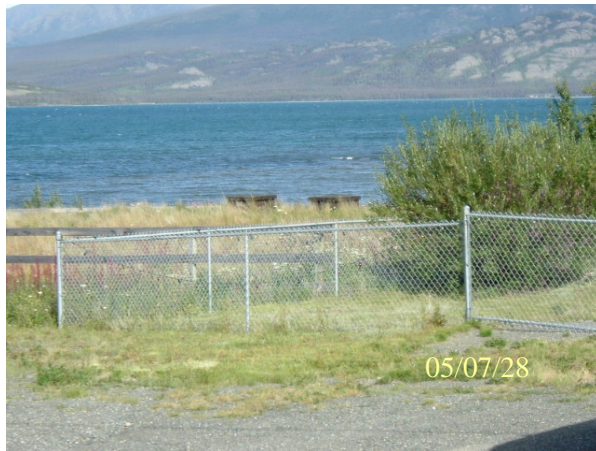
All three buildings served by this water system use a community sewer collection system. There is a community septic field located approximately 65 m east and downgradient from the well, and another community septic field located approximately 75 m northwest and potentially upgradient from the well. A site plan showing both community septic fields is given by Figure 3957-A in Appendix A21.

Photo 0588: 3957 Destruction Bay community septic system # 1

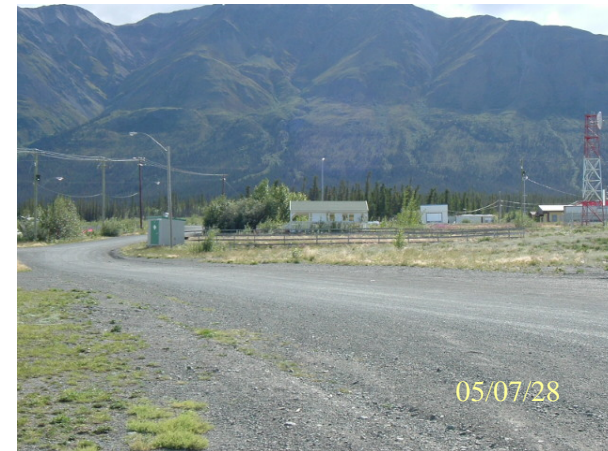
Photo 0590: 3957 Destruction Bay community septic system # 2

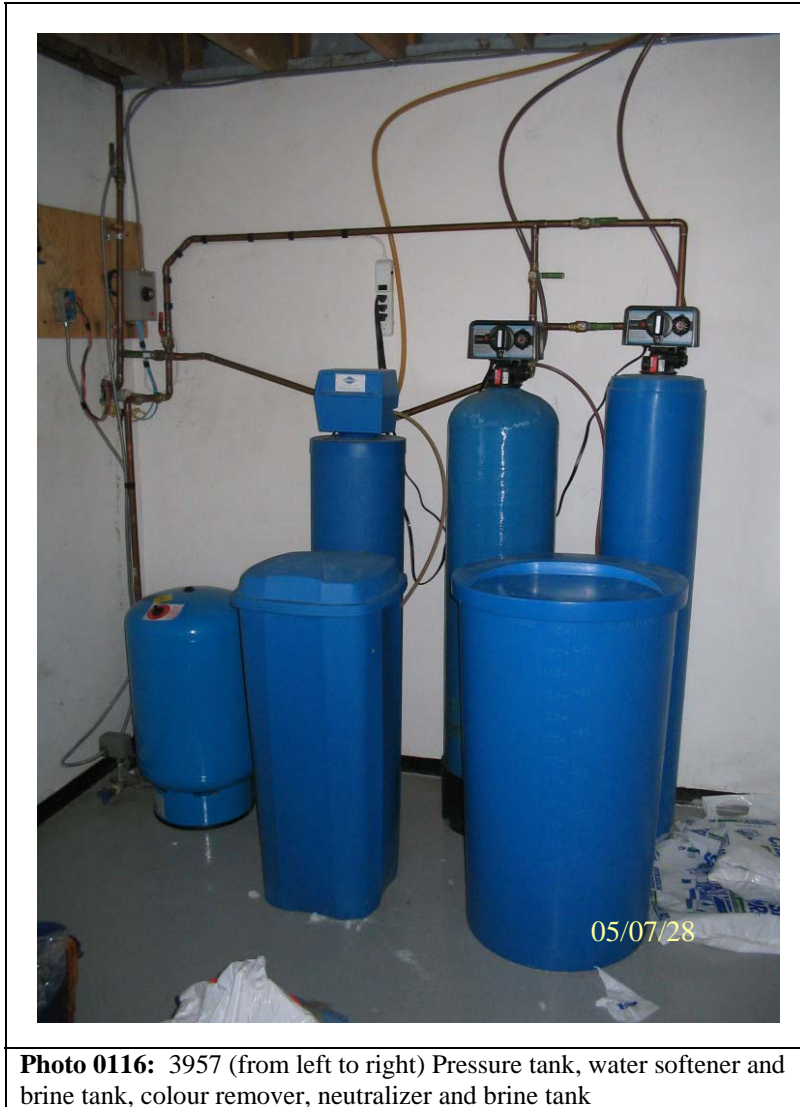
- The pH has consistently been in exceedence of the CDWQG aesthetic objective of 8.5 and elevated above the normal background pH for the region. Field measurements reported the pH to be 9.11. This is likely caused over-adjustments by the pH neutralizer, and the pH would likely drop if the neutralizer were properly adjusted;
- At 525 mg/L, the most recent previous sampling event reported the total dissolved solids concentration to be in exceedence of the CDWQG aesthetic objective of 500 mg/L; and,
- The NSF 61 filtration system has not been installed to code.

Photo 0116: 3957 (from left to right) Pressure tank, water softener and brine tank, colour remover, neutralizer and brine tank

- Superchlorinate the well and water system, and install a chlorination tap at the wellhead for future disinfection; and,
- Install filtration (to 1 micron absolute) and NSF/ANSI 55 certified UV disinfection system in Nursing Residence # 1 to provide disinfected water to all buildings.
- Bring filter installation to code (NSF 61) by ensuring proper air gaps on drains and restraint on tanks. Adjust pH neutralizer to bring pH down to below 8.5 pH units.
