16.0 BUILDING 3201: BURWASH LANDING AIRPORT BUILDING

16.1 Background and Description of Existing Water Supply System

SMALL PUBLIC WATER SYSTEMS ASSESSMENT
 WESTERN REGION

BURWASH LANDING AIRPORT
 BUILDING # 3201
 SITE LOCATION DIAGRAM
 WELL ID: 3201-A,B,C

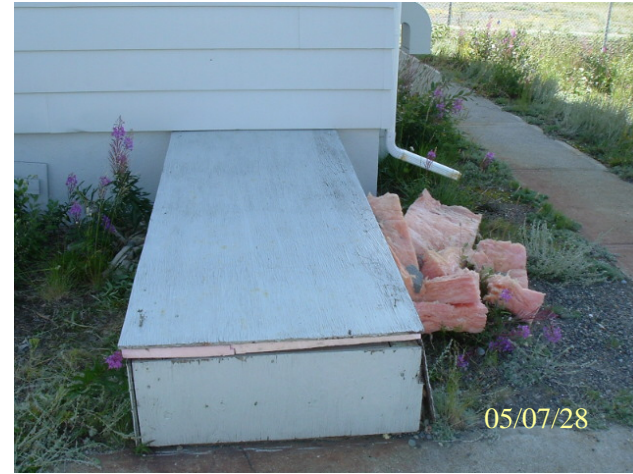
- Poor surface completion of the well (located in a wooden enclosure with fiberglass insulation, wellhead is open, subject to access by rodents and rodent feces, wellhead is at grade). Note that the wellhead was temporarily sealed with plastic and tape, however, this is not considered to be an adequate long-term solution;

Photo 0585: 3201 Wellhead enclosure

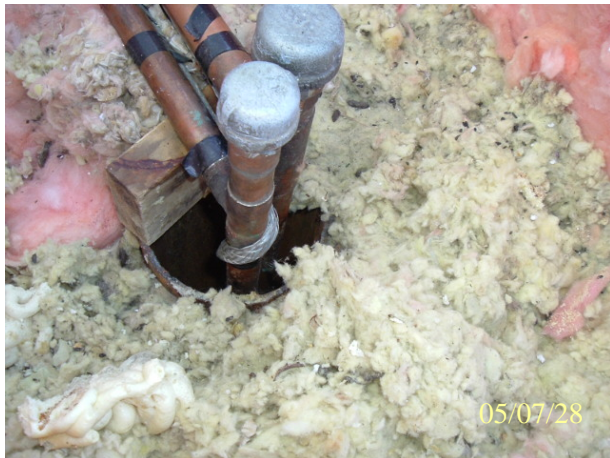
- There is no surface sanitary seal;
- By definition of the Draft Yukon GUDI Assessment Guideline, the well is potentially under the direct influence of surface water because it is a vulnerable type (unconfined aquifer), has a production zone less than 15 m below grade, and does not meet the requirements of the Guidelines for Water Well Construction;

Photo 0577: 3201 Wellhead. Note open casing.

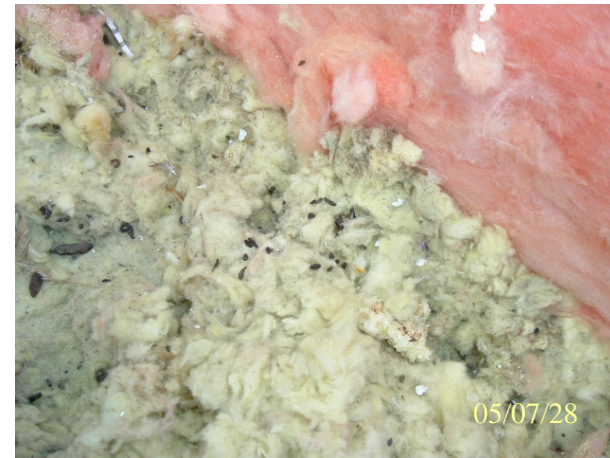
Entrance by animals? Yes No
wooden enclosure with mouse droppings present

Photo 0578: 3201 Insulation around wellhead with evidence of mouse feces

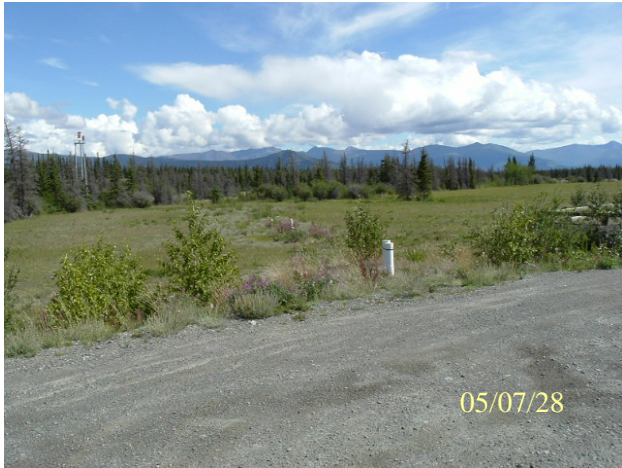
In addition, there is a septic tank located approximately 23 m away from the wellhead, a septic field is located at 40 m. There is also a bulk fuel storage area located approximately 80 m southeast and crossgradient from the well.

Photo 05980: 3201 Septic system

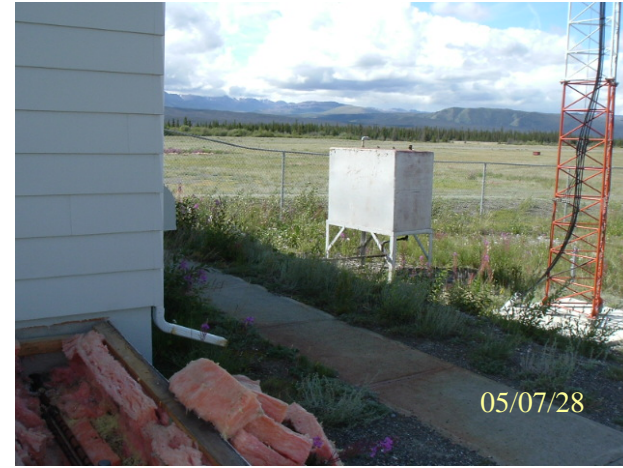
- One above ground fuel storage tank (AST); and,
- An abandoned well located beside the existing well.

Photo 0579: 3201 Above ground fuel storage tank

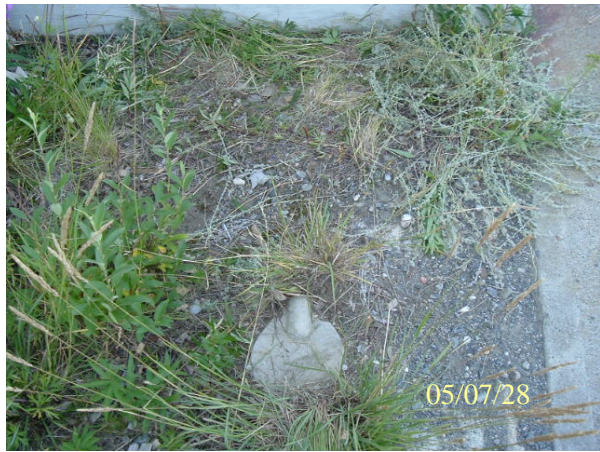
How many? 1 in use abandoned require proper sealing

Photo 0584: 3201 Abandoned well adjacent to existing well

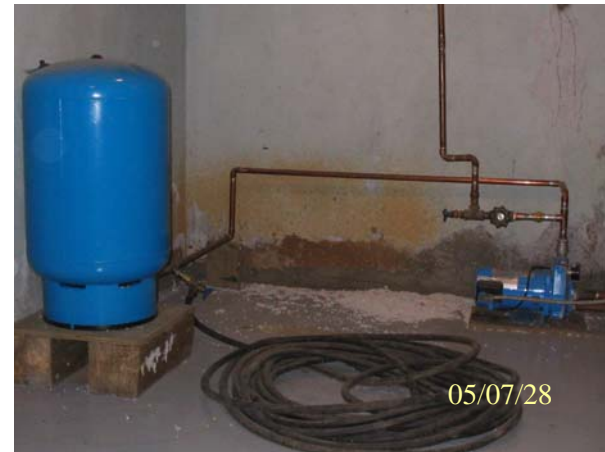
THIS INSTALLATION IS OLD, BUT WELL DONE.
WATER PUMP NEEDS REPLACING UPGRADE
TO SUB. PUMP SYSTEM

Photo 0114: 3201 Pressure tank (left), and jet pump (right)

INSTALL TREATMENT IF REQUIRED BY WATER
ANALYSIS FOR UV PRETREATMENT. INSTALL
5 GPM (NSF 55 CERTIFIED) UV SYSTEM
WITH NECESSARY PRETREATMENT - 1 BIG
BLUE 5 MICRON FILTER.
