20.0 BUILDING 6511: TANTALUS SCHOOL

**SMALL PUBLIC WATER SYSTEMS ASSESSMENT
 WHITEHORSE REGION**

TANTALUS SCHOOL
 BUILDING 6511
 SITE LOCATION DIAGRAM
 WELL ID: 6511

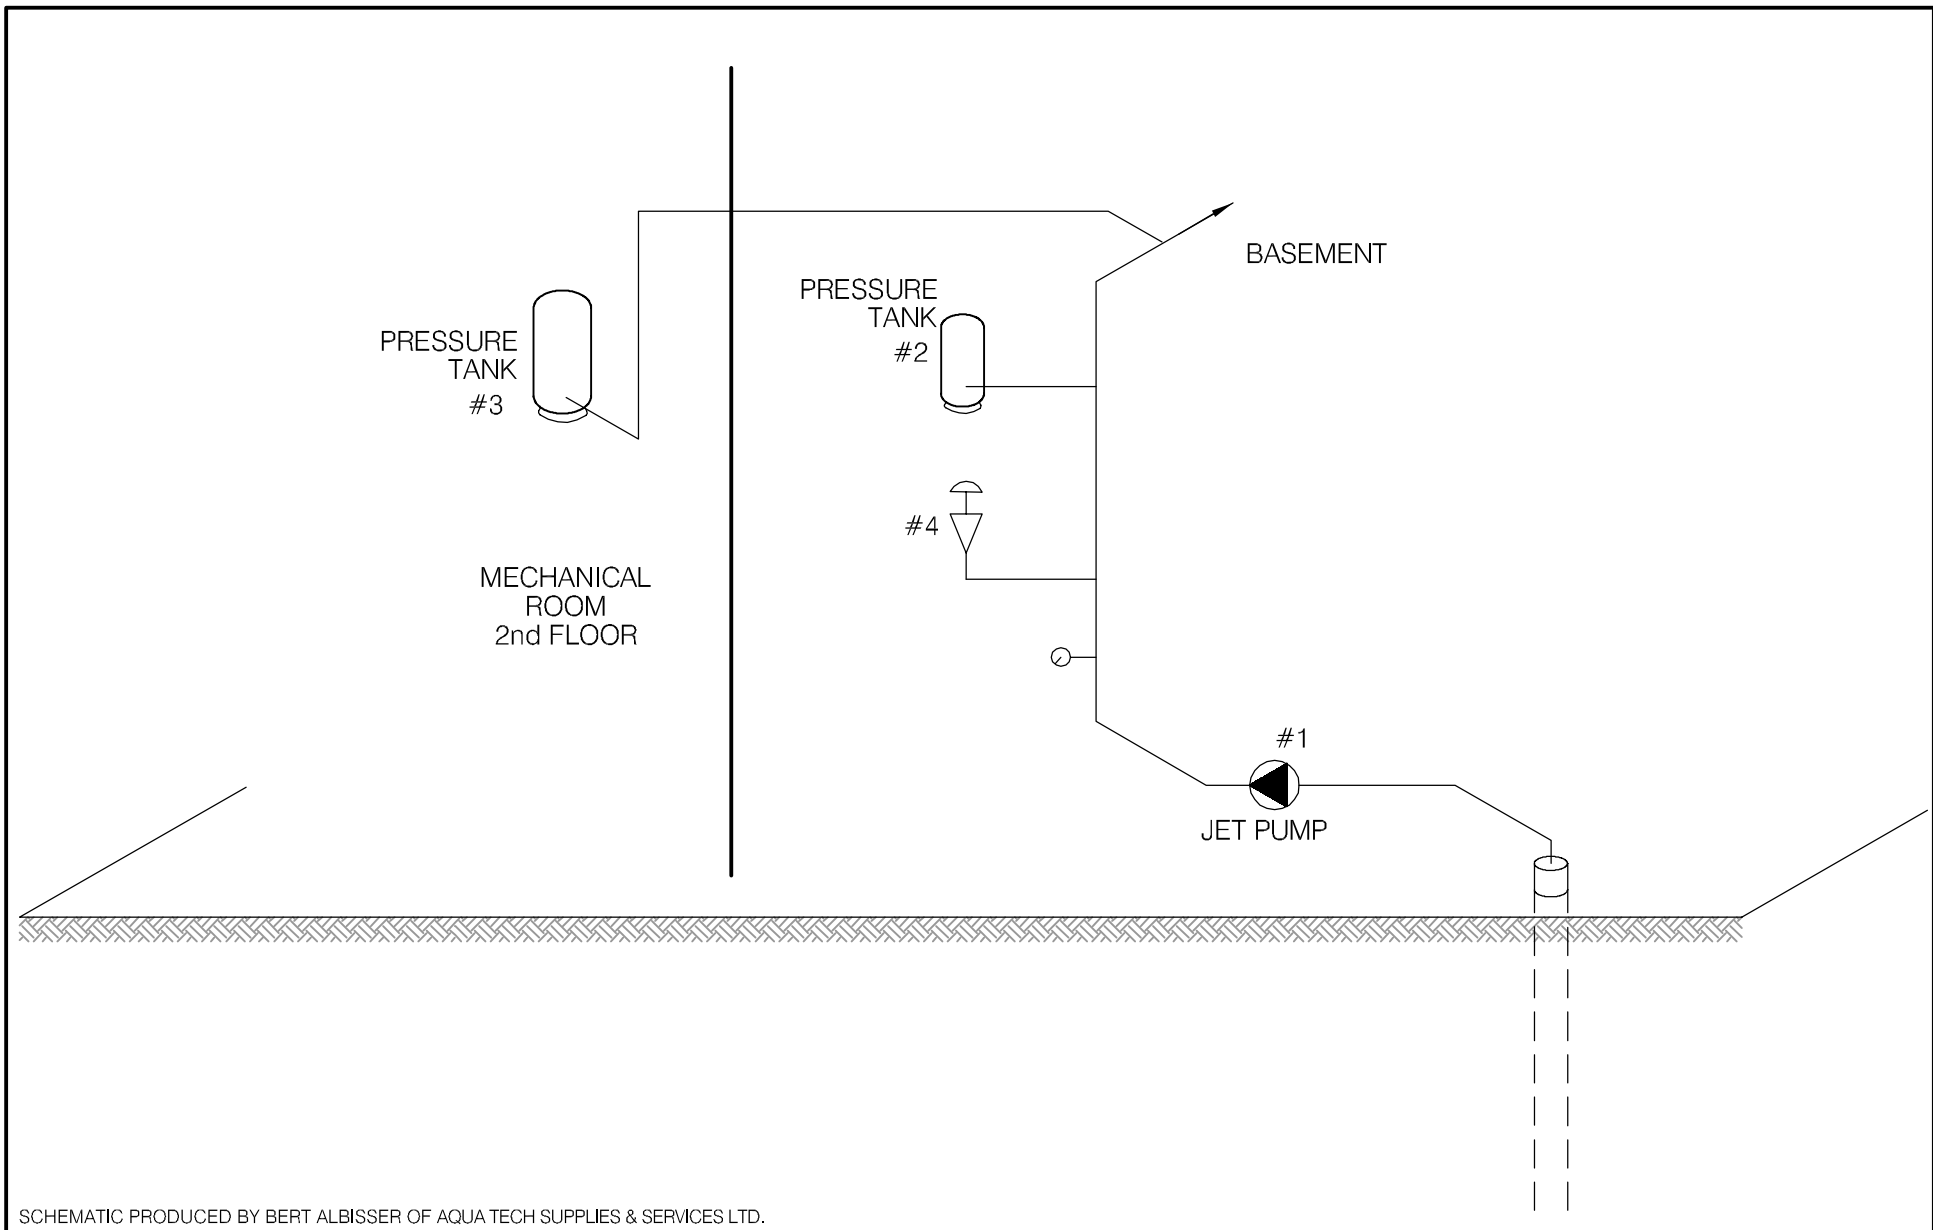
TITLE WATER SYSTEM DISTRIBUTION/TREATMENT SCHEMATIC SYSTEM ID.: 6511 TANTALUS SCHOOL - CARMACKS, YT.	
DATE	APRIL 2006	DWN.	JSB
CHKD.	RMM	FILE NO.	1260002.001
		DWG.:	FIGURE 6511B

The water is filtered through an automatic backwash filter. Disinfection treatment is not provided for this system. A system schematic is provided as Figure 6511-B in Appendix A20.

- There is no disinfection/treatment system for de-activation or removal of potential bacteria, virus and protozoa.

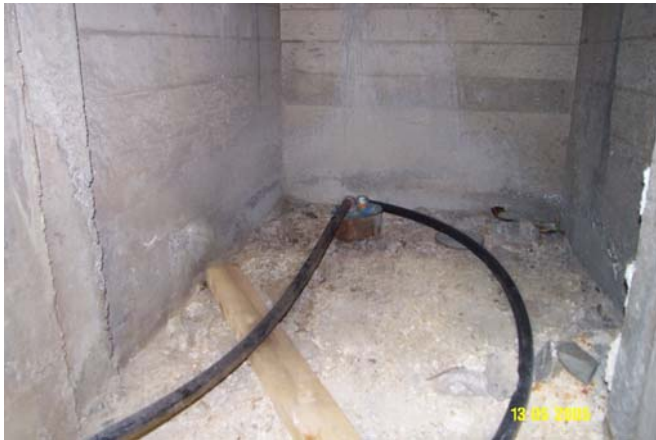
- Poor surface completion of the wellhead below ground (in concrete enclosure adjacent to the basement maintenance room). There is no surface sanitary seal (grout or bentonite seal as required by the Canadian Groundwater Association's Well Construction Guidelines);

Photo 0160: 6511-A Wellhead

- The concrete floor of the wellhead enclosure should be raised by at least 300 mm so that it can be an adequate height above floor level of the adjacent maintenance room (where there is a back-up generator);
- The well should be equipped with a surface seal as deep as possible, equipped with a pitless adapter, and the casing should be extended at least 500 mm above the level of the floor in the wellhead enclosure;
- The above ground fuel storage tank that is located 1 m from the well should be removed to another location at least 30 m from the wellhead.

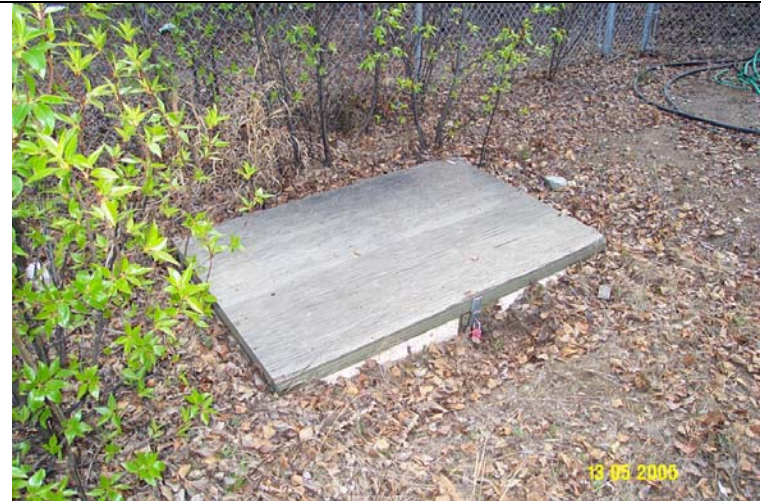
Photo 0158: 6511-C Irrigation Well Wellhead
