22.0 BUILDING 6522: CARMACKS AIRPORT TERMINAL

SMALL PUBLIC WATER SYSTEMS ASSESSMENT
 WHITEHORSE REGION

CARMACKS AIRPORT
 TERMINAL BUILDING 6522
 SITE LOCATION DIAGRAM
 WELL ID: 6522

SMALL PUBLIC WATER SYSTEM ASSESSMENT

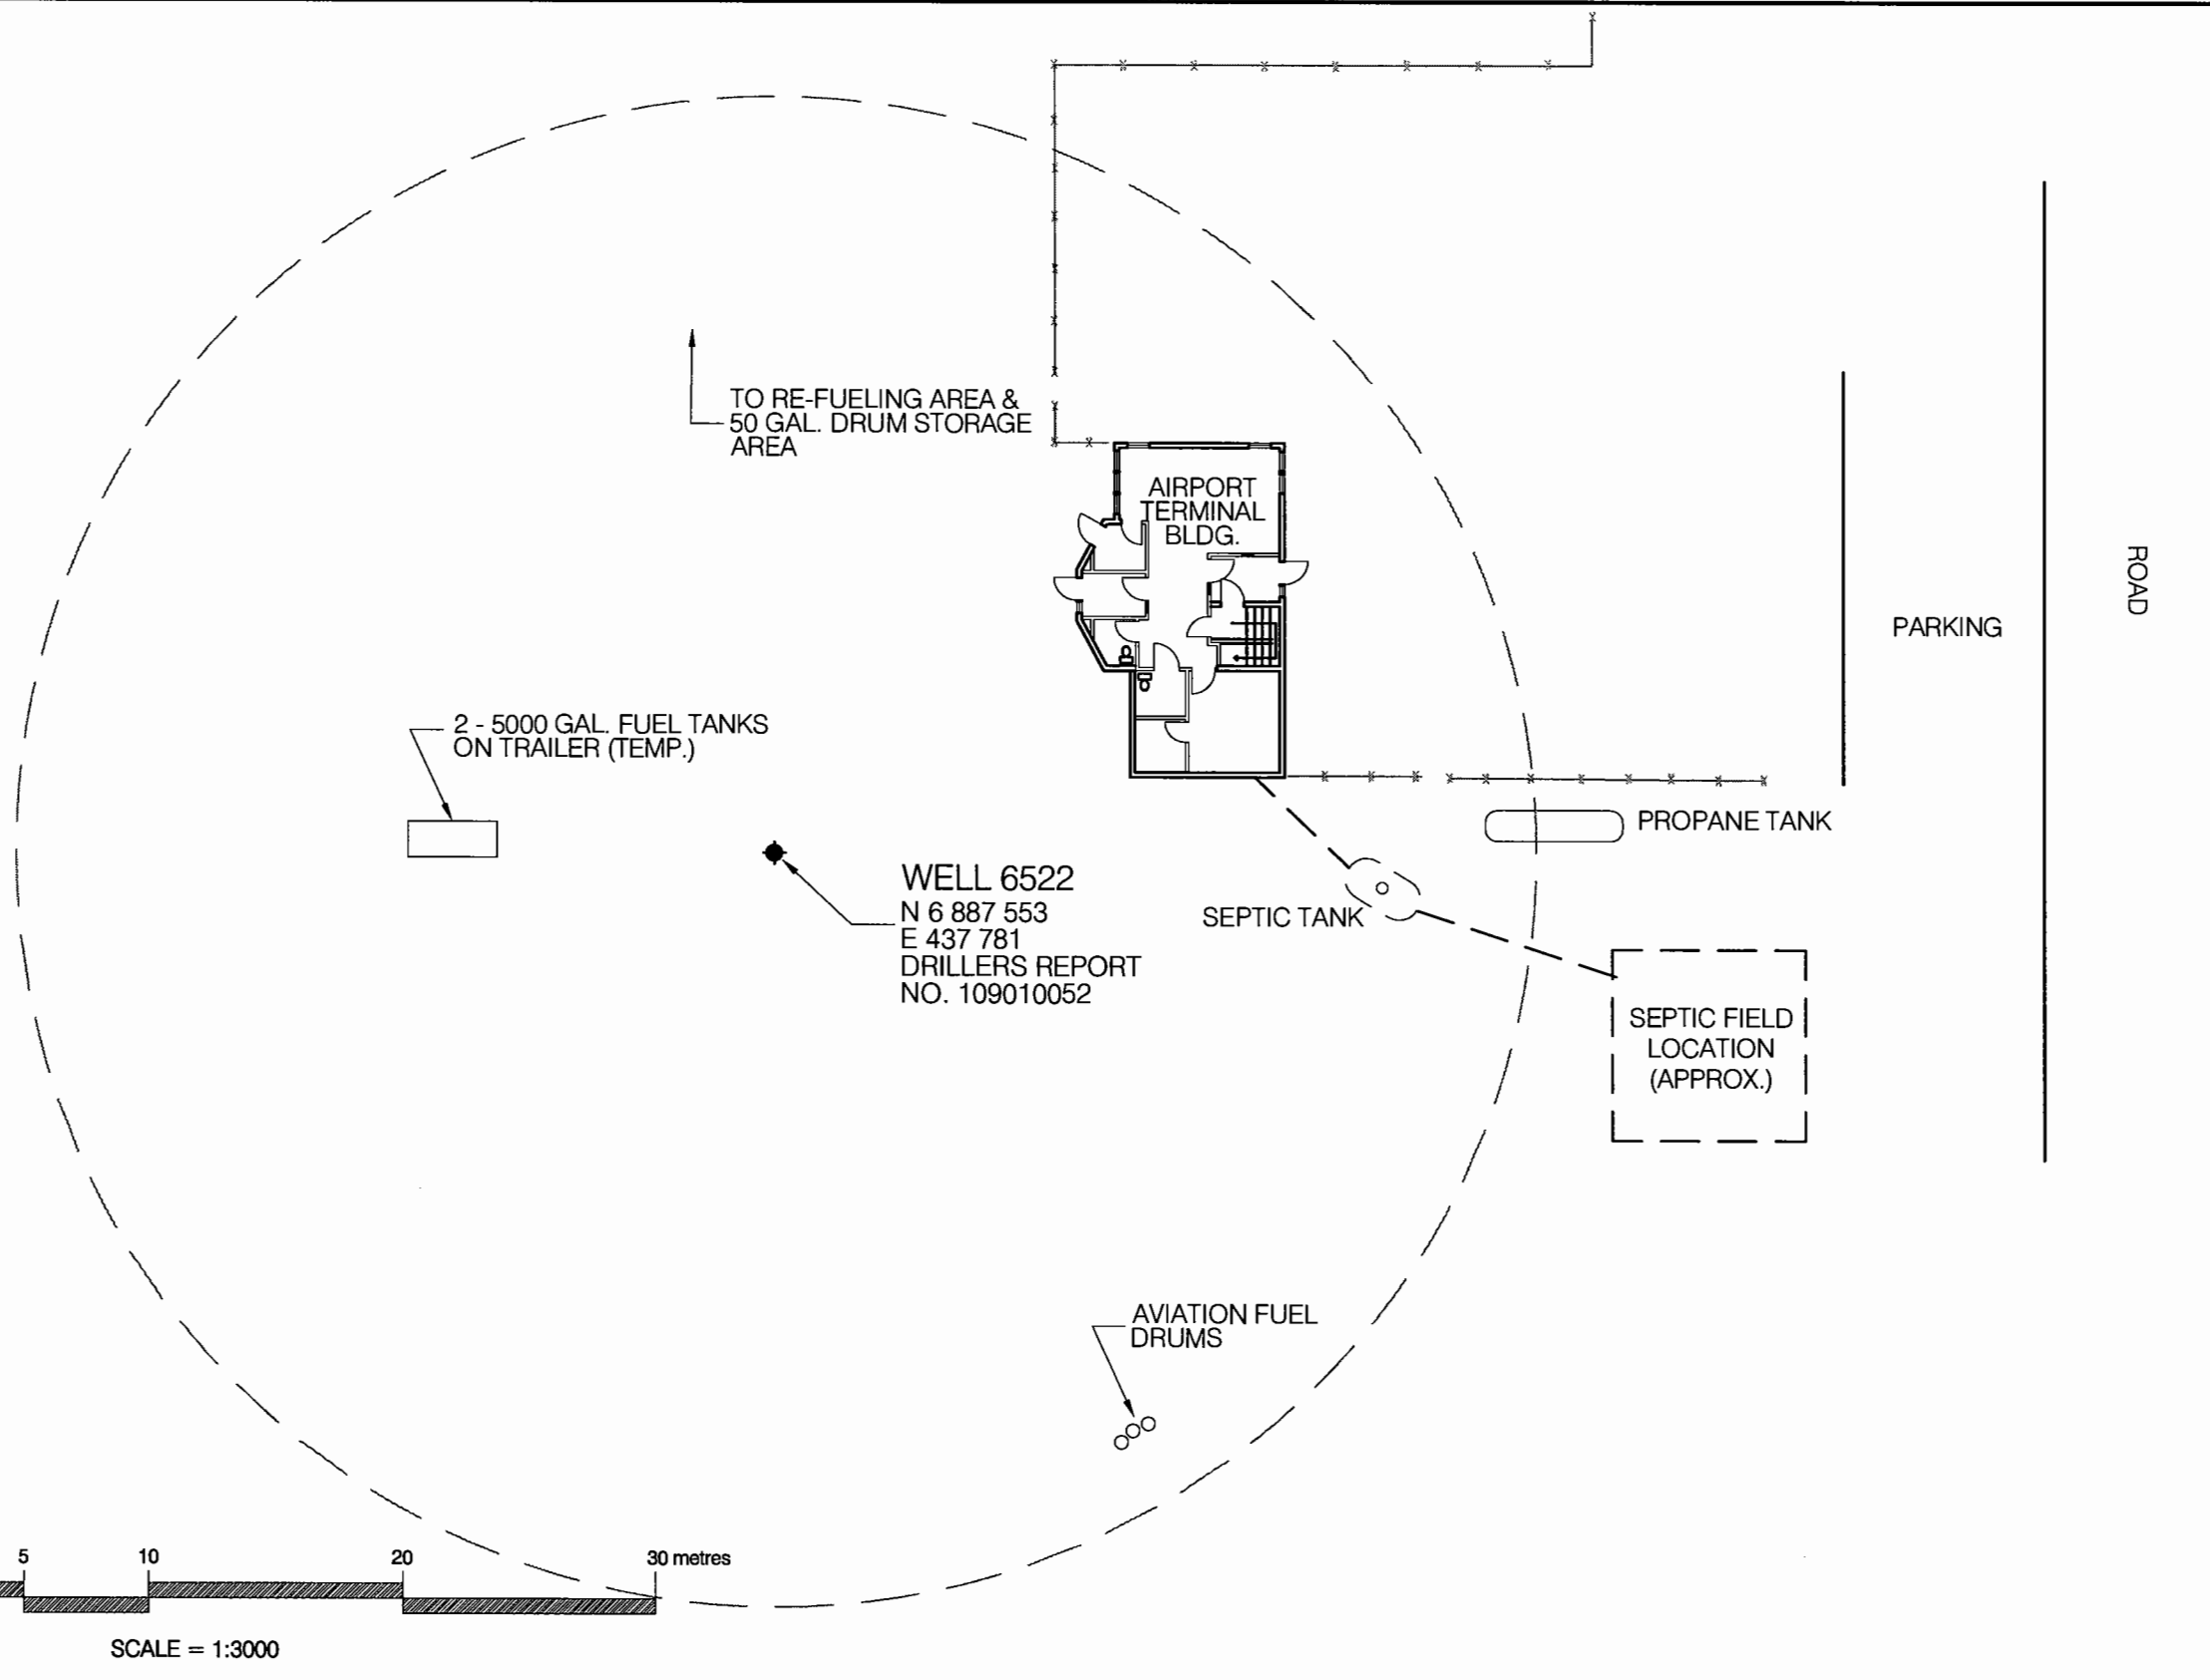
DRAWING No.
 FIGURE 6522A

The septic tank for the Carmacks Airport Terminal is located northeast of the terminal building and 22 m north of the wellhead. The septic tank discharges effluent to a field located north of the tank at a distance of 25 m from the wellhead. The septic tank and effluent field are at approximately the same elevation as the wellhead, but are likely upgradient of the well. Details of the location of the wastewater system are provided as Figure 6522-A located in Appendix A22.

30 m RADIUS FROM WATER WELL FOR CONSIDERATION OF PROXIMITY TO POTENTIAL CONTAMINANT SOURCES.

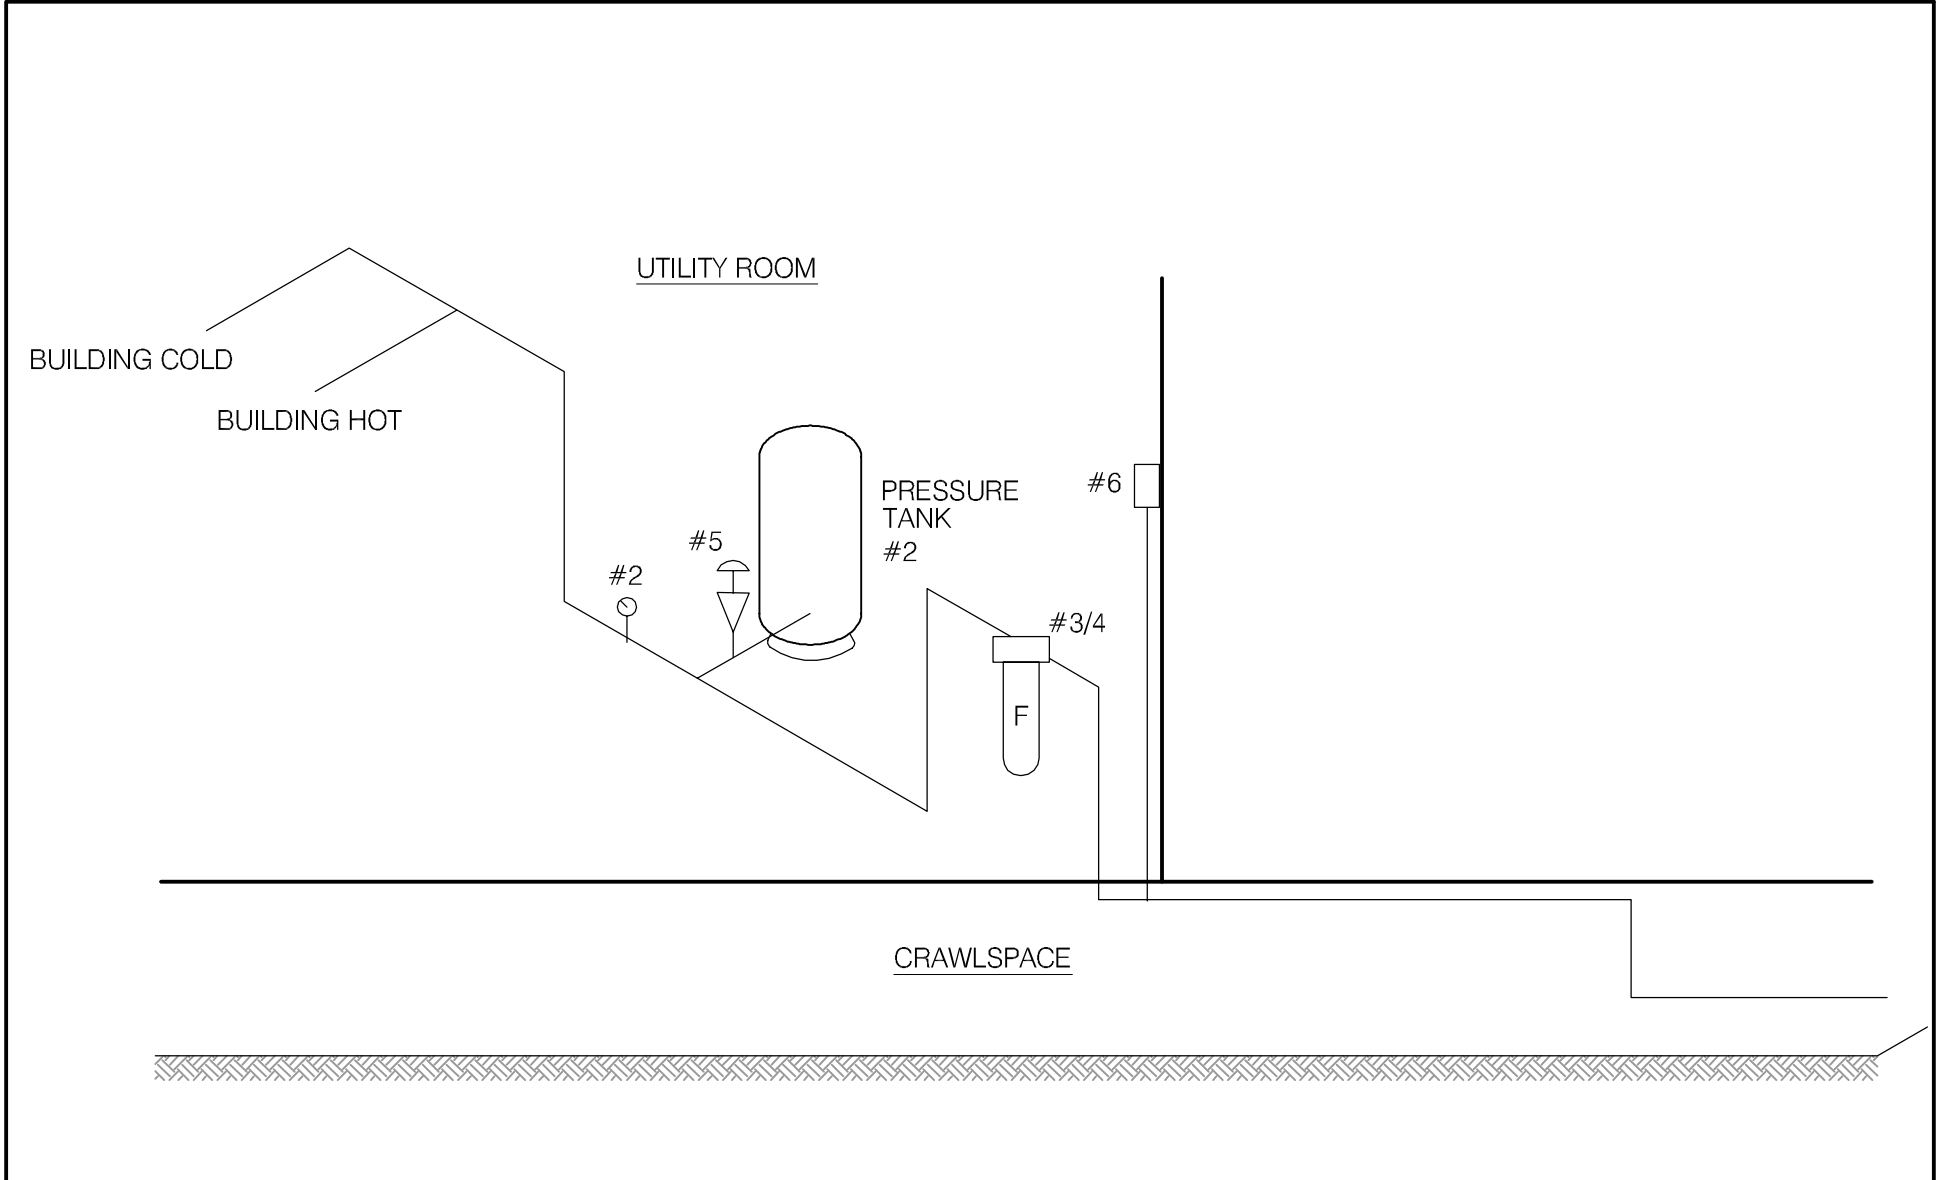
TITLE WATER SYSTEM DISTRIBUTION/TREATMENT SCHEMATIC SYSTEM ID.: 6522 CARMACKS AIRPORT	
DATE	APRIL 2006	DWN.	JSB
CHKD.	FMM	FILE NO.	1260002.001
		DWG.:	FIGURE 6522B

The water system is equipped with a submersible pump, sediment filter, pressure tank and pump controls. A system schematic detailing the water system is offered by Figure 6522-B and is located in Appendix A22.

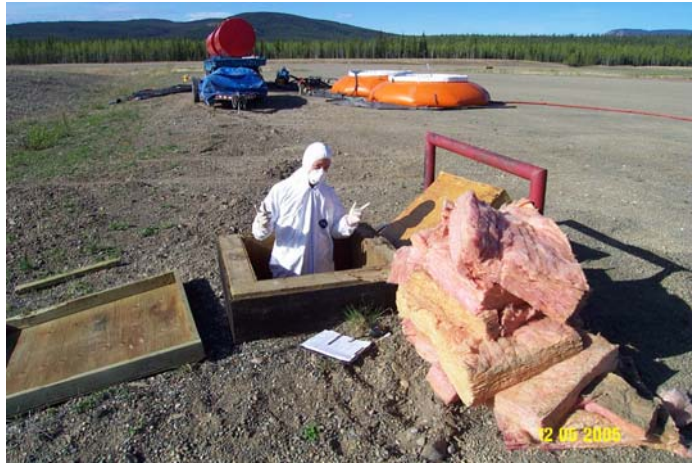
- Septic field at 25 m, which is in contravention of the proposed regulation;
- Aviation fuel drums at 30 m, and
- Fuel storage trailer (at time of inspection) at 20 m.

Photo 0148: 6522 Wellhead Enclosure (pitt, front) and Mobile Aviation Fuel Storage

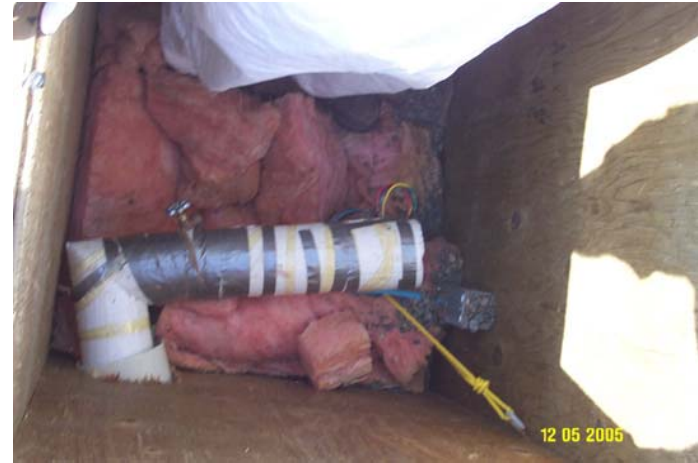
-
- Poor surface completion of the wellhead below ground (in a pit below ground level).
 - By definition of the Draft Yukon GUDI Assessment Guideline, the well is potentially under the direct influence of surface water because it does not meet the requirements of the Guidelines for Water Well Construction.

- i. Is the well head below grade? describe in detail Yes -
- ii. Are there signs of ponding on the enclosure(e.g. water stains, etc.)? Yes No
↳ some moisture evident on PWF @ bottom of enclosure
- iii. Is the wellhead enclosed by fiberglass insulations? Yes No
- iv. Any evidence of rodents? Specify None obvious, but likely accessible
- v. Does the well casing have a proper seal cap? Yes No

If no, describe condition spltd cap w gasket
→ obvious holes

Photo 0149: 6522 Wellhead

THIS INSTALLATION REQUIRES TO BE UPGRADED
TO MEET SPECIFICATIONS. CASING WILL NEED
TO BE EXTENDED TO 18" ABOVE GRADE.
SURFACE SEAL WILL NEED TO BE INSTALLED.

INSTALL SURFACE SEAL
EXTEND CASING ABOVE GROUND.
INSTALL GFI PROTECTION ON HEAT TAPE.
INSTALL MOST SUITABLE TREATMENT SYSTEM.

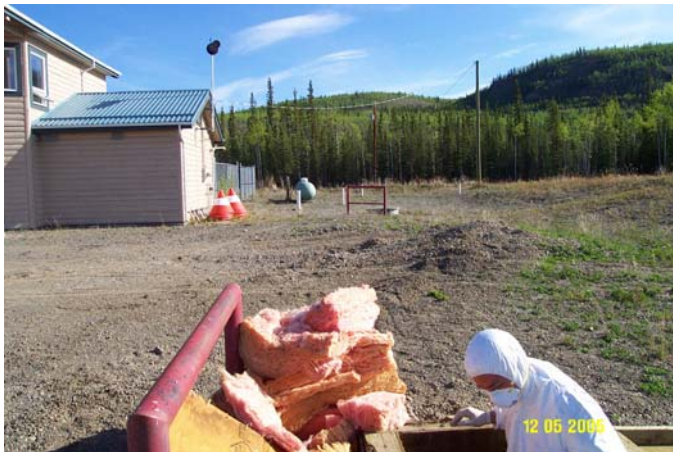
Septic field and tank ~ 22m away

Photo 0150: 6522 Wellhead Enclosure (pitt, front), Carmacks Airport Terminal Building (back left), and Septic Field (back center)

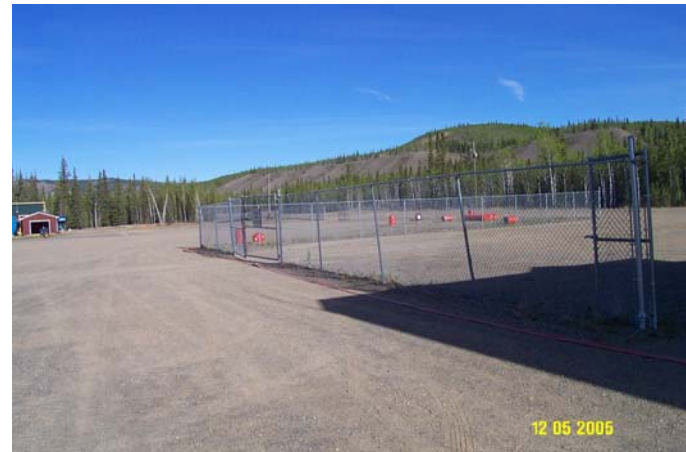
Photo 0153: 6522 Aviation Fuel Drums

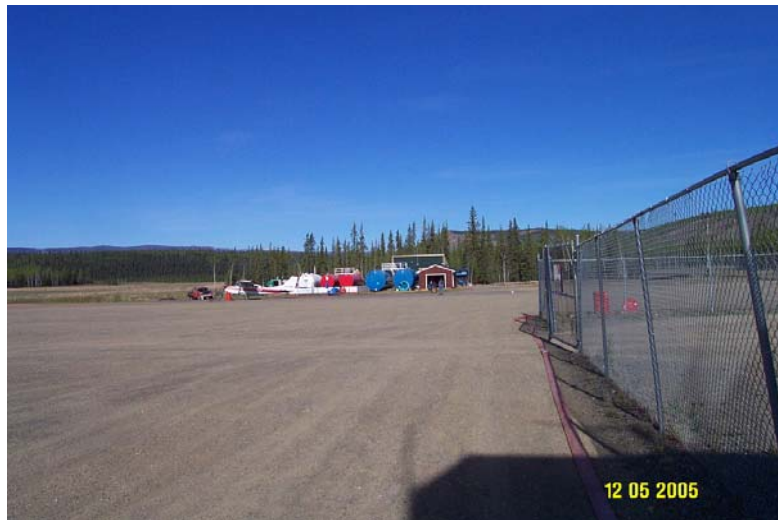
Photo 0151: 6522 Fueling Station

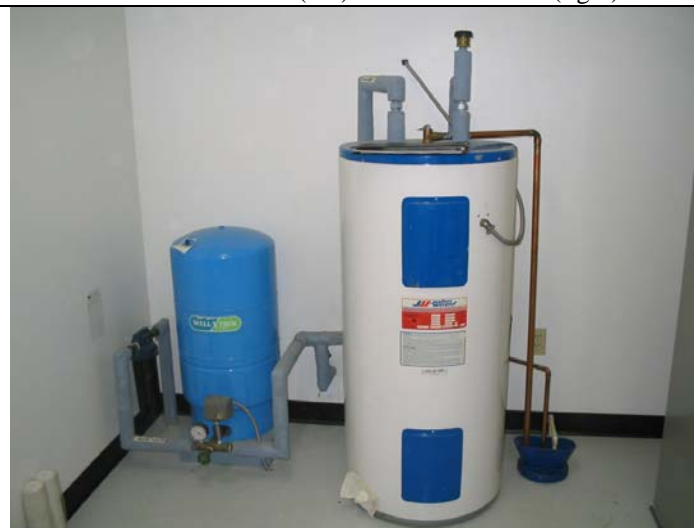
Photo 0018: 6522 Pressure Tank (left) and Water Heater (right)
