7.0 BUILDING 5676: ELIZA VAN BIBBER SCHOOL

SMALL PUBLIC WATER SYSTEMS ASSESSMENT
 NORTHERN REGION

PELLY CROSSING SCHOOL
 BUILDING # 5676
 SITE LOCATION DIAGRAM
 WELL ID: 5676

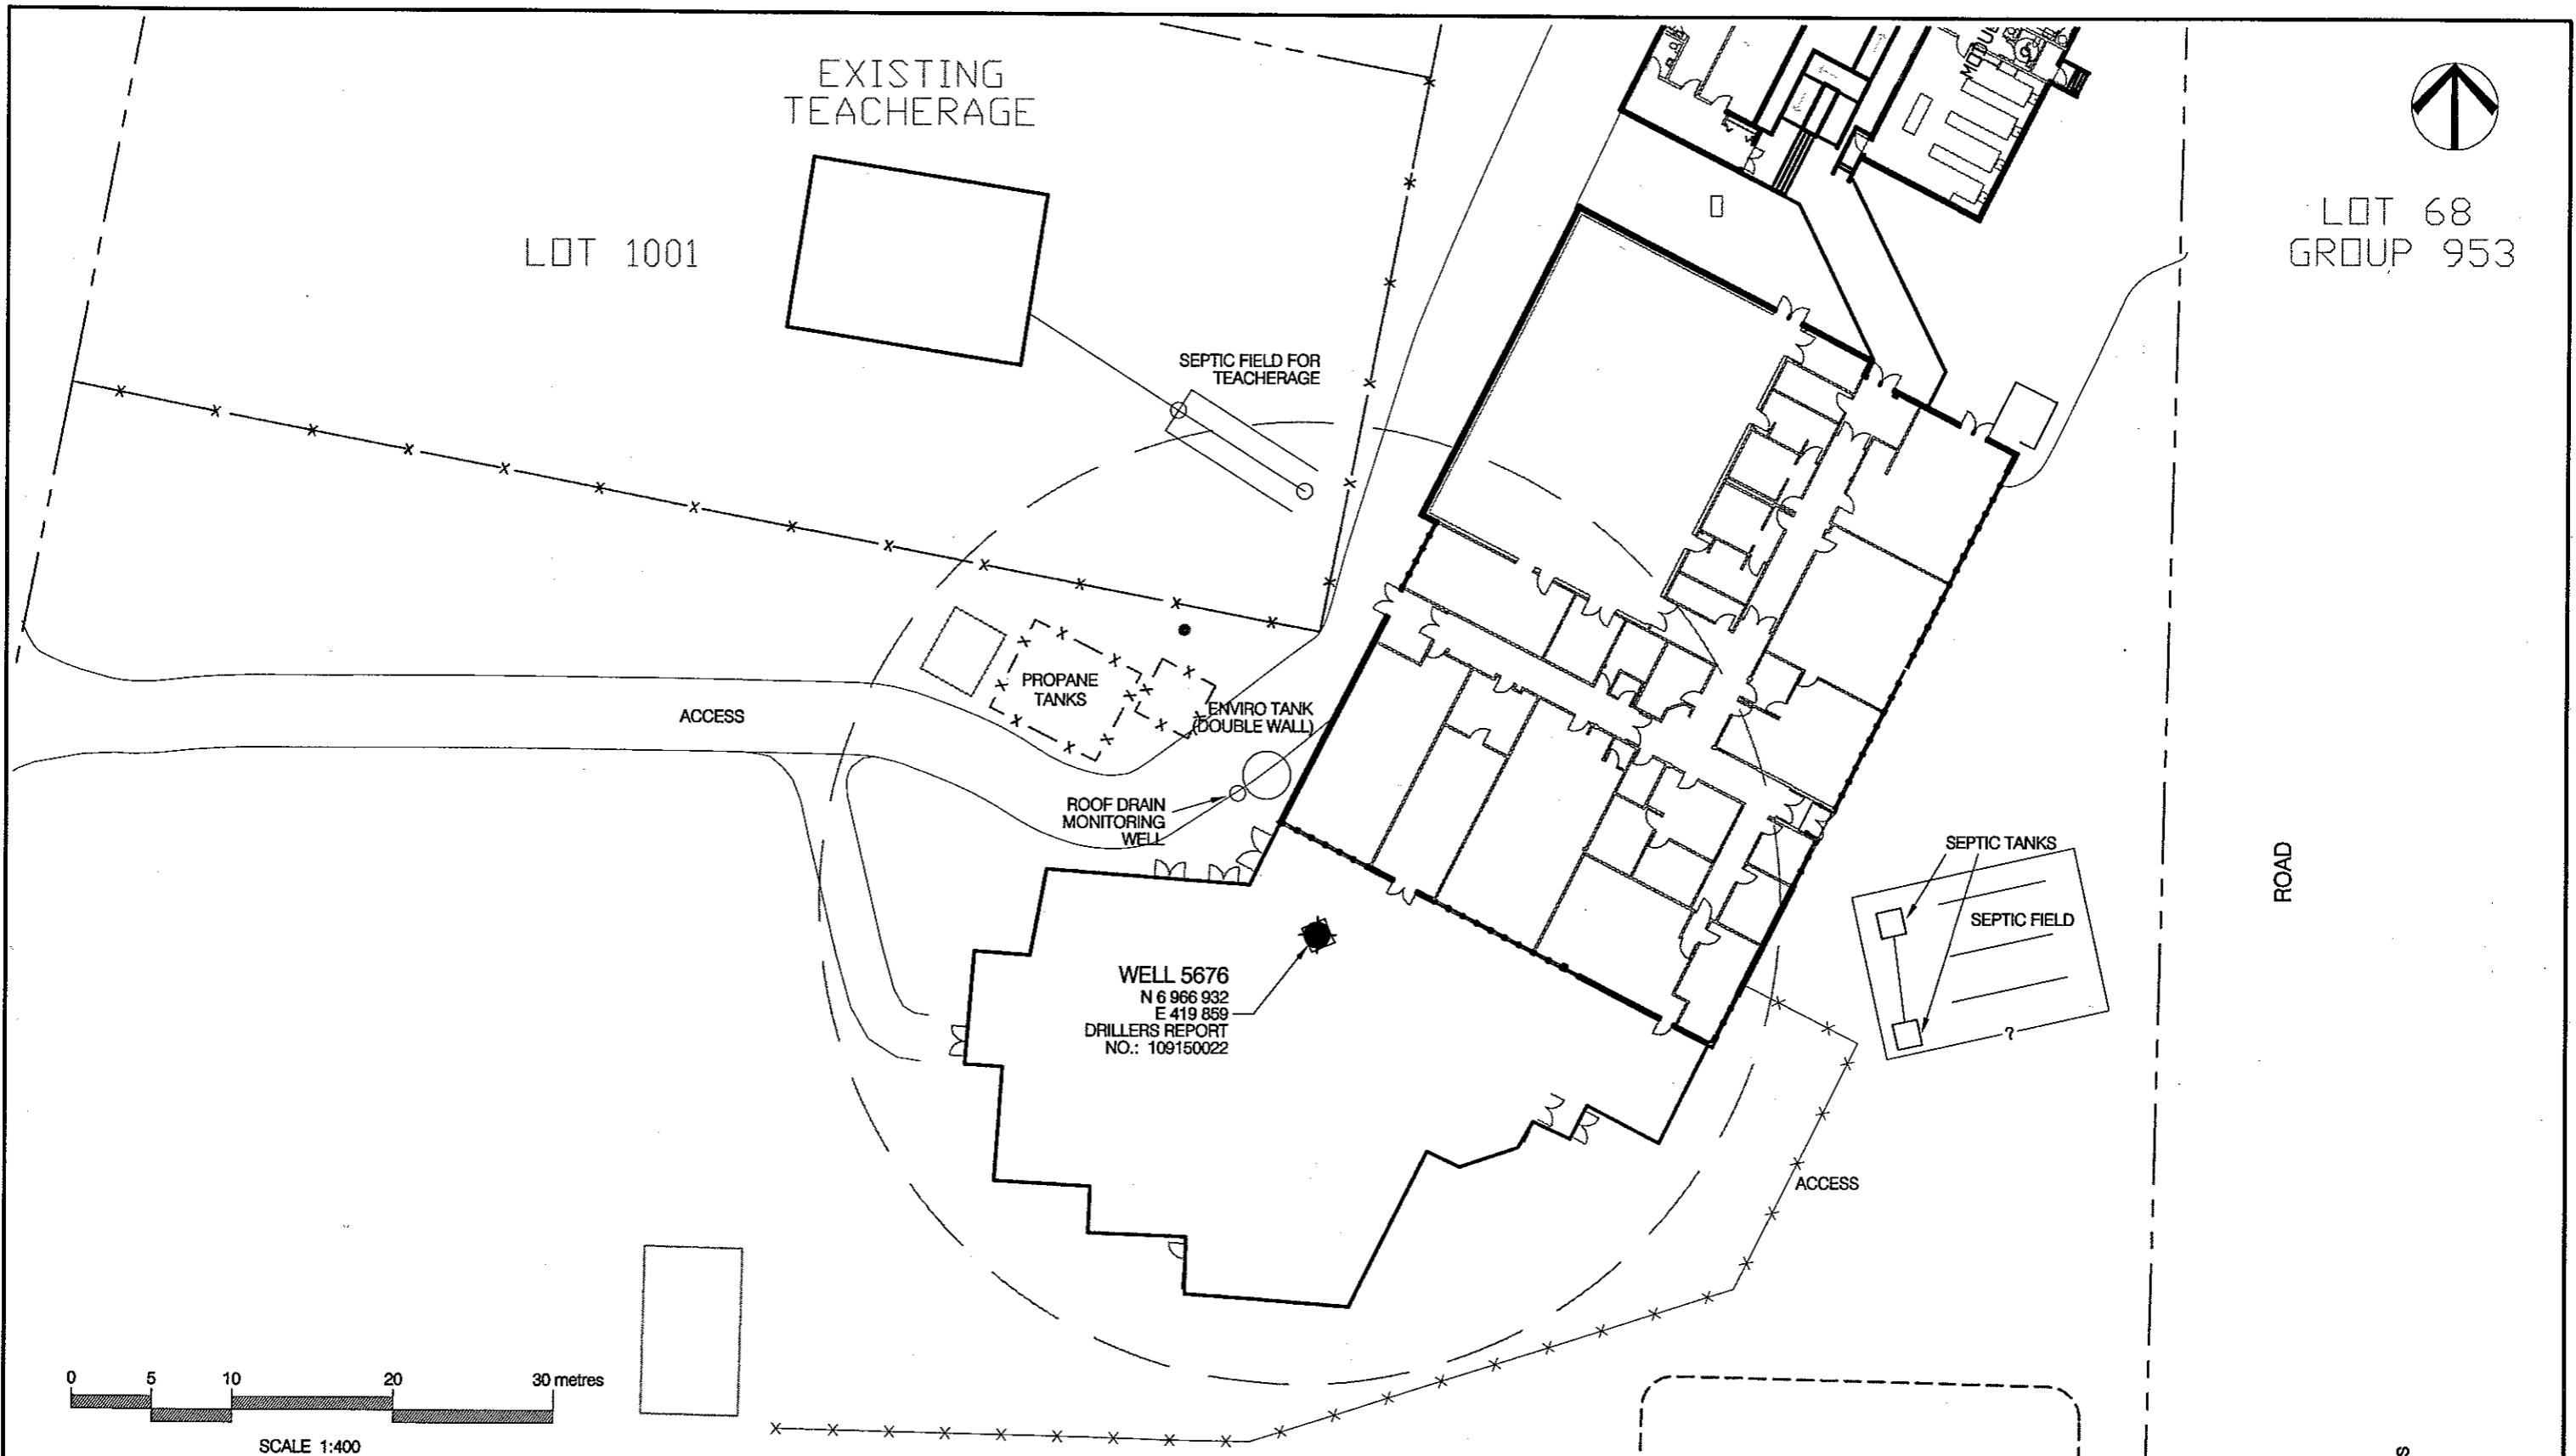
FIGURE No.
 FIGURE 5676-A

The septic system that serves the school is located on the east side of the building. The closest point of a on-site sewage disposal system (septic field) is approximately 35 m east of the well. A site plan showing the septic system is given by Figure 5676-A in Appendix A7.

There is also an on-site sewage disposal system on the adjacent teacherage property (Lot 1001). The in-ground septic disposal is approximately 24 m downgradient from the school's drinking water well, however, since it is less than 30 m from the well, it is contravention of the proposed Regulations.

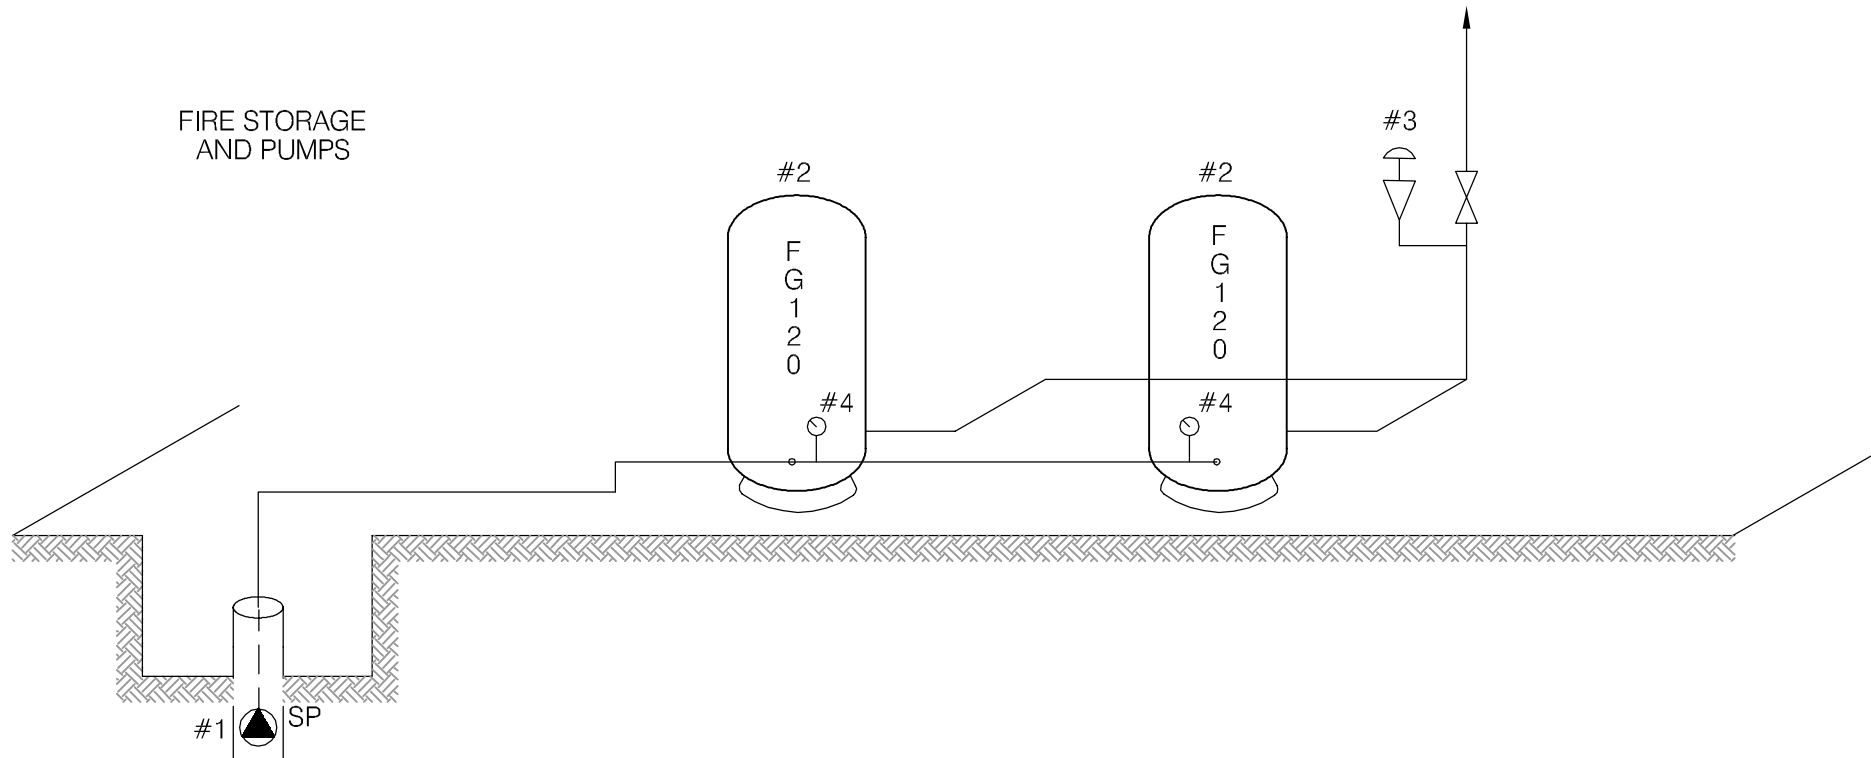
DWG.: FIGURE 5676-B

There is no treatment or disinfection for this system. A schematic detailing the water supply system is provided as Figure 5676-B in Appendix A7. Photos of the well and water system are also included at the back of this appendix.

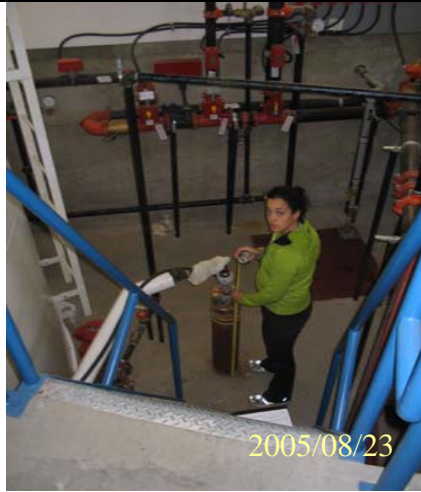
- There is no surface sanitary seal (grout or bentonite seal as required by the Canadian Groundwater Association's Guidelines for Water Well Construction);

- Poor surface completion of the wellhead (does not extend above grade, though it does extend approximately 800 mm above the floor of the school's basement and there is a sump in the basement);
- The well is located within 30 m of an indoor fuel storage tank;
- The manganese concentration has consistently been in exceedence of the CDWQG aesthetic objective; and,
- The iron concentration has previously been in exceedence of the CDWQG aesthetic objective.

Photo 203: 5676 Wellhead.

- The well and water system should be super-chlorinated.
- Disinfection treatment consisting of filtration to 1 micron (absolute), and a proportional feed chlorination system with retention tanks and appurtenances (or equivalent disinfection system) should be installed to ensure disinfection of the water supplied to the school. The benefit of the chlorination system is that it would provide residual capacity within the piped system to inactivate viruses and bacteria. These are conceptual design recommendations based on the information available for planning and budgeting purposes. Engineering input will be required for final system specifications.

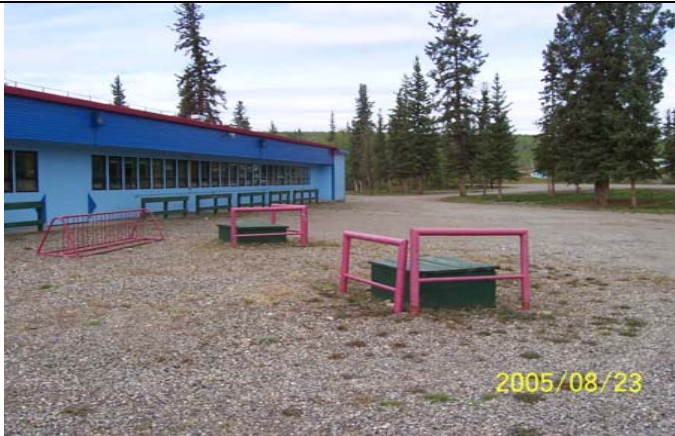
Photo 400: 5676 Eliza Van Bibber School's septic system.
