## **8.0 BUILDING 5678: PELLY CROSSING FIRE HALL**

SMALL PUBLIC WATER SYSTEMS ASSESSMENT  
WESTERN REGION

PELLY CROSSING FIRE HALL  
BUILDING # 5678  
SITE LOCATION DIAGRAM  
WELL ID: 5678

## SMALL PUBLIC WATER SYSTEM ASSESSMENT

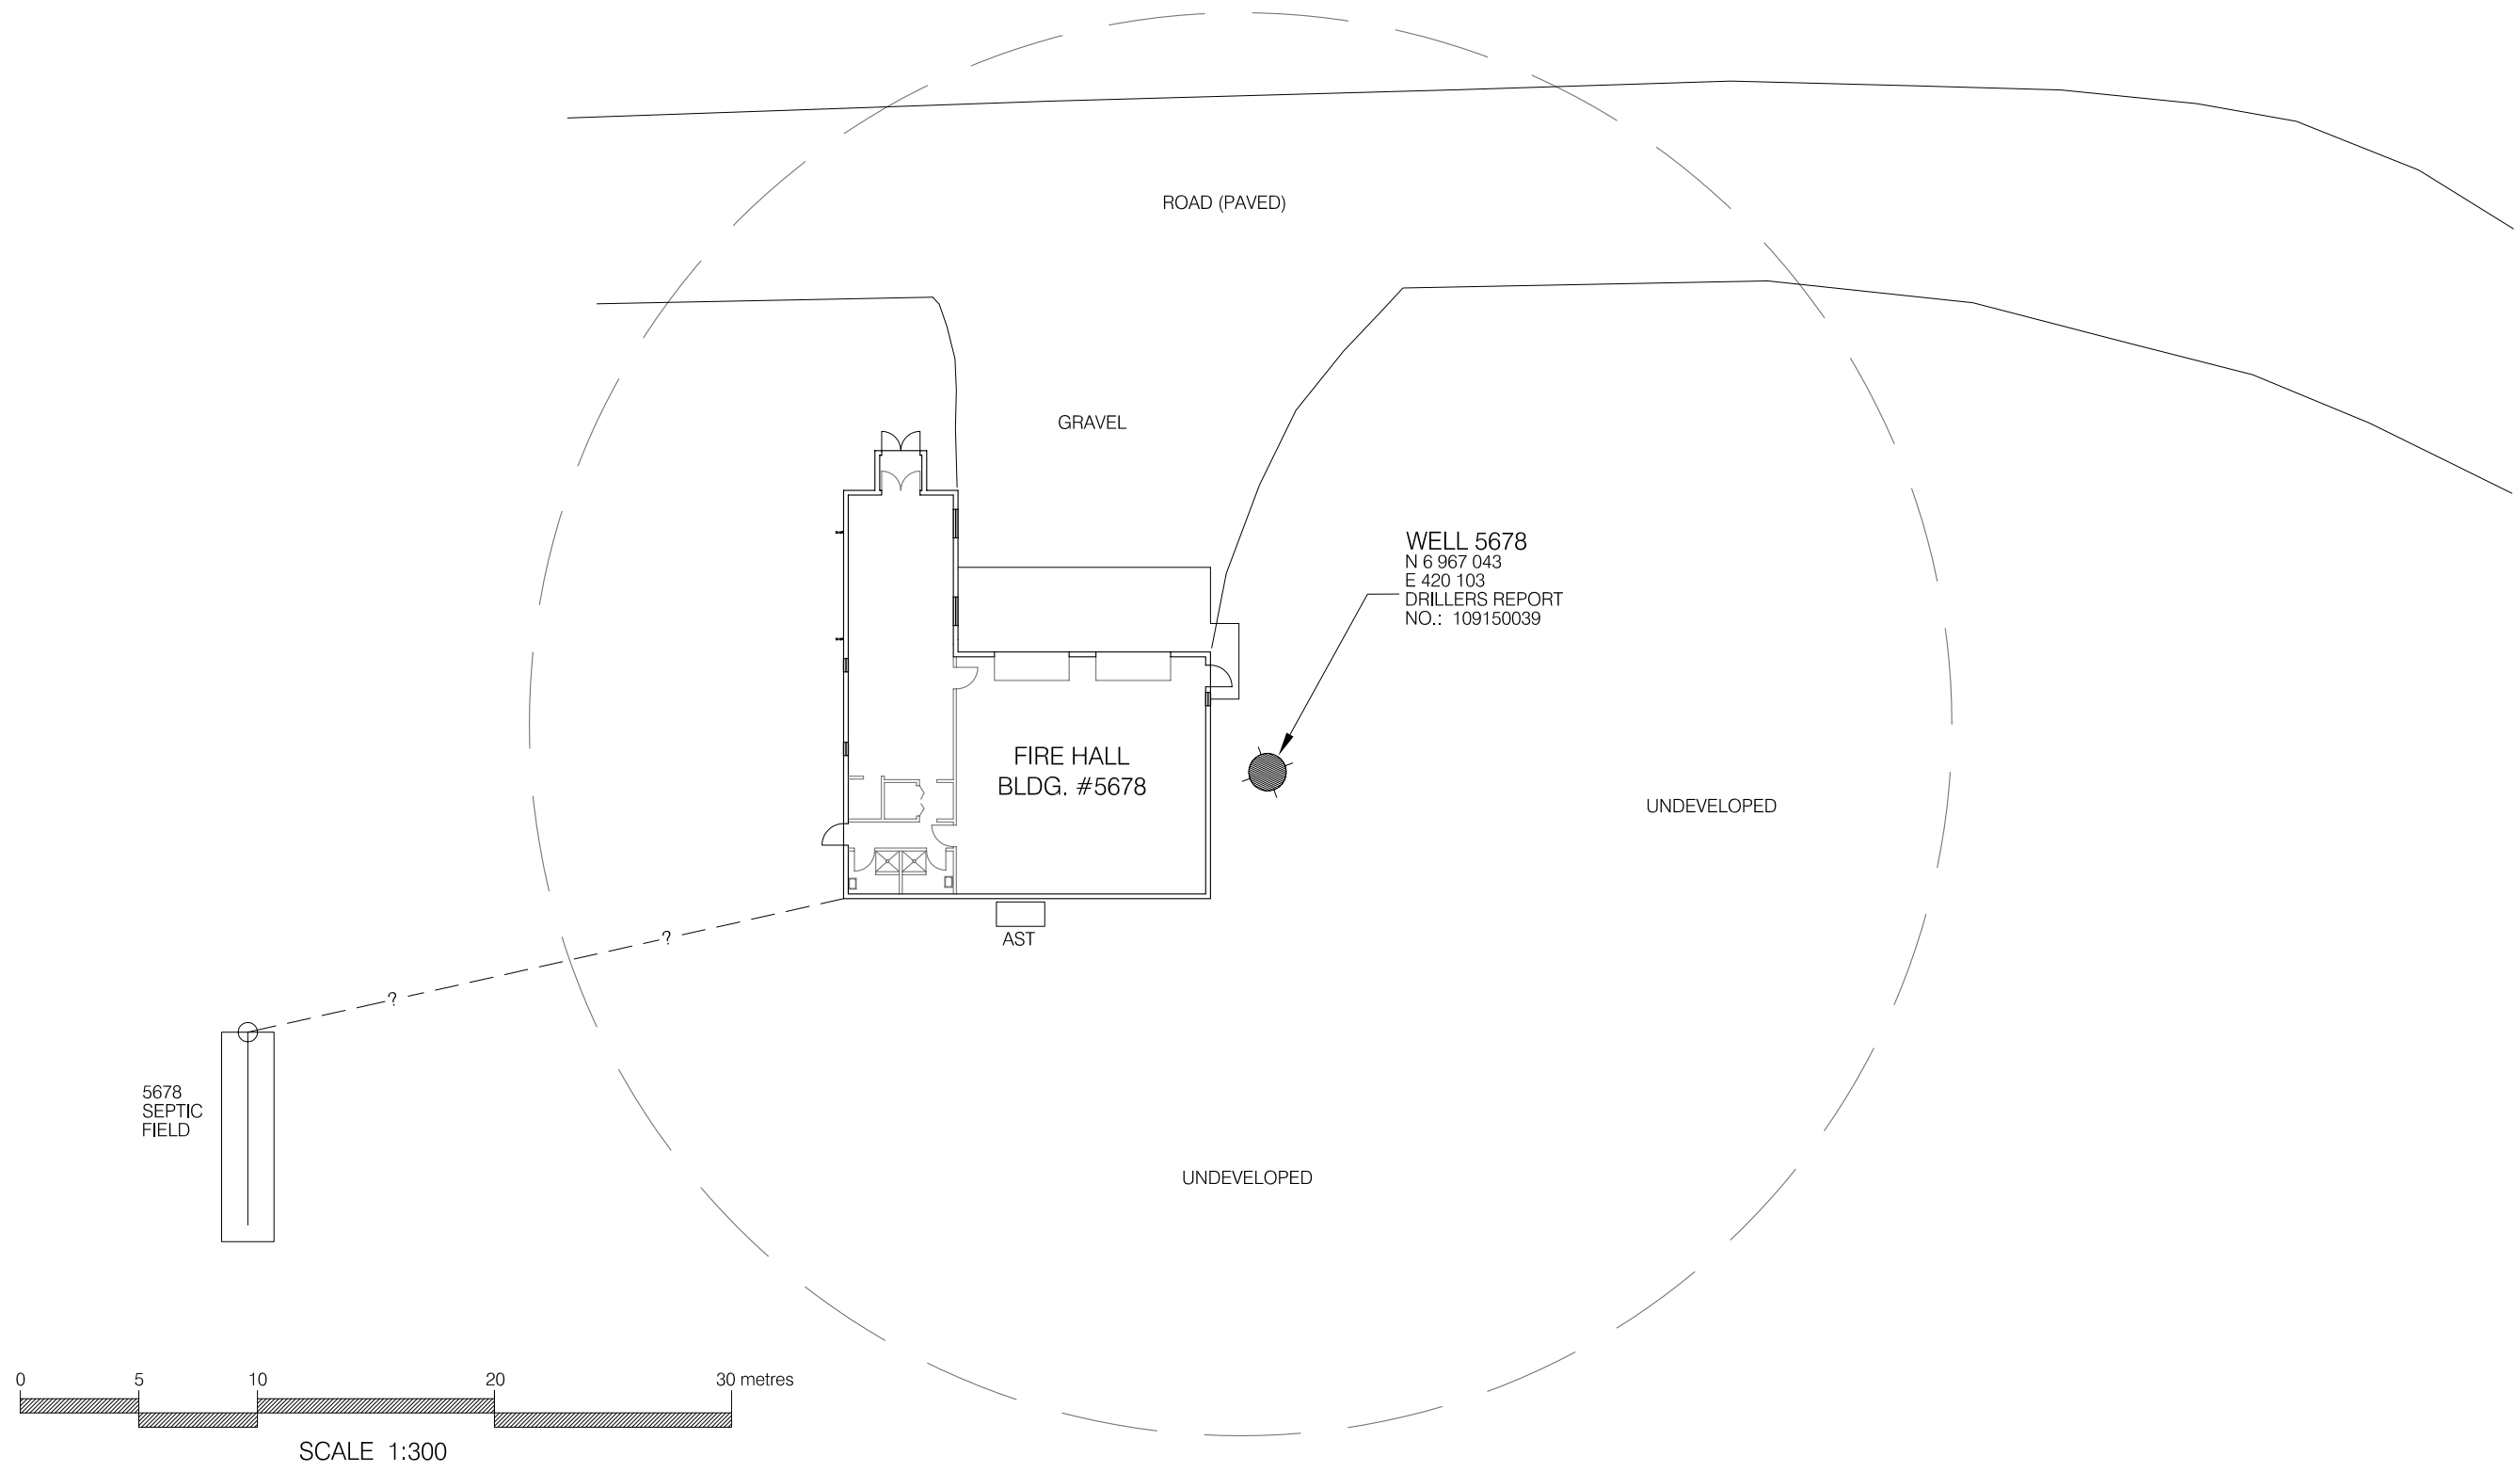
FIGURE No.  
FIGURE 5678-A

There is an on-site sewage disposal system located off of the northwest corner of the building approximately 40 m from the well as indicated on Figure 5678-A.

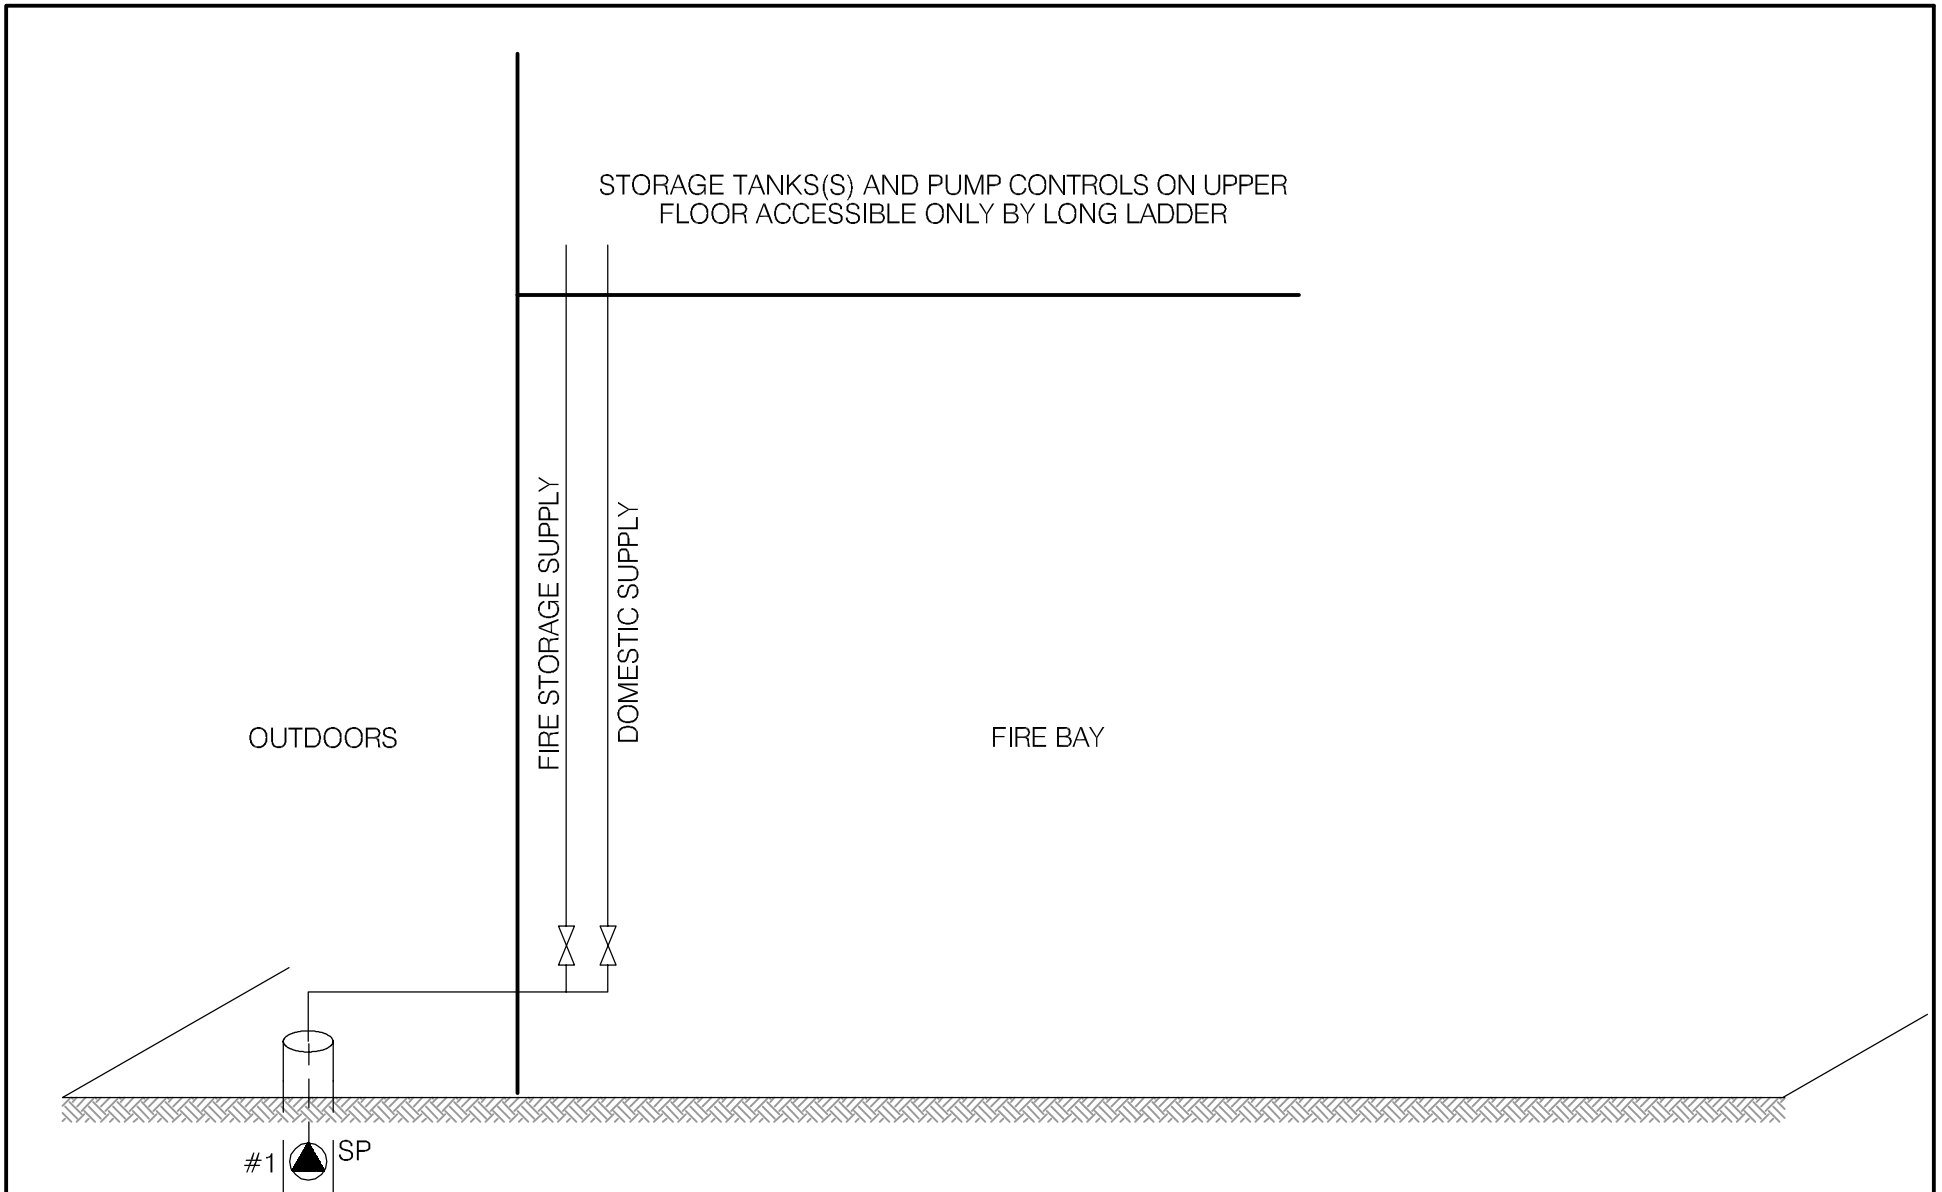
TITLE WATER SYSTEM DISTRIBUTION/TREATMENT SCHEMATIC SYSTEM ID.: 5678 PELLY CROSSING FIRE HALL							
DATE	SEPT. 2005	DWN.	JSB	CHKD.	RMM	FILE NO.	1260002.004	DWG.:	FIGURE 5678-B

Item	Description	Manufacturer	Model	Part No.	Serial No.	Size
1	Sub Pump	GRUNDFOS	16507-8			4" - 3/4 Ho.
2	Pressure Tank	NOT ACCESSIBLE				
3	WATER STORAGE TANK	NOT ACCESSIBLE				
4	Pump Controls	NOT ACCESSIBLE.				
5						
6						
7						
8						
9						
10

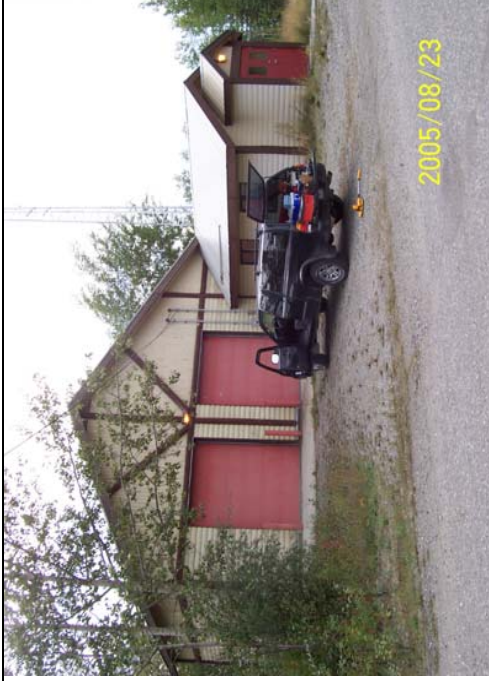
**Photo 405:** 5678 Pelly Crossing Fire hall. (looking west)

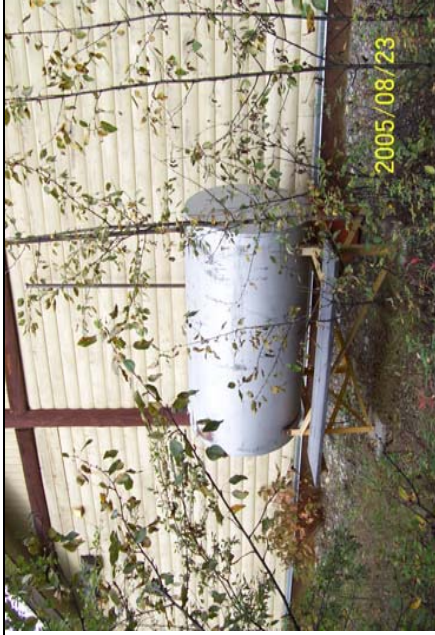
Aside from an above ground storage tank which is located approximately 14 m from the well, no other potential contaminant sources within 30 m of the well were identified during the water system assessment.

**Photo 403:** 5678 On site AST on west side of building.

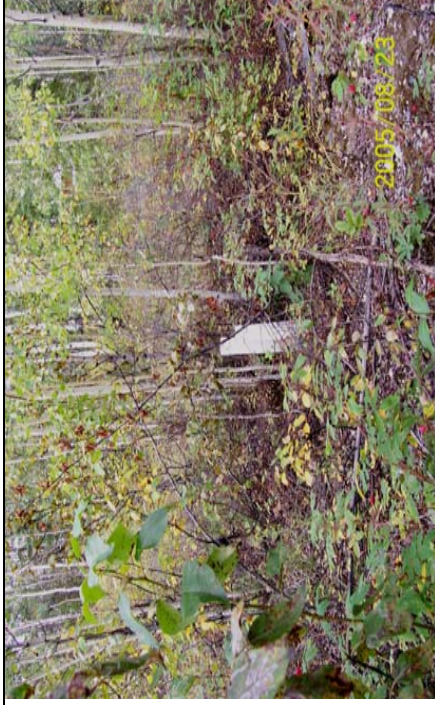
**Photo 406:** 5678 Septic system.
