6.0 BUILDING 5672: PELLY CROSSING SWIMMING POOL

SMALL PUBLIC WATER SYSTEM ASSESSMENT

PART A: EBA Site Inspection

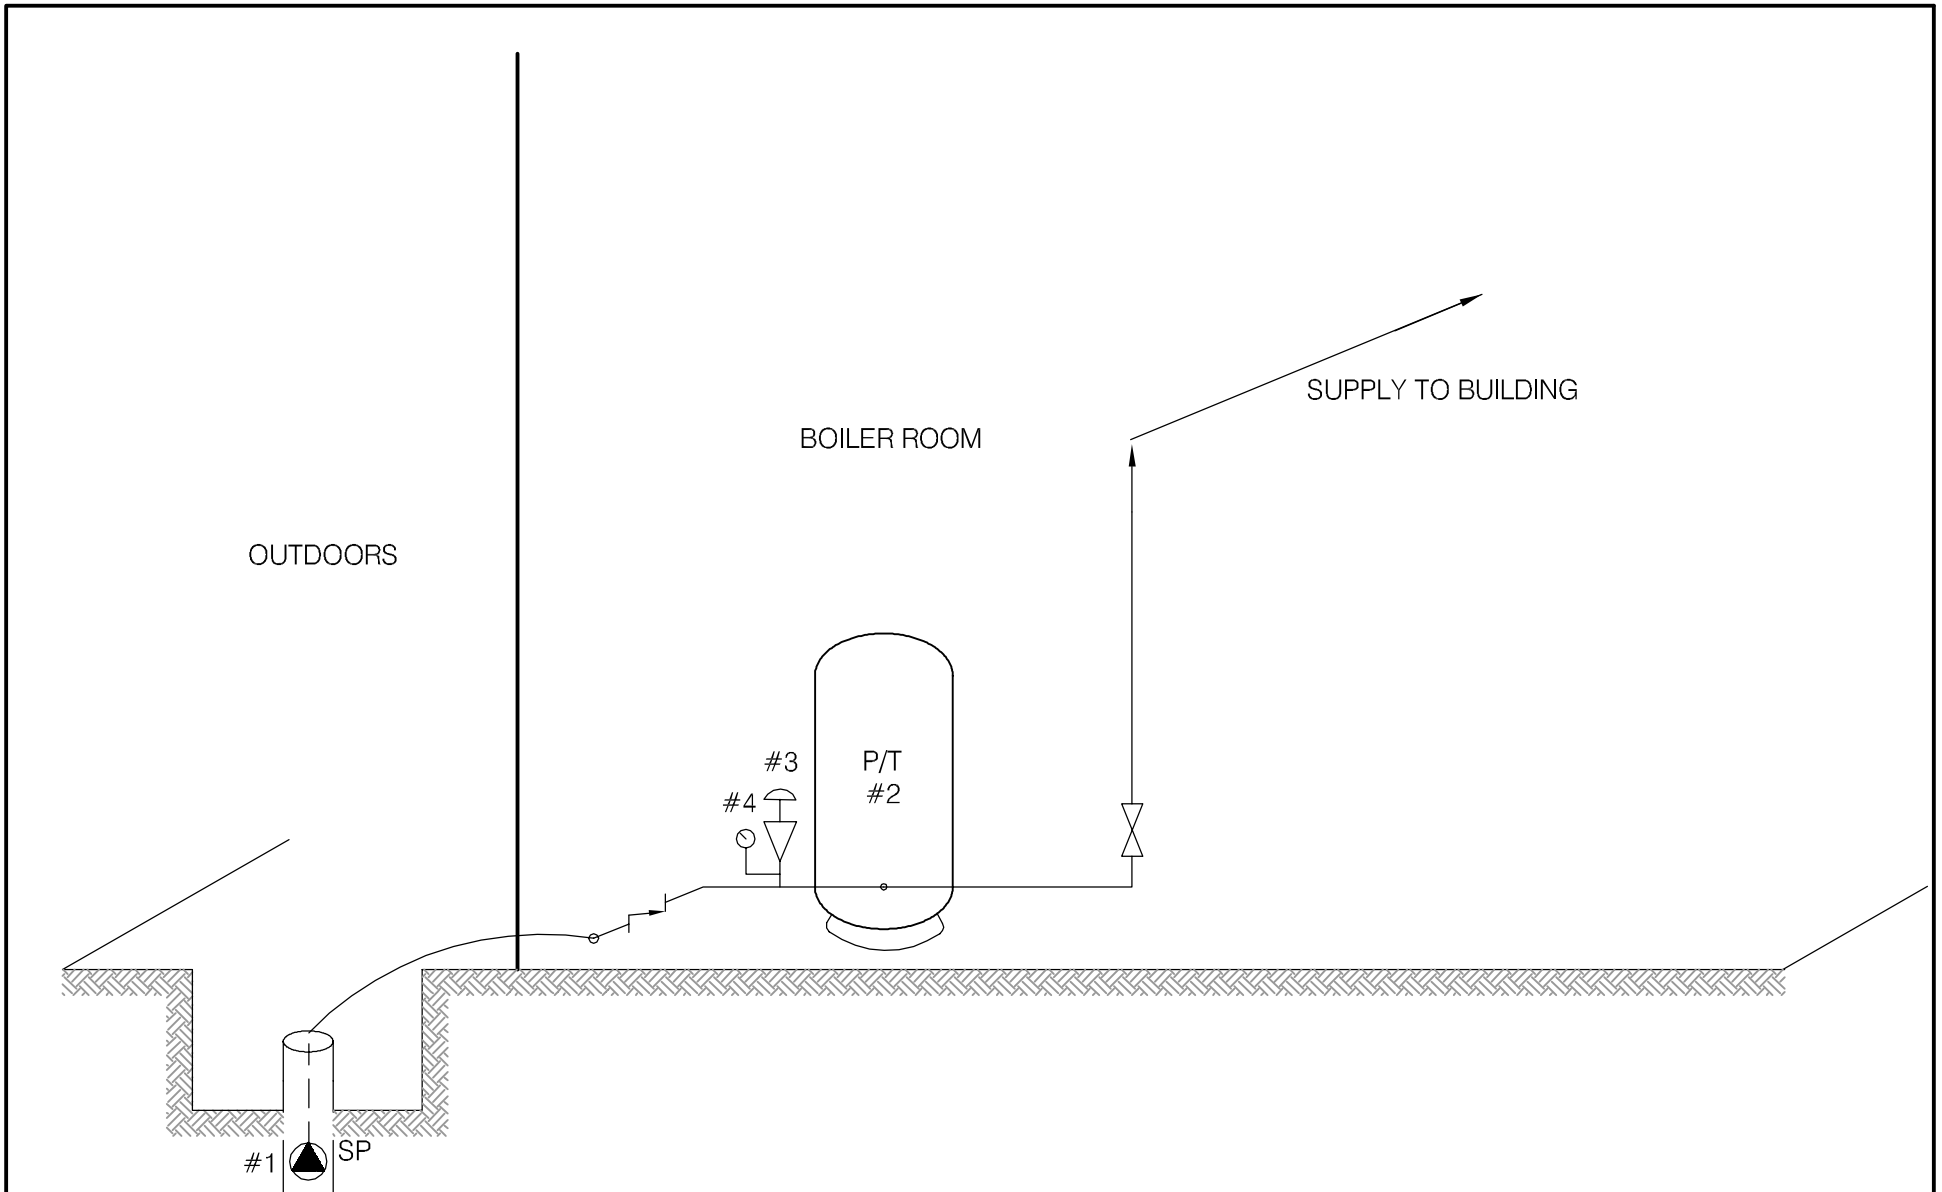
TITLE WATER SYSTEM DISTRIBUTION/TREATMENT SCHEMATIC SYSTEM ID.: 5672 PELLY CROSSING SWIMMING POOL							
DATE	SEPT. 2005	DWN.	JSB	CHKD.	RMM	FILE NO.	1260002.004	DWG.:	FIGURE 5672-B

The water system is not equipped with any treatment or disinfection. A schematic detailing the water system is provided as Figure 5672-B in Appendix A6. Photos of the well and water system are also included at the back of this appendix.

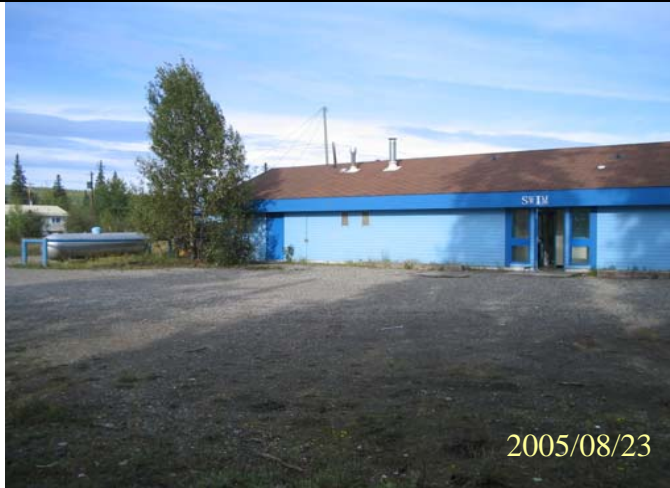
Photo 208: 5672 Pelly Crossing swimming pool. (northeast)

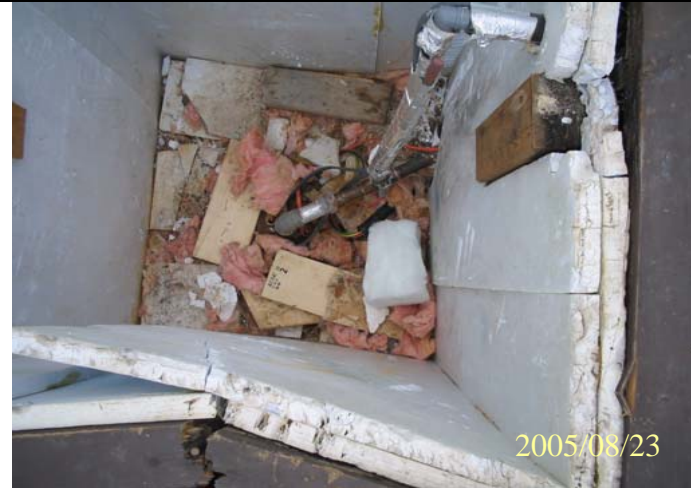
- Well head construction is inadequate (located in a pit below grade, wellhead enclosure is damaged);
- There is no surface sanitary seal (grout or bentonite seal as required by the Canadian Groundwater Association's Guidelines for Water Well Construction);

- i. Is the well head below grade? describe in detail Yes.
- ii. Are there signs of ponding on the enclosure(e.g. water stains, etc.)? Yes No
- iii. Is the wellhead enclosed by fiberglass insulations? Yes No
- iv. Any evidence of rodents? Specify No
- v. Does the well casing have a proper seal cap? Yes No

If no, describe condition split gasket cap.

Photo 209: 5672 Well enclosure and wellhead.

- The casing should be extended to at least 500 mm above the base of the well pit, and a localized near surface bentonite seal should be installed immediately around the wellhead.
- The well and water system should be super-chlorinated.

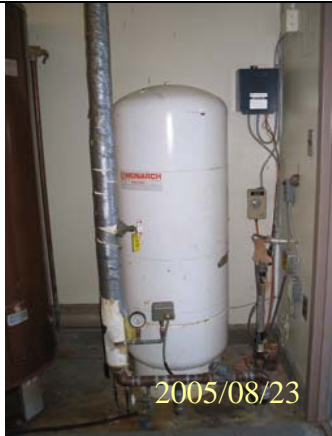
THIS INSTALLATION REQUIRES UPGRADING
THE TEMPORARY LINE IS EXPOSED ABOVE
GROUND

Photo 208: 5672 Water system. (pump controls, pressure tank)

REPAIR PIPING SYSTEM. INSTALL
WATER TREATMENT AS REQUIRED BY
WATER ANALYSIS.
INSTALL PROPORTIONAL CHLORINATION
SYSTEM

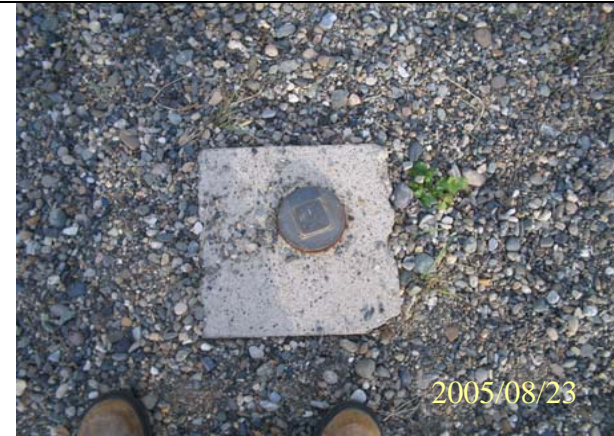
The septic system could not be located during the water system assessment, but likely exists to the west of the building. Two potential septic clean-outs were observed near each corner of the west side of the building as indicated on Figure 5672-A. The exact type (in-ground disposal, or sewage eduction tank) and location of the septic system relative to the well should be confirmed.

Photo 214: 5672 Potential septic clean out?

An attempt should be made to locate the well log for this well, and to identify the location and construction of the septic system.
