12.0 BUILDING 3122: BEAVER CREEK SWIMMING POOL

SMALL PUBLIC WATER SYSTEMS ASSESSMENT
 WESTERN REGION

BEAVER CREEK SWIMMING POOL
 BUILDING # 3122
 SITE LOCATION DIAGRAM
 WELL ID: 3122

SMALL PUBLIC WATER SYSTEM ASSESSMENT

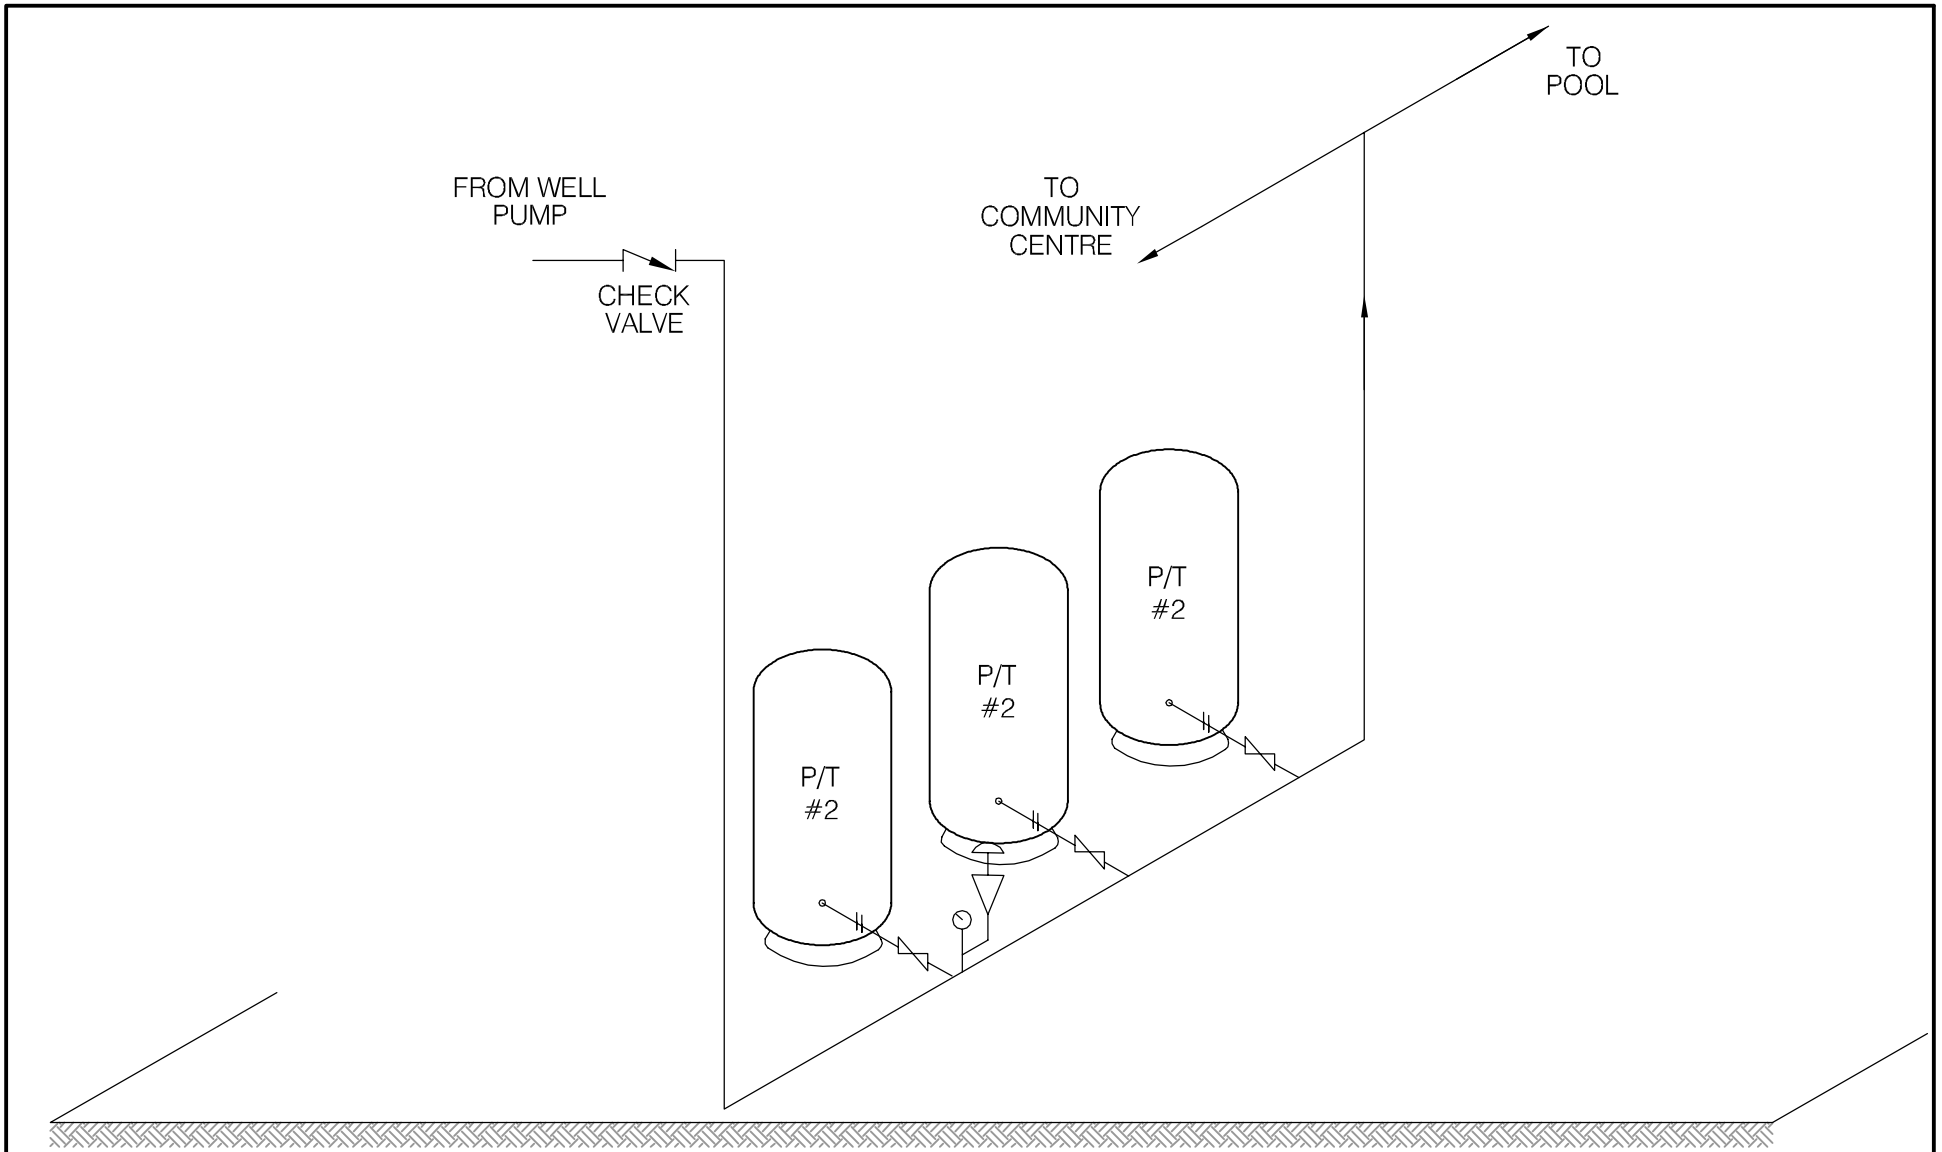
TITLE WATER SYSTEM DISTRIBUTION/TREATMENT SCHEMATIC SYSTEM ID.: 3122 BEAVER CREEK SWIMMING POOL							
DATE	SEPT. 2005	DWN.	JSB	CHKD.	RMM	FILE NO.	1260002.003	DWG.:	FIGURE 3122-B

There is no treatment or disinfection system for the water supplying this system. A schematic detailing the well supply system is provided as Figure 3122-B in Appendix A12.

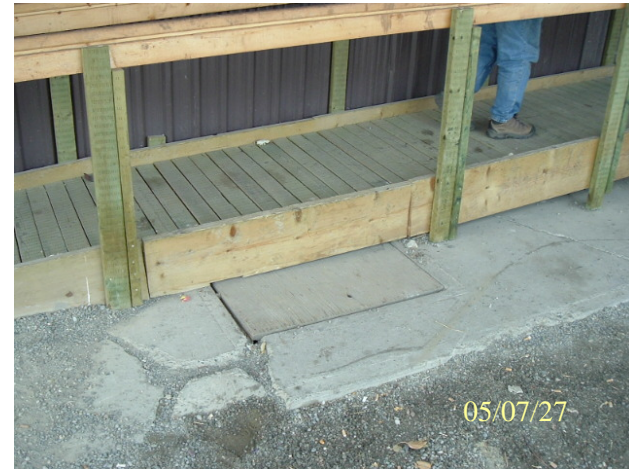
Photo 0537: 3122 Wellhead enclosure under wheelchair ramp

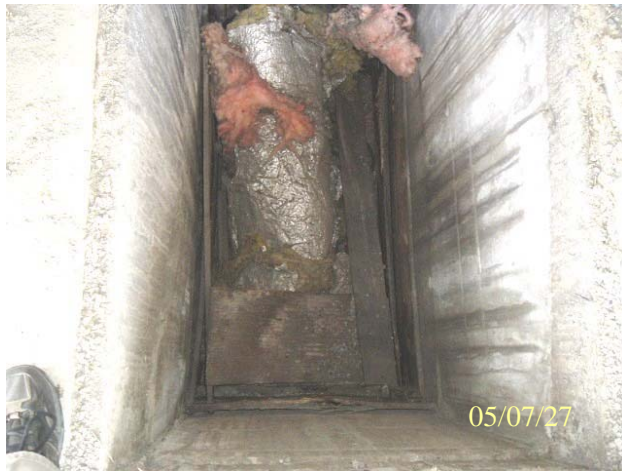
- Poor surface completion of the wellhead (located in a pit below grade);
- There is no surface sanitary seal (grout or bentonite seal) as required by the Canadian Groundwater Association's Guidelines for Water Well Construction;
- By definition of the Draft Yukon GUDI Assessment Guideline, the well is potentially under the direct influence of surface water because it does not meet the requirements of the Guidelines for Water Well Construction.
- The well is located within 30 m of potential sources of contamination, including an above ground fuel storage tank at 20 m and a septic discharge field at 22 m, both of which are upgradient from the well; and,
- There is no treatment or disinfection system present.

Photo 0535: 3122 Wellhead in pit

- The casing should be extended to at least 500 mm above the base of the well pit, and a localized near surface bentonite seal installed immediately around the wellhead, while leaving the remainder of the base of the well pit for drainage.
- The well and water system should be superchlorinated.
- Disinfection treatment consisting of filtration to 1 micron absolute, and a proportional feed chlorination system with retention tanks and necessary appurtenances should be installed. These are conceptual design recommendations based on the information available for planning and budgeting purposes. Engineering input will be required for final system specifications.

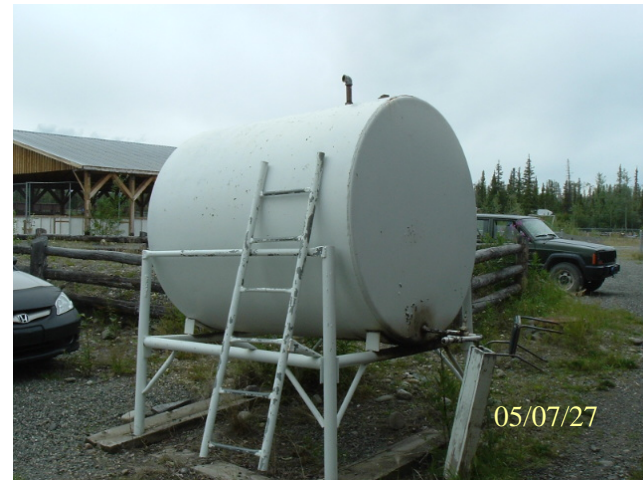
- An above ground fuel storage tank (AST) at 20 m; and
- A septic field located at 22 m.

Photo 0539: 3122 Above ground fuel storage tank

- The well must be located at a distance greater than 30 m from any potential source of contamination, including the AST and all parts of the septic system; and

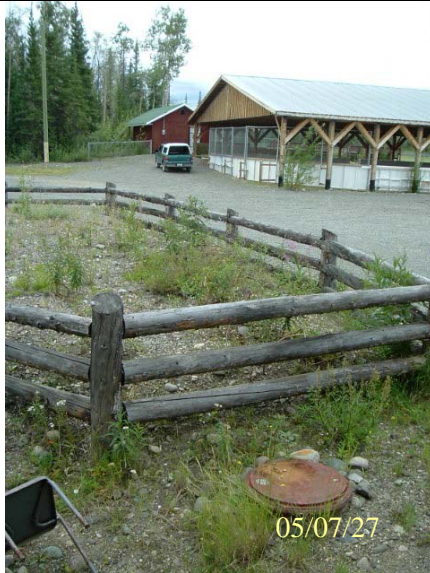
The septic tank that serves the community club is located south of the building approximately 20 m from the well and the effluent field is located to the south of the tank approximately 22 m from the well. The septic tank that serves the swimming pool is located to the east of the building and effluent is discharged in a septic field to the south of the tank. The swimming pool septic system is approximately 50 m from and likely downgradient from the well, but the community club septic system is likely up or cross gradient from the well. A site plan showing the septic systems is given by Figure 3122-A in Appendix A12.

Photo 0540: 3122 Community Club septic field

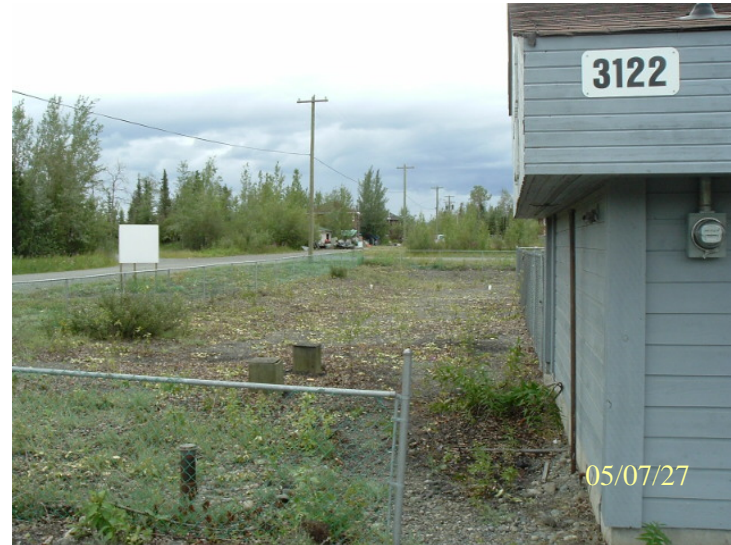
Photo 0542: 3122 Swimming pool septic field

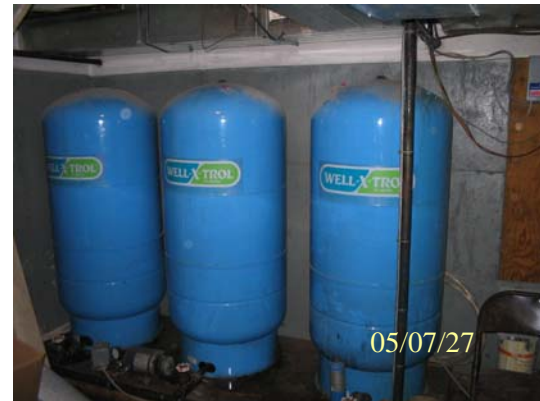
- The copper concentration is elevated above normal background concentrations for the Beaver Creek area, and may signify leaching from copper pipes; and,
- It was observed during the water system assessment that two of the pressure tanks are leaking slightly.

THIS IS A PROFESSIONAL BUT OLD INSTALLATIONS. 2 OF THE TANKS HAVE SLIGHT LEAKS. THE PUMP IS VERY NOISY AND RUNS FOR A LONG TIME. IT IS WORTH NOTING THAT THIS SYSTEM HAD EARLIER BEEN SERVED BY A 2 HP SUB. PUMP. IT NOW HAS ONLY A 3/4 HP PUMP.

Photo 0087: 3122 Pressure tanks in crawl space of Community Club

- Copper concentrations should be monitored as part of routine operation and maintenance.
- The pressure tanks should be replaced with an adequately sized bladder pressure tank during Phase 2 upgrades.

REPAIR THE LEAKS. BRING INSTALLATION BACK UP TO CODE IE INSULATE THE COPPER LINES AS THEY ARE SWEATING ~~HEAVY~~ HEAVY AT THIS POINT. INSTALL TREATMENT AS DETERMINED BY THE WATER ANALYSIS TO SUIT UV TREATMENT. INSTALL APPROPRIATE UV FOR FLOW REQUIREMENT. INSTITUTE AN ANNUAL WELL MAINTENANCE PROGRAM.
