11.0 BUILDING 3121: BEAVER CREEK VISITOR RECEPTION CENTRE

SMALL PUBLIC WATER SYSTEMS ASSESSMENT
 WESTERN REGION

BEAVER CREEK VISITOR RECEPTION
 CENTRE BUILDING # 3121
 SITE LOCATION DIAGRAM
 WELL ID: 3121

SMALL PUBLIC WATER SYSTEM ASSESSMENT

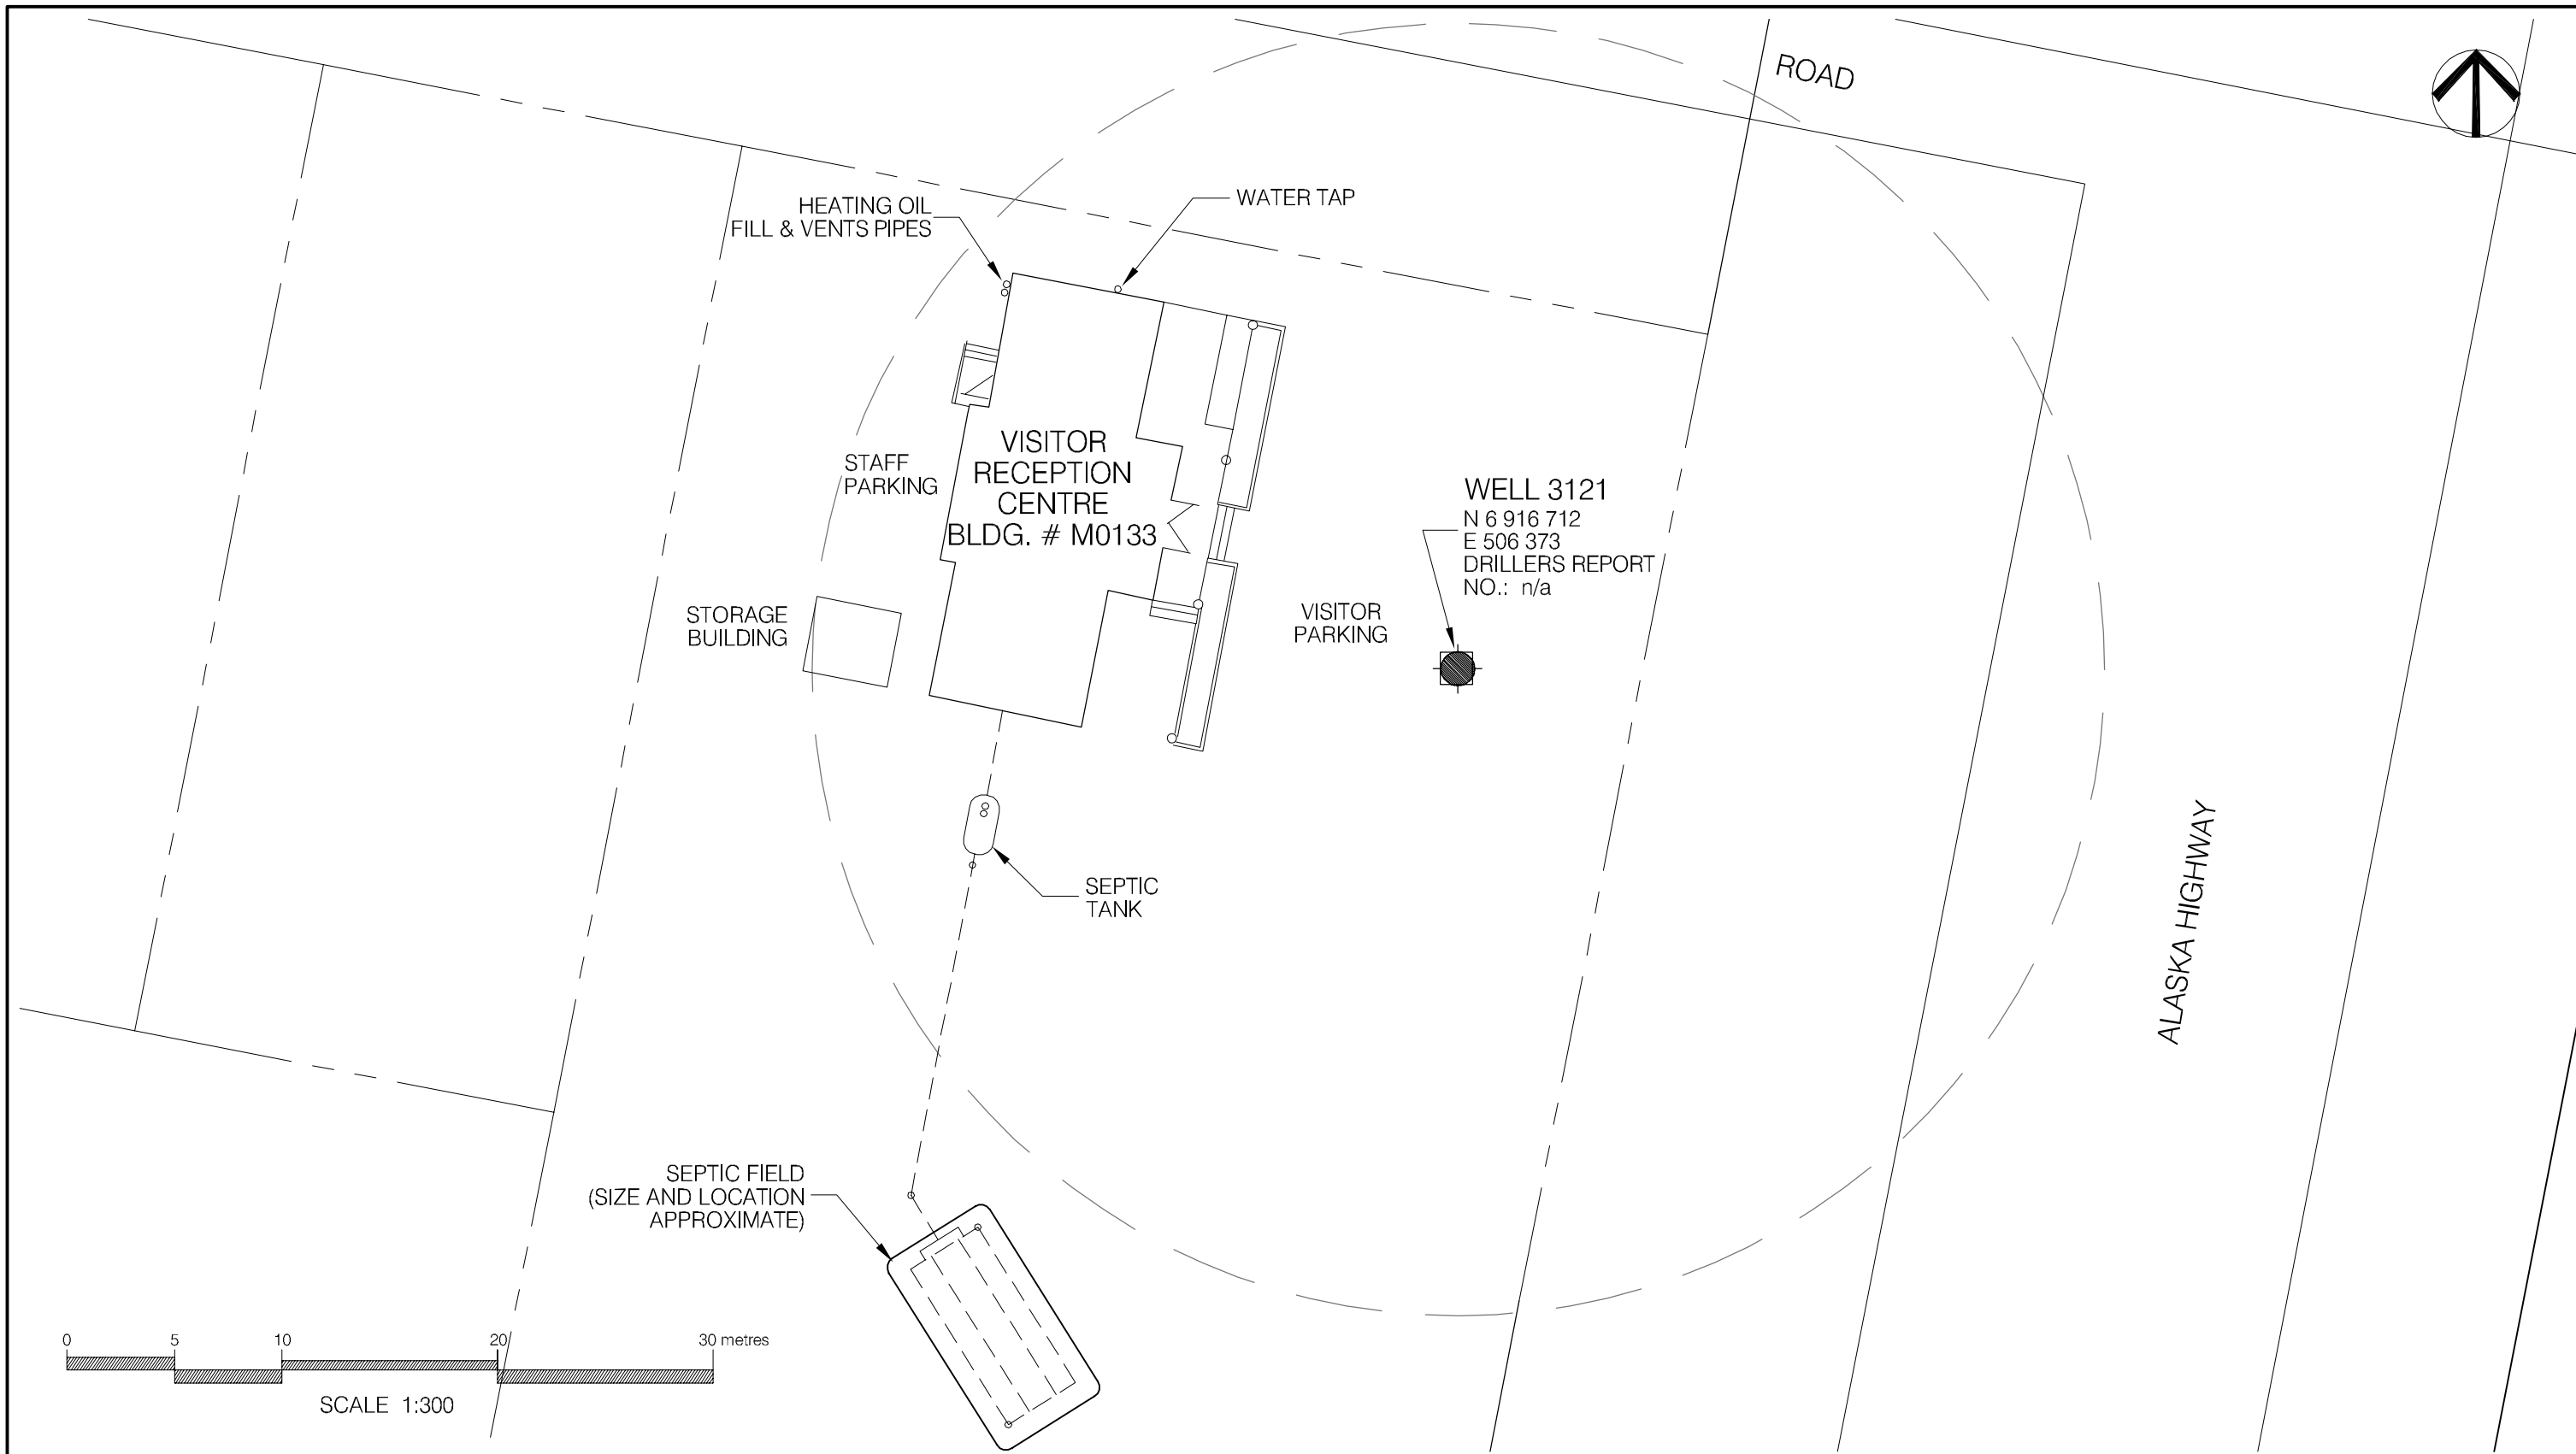
REVISION	ISSUE
	0
FIGURE No.	FIGURE 3121-A

There is a septic tank located south of the VRC approximately 18 m from the well. Septic effluent is discharged to ground via a septic field to the south of the tank approximately 33 m from the well. Conceptual hydrogeology (outlined in Section 10.4) indicates that the septic system is likely upgradient from the well. A site plan showing the septic system is given by Figure 3121-A in Appendix A11.

30 m RADIUS FROM WATER WELL FOR CONSIDERATION OF PROXIMITY TO POTENTIAL CONTAMINANT SOURCES.

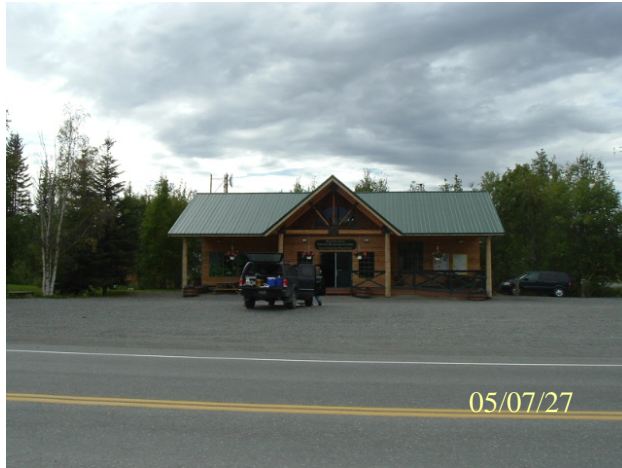
Photo 0562: 3121 Beaver Creek Visitor Reception Centre looking east

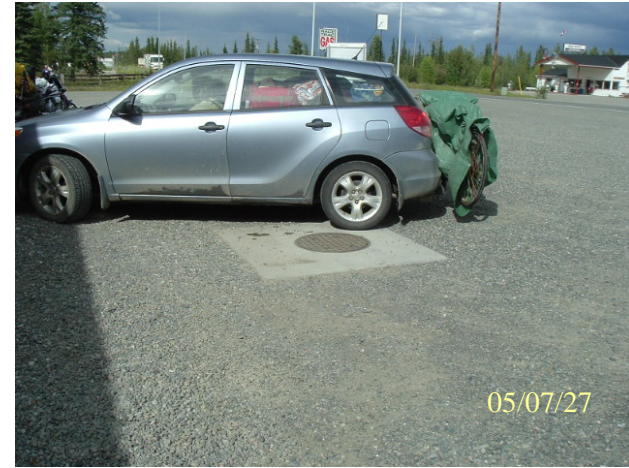
- Poor surface completion of the wellhead (located in a pit below grade);
- Poor location of the well (located in the reception centre parking lot where it may be subject to fuel and sewage spills from automobiles and recreational vehicles);

- The well is located within 30 m of potential sources of contamination, including an above ground fuel storage tank at 19 m and an active parking lot;

Photo 0559: 3121 Wellhead enclosure in parking lot

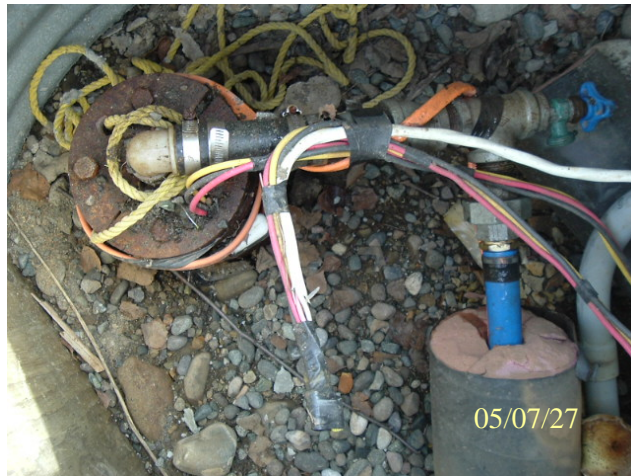
- There is no surface sanitary seal (grout or bentonite seal as required by the Canadian Groundwater Association's Guidelines for Water Well Construction);

- i. Is the well head below grade? describe in detail ~0.45m below grade
- ii. Are there signs of ponding on the enclosure(e.g. water stains, etc.)? Yes No
- iii. Is the wellhead enclosed by fiberglass insulations? Yes No
- iv. Any evidence of rodents? Specify No
- v. Does the well casing have a proper seal cap? Yes No

If no, describe condition split gasket cap

Photo 0561: 3121 Wellhead in pit

- The casing should be extended to at least 500 mm above the base of the well pit, and a localized near surface bentonite seal installed immediately around the wellhead, while leaving the remainder of the base of the well pit for drainage;
- The well and water system should be superchlorinated; and
- A disinfection treatment consisting of filtration to 1 micron absolute, and a UV system that is NSF/ANSI certified should be installed. Pretreatment (softening) will likely be required. This is a conceptual design recommendations based on the information available for planning and budgeting purposes. Engineering input will be required for final system specifications.

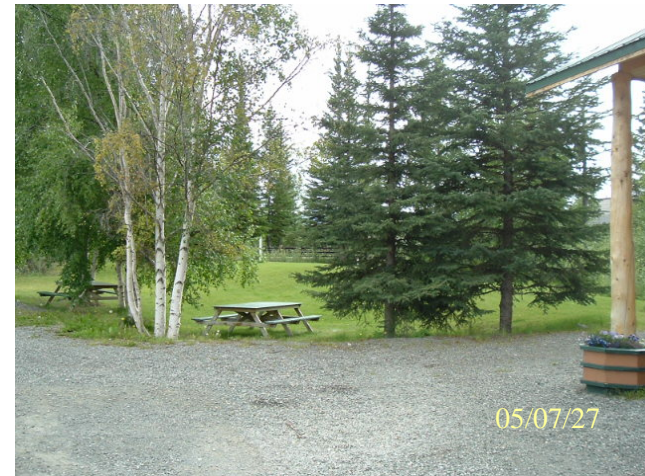
- The septic system for the visitor reception centre is located upgradient from the well. The nearest point of the effluent discharge field is 33 m upgradient;

Photo 0563: 3121 Septic field at rear to south of building

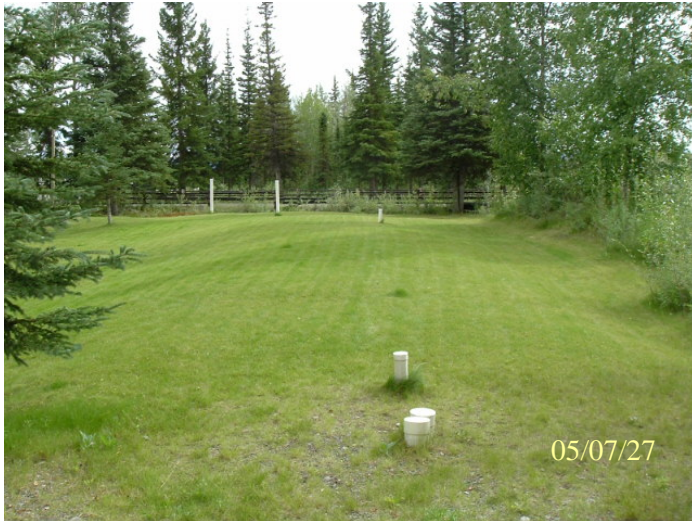
Photo 0564: 3121 Septic field looking south

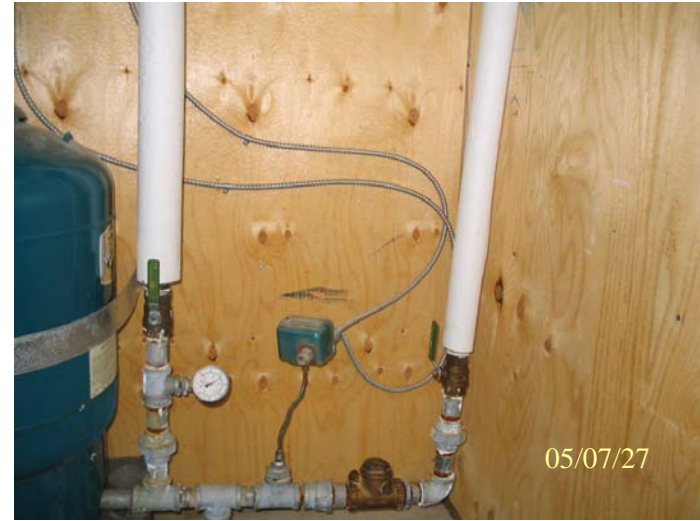
- The pump control system is not up to standards; and,
- The pressure switch is located too far away from the pressure tank.

THE PUMP CONTROL SYSTEM DOES NOT MEET CODE.

Photo 0099: 3121 Point of entry and pressure tank

REPIPE THE PUMP CONTROLS WITH MATERIAL THAT MEETS THE PLUMBING CODE. REPLACE THE PRESSURE SWITCH - IT DATES BACK TO 1970. INSTALL TREATMENT IF REQUIRED TO SUIT UV INSTALLATION. INSTALL UV (NSF55 CERTIFIED) STERILIZER. INSTITUTE B. ANNUAL WELL MAINTENANCE PROGRAM SERVICE UV SYSTEM REGULARLY.
