## **7.0 BULDING 4951 – TESLIN HEALTH CENTRE**

SMALL PUBLIC WATER SYSTEMS ASSESSMENT  
EASTERN REGION

TESLIN HEALTH CENTRE  
BUILDING # 4951  
SITE LOCATION DIAGRAM  
WELL ID: 4951

## SMALL PUBLIC WATER SYSTEM ASSESSMENT

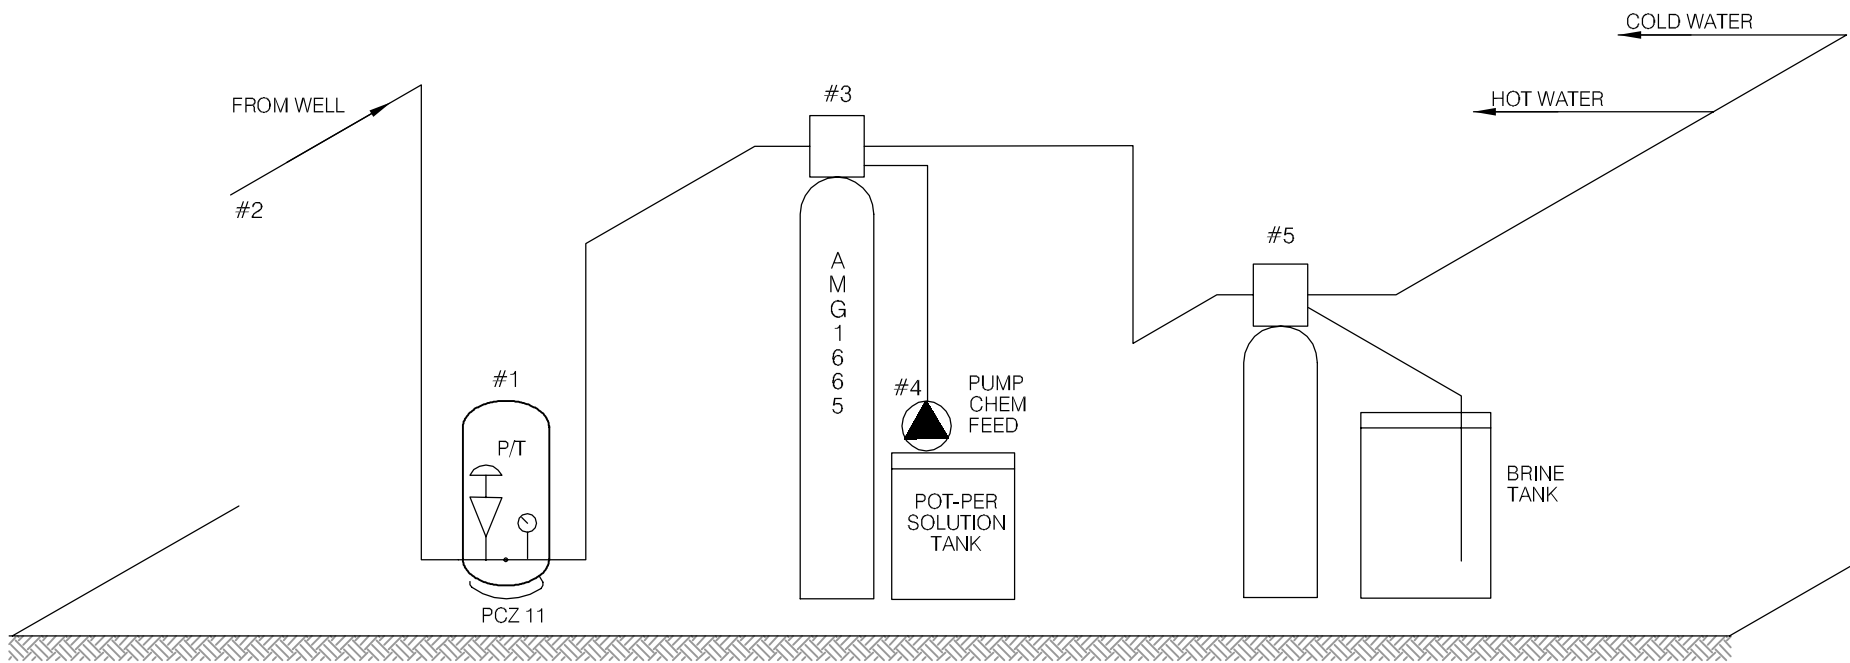
DWG.: FIGURE 4951-B

The Teslin Health Centre water treatment system consists of a sand filter and a water softener. A schematic detailing the current water system is provided as Figure 4951-B in Appendix A7.

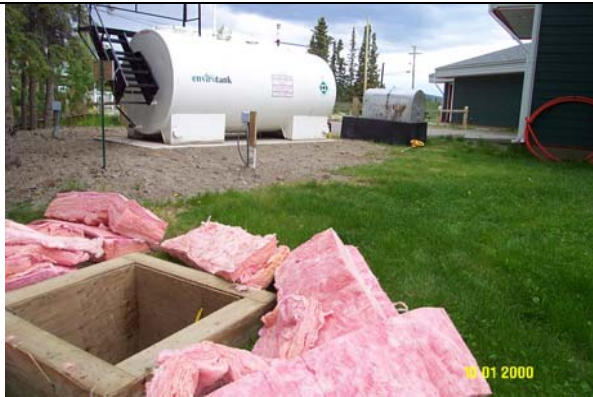
- There are above ground fuel storage tanks within 30 m of the well. They are, however, both equipped with secondary containment. One tank

appeared to be a temporary installation and will likely be removed in the near future; and,

**Photo 0217:** 4951 Wellhead enclosure (front), doubled walled enviro tank above ground fuel storage tank (back left), existing above ground storage tank with secondary containment tub (back centre), and Teslin Health Centre (back right).

- A point of entry arsenic removal system should be installed to ensure that the water meets the proposed CDWQG maximum acceptable concentration of 0.005 mg/L; and,
- The ASTs should be moved to suitable location greater than 15 m from the well and preferably downgradient.

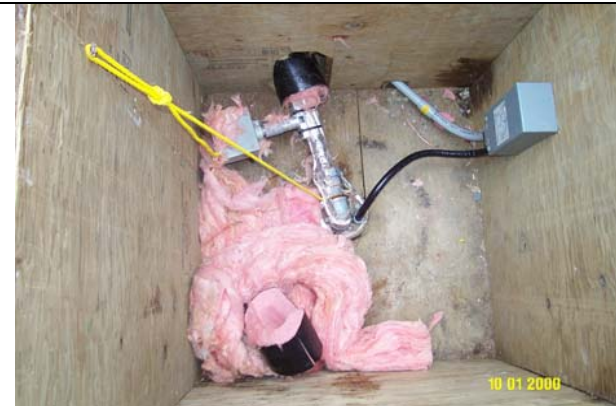
- There is no disinfection system on this water system.
- The well is located in a pit below grade and is not equipped with a surface sanitary seal (grout or bentonite) to at least 6 m in depth.
- By definition of the Draft Yukon GUDI Assessment Guideline, the well is potentially under the direct influence of surface water because it does not meet the requirements of the Guidelines for Water Well Construction.

- i. Is the well head below grade? describe in detail 0.75 m below grade
- ii. Are there signs of ponding on the enclosure(e.g. water stains, etc.)?  Yes  No
- iii. Is the wellhead enclosed by fiberglass insulations?  Yes  No
- iv. Any evidence of rodents? Specify No evidence, access possible
- v. Does the well casing have a proper seal cap?  Yes  No  
split seal gasket  
If no, describe condition \_\_\_\_\_

**Photo 0216:** 4951 Wellhead in pit

- The wellhead completion should be improved by extending the casing to a minimum of 0.5 m above ground and installing an adequate surface seal around the well casing.

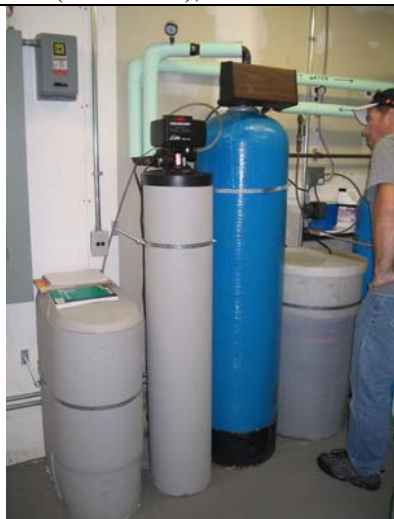
**Photo 0026:** 4951 Water softener (left), greensand filter (centre), and brine tank (right)

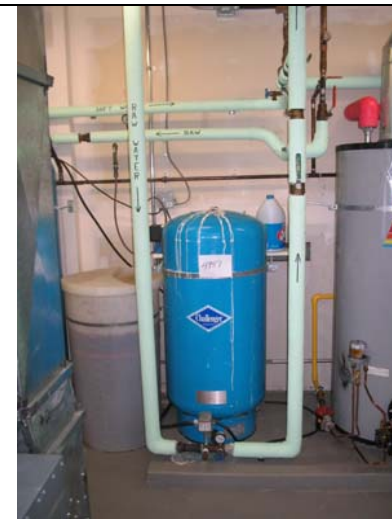
**Photo 0028:** 4951 Pressure tank
