15.0 BUILDING 1955: MOUNT LORNE FIRE HALL

PROJECT SMALL PUBLIC WATER SYSTEMS ASSESSMENT
WHITEHORSE REGION

TITLE WATER SYSTEM DISTRIBUTION/TREATMENT SCHEMATIC SYSTEM ID.: 1955 MOUNTE LORNE FIRE HALL - WELL ID.: 1955	
DATE	JULY 2005	DWN.	JSB
CHKD.	FMM	FILE NO.	1260002.002
		DWG.:	FIGURE 1955B

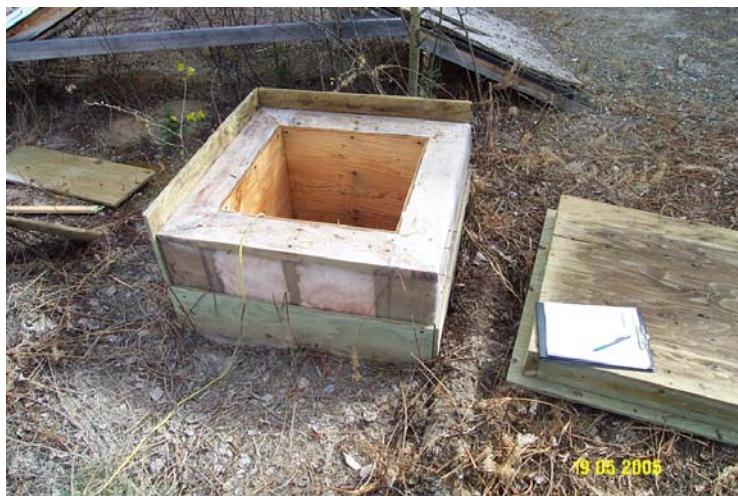
- The wellhead is located in a pit below grade. The pit is prone to flooding and at the time of inspection the wellhead was no longer visible due to the silt that had built up over the wellhead due to prolonged flooding (over several years) or from the recent snowmelt event. At the time of the assessment, the well would be considered to be under the direct influence of surfacewater. Furthermore, by definition of the Draft Yukon GUDI Assessment Guideline, the well is potentially under the direct influence of surface water because it does not meet the requirements of the Guidelines for Water Well Construction.

-
- The well is located in an enclosure that is not locked and may be accessible to animals and unauthorized personnel.
 - There is no sanitary surface seal between the well casing and the well formation.
 - There is no disinfection treatment system for this well.
 - The well is in close proximity to a former landfill and active waste transfer station.

Photo 0192: 1955 Well Head Enclosure

- The wellhead completion should be improved to prevent potential for surfacewater to travel through the top of the casing, or down the annulus between the casing and the formation. This would involve raising the well casing to a minimum of 500 mm above ground level and retrofitting a proper surface seal to 3 m depth around the well casing;
- A proper wellhead enclosure that is inaccessible to animals and unauthorized personnel should be constructed;
- The ground surface should then be graded to promote surface drainage away from the well; and,
- The well and water system should be shock chlorinated.

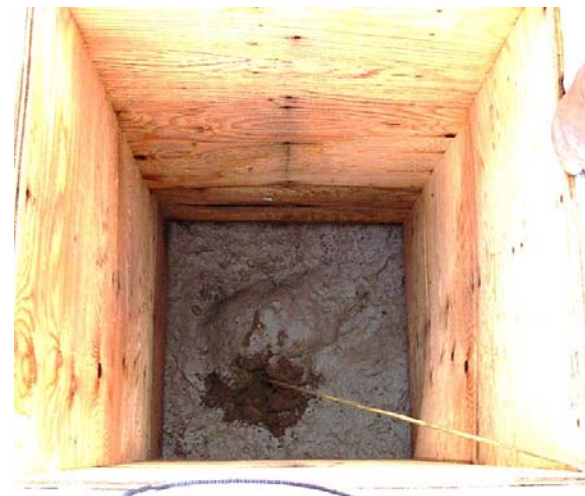
Extremely serious flooding. Well head is inaccessible due to sediment carried down by flooding

Photo 0191: 1955 Well Head

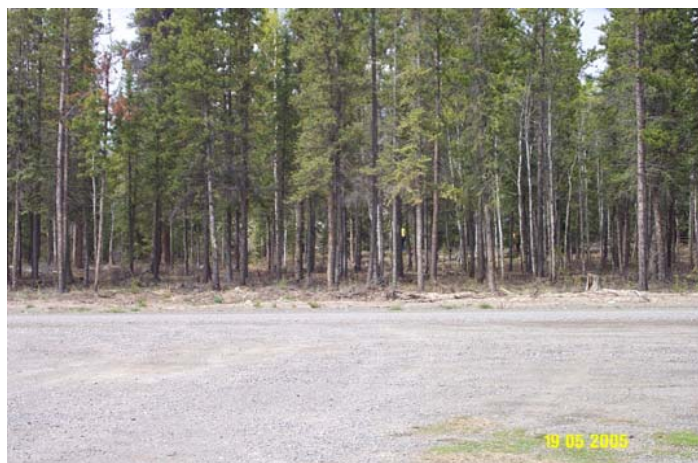
There is a solid waste transfer station in the vicinity of the Mount Lorne Fire Hall. The perimeter of the solid waste transfer station is located 180 m to the north of the fire hall. Although no actual burying of refuse has recently been done, the solid waste transfer station used to be a burn pit, and then was converted into a landfill before being again converted into a solid waste transfer station. The solid waste transfer station is greater than the minimum 120 m required between any refuse disposal site and water well according to the draft Part III Small Public Drinking Water System Guidelines, but since the solid waste transfer station is potentially upgradient from the well (groundwater flow direction is unknown), the solid waste transfer station still has the potential to pose a risk to the water supply at Mount Lorne Fire Hall.

Photo 0193: 1955 180 Meters to Landfill Site

- Given the relatively close proximity to the landfill, it is recommended that a drilling program be completed and monitoring wells be installed in the vicinity of the landfill and transfer station to determine groundwater flow direction and to ensure that leachate is not deriving from the former landfill. Similar groundwater monitoring programs are required for many other landfills in Yukon. A minimum of three monitoring wells would be required. PMA should consult with the Community Services and Environment departments of YTG to determine who would be responsible to implement a groundwater-monitoring program. Additional sampling of water from this well was completed on March 8, 2006 by EBA. A sample was collected to analyze for potential indications of contamination from the adjacent landfill. ALS Environmental in Vancouver analyzed the sample for Volatile Organic Chemicals, Polycyclic Aromatic Hydrocarbons and Organochlorine Pesticides. All parameters analyzed were below analytical detection limit, and below all Canadian Drinking Water Quality Guidelines for these chemicals. There were no chemicals identified in the water quality results from this most recent sampling event or the previous sampling that would suggest that there was impact on the water quality from the adjacent landfill at the time of sampling. The results of this sampling program will be reported in a letter report detailing well upgrades.

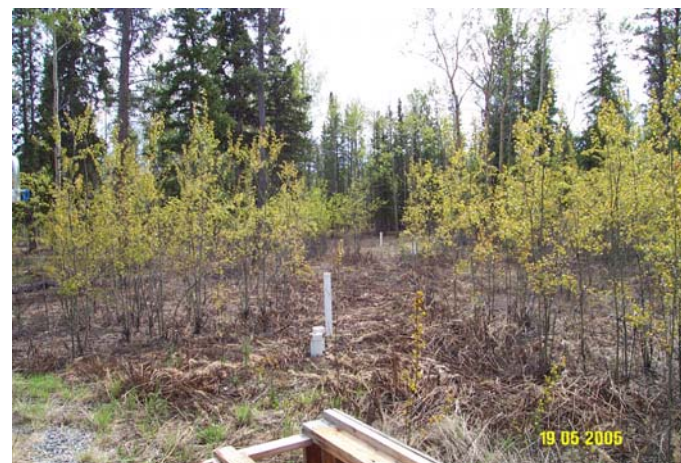
The septic tank for the Mount Lorne Fire Hall is located south of the fire hall, approximately 30 m from the wellhead. A site plan that shows the position of the septic system relative to the well is provided as Figure 1955-A in Appendix A15. The septic tank discharges effluent to a field located south of the tank. The septic tank and effluent field are located at approximately the same elevation as the well.

Photo 0194: 1955 Septic Field

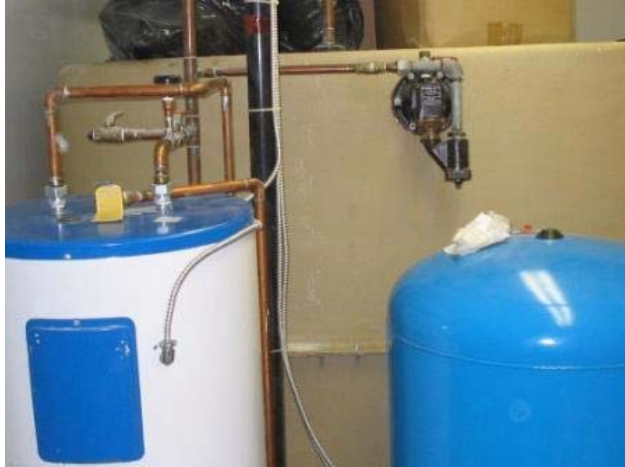
Photo 0018: 1955 Hot Water Tank (left) and Pressure Tank (right)

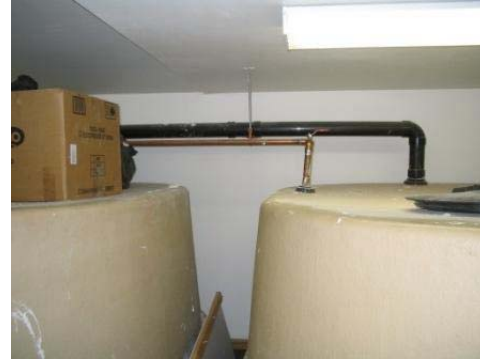
- The overflow from the water storage tank is higher than the tank so that if the tank were to be over-filled the water would spill over inside the building.

Photo 0021: 1955 Water Storage Tanks

- The overflow for the water storage tank should be re-piped so that it is below the level of the tank.

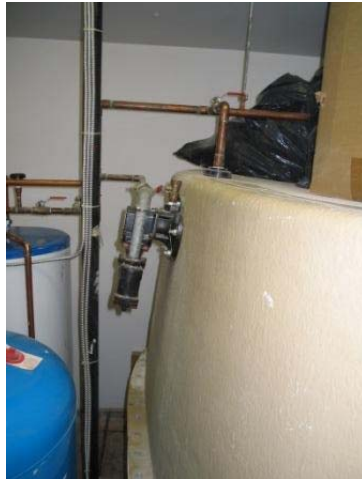
Photo 0020: 1955 Fill Control

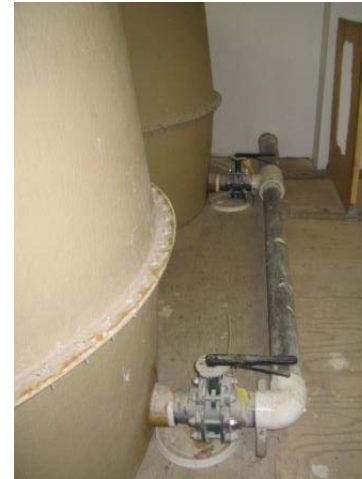
Photo 0022: 1955 Storage Tank Piping
