## **11.0 BUILDING 1421: MENDENHALL FIRE HALL**

PROJECT SMALL PUBLIC WATER SYSTEMS ASSESSMENT  
WHITEHORSE REGION

**Whitehorse Region – Mendenhall Firehall  
Building # 1421**

## SMALL PUBLIC WATER SYSTEM ASSESSMENT

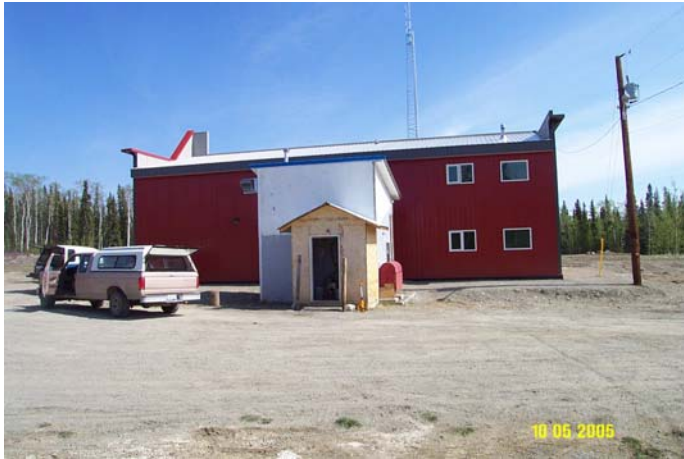
**Photo 0091:** 1421 Well house, Above Ground Storage Tank and Water-Pickup (front) and Mendenhall Firehall (back)

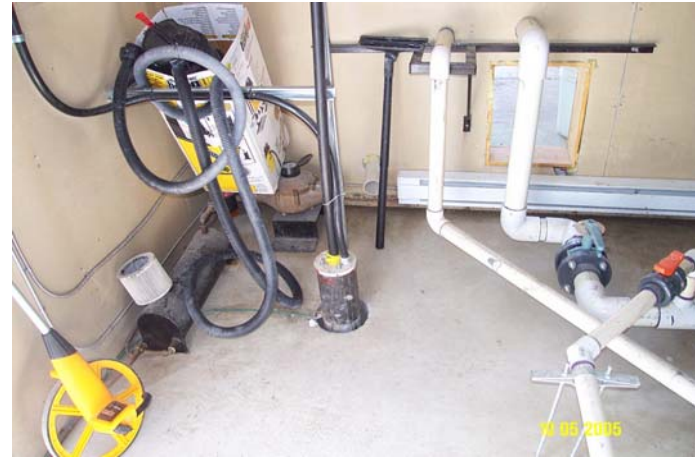
- By definition of the Draft Yukon GUDI Assessment Guideline, the well is potentially under the direct influence of surface water because it does not meet the requirements of the Guidelines for Water Well Construction.

- i. Is the well head below grade? describe in detail No, 43cm above grade, 26cm above concrete floor
- ii. Are there signs of ponding on the enclosure(e.g. water stains, etc.)?  Yes  No
- iii. Is the wellhead enclosed by fiberglass insulations?  Yes  No  
The well house is well insulated and heated
- iv. Any evidence of rodents? Specify There is no evidence, however it appears that the wellhouse is regularly cleaned, No mouse traps
- v. Does the well casing have a proper seal cap?  Yes  No

**Photo 0087:** 1421 Wellhead

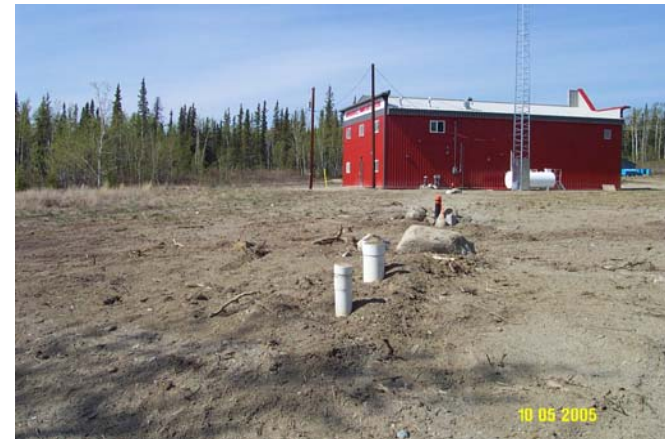
The septic tank for the Mendenhall Fire Hall is located on the south side (opposite the well) of the fire hall, approximately 50 m from the wellhead. The septic tank discharges effluent to a field located south of the tank. The septic tank and effluent field are both located downslope from the well.

**Photo 0094:** 1421 Septic Field (front) and Mendenhall Firehall (back)

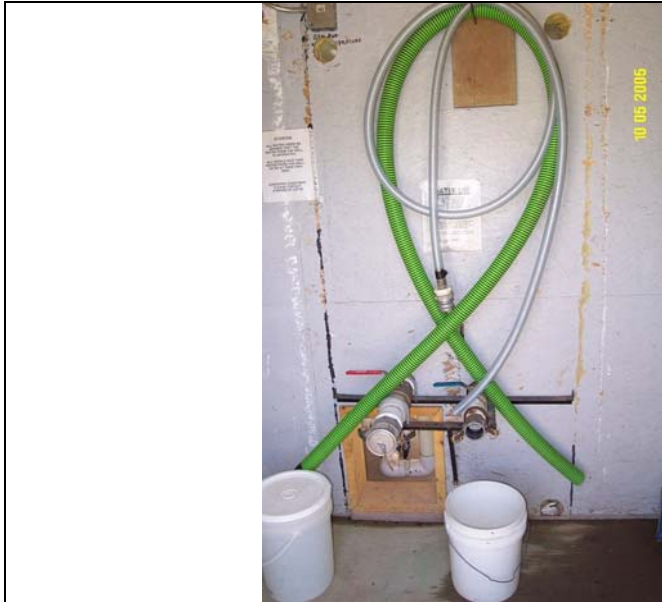
**Photo 0089:** 1421 Water-Pickup

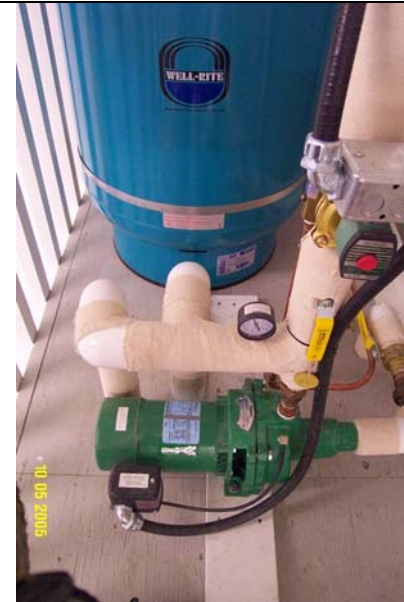
**Photo 0098:** 1421 Pressure Tank and System

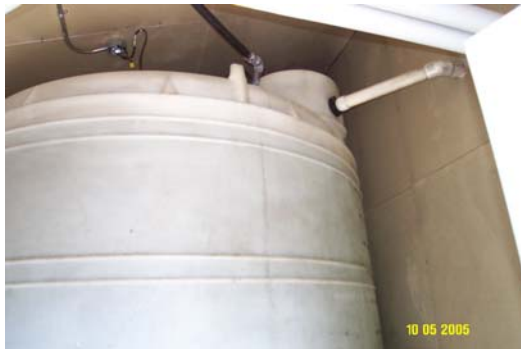
- Poor storage tank design for the potable water within the pumphouse makes it inaccessible for cleaning, and the tank has likely never been cleaned which could lead to deterioration of water quality; and

**Photo 0088:** 1421 Water Reservoir (in wellhouse)

- The 2000 US gal polyethylene tank should be dismantled and removed from the building and replaced with a sectional tank that can meet the demand of the fire hall and water pick-up station. It is anticipated that the tank could be replaced with a 1250 US gal tank of suitable design for potable water storage and with an accessible cleaning port. Once the tank is replaced, it is recommended that a regular cleaning program (every 6 months) be initiated.

REPLACE TANK IN WELL HOUSE WITH A TANK SIZE THAT IS ACCESSABLE FOR CLEANING. INITIATE REGULAR CLEANING SCHEDULE & INSTALL LIQUID CHLORINATION SYSTEM AND SCHEDULE REGULAR CHLORINE RESIDUAL ~~TESTING~~ TESTING.

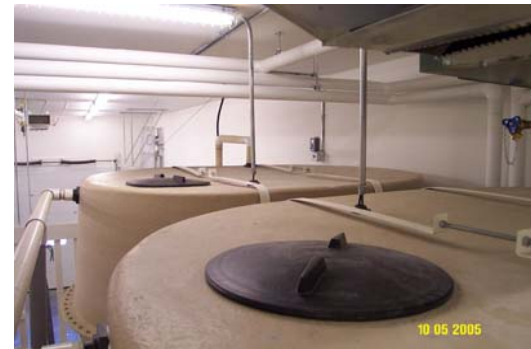
**Photo 0097:** 1421 Water Storage Tanks (in firehall)
