27.0 BUILDING 6746: ROSS RIVER HALL

SMALL PUBLIC WATER SYSTEMS ASSESSMENT
 EASTERN REGION

ROSS RIVER FIRE HALL
 BUILDING # 6746
 SITE LOCATION DIAGRAM
 WELL ID: 6746-A

SMALL PUBLIC WATER SYSTEM ASSESSMENT

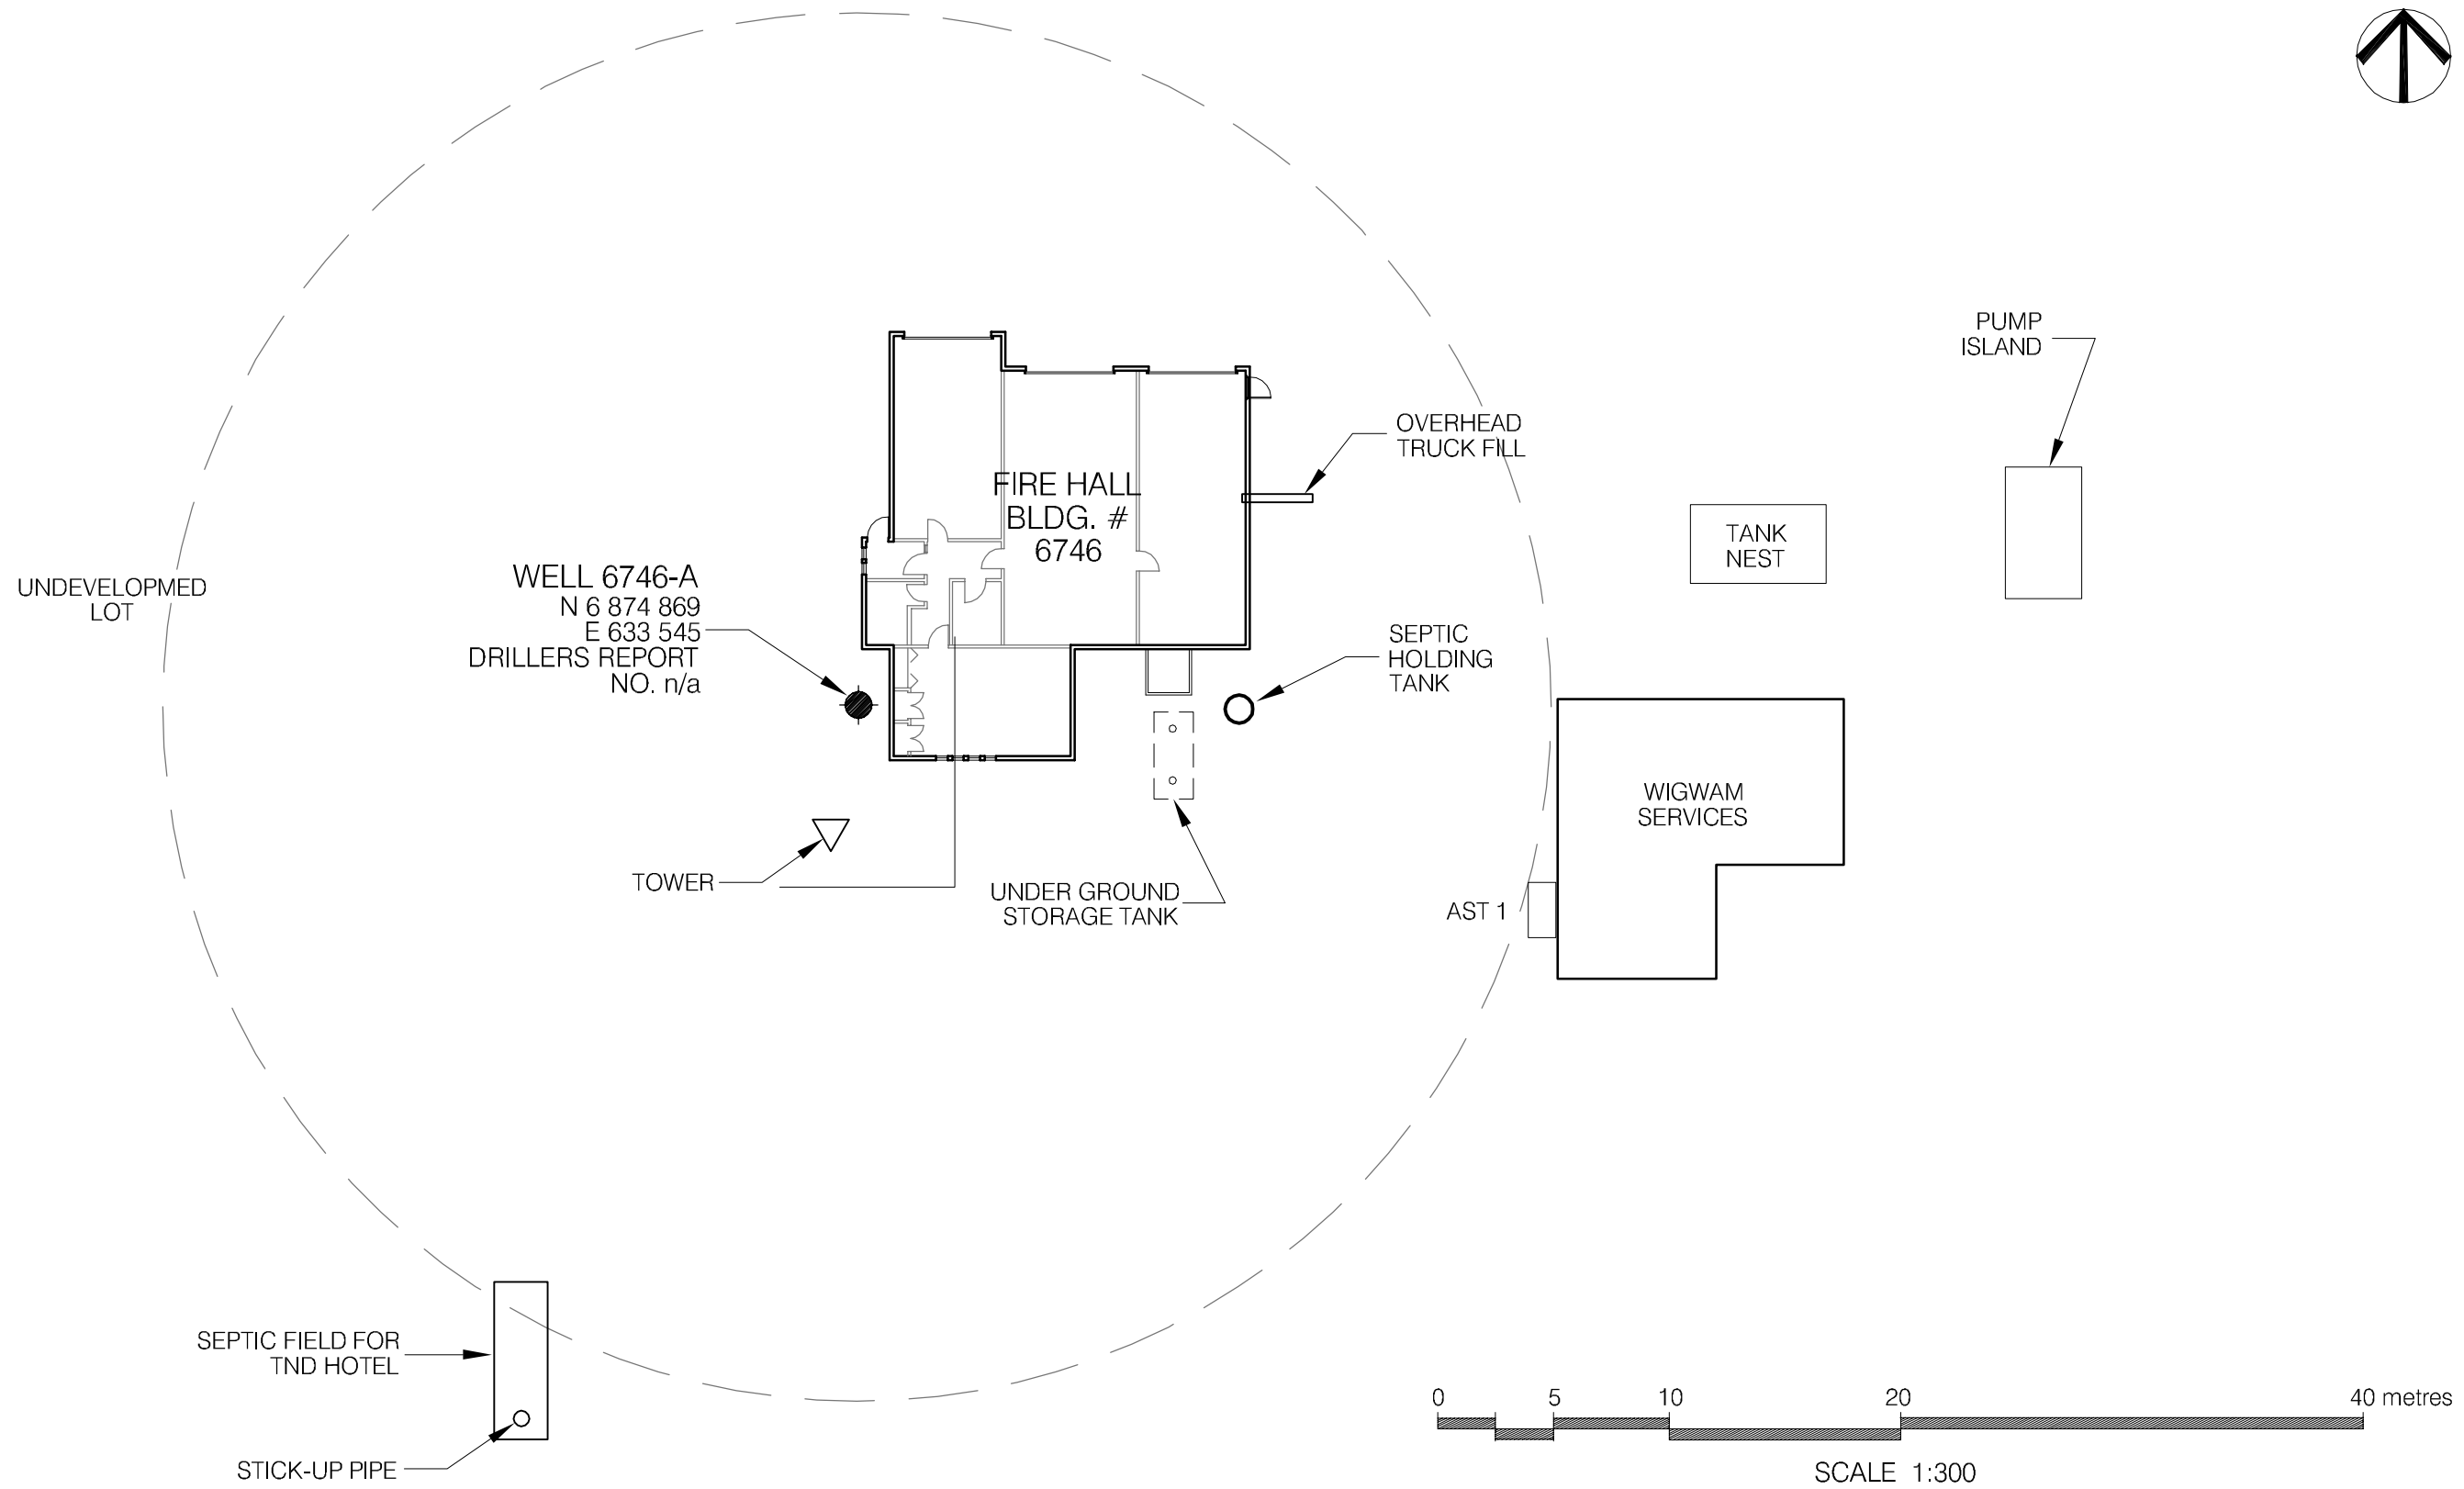
REVISION ISSUE
 0
 FIGURE No.
 6746-A

30 m RADIUS FROM WATER WELL FOR CONSIDERATION OF PROXIMITY TO POTENTIAL CONTAMINANT SOURCES.

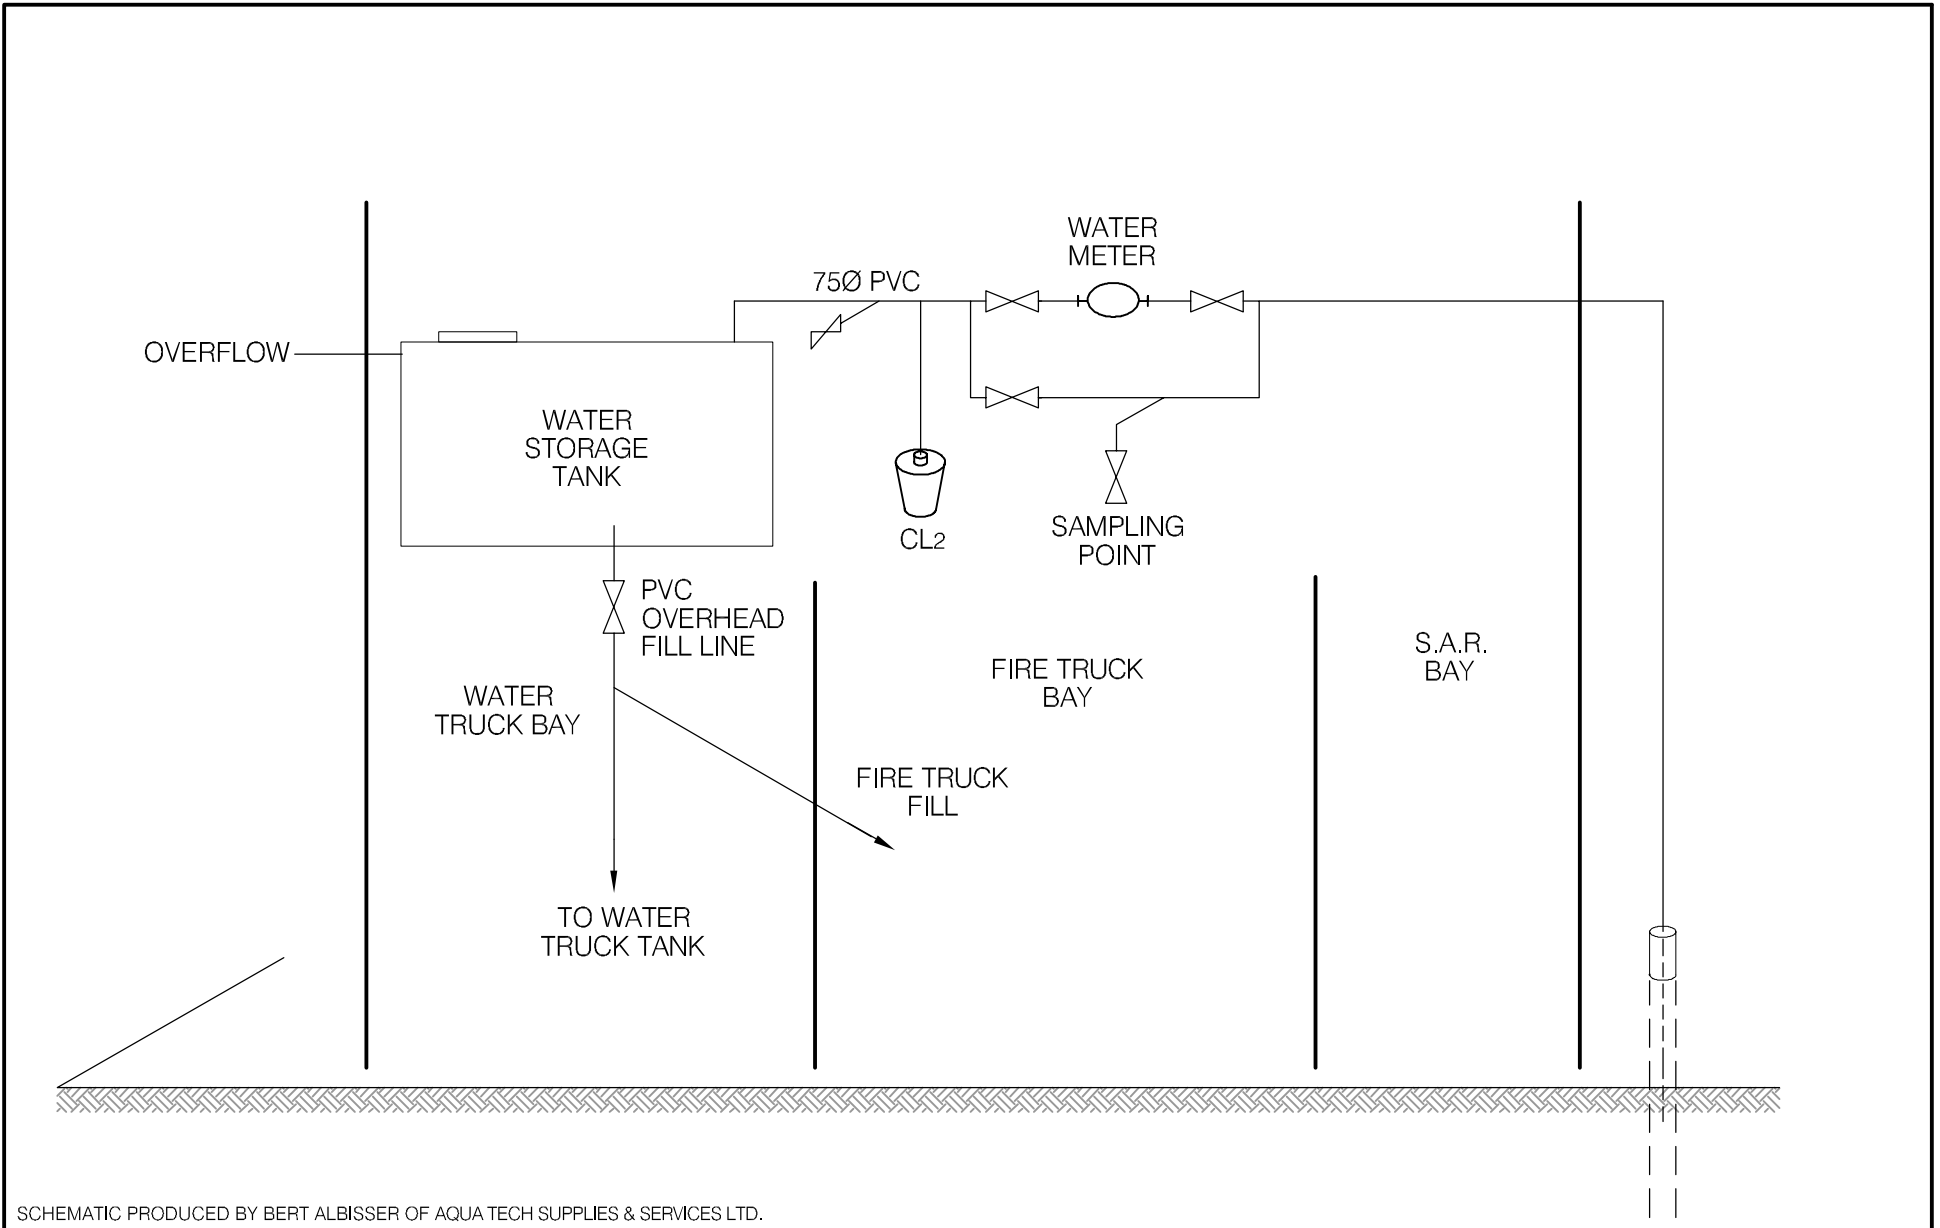
TITLE WATER SYSTEM DISTRIBUTION/TREATMENT SCHEMATIC SYSTEM ID.: 6746 ROSS RIVER FIRE HALL			
DATE JULY 2005	DWN. JSB	CHKD. RMM	FILE NO. 1260002.002	DWG.: FIGURE 6746-B

-
- Low residual chlorine concentration at the point of consumption;
 - At the time of the inspection, a flow switch controlled the Grundfos digital dosing meter chlorine injection pump. Apparently, the switch had been “sticking”. We understand that Community Development had ordered a flow meter to install with the DME system to ensure proportional feed of chlorine to the system.
 - The arsenic concentration, although it is not in exceedence of the current MAC, is in exceedence of the proposed CDWQG MAC of 0.005 mg/L; and,
 - There is an abandoned service station approximately 66 m from the site that potentially has hydrocarbon impacted soil and groundwater.

REPLACE FLOW SWITCH WITH PULSE
WATER METER TO EFFECT PROPORTIONAL
CHLORINE FEED.

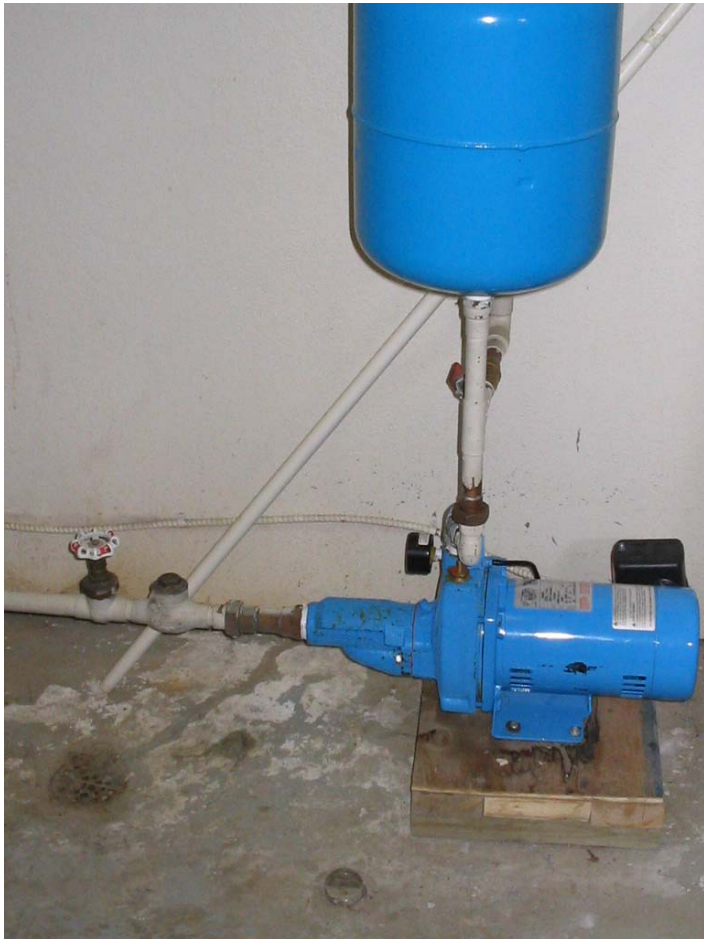
Photo 0059: 6746 Jet pump and pressure tank

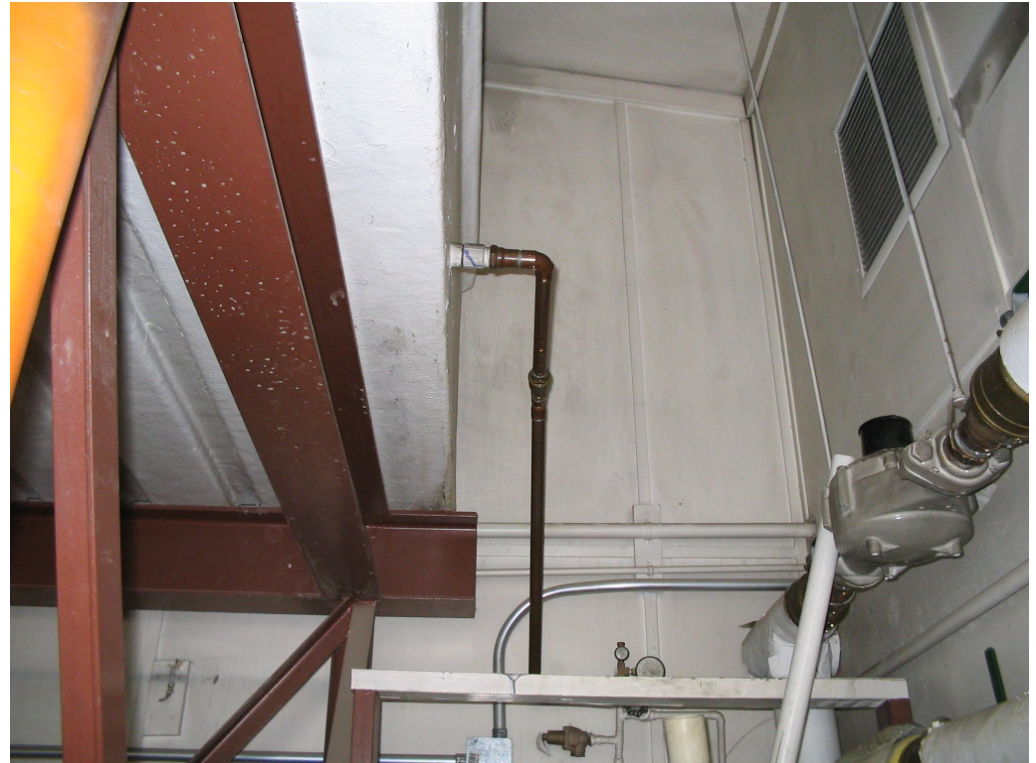
Photo 0060: 6746 Water storage tank
