15.0 BUILDING 5653: MAYO AIRPORT TERMINAL BUILDING

15.1 Description of Existing Water Supply System

SMALL PUBLIC WATER SYSTEMS ASSESSMENT
 NORTHERN REGION

SMALL PUBLIC WATER SYSTEM ASSESSMENT

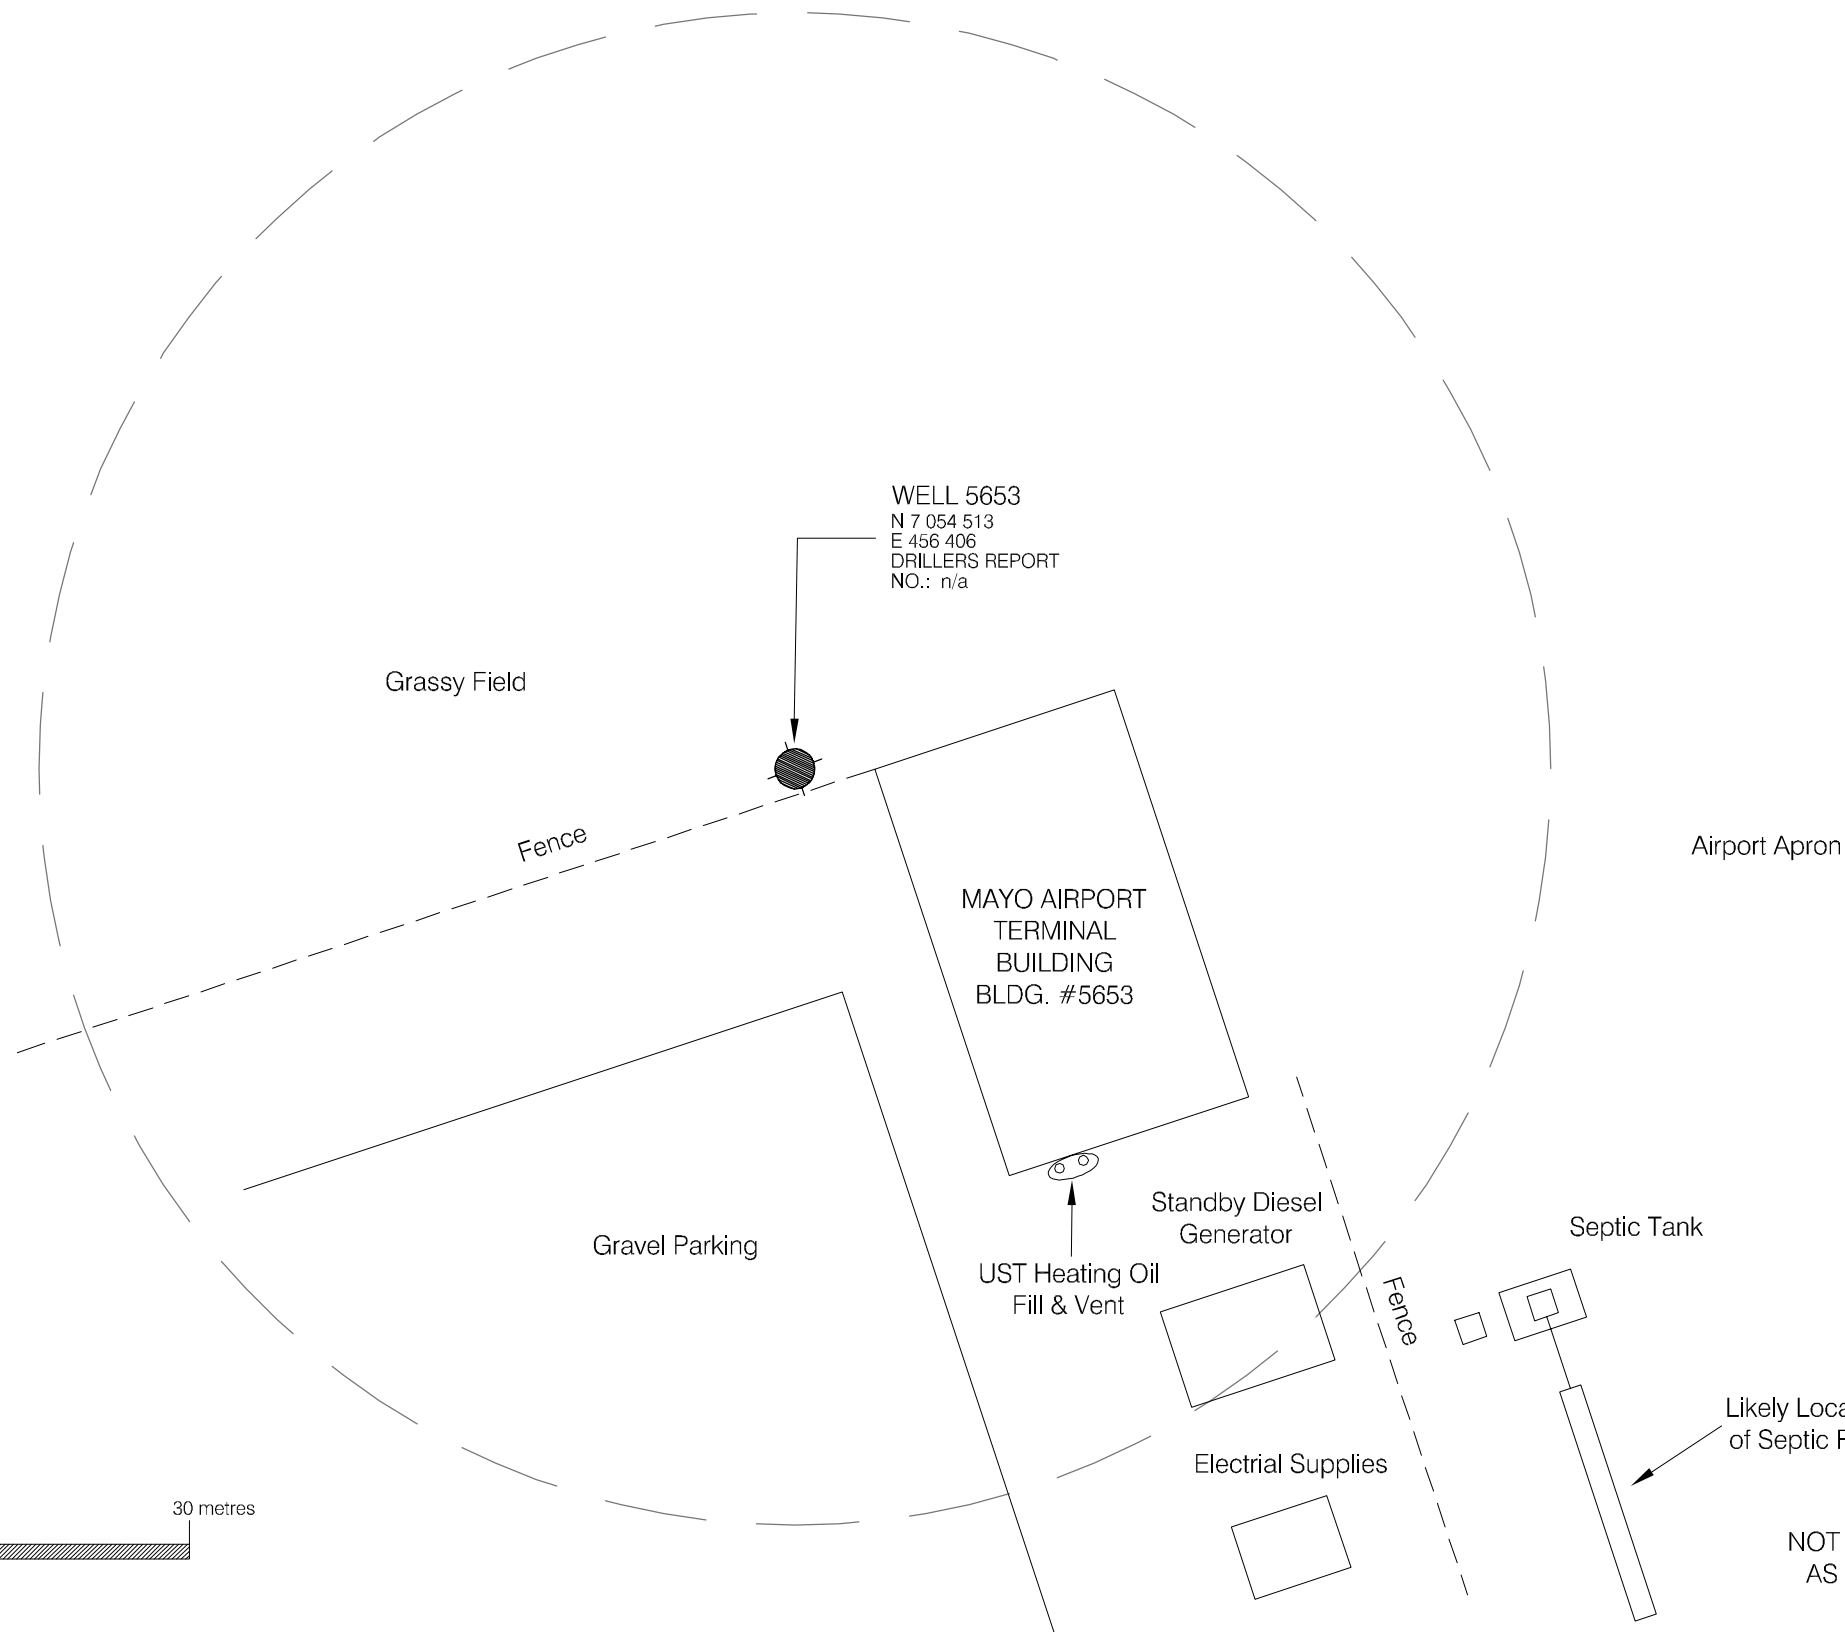
FIGURE No.
 FIGURE 5653-A

Wastewater from the terminal building is discharged into a septic system located to the southeast of the building. The tank is approximately 34 m southeast of the well. It is unknown whether the septic system uses a holding tank and sewage education, or an effluent disposal field, however due to the location of the tank it can likely be inferred that a septic field (if present) would be located greater than the required 30 m from the well. A site plan showing the location of the septic tank is given by Figure 5653-A in Appendix A15.

Potential contaminant sources within 30 m of the wellhead are:

- An underground fuel storage tank (UST) at 18 m.

In addition, there is a cemetery located 63 m south of the well; the proposed required setback distance from wells to Cemeteries in the proposed Part III - Small Water Systems Regulations is 120 m. As mentioned in the previous section, the well is completed at a depth of 56 m, likely within a confined aquifer and may have thick sequences of fine grained soils overlying the aquifer. Additionally, the well is inferred to be upgradient of the cemetery and the proximity to the cemetery is not considered to be a significant concern.

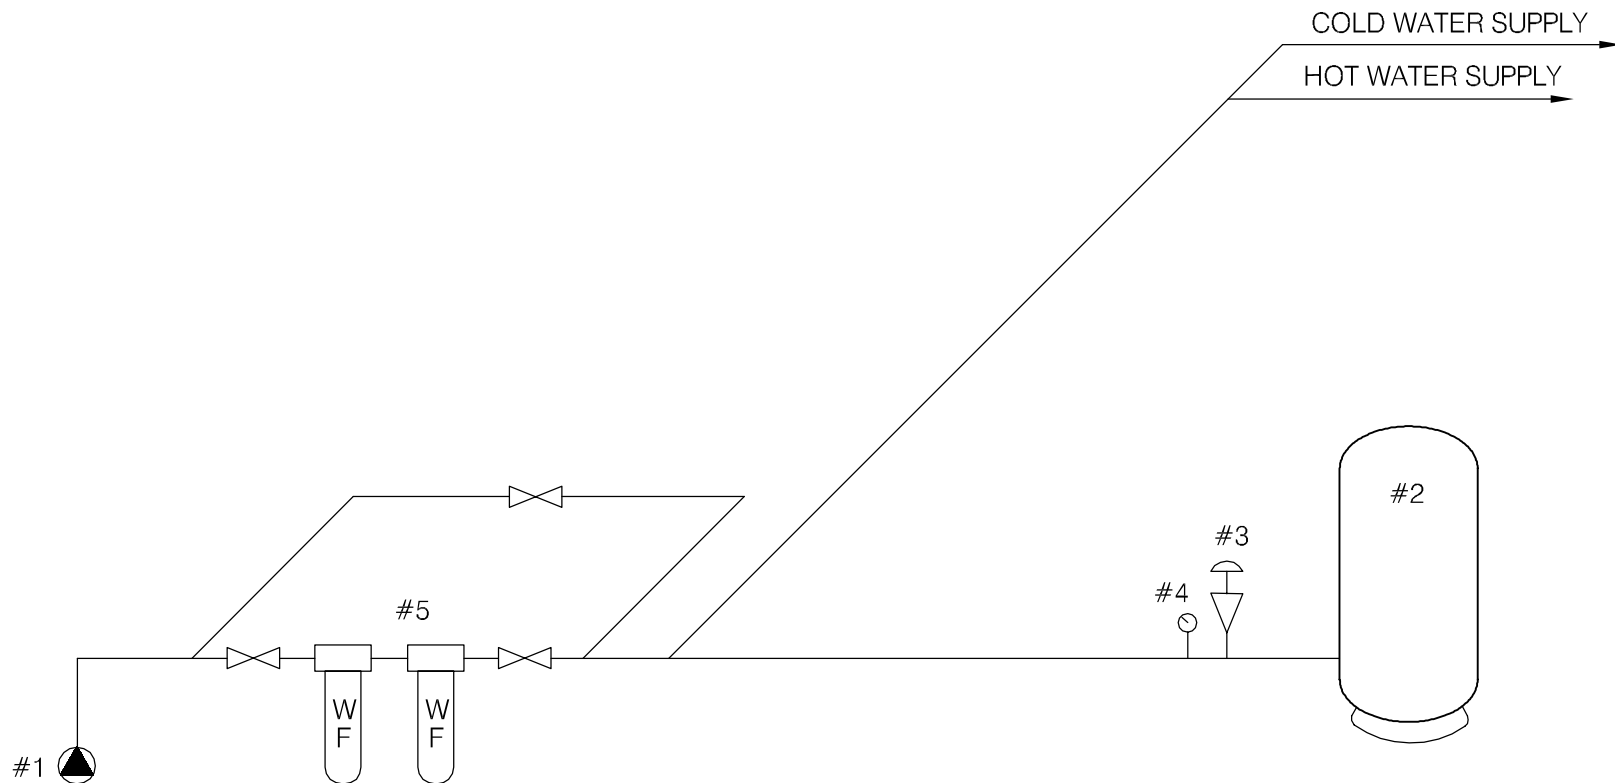
| DATE | SEPT. 2005 | DWN. | JSB | CHKD. | RMM | FILE NO. | 1260002.004 | DWG.: | FIGURE 5653-B |

This system is equipped with a 5-micron filter however; there is no other treatment or disinfection for this system. A schematic detailing the water system is provided as Figure 5653-B in Appendix A15. Photos of the well and water system are also included at the back of this appendix.

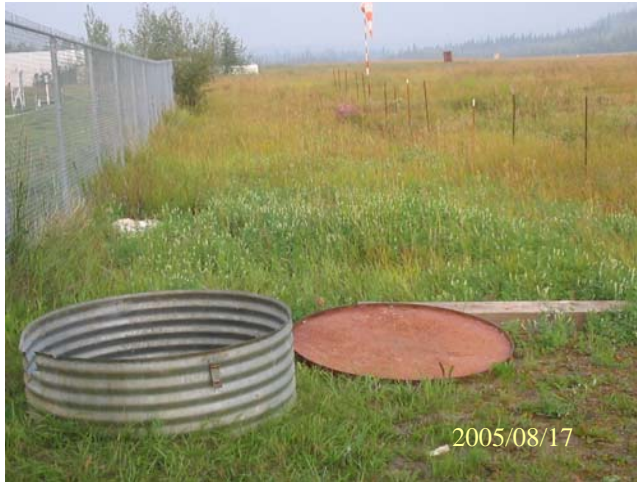
- Poor surface completion of the wellhead (located in a pit below grade);
- There is no surface sanitary seal (grout or bentonite seal as required by the Canadian Groundwater Association's Guidelines for Water Well Construction);
- There is no driller's log available to review well construction and lithology;
- By definition of the Draft Yukon GUDI Assessment Guideline, the well is potentially under the direct influence of surface water because it does not meet the requirements of the Guidelines for Water Well Construction).
- The well is located within 30 m of potential contaminant sources including a UST;
- A water sample collected for bacteriological analysis tested positive for total coliform bacteria;
- The total arsenic concentration was in exceedence of the CDWQG MAC;
- The turbidity was in exceedence of both the CDWQG MAC and AO; and,
- There is no disinfection system present.

- i. Is the well head below grade? describe in detail ~ 1.2m bg
- ii. Are there signs of ponding on the enclosure(e.g. water stains, etc.)? Yes No
- iii. Is the wellhead enclosed by fiberglass insulations? Yes No has been removed
- iv. Any evidence of rodents? Specify Access possible
- v. Does the well casing have a proper seal cap? Yes No

If no, describe condition No cap - only garbage bag above well casing

Photo 0187: 5653 Mayo Airport wellhead enclosure.

- Standard wellhead upgrades consisting of a pitless unit installation, extension of casing to at least 500 mm above grade, and retrofitting the wellhead with a bentonite/grout surface sanitary seal should be completed.
- A duplex water softener should be installed for UV system pre-treatment and general water quality improvement.

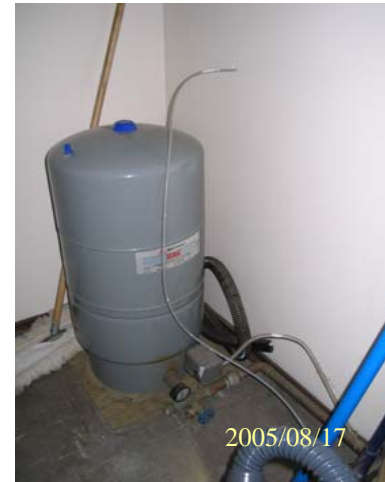
Photo 0189: 5653 Pressure tank and pump controls.

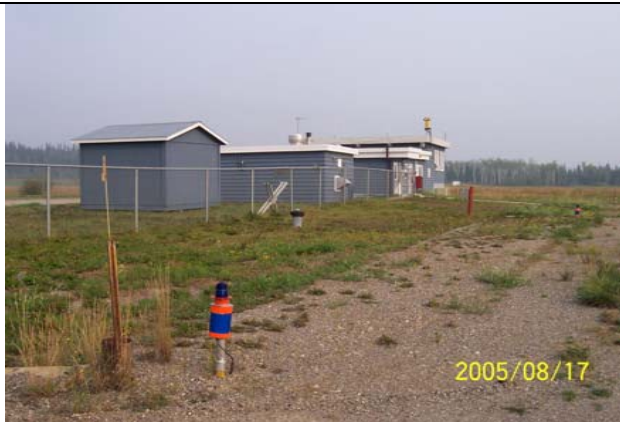
Photo 027: 5653 Mayo Airport Terminal Building.

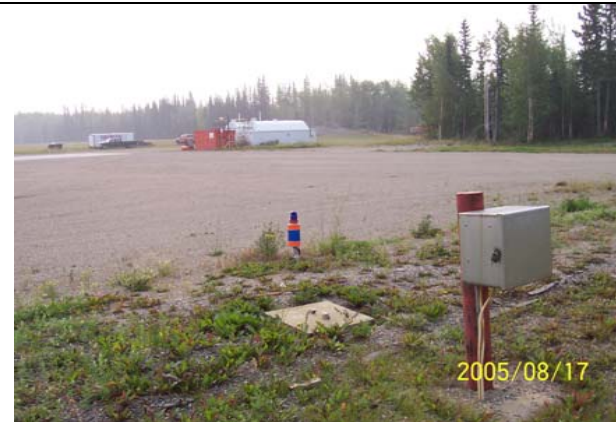
Photo 007: 5653 Septic tank (front) and bulk fuel storage (back).

The existing UST should be removed and replaced with a double walled tank with “Kamlock” fill connections and flex hosing. Any hydrocarbon-impacted soils should be documented and removed from the site for treatment at a land farm. This work should be completed under the supervision of a qualified environmental consultant.
