14.0 BUILDING 5650: MAYO WILDLIFE WORKSHOP

SMALL PUBLIC WATER SYSTEMS ASSESSMENT
NORTHERN REGION

MAYO WILDLIFE WORKSHOP
BUILDING # 5650
SITE LOCATION DIAGRAM
WELL ID: 5650

SMALL PUBLIC WATER SYSTEM ASSESSMENT

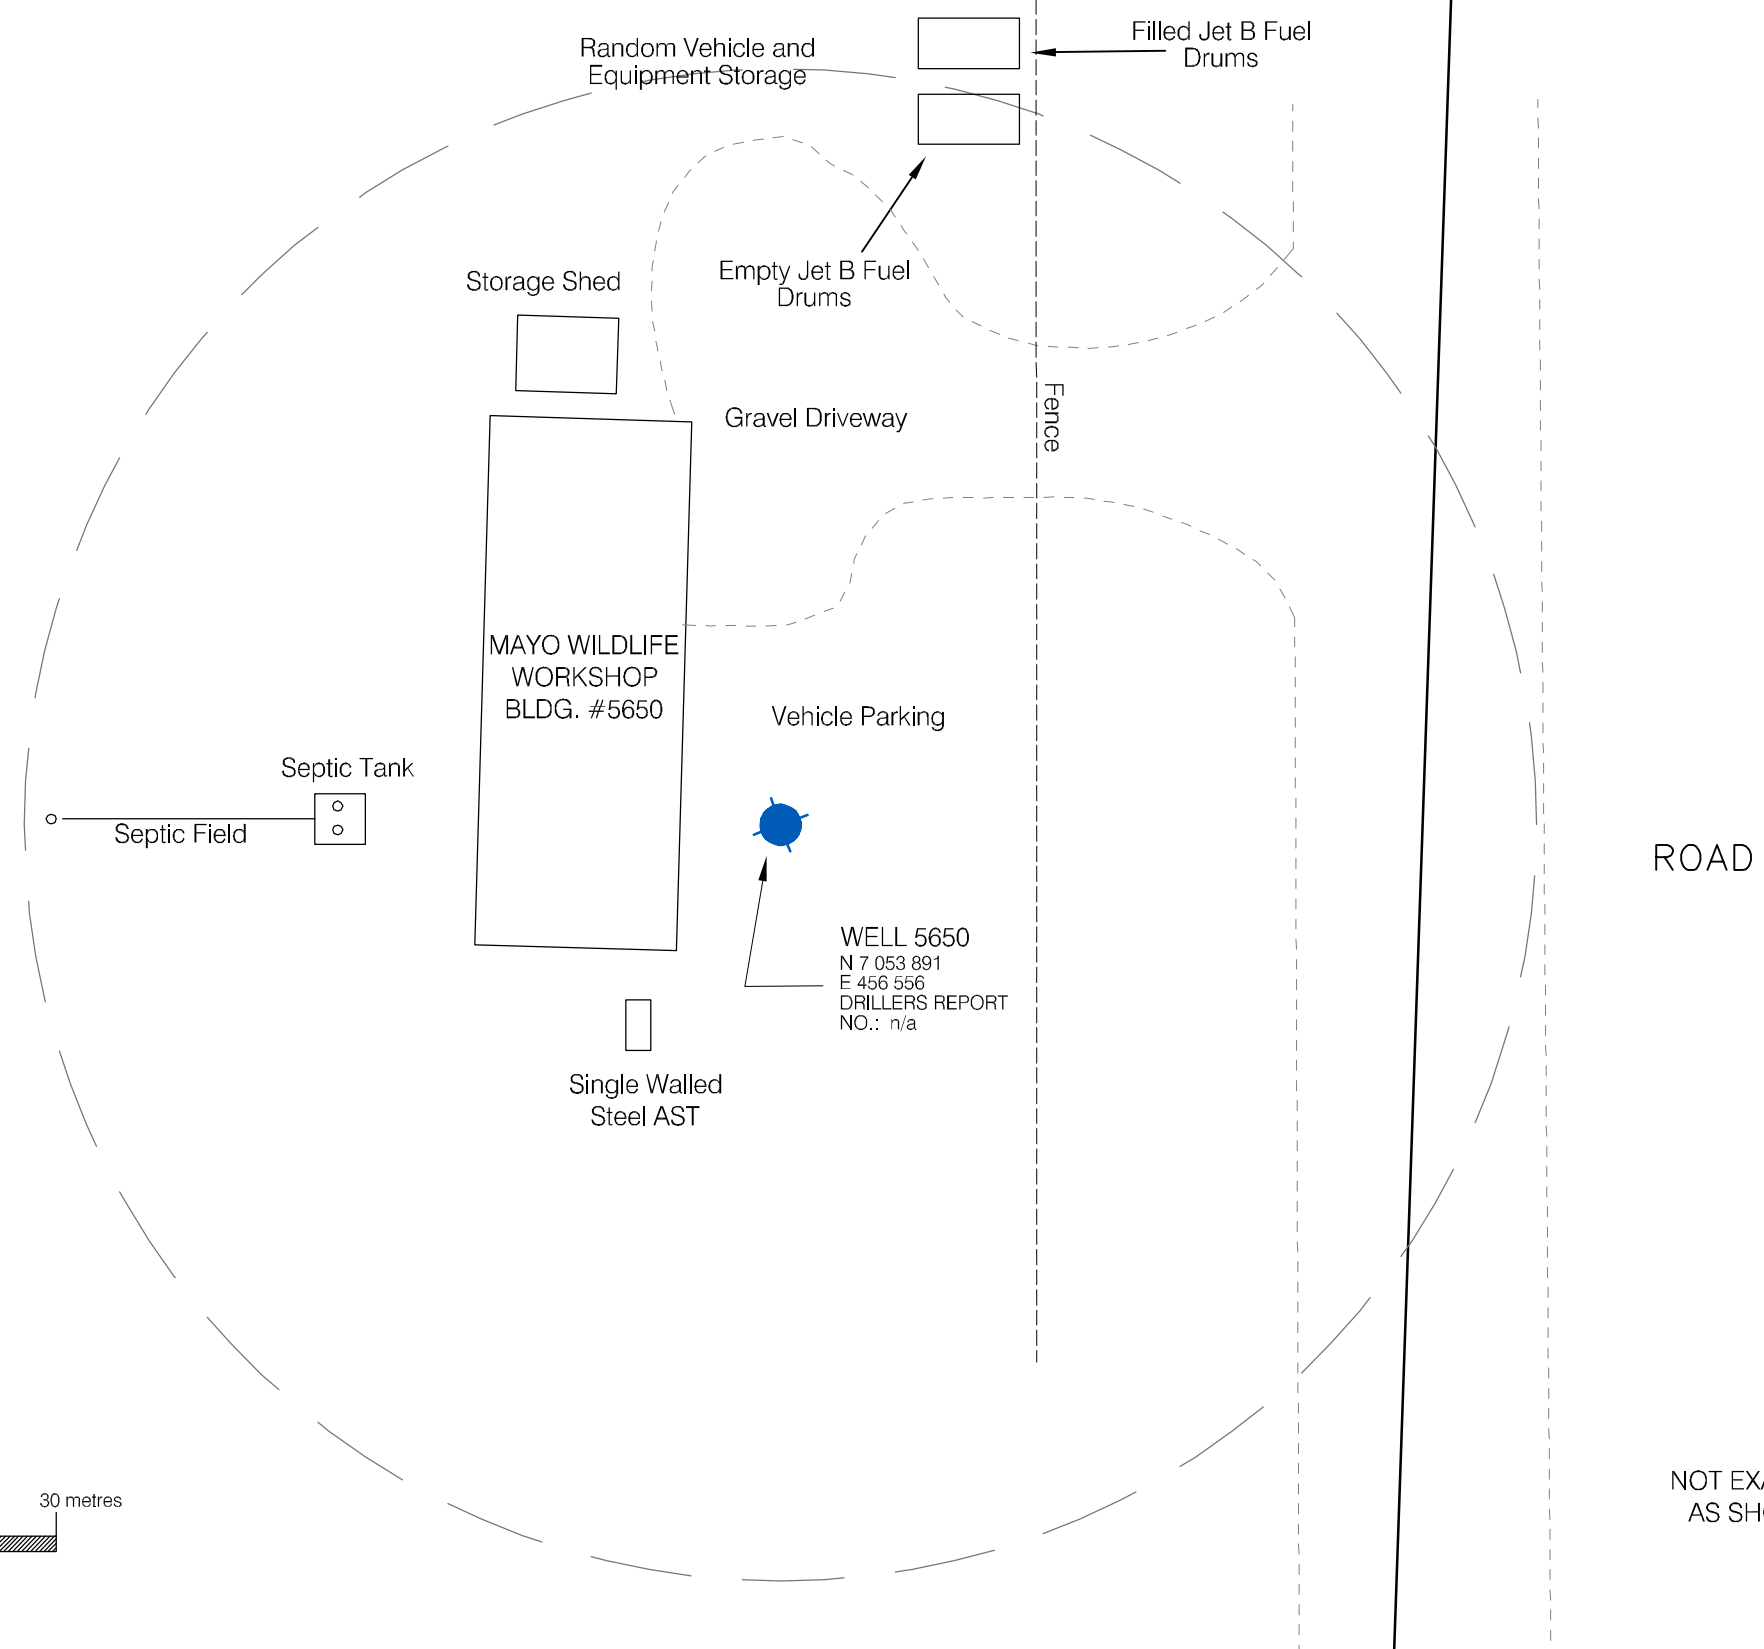
FIGURE No.
FIGURE 5650-A

There is a septic tank located on the west side of the wildlife workshop, and septic effluent is discharged to the west of the tank. The septic tank is located approximately 16 m west of the well and the in-ground effluent disposal field is located between approximately 16 m and 28 m from the well. The location of the septic system is indicated on Figure 5650-A.

- A septic tank at 16 m; the septic field is between 16 m and 28 m;
- An above ground fuel storage tank (AST) at 7 m; and
- Vehicle parking at 2 m.

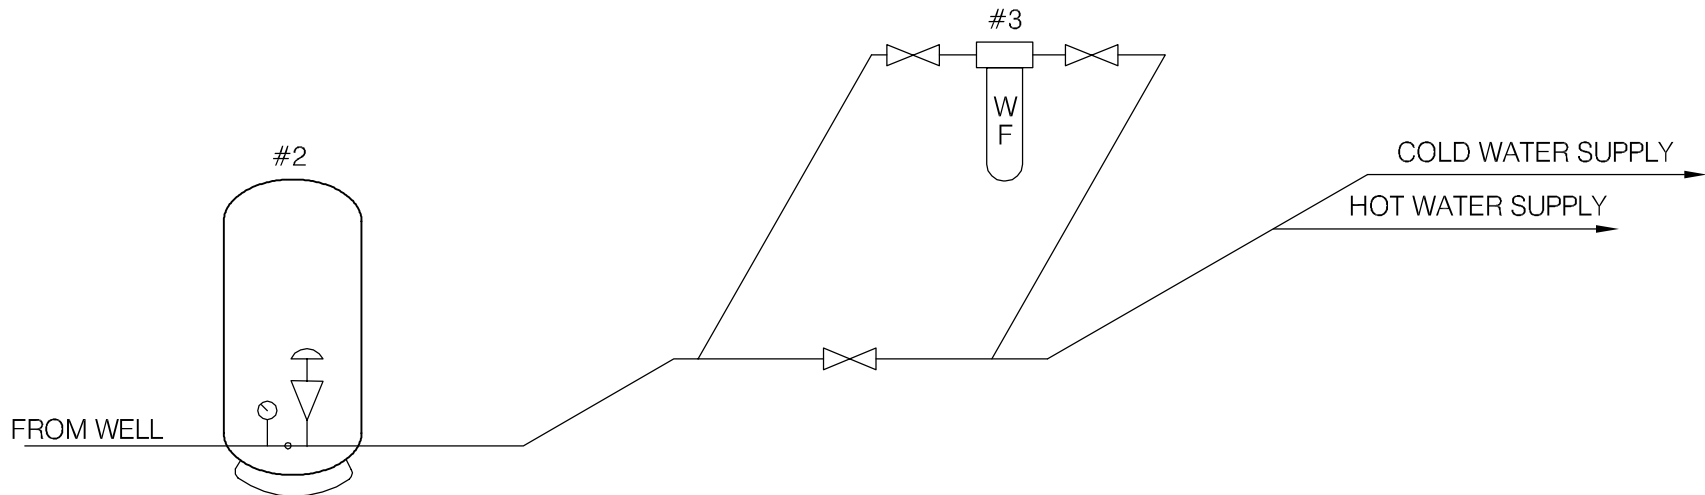
TITLE WATER SYSTEM DISTRIBUTION/TREATMENT SCHEMATIC SYSTEM ID.: 5650 WILDLIFE WORKSHOP - MAYO, YT.							
DATE	SEPT. 2005	DWN.	JSB	CHKD.	FMM	FILE NO.	1260002.004	DWG.:	FIGURE 5650-B

This system is equipped with an inline filter; however, there is no other treatment and no disinfection for the system. A schematic detailing the water supply system is provided as Figure 5650-B in Appendix A14. Photos of the well and water system are also included at the back of this appendix.

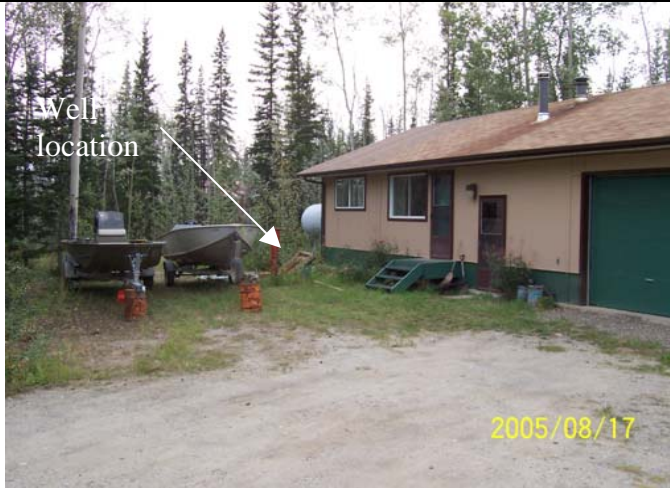
Photo 033: 5650 Wildlife Workshop (northeast side of building).

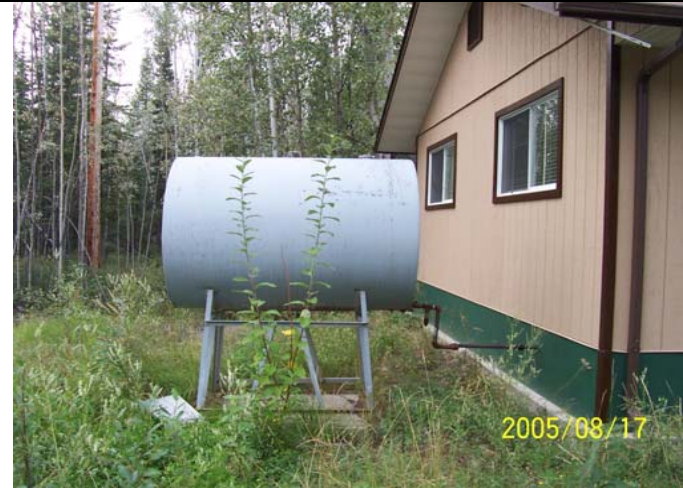
Potential Source 2: AST; Distance from well to Potential Source 2: ~7m

Photo 057: 5650 On site AST.

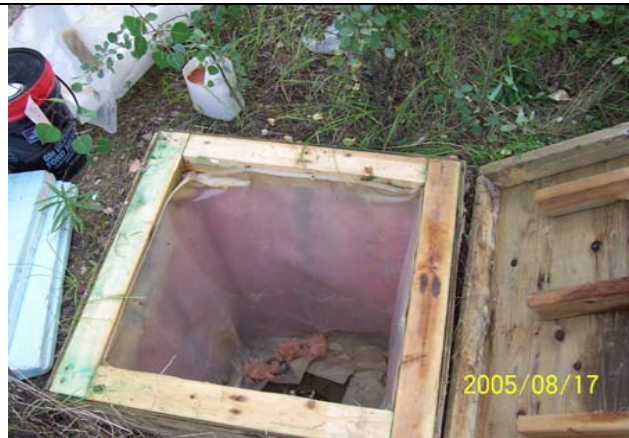
- Poor surface completion of the wellhead (located in a pit below grade, evidence of sediment build-up on the base of the enclosure due to flooding);
- There is no surface sanitary seal (grout or bentonite seal as required by the Canadian Groundwater Association's Guidelines for Water Well Construction);
- There is no well log available to review well construction and lithology;
- By definition of the Draft Yukon GUDI Assessment Guideline, the well is potentially under the direct influence of surface water because it does not meet the requirements of the Guidelines for Water Well Construction);
- The well is located within 30 m of potential contaminant sources, including a septic field, an AST, and vehicle parking;
- The barium concentration is above the CDWQG MAC;
- The turbidity is above both the CDWQG MAC and AO; and
- There is no disinfection system present.

Unauthorized access by humans? Yes No *Unlocked enclosure* Entrance by animals? Yes No *Access possible*

p. Is well site subject to flooding? Yes No *enclosure damp*

- i. Is the well head below grade? describe in detail ~1.0m bg
- ii. Are there signs of ponding on the enclosure(e.g. water stains, etc.)? Yes No
- iii. Is the wellhead enclosed by fiberglass insulations? Yes No styrofoam
- iv. Any evidence of rodents? Specify Access possible
- v. Does the well casing have a proper seal cap? Yes No
If no, describe condition split gasket cap

Photo 056: 5650 Wellhead enclosure.

- The well should be equipped with a surface seal to at least 6 m and a pitless unit should be installed with the casing raised above grade (500 mm);
- The well must be located at a distance greater than 30 m and upgradient from any potential source of contamination;
- The well should be at least 15 m in depth;
- The water from the new well must meet all CDWQG health based guidelines. If there are any exceedences in the CDWQG health-based guidelines then a treatment system must be designed and installed as necessary. A treatment/disinfection system would likely consist of a filtration system (to 1 micron absolute) followed by a UV disinfection system. Pretreatment would likely be required.

Following Priority 2 upgrades, the existing well should be properly decommissioned. It is anticipated that Priority 1 and 2 upgrades would mitigate all health risks.

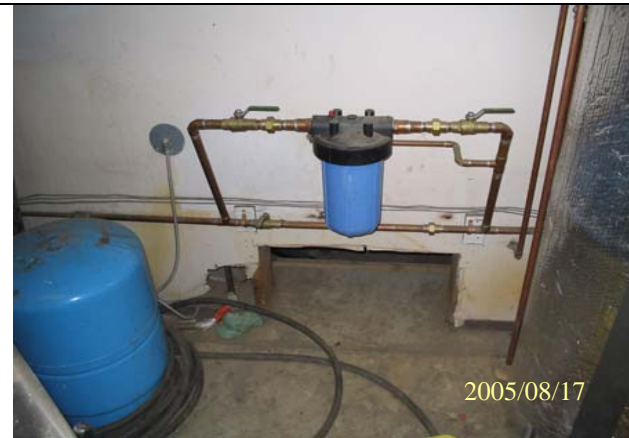
THE INSTALLATION IS SATISFACTORY
THE PRESSURE TANK IS WATER LOGGED - IT NEEDS TO
BE REPLACED.

Photo 194: 5650 Water system. (pressure tank and filter)
