## **18.0 BUILDING 2592: KLONDIKE VALLEY FIRE HALL**

SMALL PUBLIC WATER SYSTEMS ASSESSMENT  
 NORTHERN REGION

KLONDIKE VALLEY FIRE HALL  
 BUILDING # 2592  
 SITE LOCATION DIAGRAM  
 WELL ID: 2592

## SMALL PUBLIC WATER SYSTEM ASSESSMENT

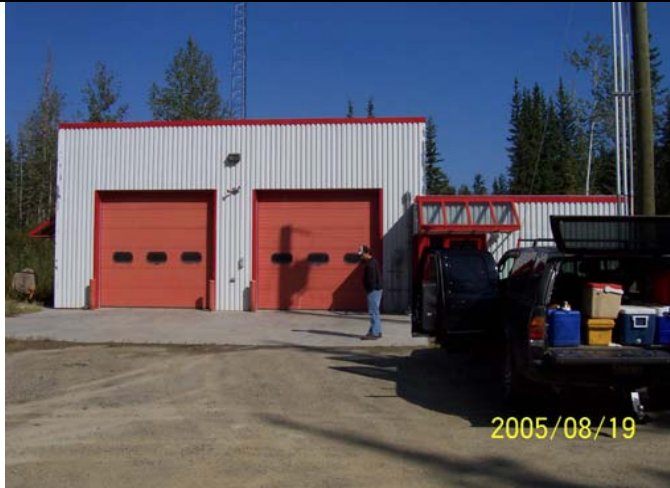
**Photo 093:** 2592 Klondike Valley Fire Hall

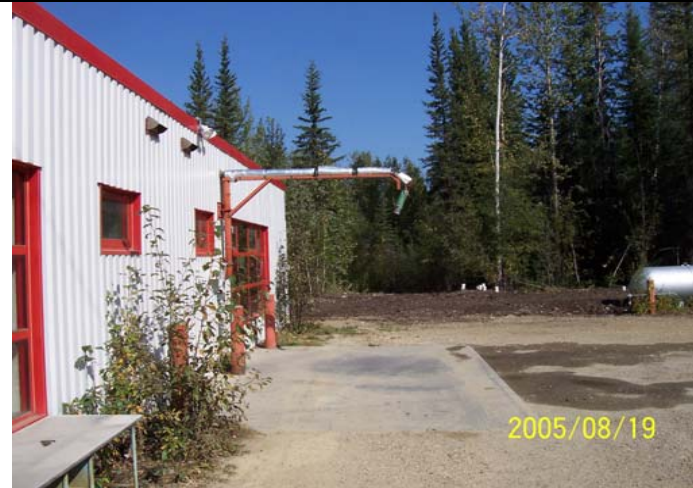
- The well is located within 12 m of a road.
- The outside hose bib water pick-up is located approximately 12 inches off of the ground, and may be subject to contamination.

**Photo 096:** 2592 Water filling station.

The outside hose bib should be raised to about 1.0 m above grade. This should include rerouting of the interior piping so that it is accessible for maintenance. If there is no backflow prevention device to this outside hose bib, it should be installed at the same time as these upgrades.

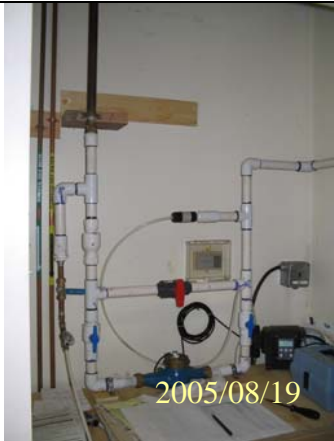
**Photo 236:** 2592 Chlorination system, flow meter, and associated plumbing.

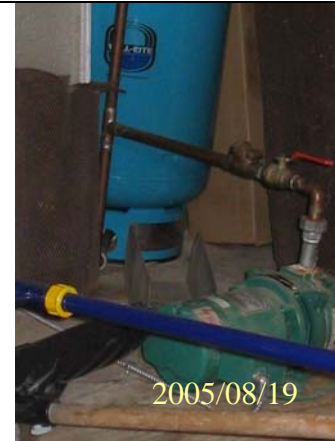
**Photo 237:** 2592 Jet pump and pressure tank.
