STEFFEN ROBERTSON AND KIRSTEN (B.C.) INC. Consulting Engineers

Project Number 60619

Curragh Resources Ltd.

RE: OCTOBER 23, 1991 SITE VISIT

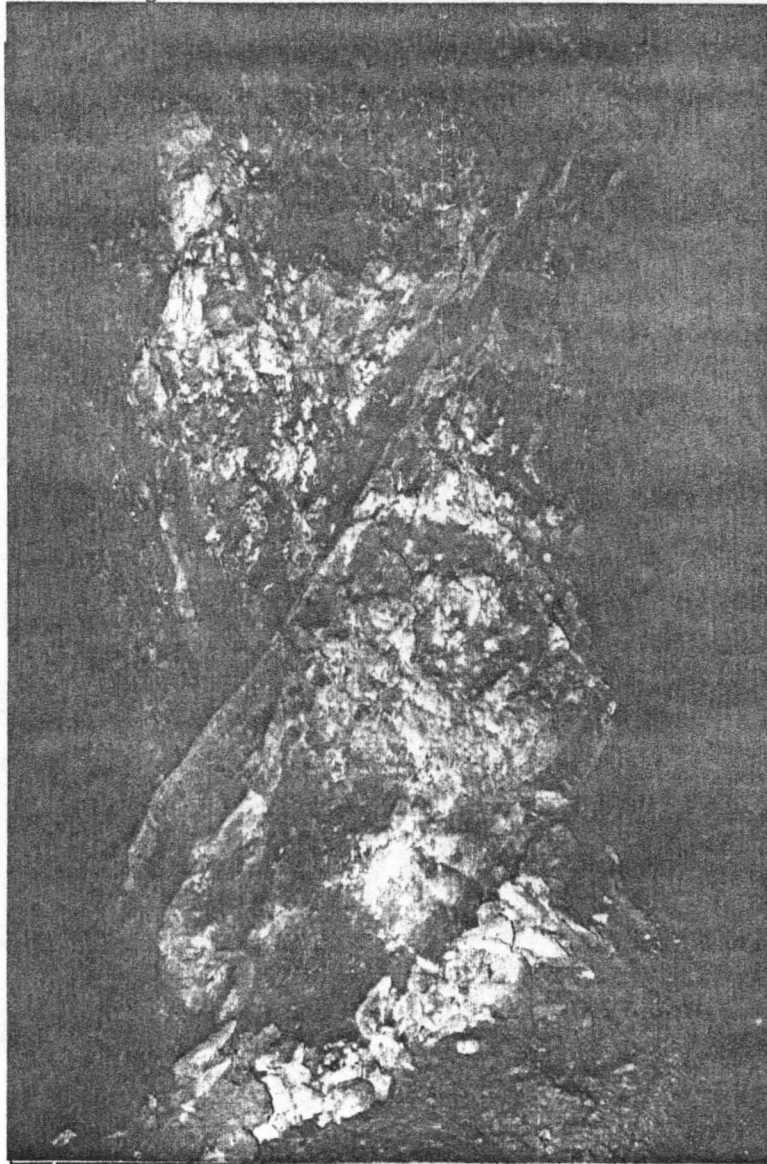
An example of what should be noted during pillar inspection is indicated in Plates 1 and 2. Both photographs were taken during the current site visit. Plate 1 is a photograph of a pillar in the North B ramp. Several items may be noted from examining this picture:

- diagonal fault through pillar. Pillar is likely only supporting itself
- lack of bolting. Two split-sets are visible in the pillar, with both being ineffective.
- lack of monitoring. No paintlines or other methods to indicate possibly dangerous pillar movement.
- breasting conducted adjacent to pillar without proper pillar support or pillar monitoring.

A pillar and back monitoring program was suggested in the October 1, 1991 SRK letter. This program should be implemented immediately. This should be summarized in a written record with associated maps. Monitoring will be necessary on retreat mining in order to insure safe mining conditions exist in the mining areas.

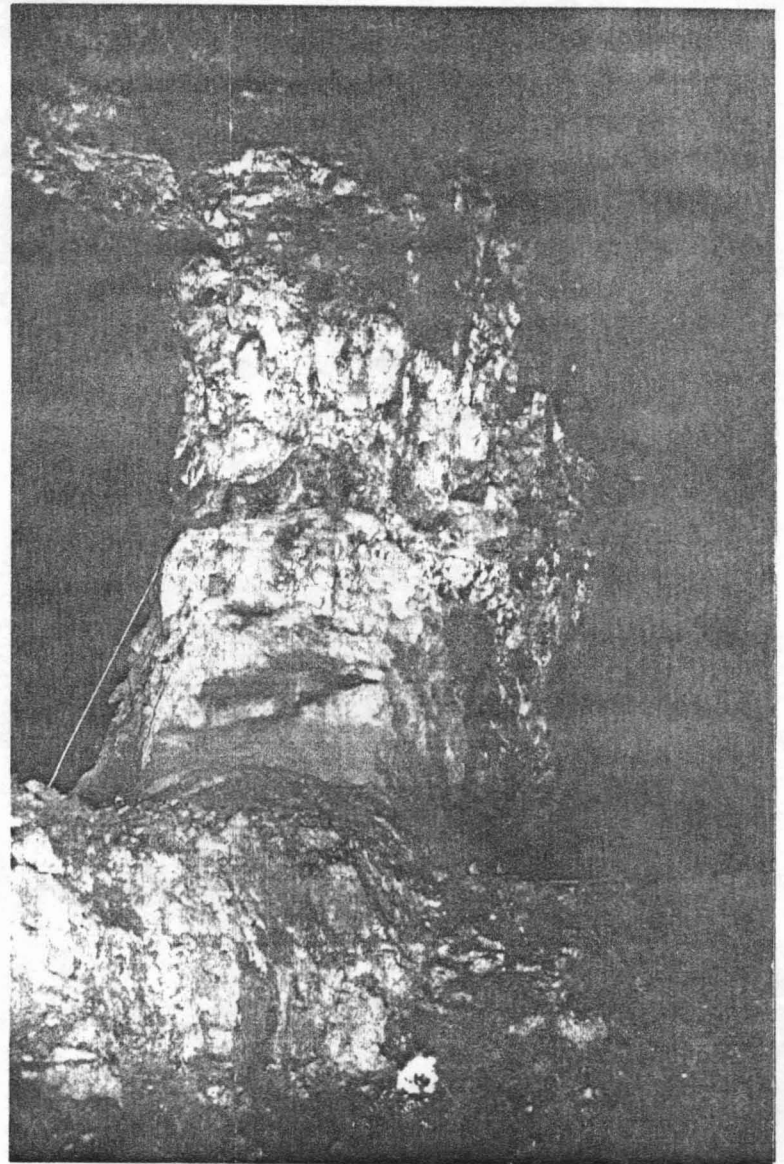
Plate 2 shows the pillar adjacent to that shown in Plate 1. Note that:

- pillar is curved in the vertical plane. Load line falls near one edge, decreasing stability.
- no pillar or back monitoring
- no pillar support
- active breast face (note trunklines) adjacent to pillar which cannot be scaled (too high) and is not monitored for stability.
