**1995 ANNUAL GEOTECHNICAL
PERFORMANCE EVALUATION
and
INSTRUMENTATION DATA REPORT
FARO MINE
YUKON
VOLUME I**

**Anvil Range Mining Corporation
Faro, Yukon
Y0B 1K0**

March 1996

RE: 1995 ANNUAL GEOTECHNICAL PERFORMANCE EVALUATION- FARO MINE

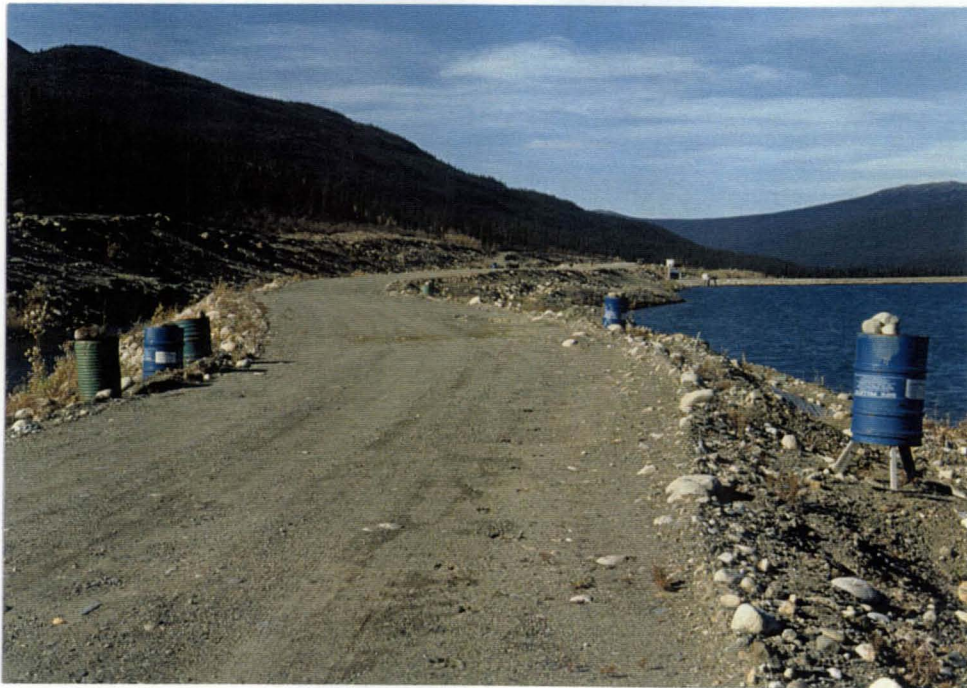
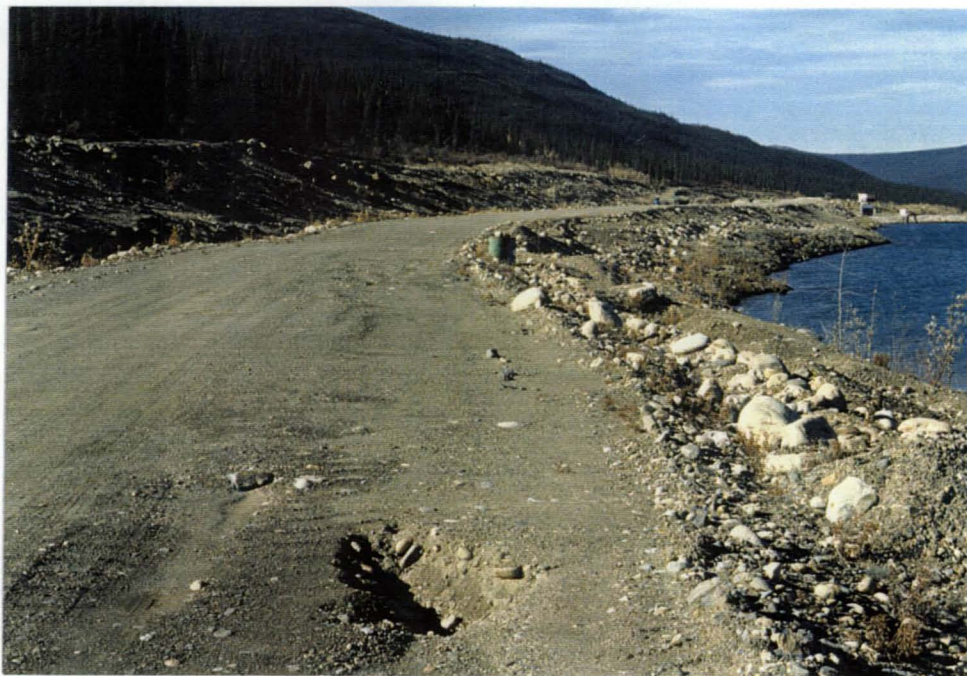
Figure 5

Looking downstream from about Sta. 2+100, the above photo illustrates the condition of the dyke top. The lower photo is of the area between the two right side barrels; it illustrates a case of a partially-collapsed crack in the crest of the dyke.

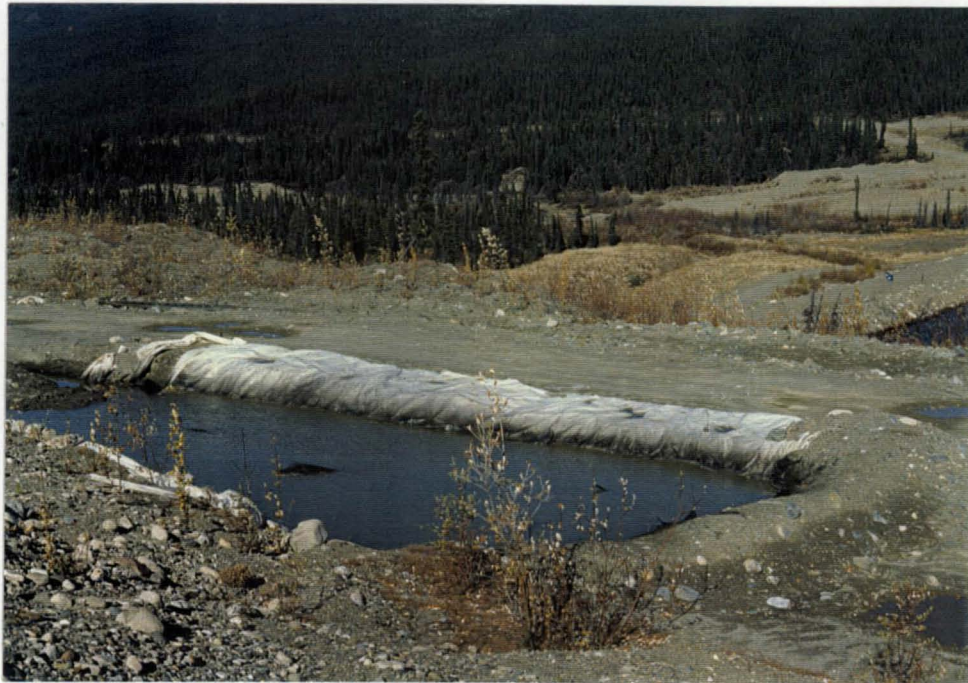
Figure 6

Situated just off the edge of the canal dyke and somewhat downstream of the Intermediate Dam, this unused sump is providing groundwater recharge to the area and it must be drained in the interests of local stability.

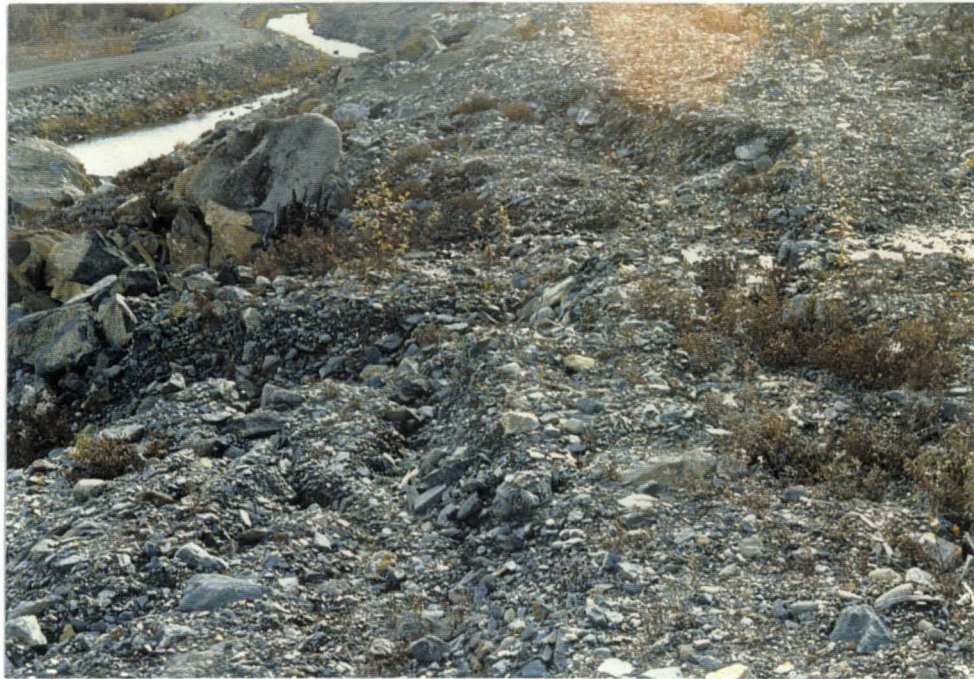
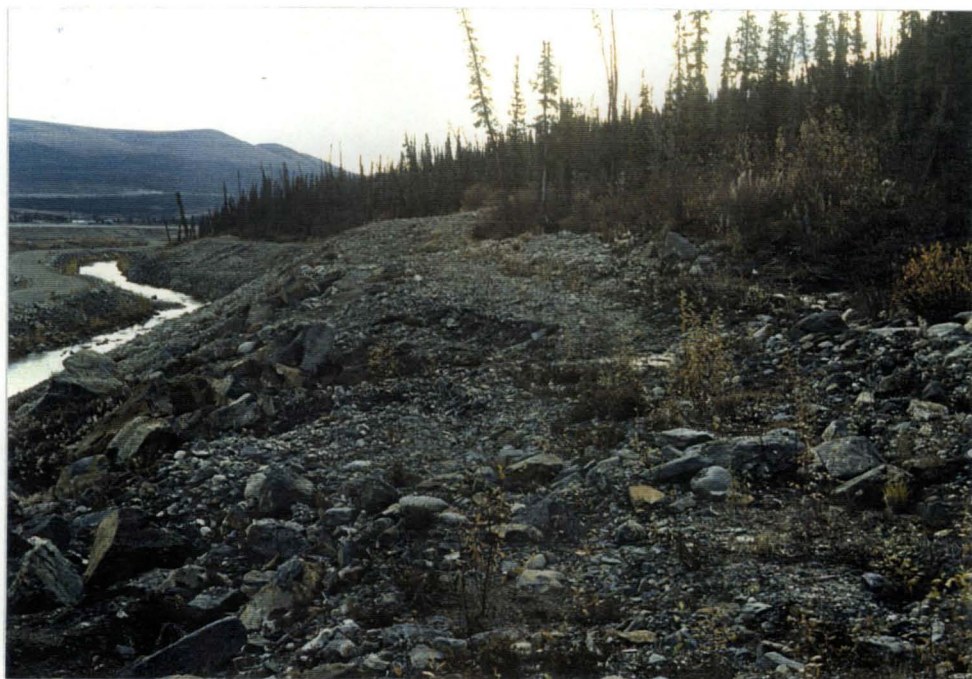
Figure 8

Referring to the previous figure, the upper photo is viewing upstream. Note the scarp in the centre of the photo. It appears not to have moved in the past year. Likewise, comparison of the lower photo with a similar 1994 photo indicates little or no movement in the lower left area.

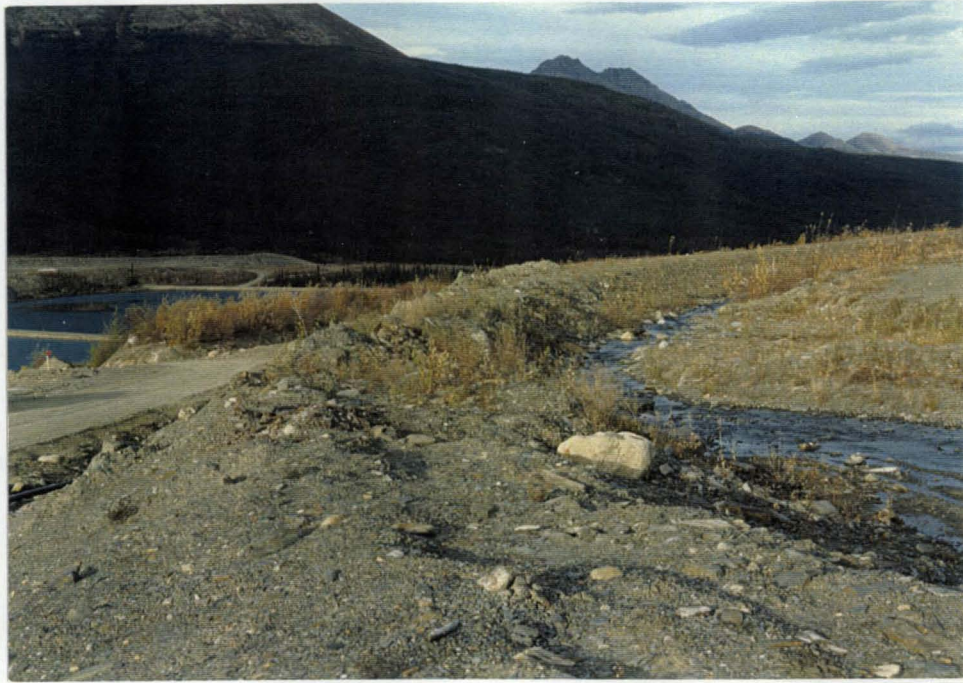
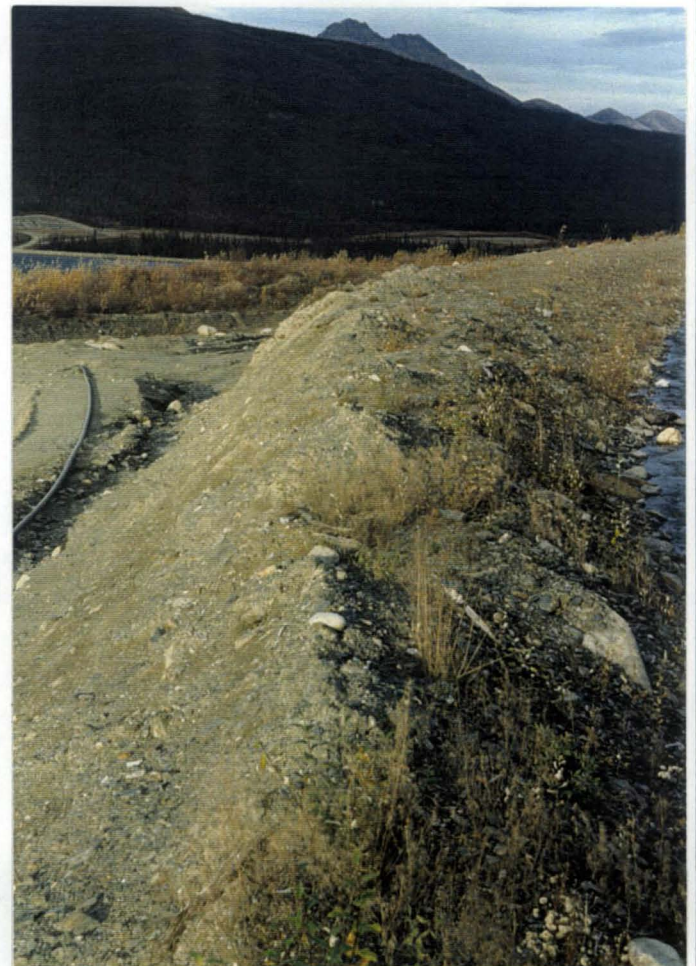
Figure 9

The subject area is upstream and above the north abutment of the Intermediate Dam. The north main access road is in the left centre of the upper photo. The adjacent dyke must contain the interceptor flow. As indicated by the lower photo, it needs to be raised and widened.

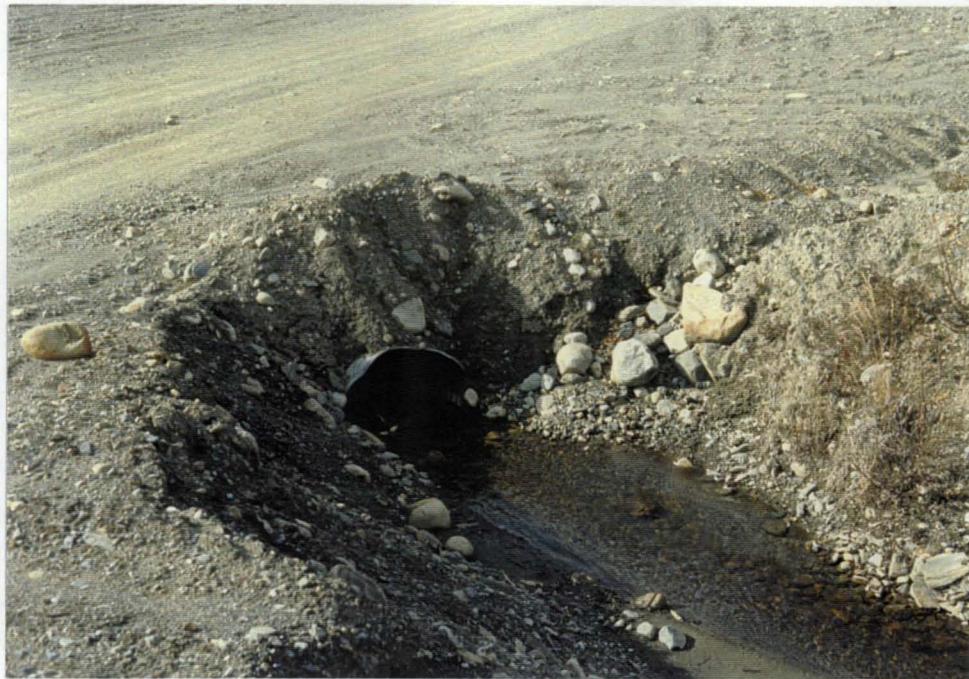
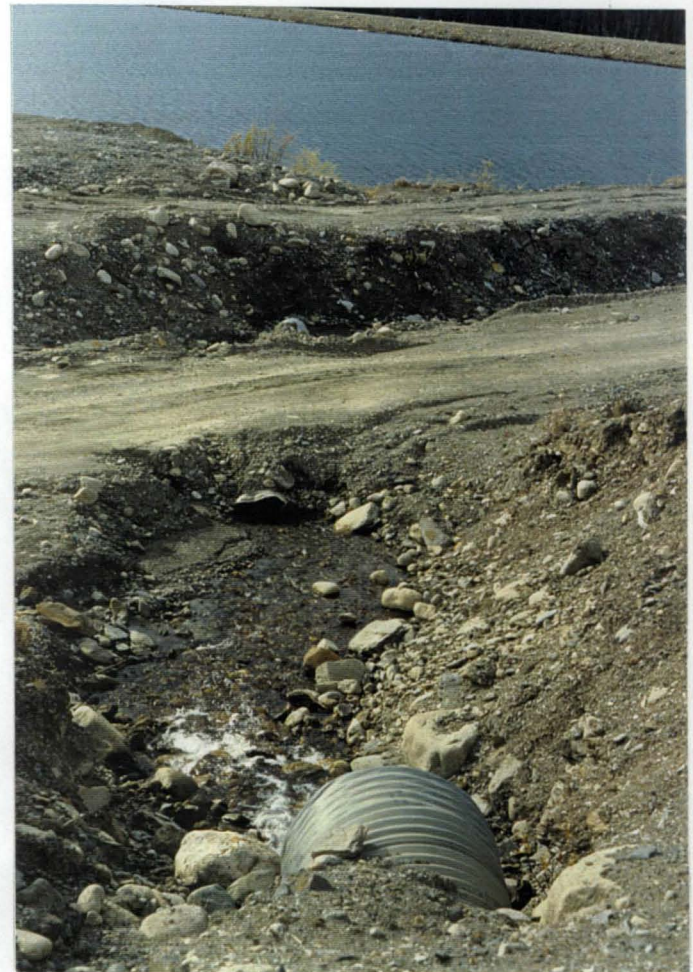
Figure 10

The upper photo is looking westerly across the main north wall access road; the lower photo across the trail that parallels the channel which conveys all flow past the Cross Valley Dam's north abutment. These culverts are of insufficient size to convey the $17.7 \text{ m}^3/\text{s}$ design flow (50 yr. return period).

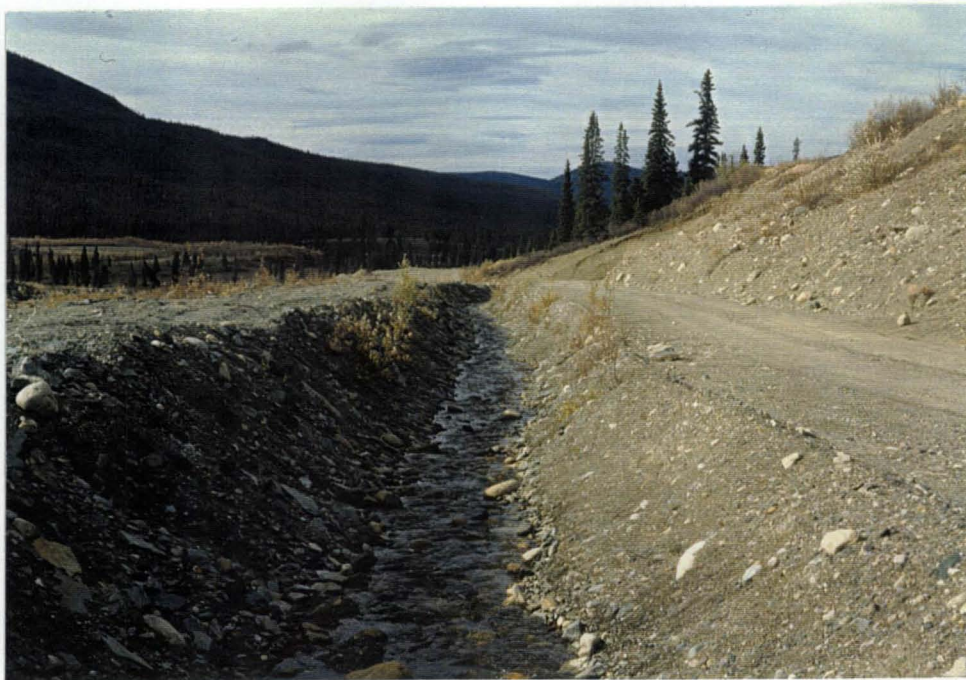
Figure 11

The outfall channel that conveys the flow past the Cross Valley Dam is insufficiently sized for the 50 yr. design flow of $17.7 \text{ m}^3/\text{s}$; 2H:1V sideslopes, 6.1 m bottom width and bank height of 2.6 m is the required design section, including 0.5 m of freeboard.

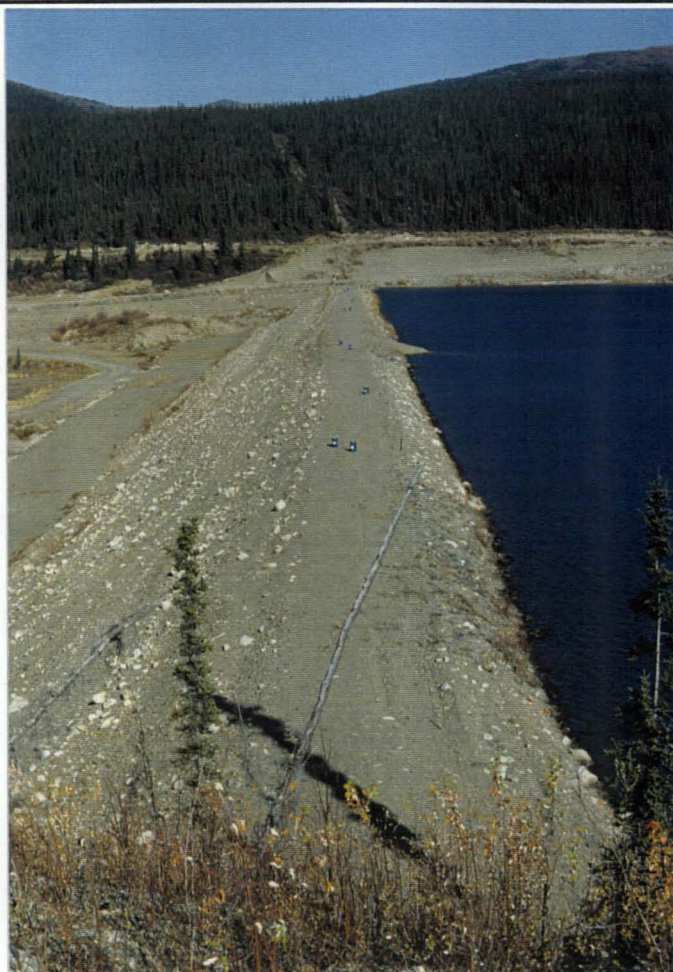
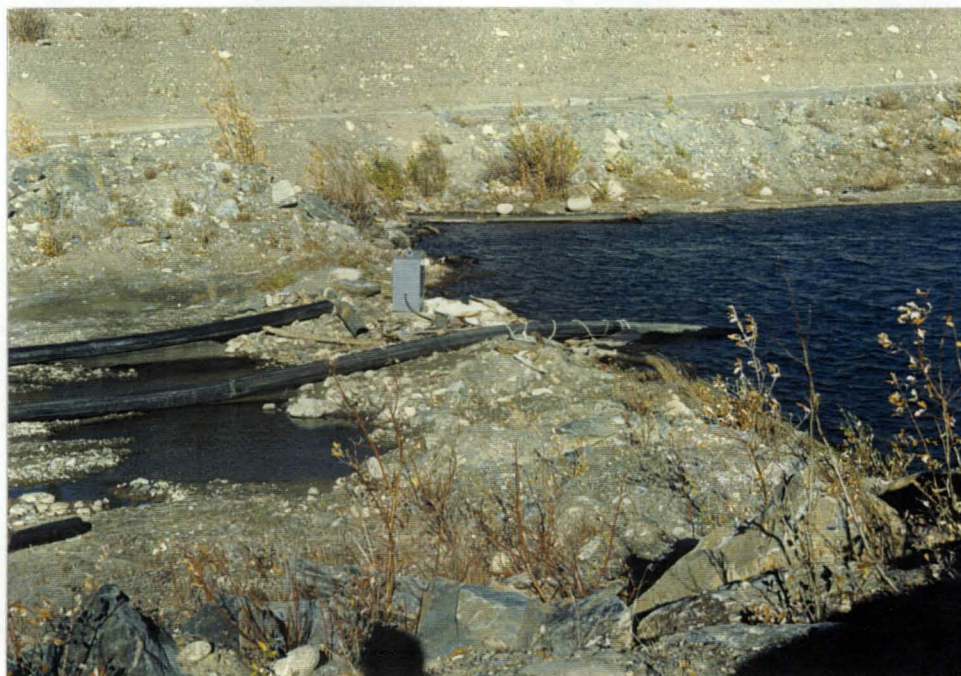
Figure 12

The upper photo illustrates the crest of the dam, looking northward. The lower photo is of the inlet to the spillway; the dyke may be retaining a pond level slightly above design FSL.

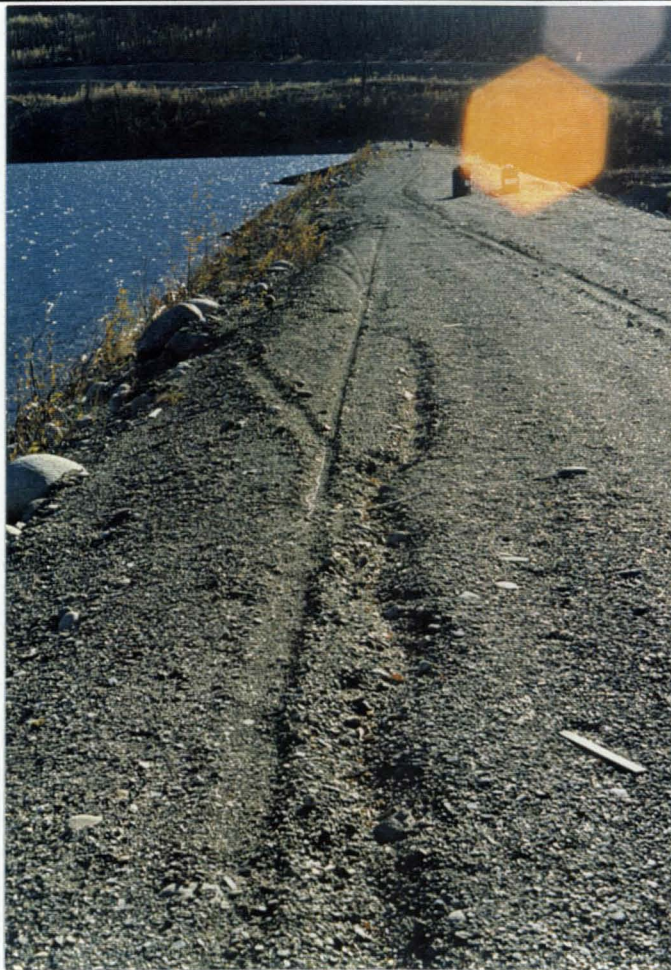
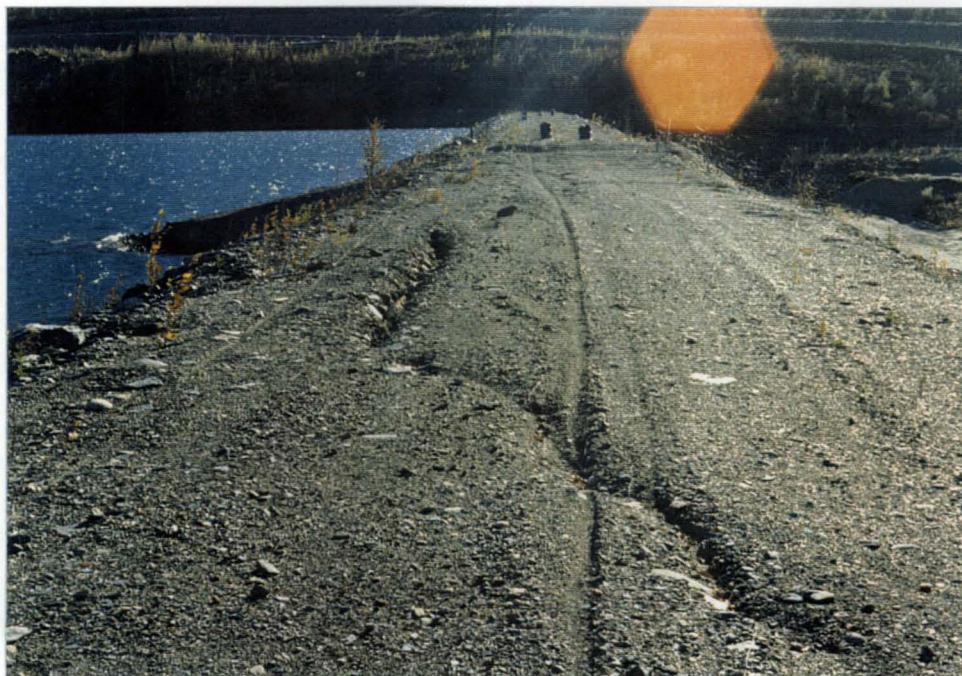
Looking southward along the crest, these photos illustrate the weathered status of old cracking. No sharp-edged cracks were observed.

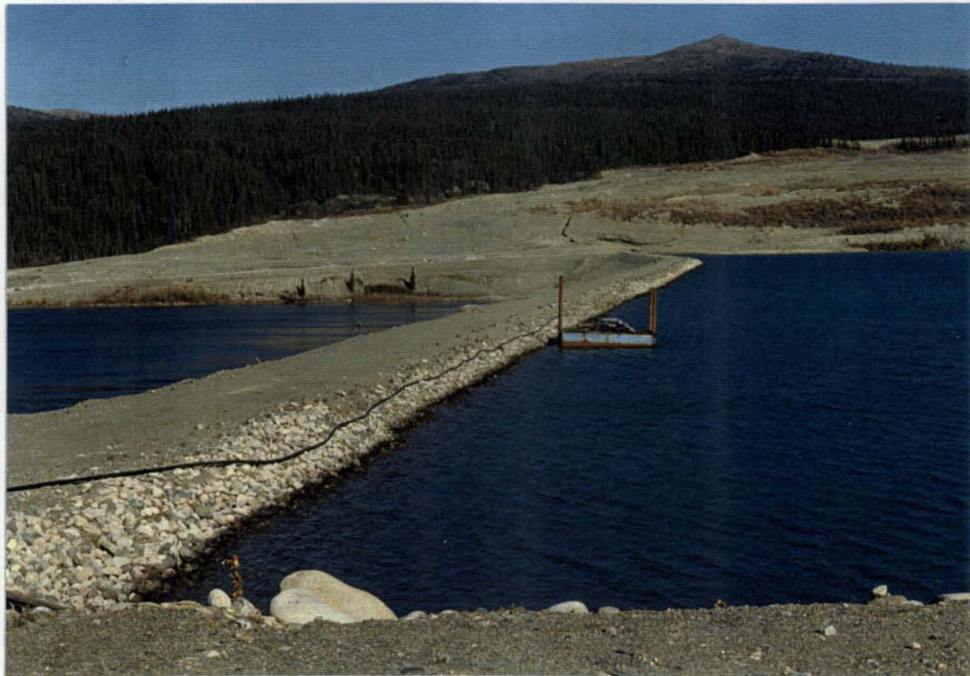
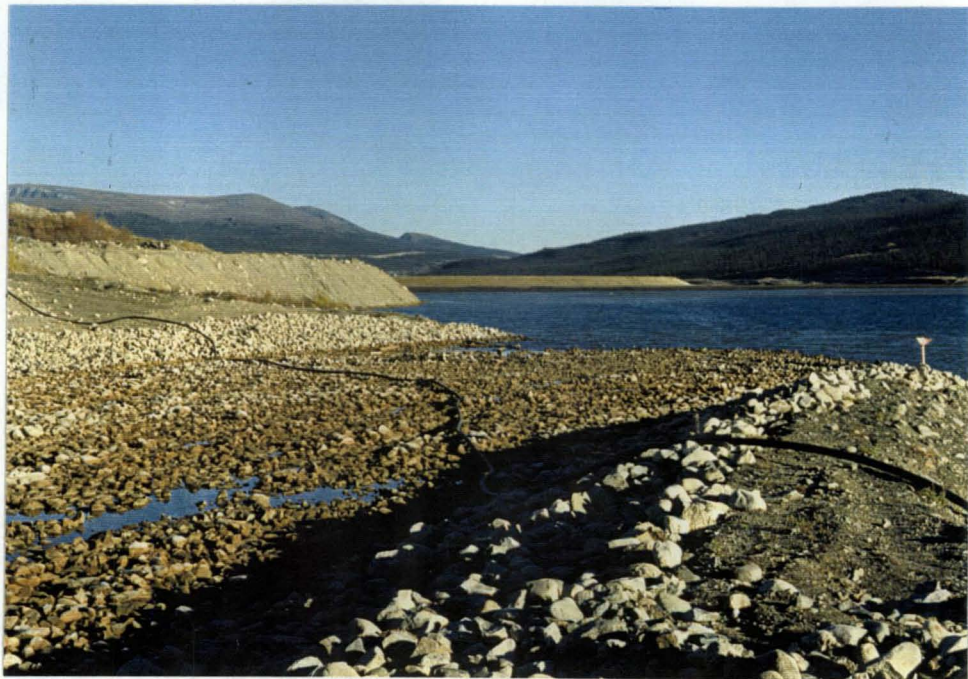
The upper photo illustrates the crest of the dam, looking northward. The lower photo is of the inlet to the spillway. Pond level is at FSL.

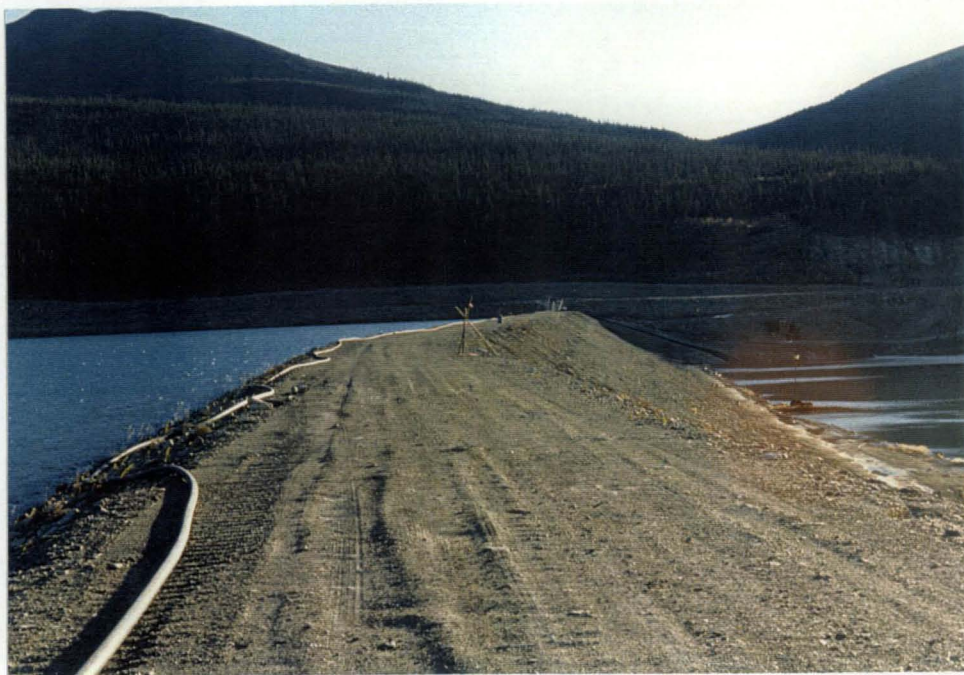
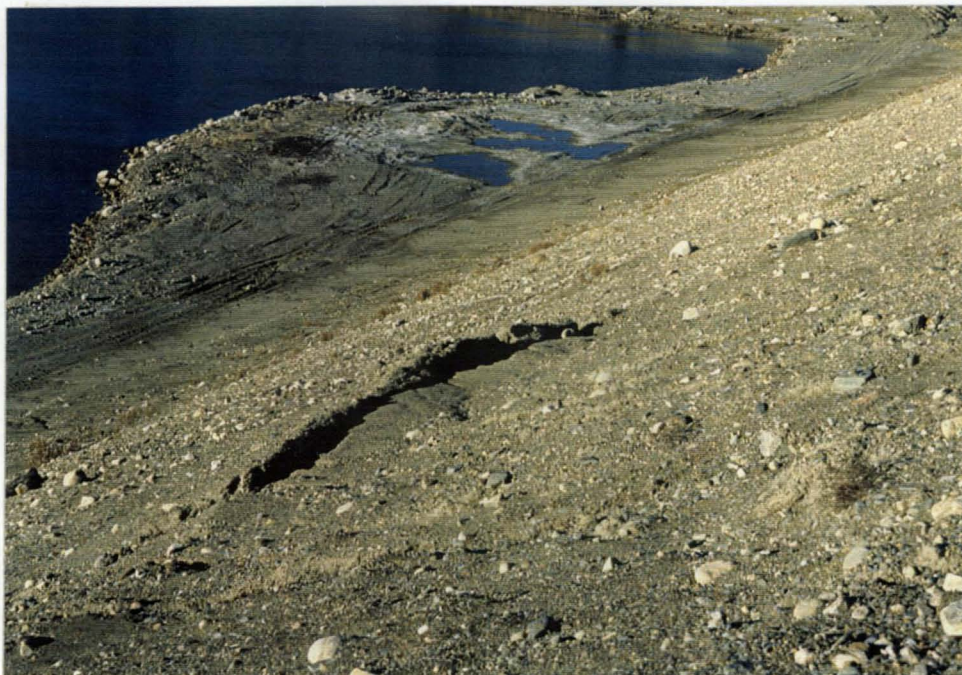
The upper photo illustrates the condition of the crest, viewing south. The lower photo is of the backslope, illustrating what appears to be a frost slab, perhaps dislodged by rill drainage, and propped up by sand carried along with the flow. The feature is about 3 m in length.

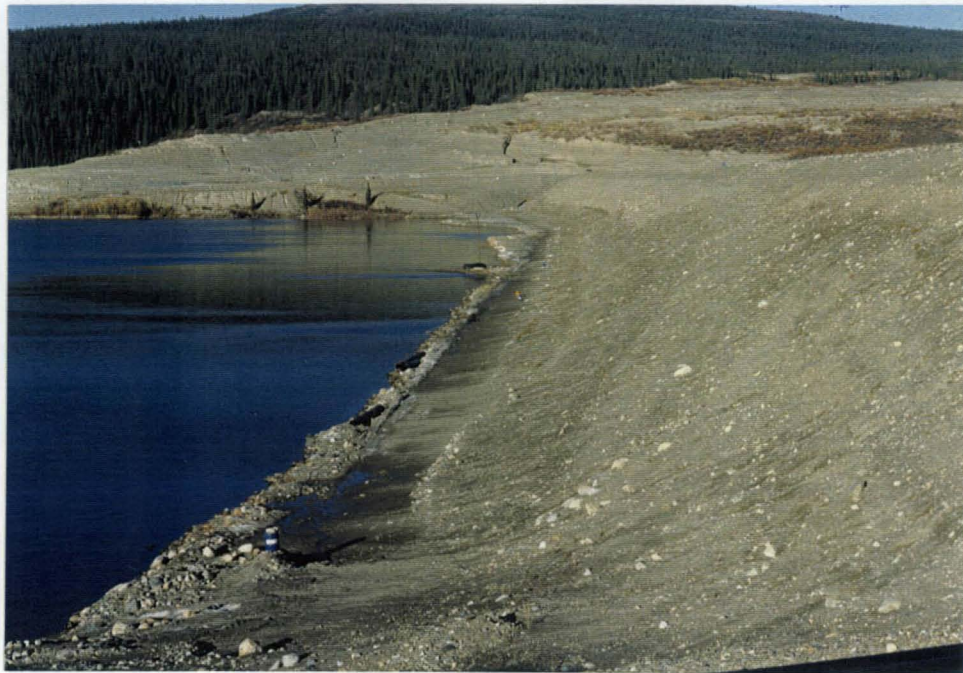
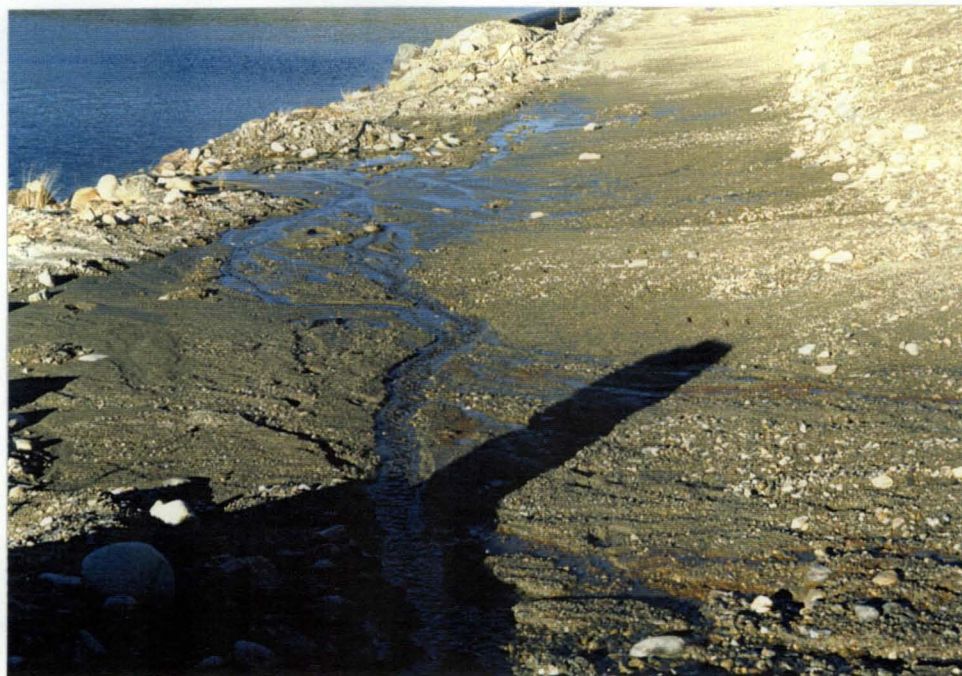
The upper photo is a general view of the backslope, looking northward. The wet area on the toe berm in the left foreground is illustrated in detail by the lower photograph. Seepage rate was an estimated 10 l/minute. Seepage is issuing from the drainage layer which daylights at berm level.

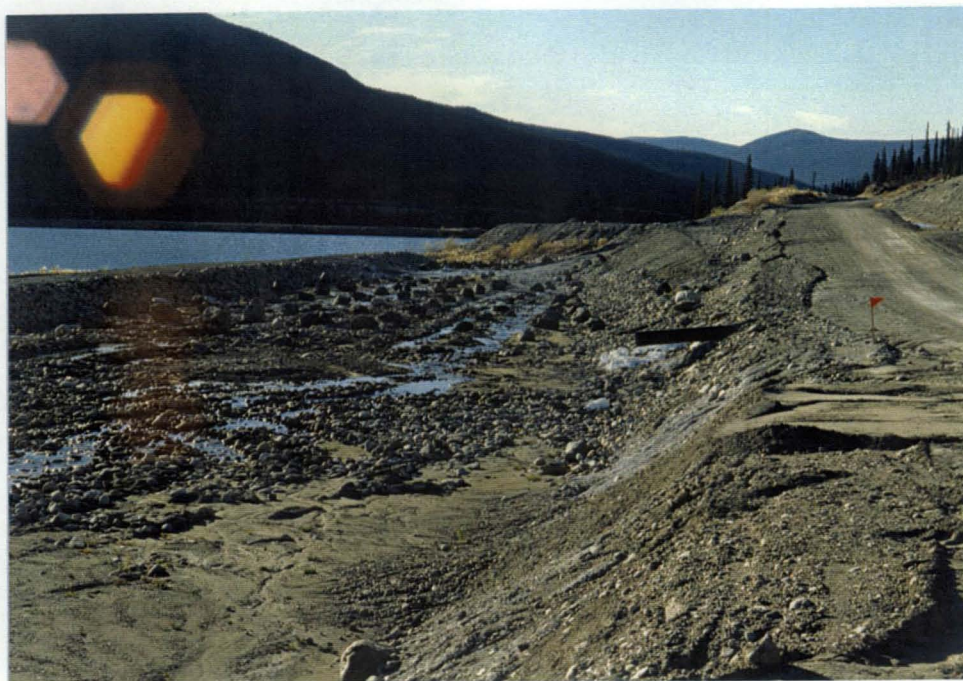
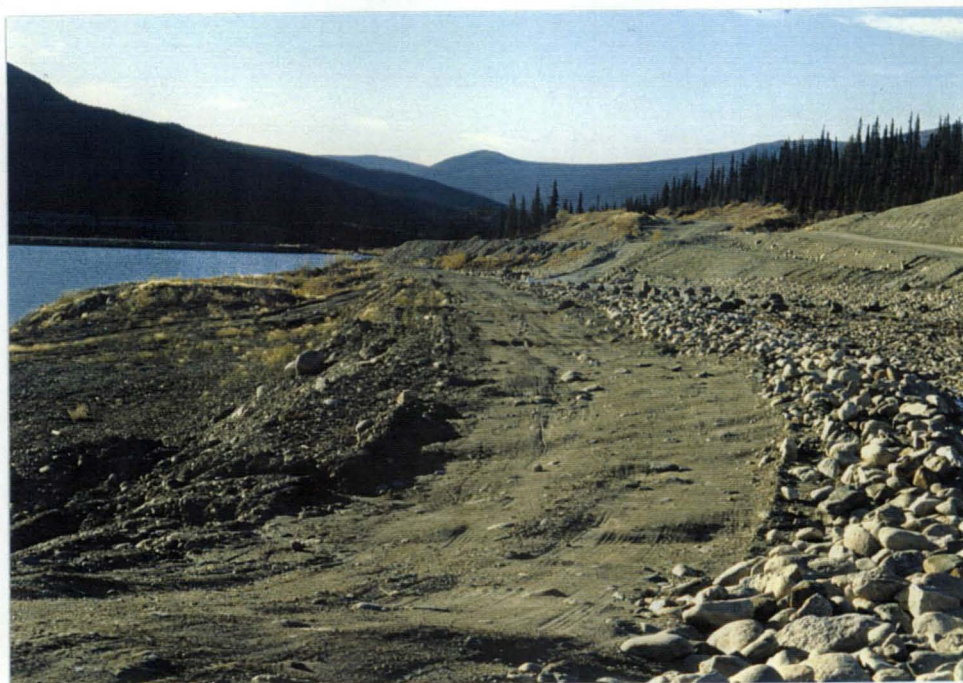
The upper photo is a general view of the gently graded spillway section with the retaining dyke to the left. The lower photo, taken from the dam crest, illustrates the crest of the spillway dyke. The dyke needs to be raised further, in spite of work done in late 1994.

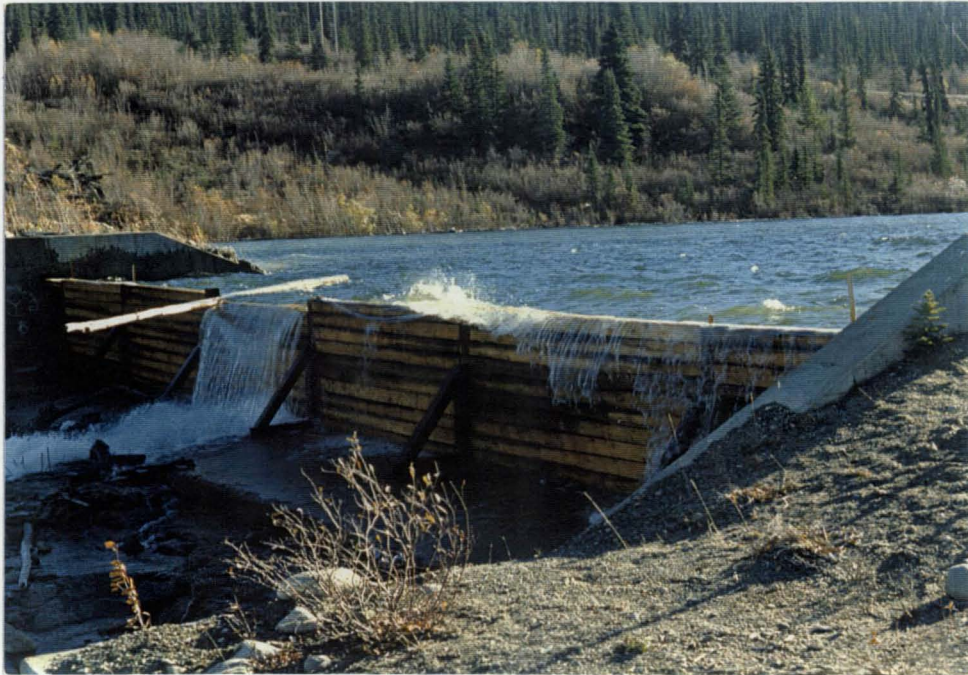
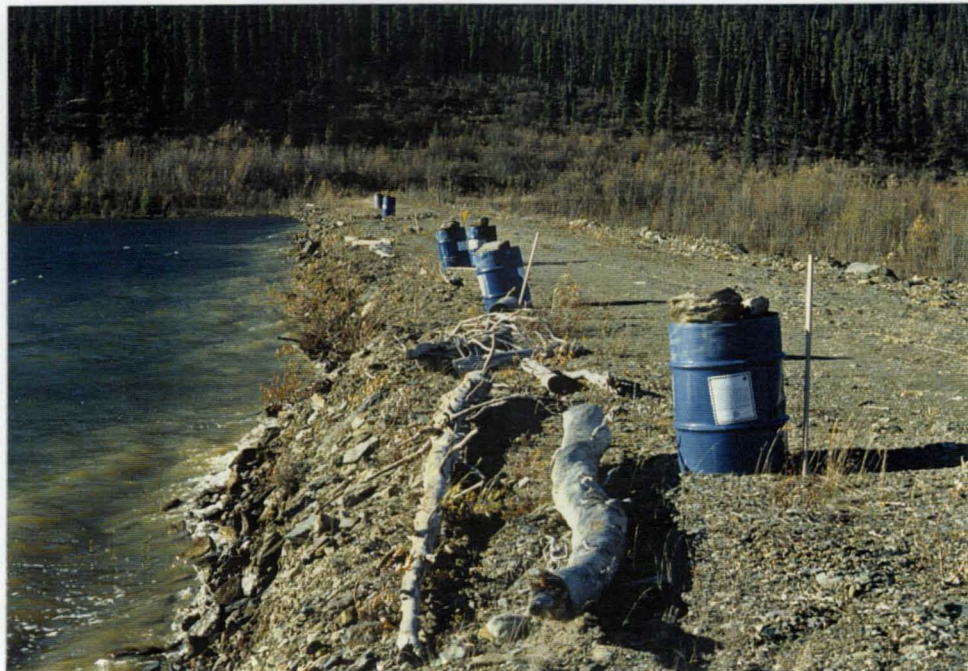
The upper photo illustrates the degree to which the spillway was stop-logged on September 20, 1995. The lower photo indicates that, as a consequence of this excessively high water level, waves have driven debris onto the crest. **This high water level is an unacceptable condition.**

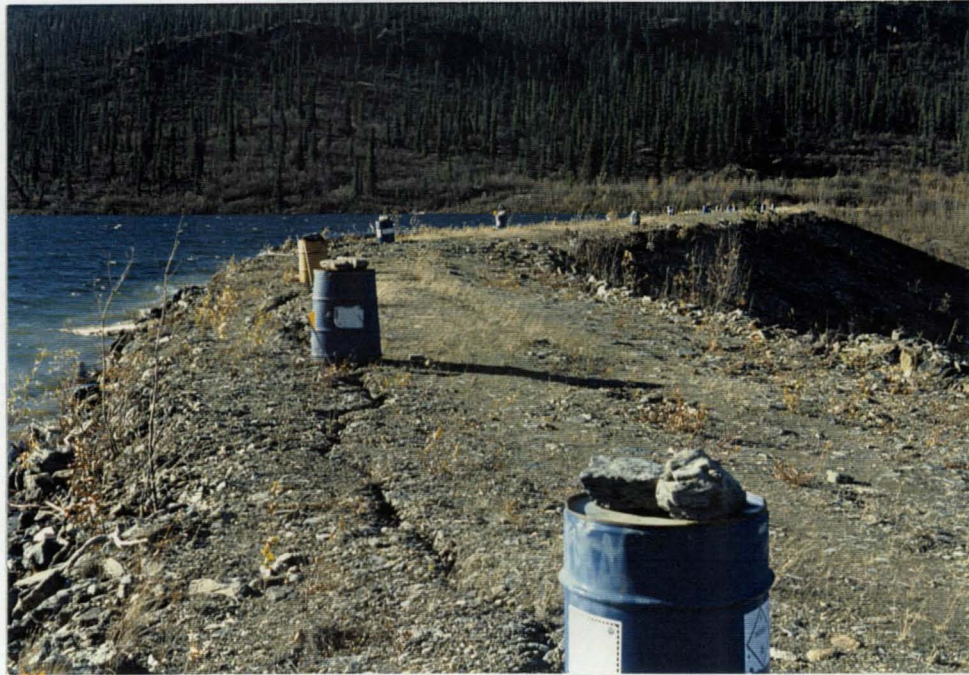
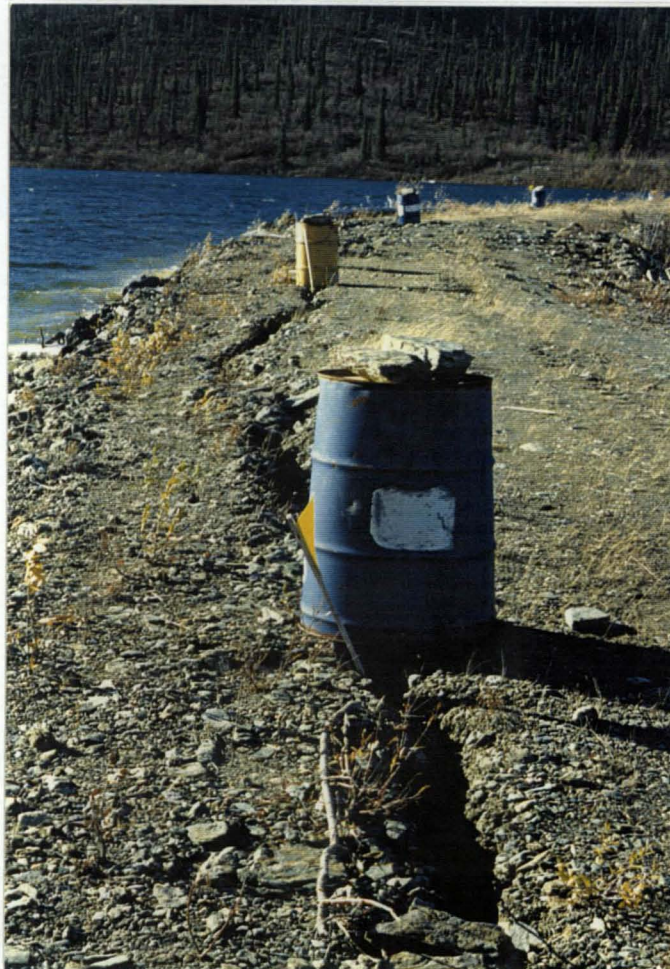
The upper photo illustrates the crest, looking south along the crest from near the spillway. The near-foreground blue barrel in this photo is captured by the lower photo, and the nature of the crest cracking can be noted.

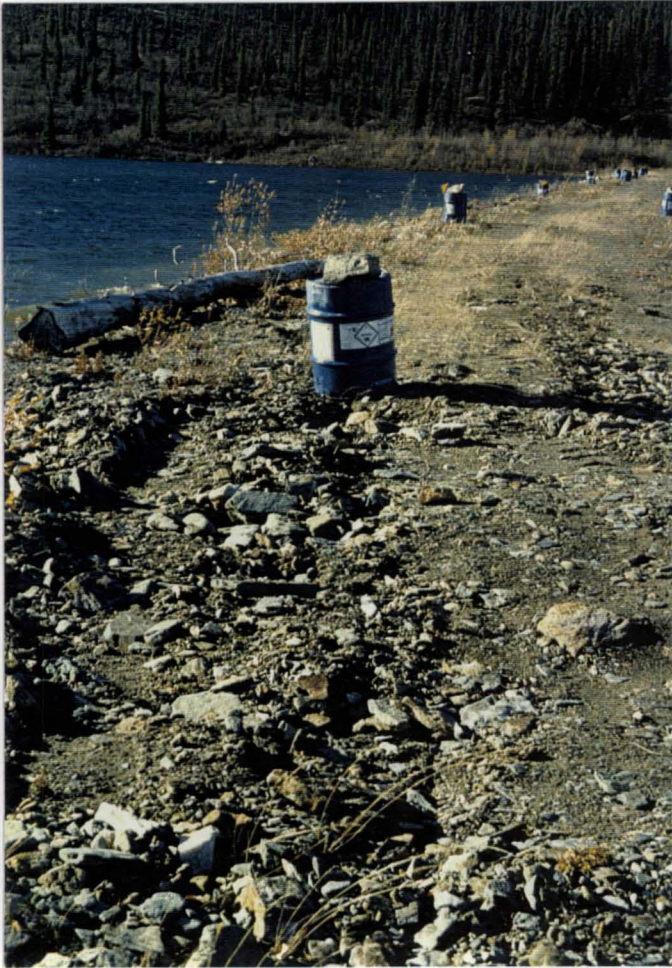
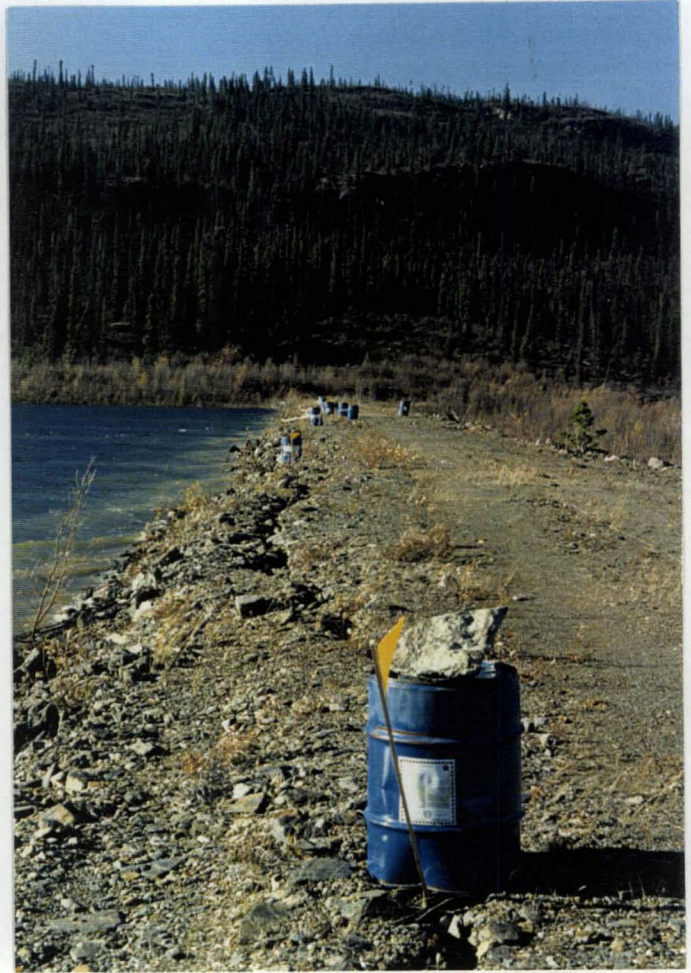
The left photo is of a test pit area, excavated and backfilled in June, 1994. Not much cracking has occurred since it was backfilled. The barrel in the foreground of the right photo can be seen in the left photo. Cracks in this area have not been disturbed by test pit activity.

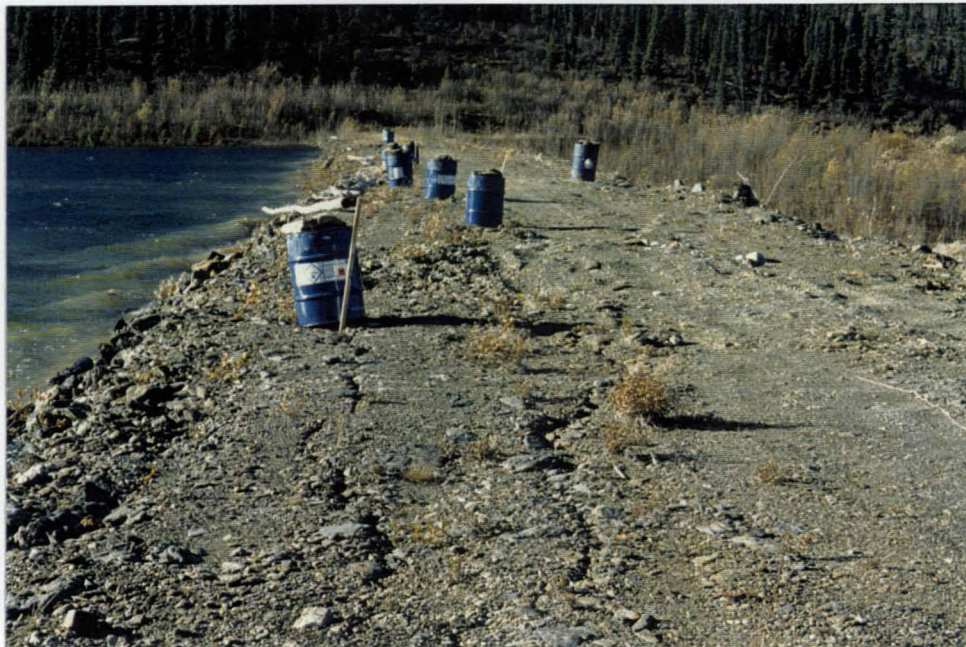
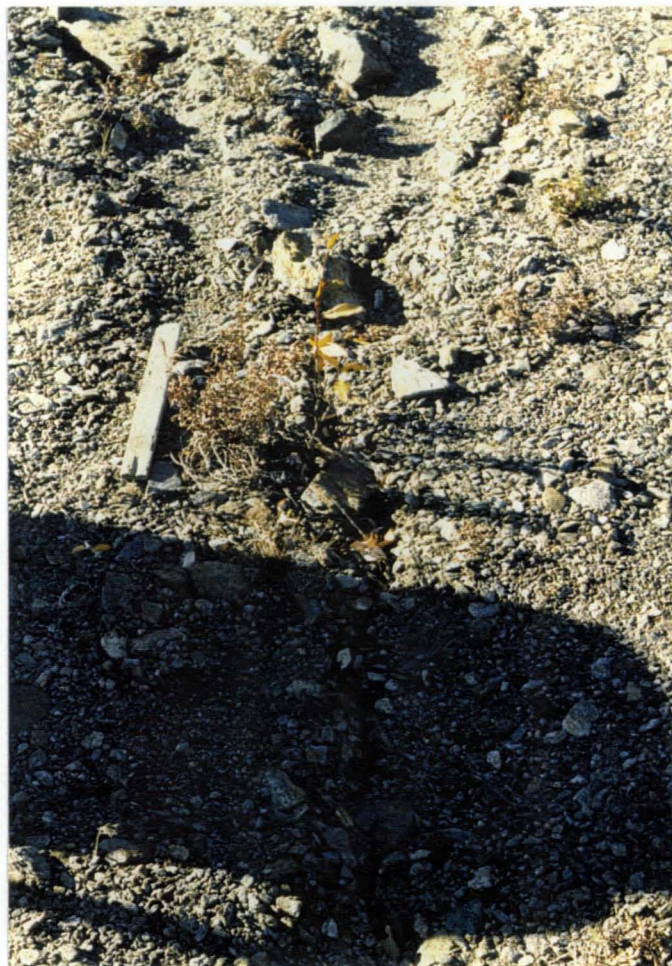
The upper photo shows a well-worn major crack at the edge of the crest, as well as 2 minor cracks farther to the right. The lower photo is a close-up of the test pit area immediately behind the barrel shadow. The lath can be used for scale to appreciate the width of the 1994/95 crack.
