June 26, 1990
Project Number 60619

Curragh Resources Ltd.
117 Industrial Road
Whitehorse, Yukon
Y1A 2T8

RE: Room and Pillar Review

The following is a brief report of the visit by Chris Page and Jim Mathis to the room-and-pillar operations at Faro during the week of 19 July.

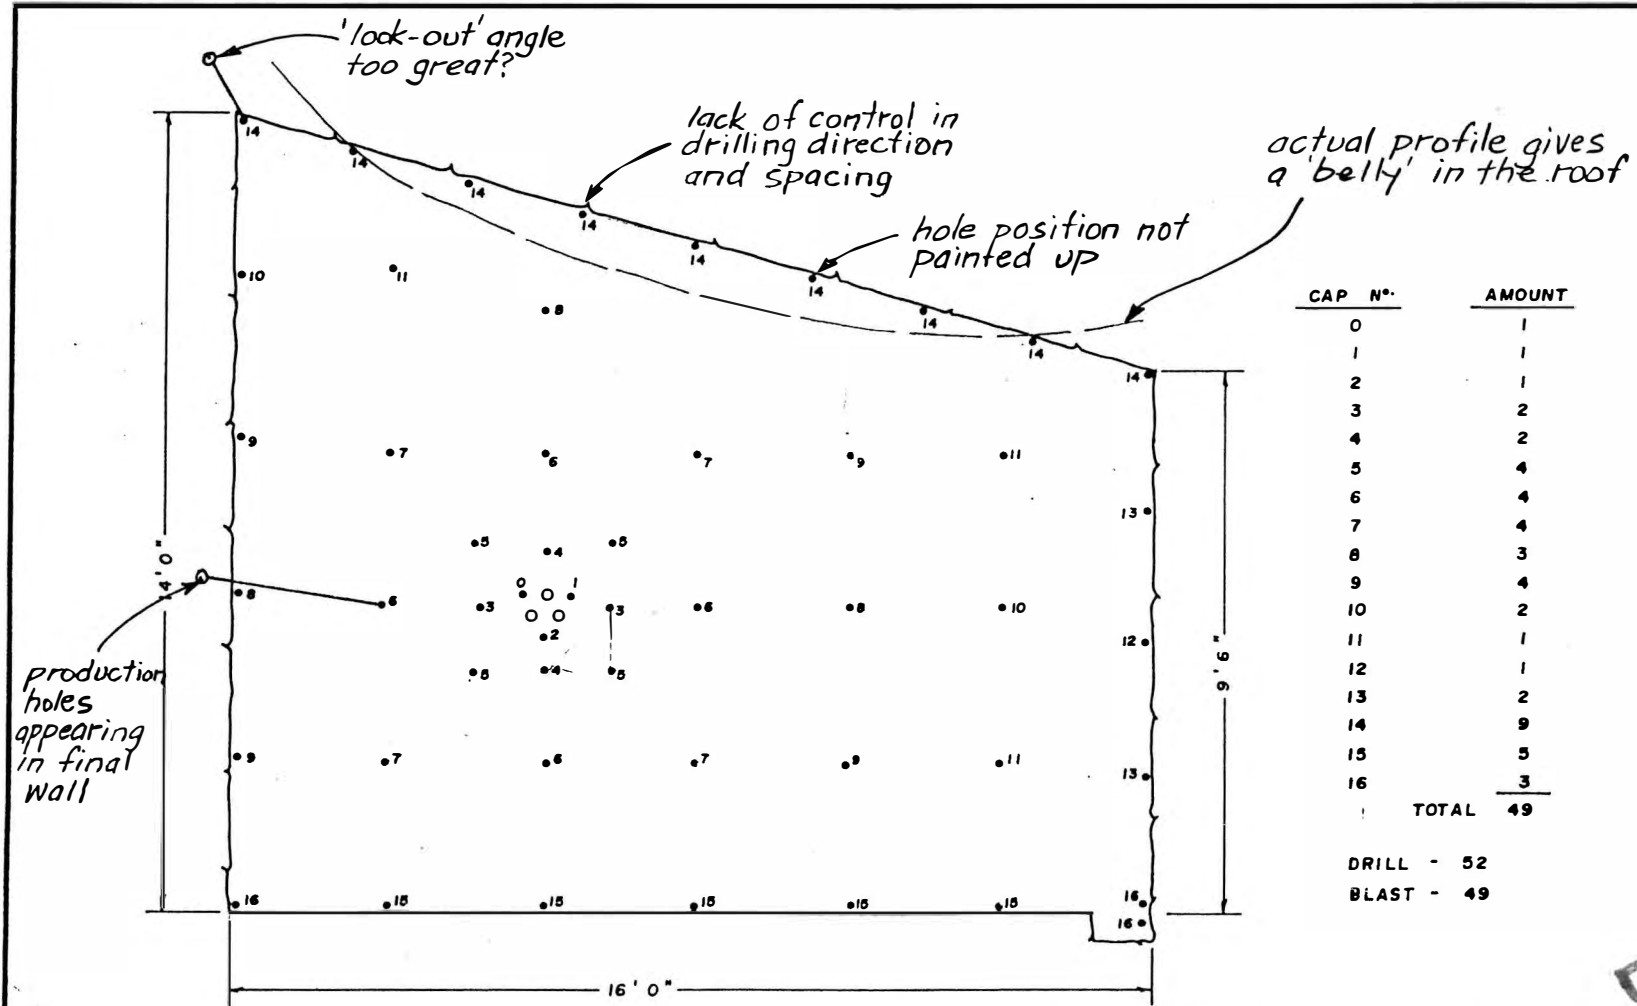
FIGURE

It is evident that there is not auto-parallelism on the drill jumbos, or it is not in use, and that there are many instances of incorrect hole alignment. This problem is especially critical in the corner holes of the roof. These are consistently overbreaking due to large look-out angles. The roof often has a convex profile due to poor spotting of holes and differences in hole angle. These points are highlighted in the accompanying sketch, Figure 4. It does not appear that the hole pattern is formally marked-up at the face. The angle on the holes varies throughout the ground. The result of poor layout is an uneven roof and walls, extra confinement for some of the holes and overbreak. The resulting surfaces will, therefore, be less stable.

A review of the standard drill layout indicates two problem areas. These are identified in Figure 5 and concern incorrect timing and overcharging of holes close to the roof.

The layout from CMD, "typical stope mining" has been reviewed. The layout appears effective but far fewer holes could be used. Most of the holes should have a good free face if the blast is broken into stages. A powder factor of 1 kg/m³ should be adequate which is an average burden and spacing of 4.5 ft.
