March 18, 1991
Project Number 60619

Curragh Resources Ltd.
Box 1000
Faro, Yukon
Y0B 1K0

RE: MARCH 5 SITE VISIT

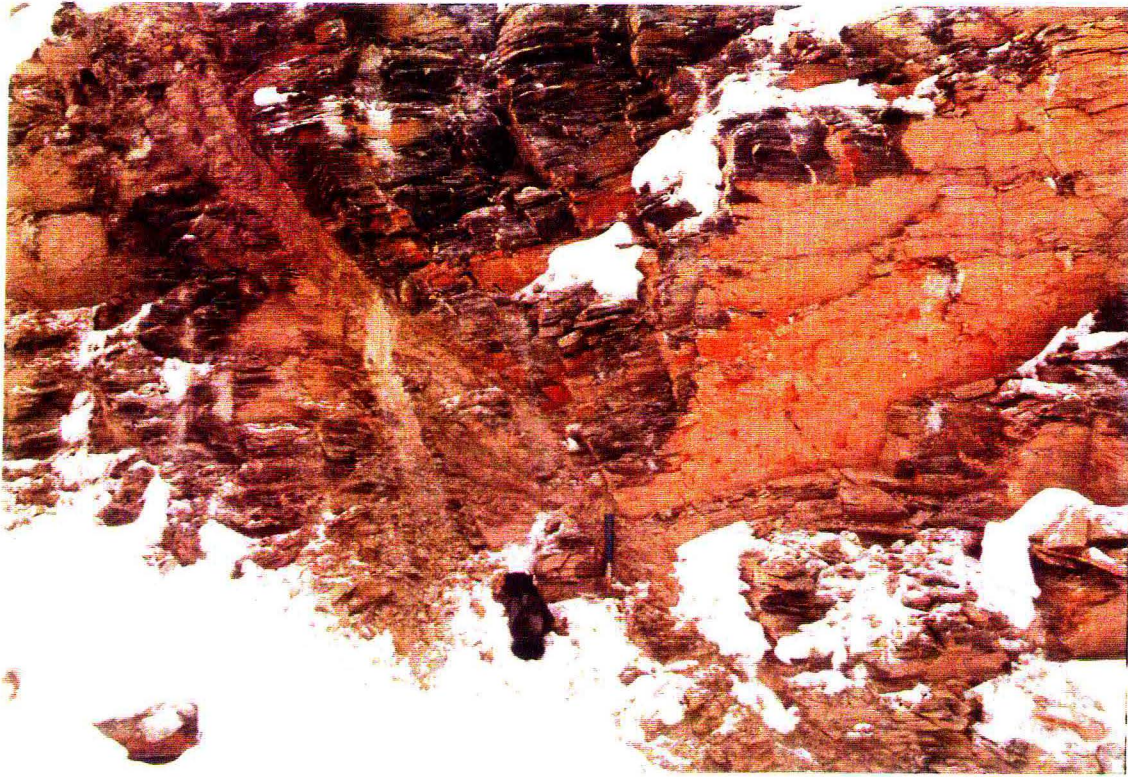
Plate 1

The proposed portal area was examined during the site visit. As was expected from core, the rock is very fissile but reinforceable (Plates 1-3). The RMR of the material is in the 20-30 range. The material is, however, extremely sensitive to vibration (de-lamination of the foliation planes). Only controlled blasting, with a minimum of explosives, should be used. Mechanical excavation, such as with a road-header machine, should be explored. Mechanical excavation would not disturb the rock mass, minimizing support. It may also be cheaper and give more rapid advance rates than standard drill-blast-muck excavation techniques. In either case, shotcrete or fibercrete must be used as support and to protect the rock from possible slaking.

Date
Plate 1:	Portal cut, right hand side facing portal	Proj No.
		Approved
Plate 2:	Portal cut, portal face	
STEFFEN ROBERTSON & KIRSTEN, Consulting Engineers

Drillholes along the proposed decline alignment should be re-logged, or the data reinterpreted using the MRMR system. Support should be estimated for both a mechanical and blasting excavation scenario.

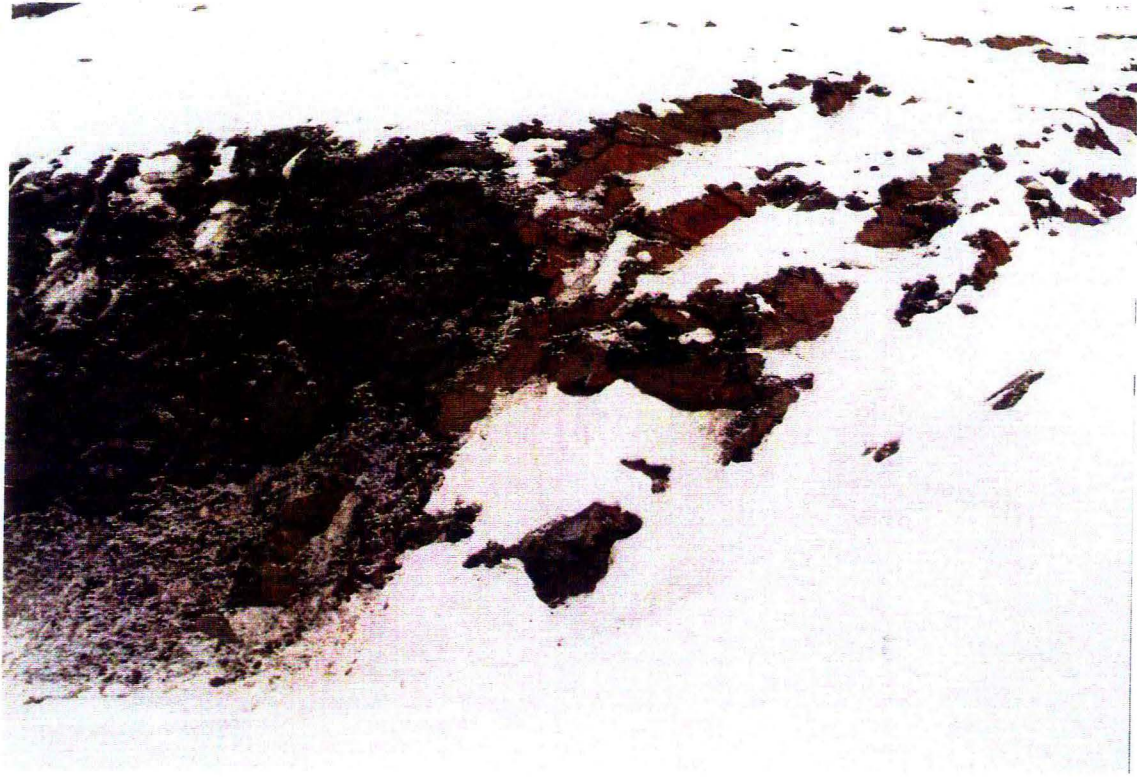
Plate 3

In addition, the soil composing the left side of the portal cut may become unstable during spring thaw. It appears as if the overall soil cut is too steep. However, this is an assessment made on a slope covered with snow and should be taken as such.

Date
Plate 3:	Portal cut, left hand side facing portal	Proj No.
		Approved
Plate 4:	Failure in NB725 near dike crossing. Note unbent and still anchored split sets, fragmented failure mass.

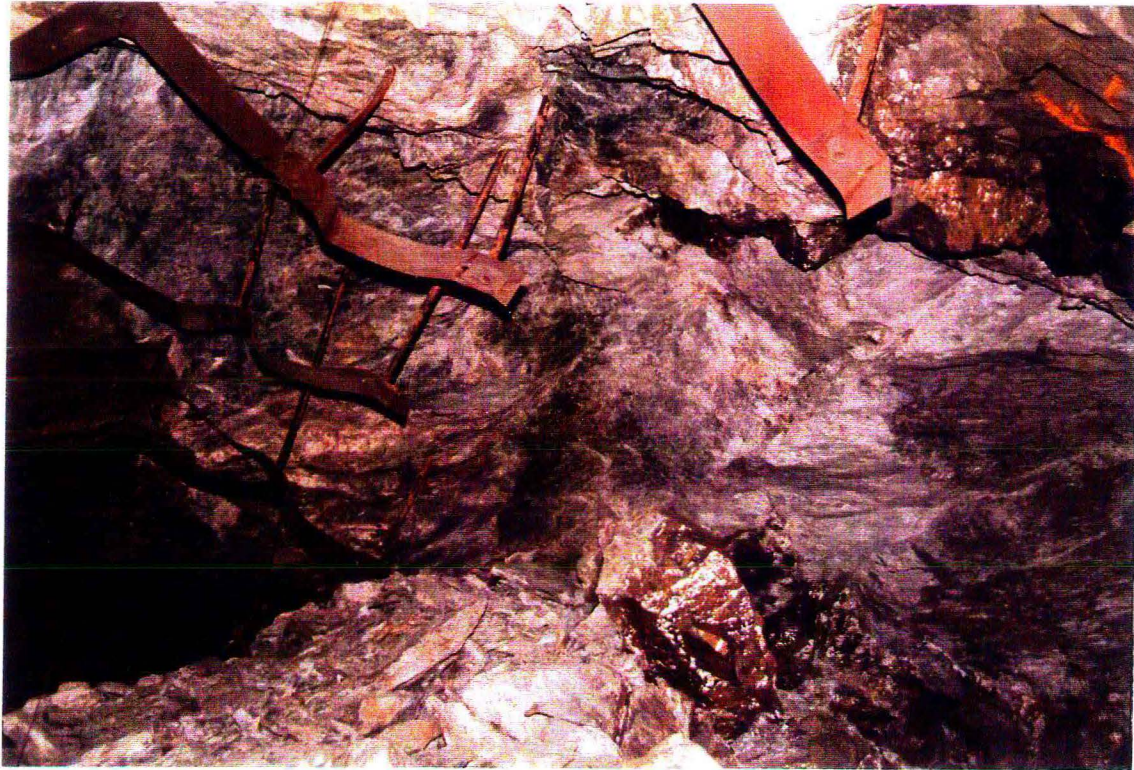
Plate 4

North extension where the drifts cross the dike defining the orebody limits, as well as in the South G ramp area. Frame 4 shows how the rock has peeled away from the split sets, leaving them not only unbent but still firmly anchored in the back. This is indicative of a rock substance failure. Shotcrete followed by bolting should be attempted in such areas.

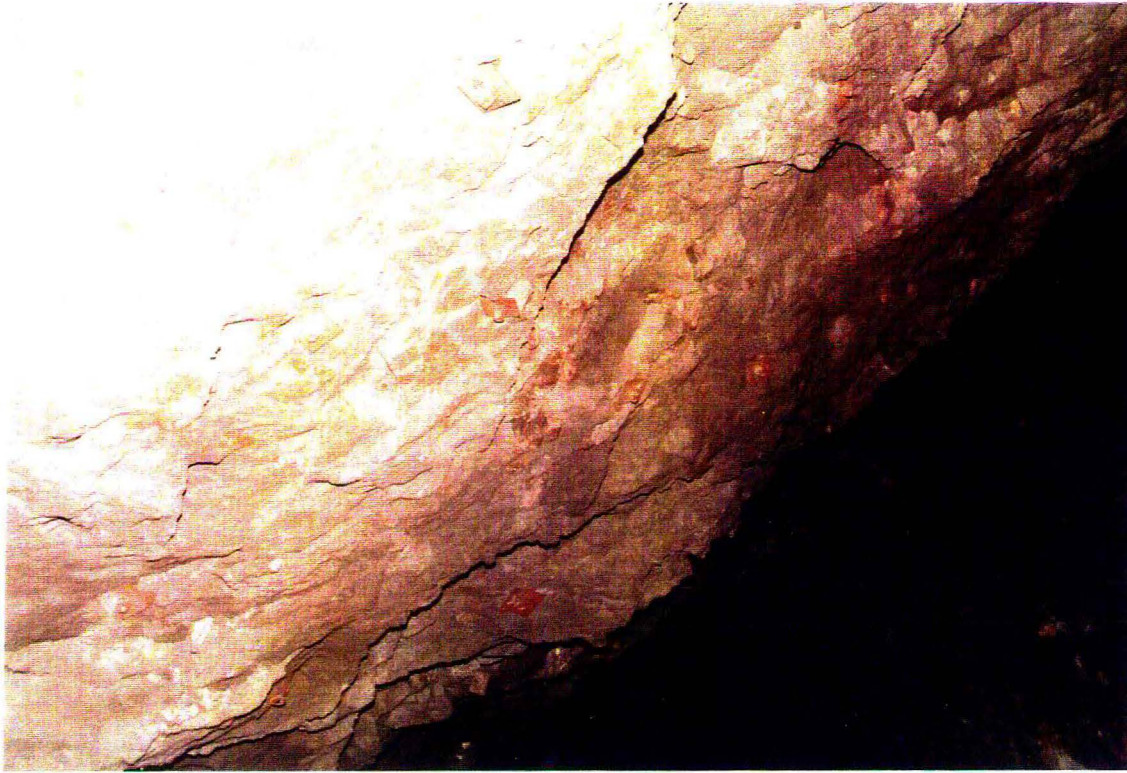
Plate 5

The one slusher stope which has been mined, although not technically a slusher stope, is not adequately supported. Mechanical rockbolts (Frame 5) are used almost exclusively in the back of the stope. Between 60-80% of these bolts are no longer tensioned (bearing plate not in contact with rock) and are therefore providing no support. The mining span is such that the back must be supported with a support system which does not need maintenance. This means that either split sets or grouted bolts must be used. Mechanical anchor bolts are dangerous if they cannot be maintained (re-tensioned) on a regular basis. They should never be used where they cannot be accessed.

Date
Plate 5:	Mechanical anchor rockbolts in SA-500STP	Proj No.
		Approved
Plate 6:	Possible bearing plate bending in South B room area	
STEFFEN ROBERTSON & KIRSTEN, Consulting Engineers

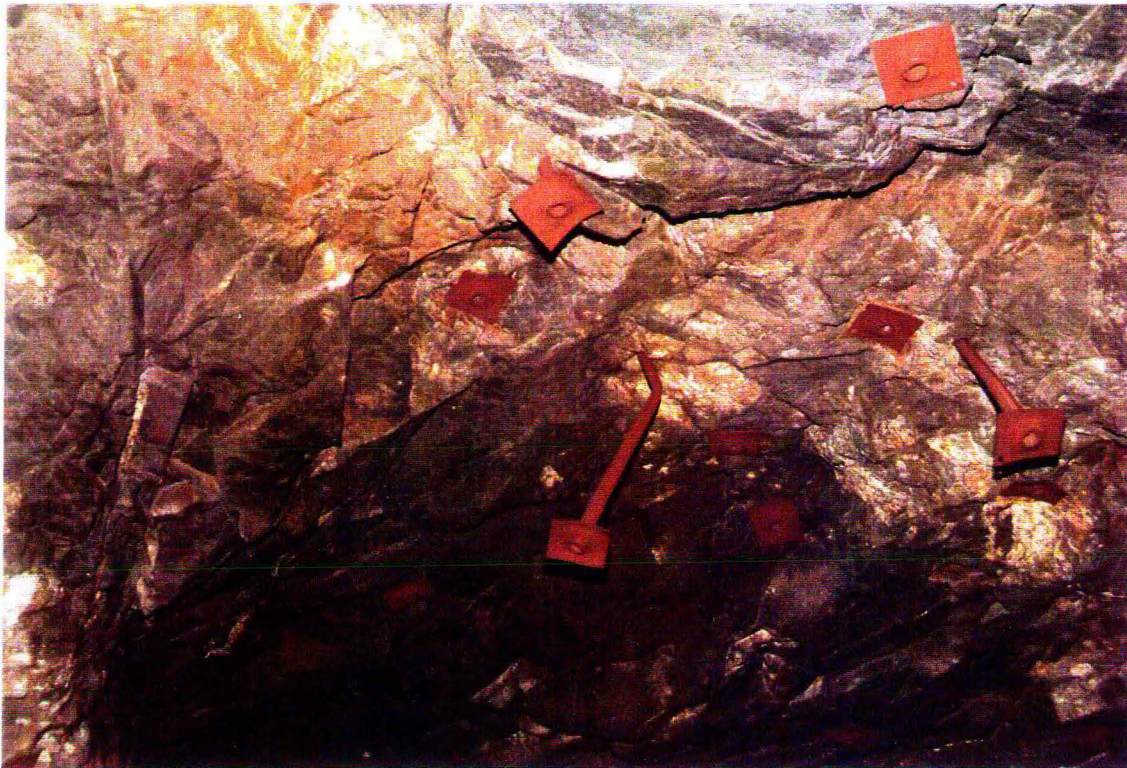
Plate 6

An examination of the South B stoping area uncovered very minor pillar spalling, indicating that the pillars are beginning to take some load. Bearing plate bending (Plate 6), between some of the pillars in the area, may indicate that the back is beginning to sag slightly. The conditions of both pillars and spans between pillars should be monitored on a continuing basis.
