Project Number 60619

Curragh Resources Inc.

RE: REVIEW OF ROCKFALL IN SN711 AREA

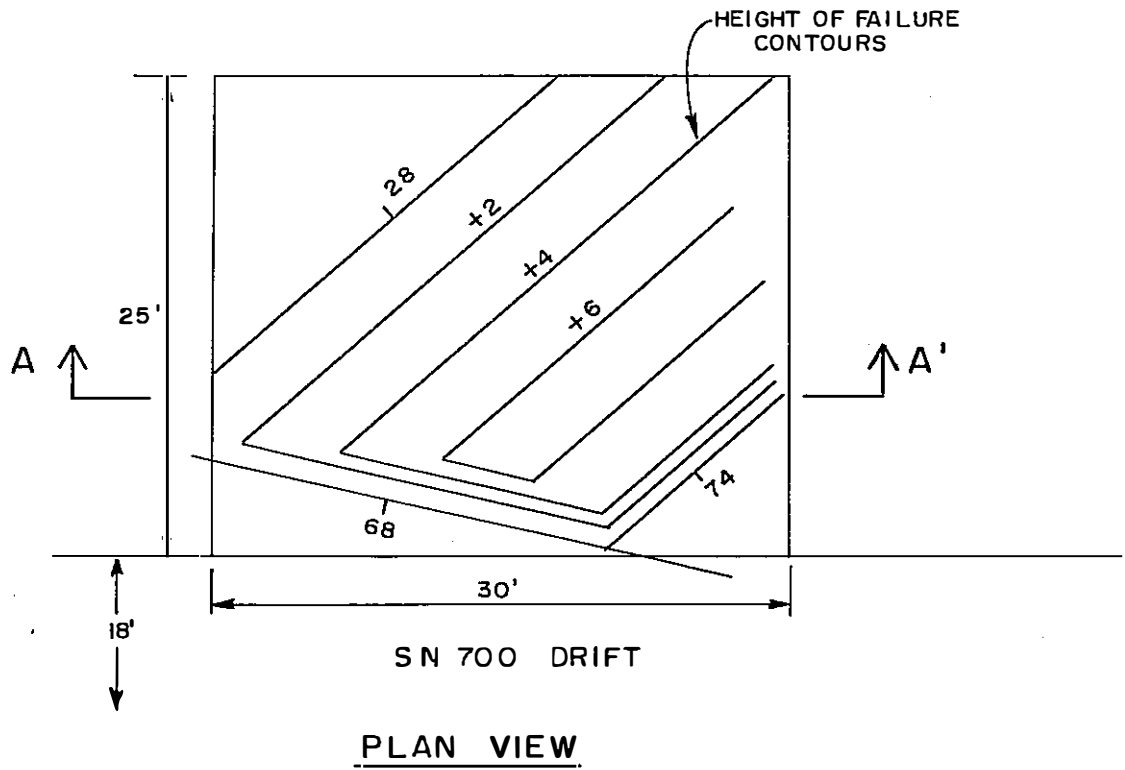
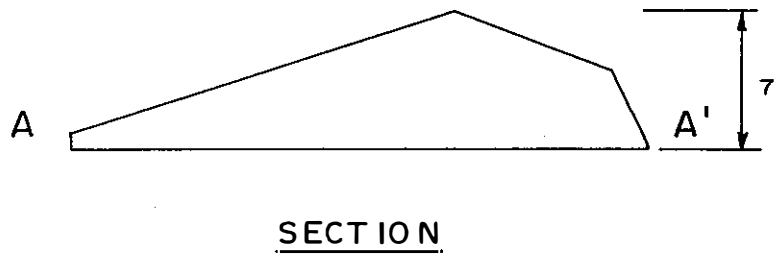
CURRAGH RESOURCES LTD.	FARO UNDERGROUND	DATE JAN. 1992
SN 711 ROCKFALL APPROXIMATE DIMENSIONS		PROJ. NO. 60619
		APPROVED
STEFFEN ROBERTSON & KIRSTEN, Consulting Engineers		NO.
		1

The rock fall experienced in the SN711 area is depicted in plan and section in Figure 1 and as a photographic plate in Figure 2. Please note that Figure 1 is based on approximate measurements as the area was, at the time, unstable and did not allow for exact measurements.

Geologic structure was the main cause of this failure. It is a wedge bounded by a low angle geologic structure (joint or fault) on one side together with two higher angle (steeper) structures. Maximum failure depth appears to be 7 to 8 feet, with a volume in the range of 150 - 200 tons. The failure is approximately 25 foot long parallel to the SN700 drift, extending into the SN711 area approximately 14 to 17 feet. Failure occurred immediately after the slash round was detonated as the wedge, which ultimately failed, was cantilevered over the room. The slash round removed the support under the pinned end of the cantilever, allowing failure.

Rock support in the area was composed of 6 foot split sets on an average 4 ft by 4 ft pattern (Curragh personnel estimate). As this was a structurally defined wedge, it became a suspension load on the bolts. Split sets are not designed for, nor do they function well, carrying suspended loads (SRK letter 04/12/91). In addition, they were not long enough to penetrate the observed failure planes. A simplified back analysis of the failure, based on the observations made for Figure 1, indicates a safety factor of 0.2. This does not take into account intact rock which may bring the factor of safety to near 1. The bolt pattern recommended in our letter (SRK 4/12/91) gives safety factors of 1.05 and 1.44 respectively for 8 ft long, 3/4-inch and 7/8-inch grouted bolts, not including the intact rock. It is impossible to say whether grouted

bolts, as recommended, would have prevented the fall as the ground is badly fractured, however, the numbers suggest that they could only have helped.

Adequately supporting the back would entail using 8 to 10 foot long grouted bolts on 4 to 5 foot centers. Split sets would be required between the grouted bolts as a fill-in support measure to support the smaller rock blocks. Mesh or strap would also be required to prevent raveling from around the bolts as well as to protect the miners during benching operations. Pull tests would be required on the grouted bolts in order to determine if they are holding correctly in the talc and muscovite schists. Cement grouted bolts would be preferred. A motion alert system, such as tell-tales or extensometers would be required to verify if the support system is effective.

A minimum thickness of ore, varying from 4 to 6 feet, could be left in the back. The ore could then be supported as required. This would require a good knowledge of the back before excavation so that the

Reducing the mining span from 30 foot to 20 foot would dramatically decrease the size and total depth of potential failures. As such, the support requirements, in terms of length of support and support intensity would be reduced compared to the other two options. Pillar sizes can be reduced according to the design methods outlined in our previous letters to reflect the change in the area which they are supporting. Longer bolts should still be used and where suspension type loads are suspected, grouted bolts should be used. Pillars, being thinner, will be much more sensitive to damage and undercutting. As such, extra care must be taken while cutting the initial pillar and during benching. As a direct consequence, pillar bolting will become more critical to prevent pillar slabbing as well as to contain damaged rock.
