U/G PILLAR  
INSPECTION

PIVAR INSPECTION

CURRAGH RESOURCES INC.  
file: PILLAR

FARO U/G PILLAR INSPECTION  
=====

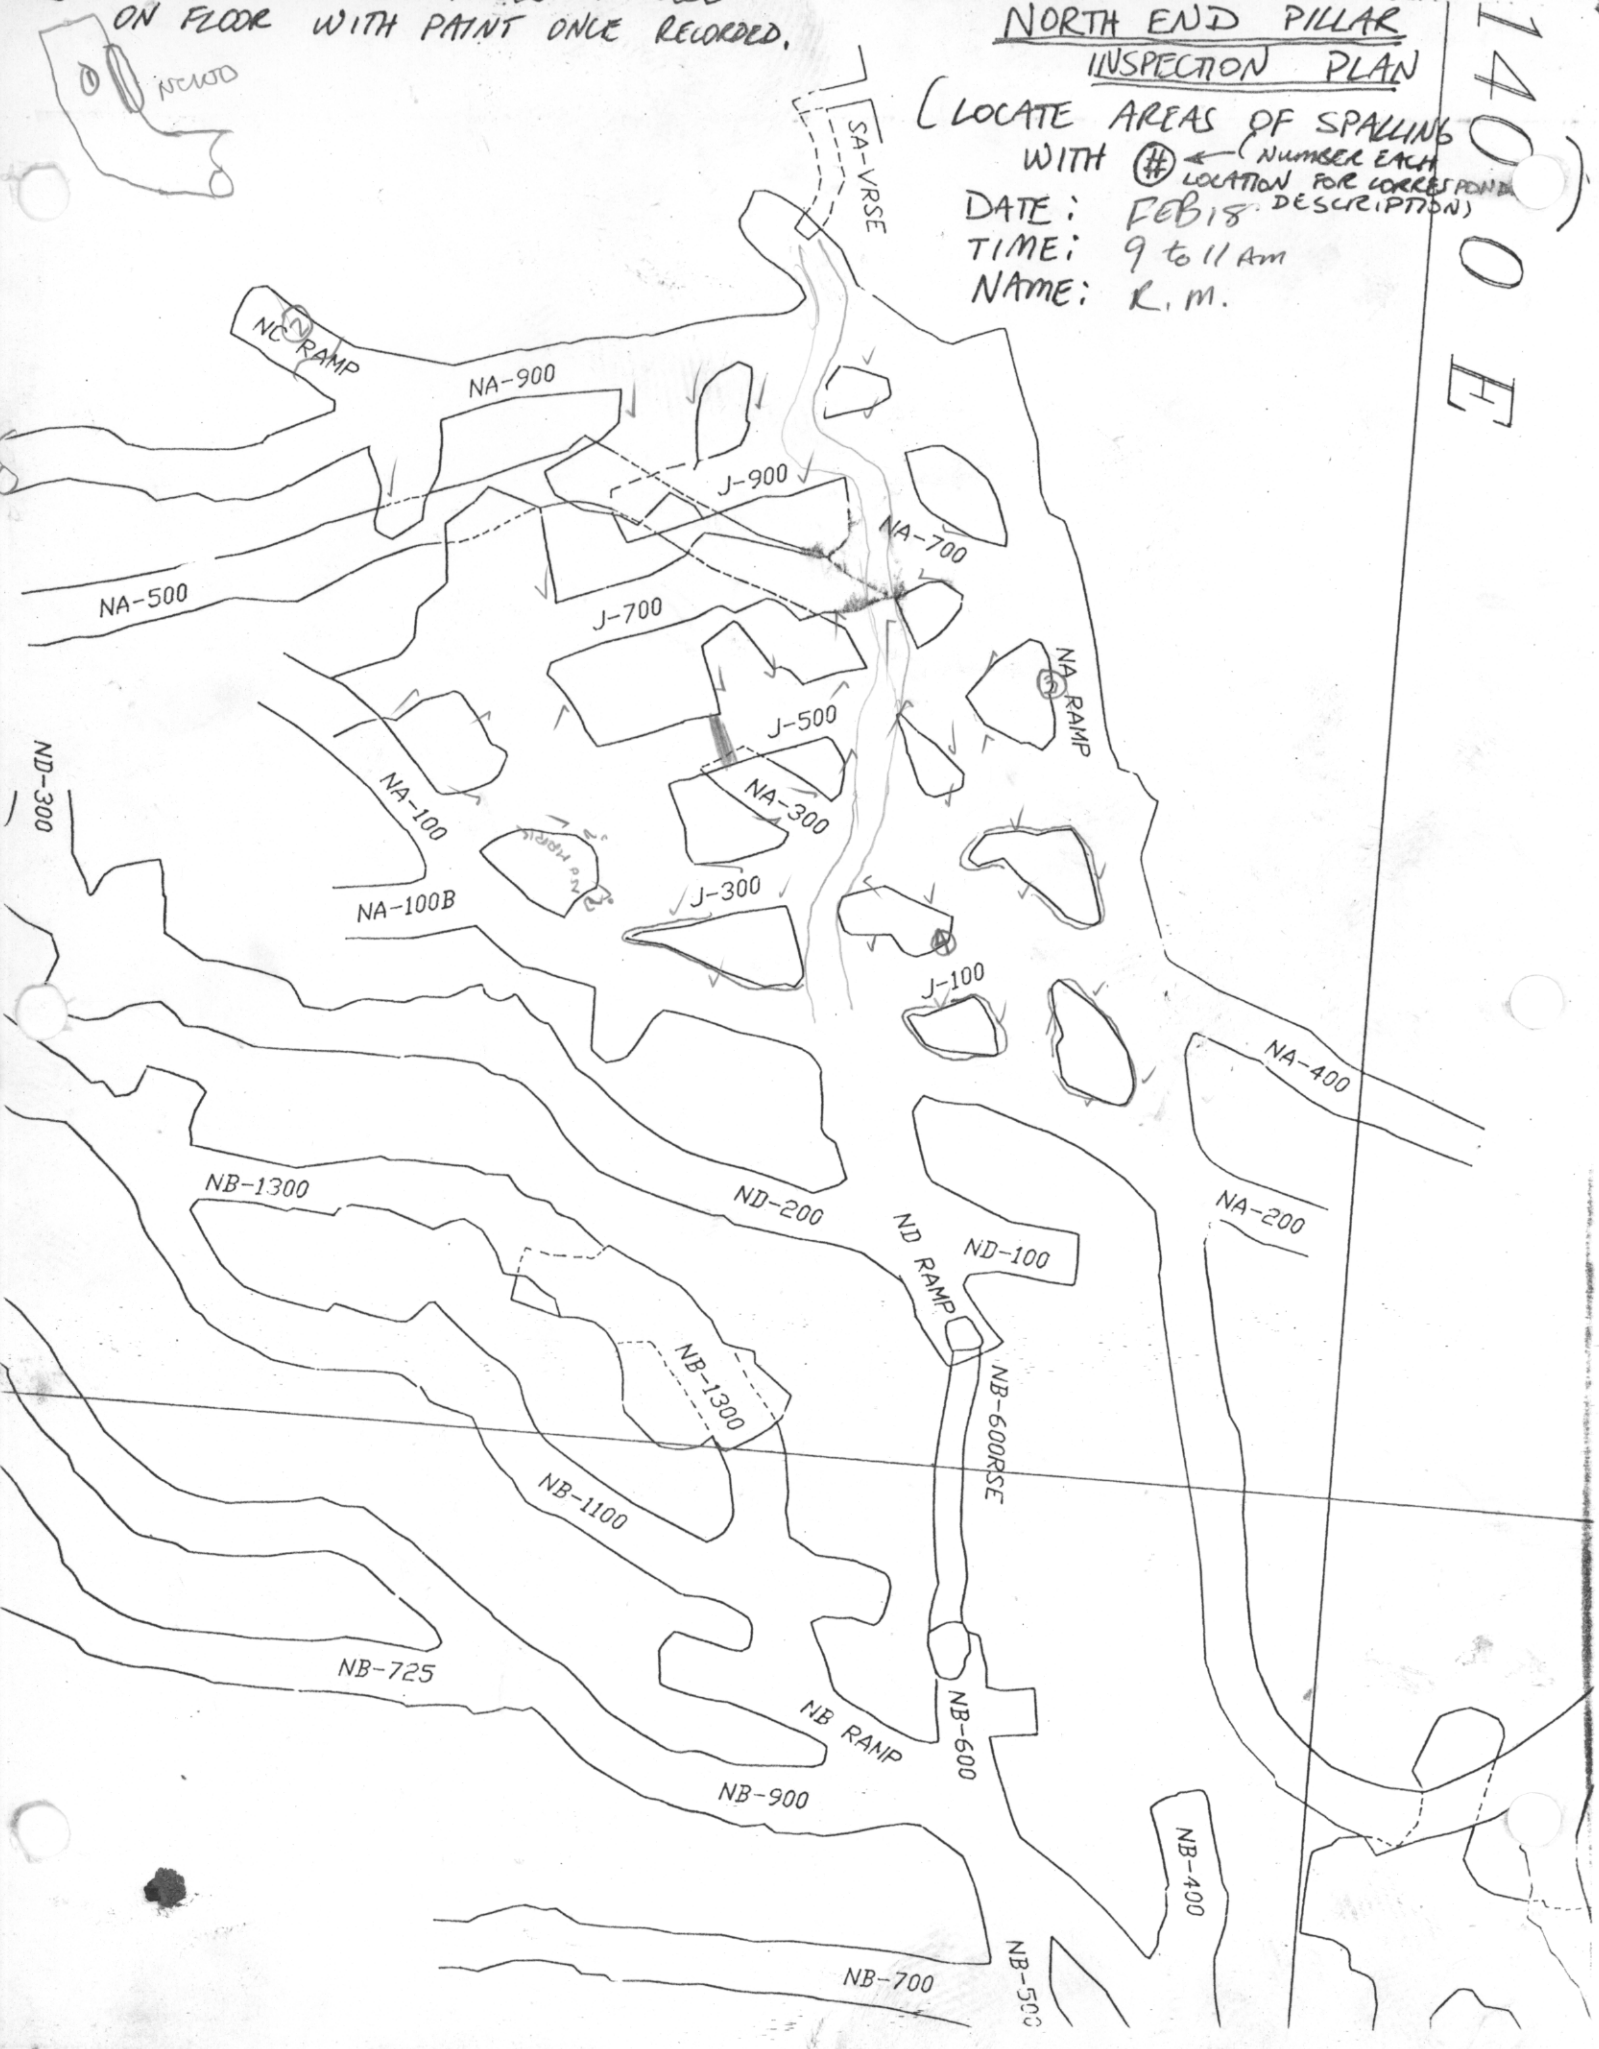
# NORTH END PILLAR INSPECTION PLAN

THE FIRST PIVAR INSPECTION OF THE NORTH "A", SOUTH "B" AND SOUTH "J" STOPS WAS PERFORMED ON FEB 18/91. NO MAJOR SPALLING OR CAVING HAS OCCURRED ON EITHER THE PIVARS OR THE BACK OF THE NORTH "A" STOP. UNMARKED PIVARS WERE INSPECTED AND PAINTED. INCLUDED ARE PIVAR INSPECTION PLANS AND A LIST OF PARTICULARS FOR EACH STOP.

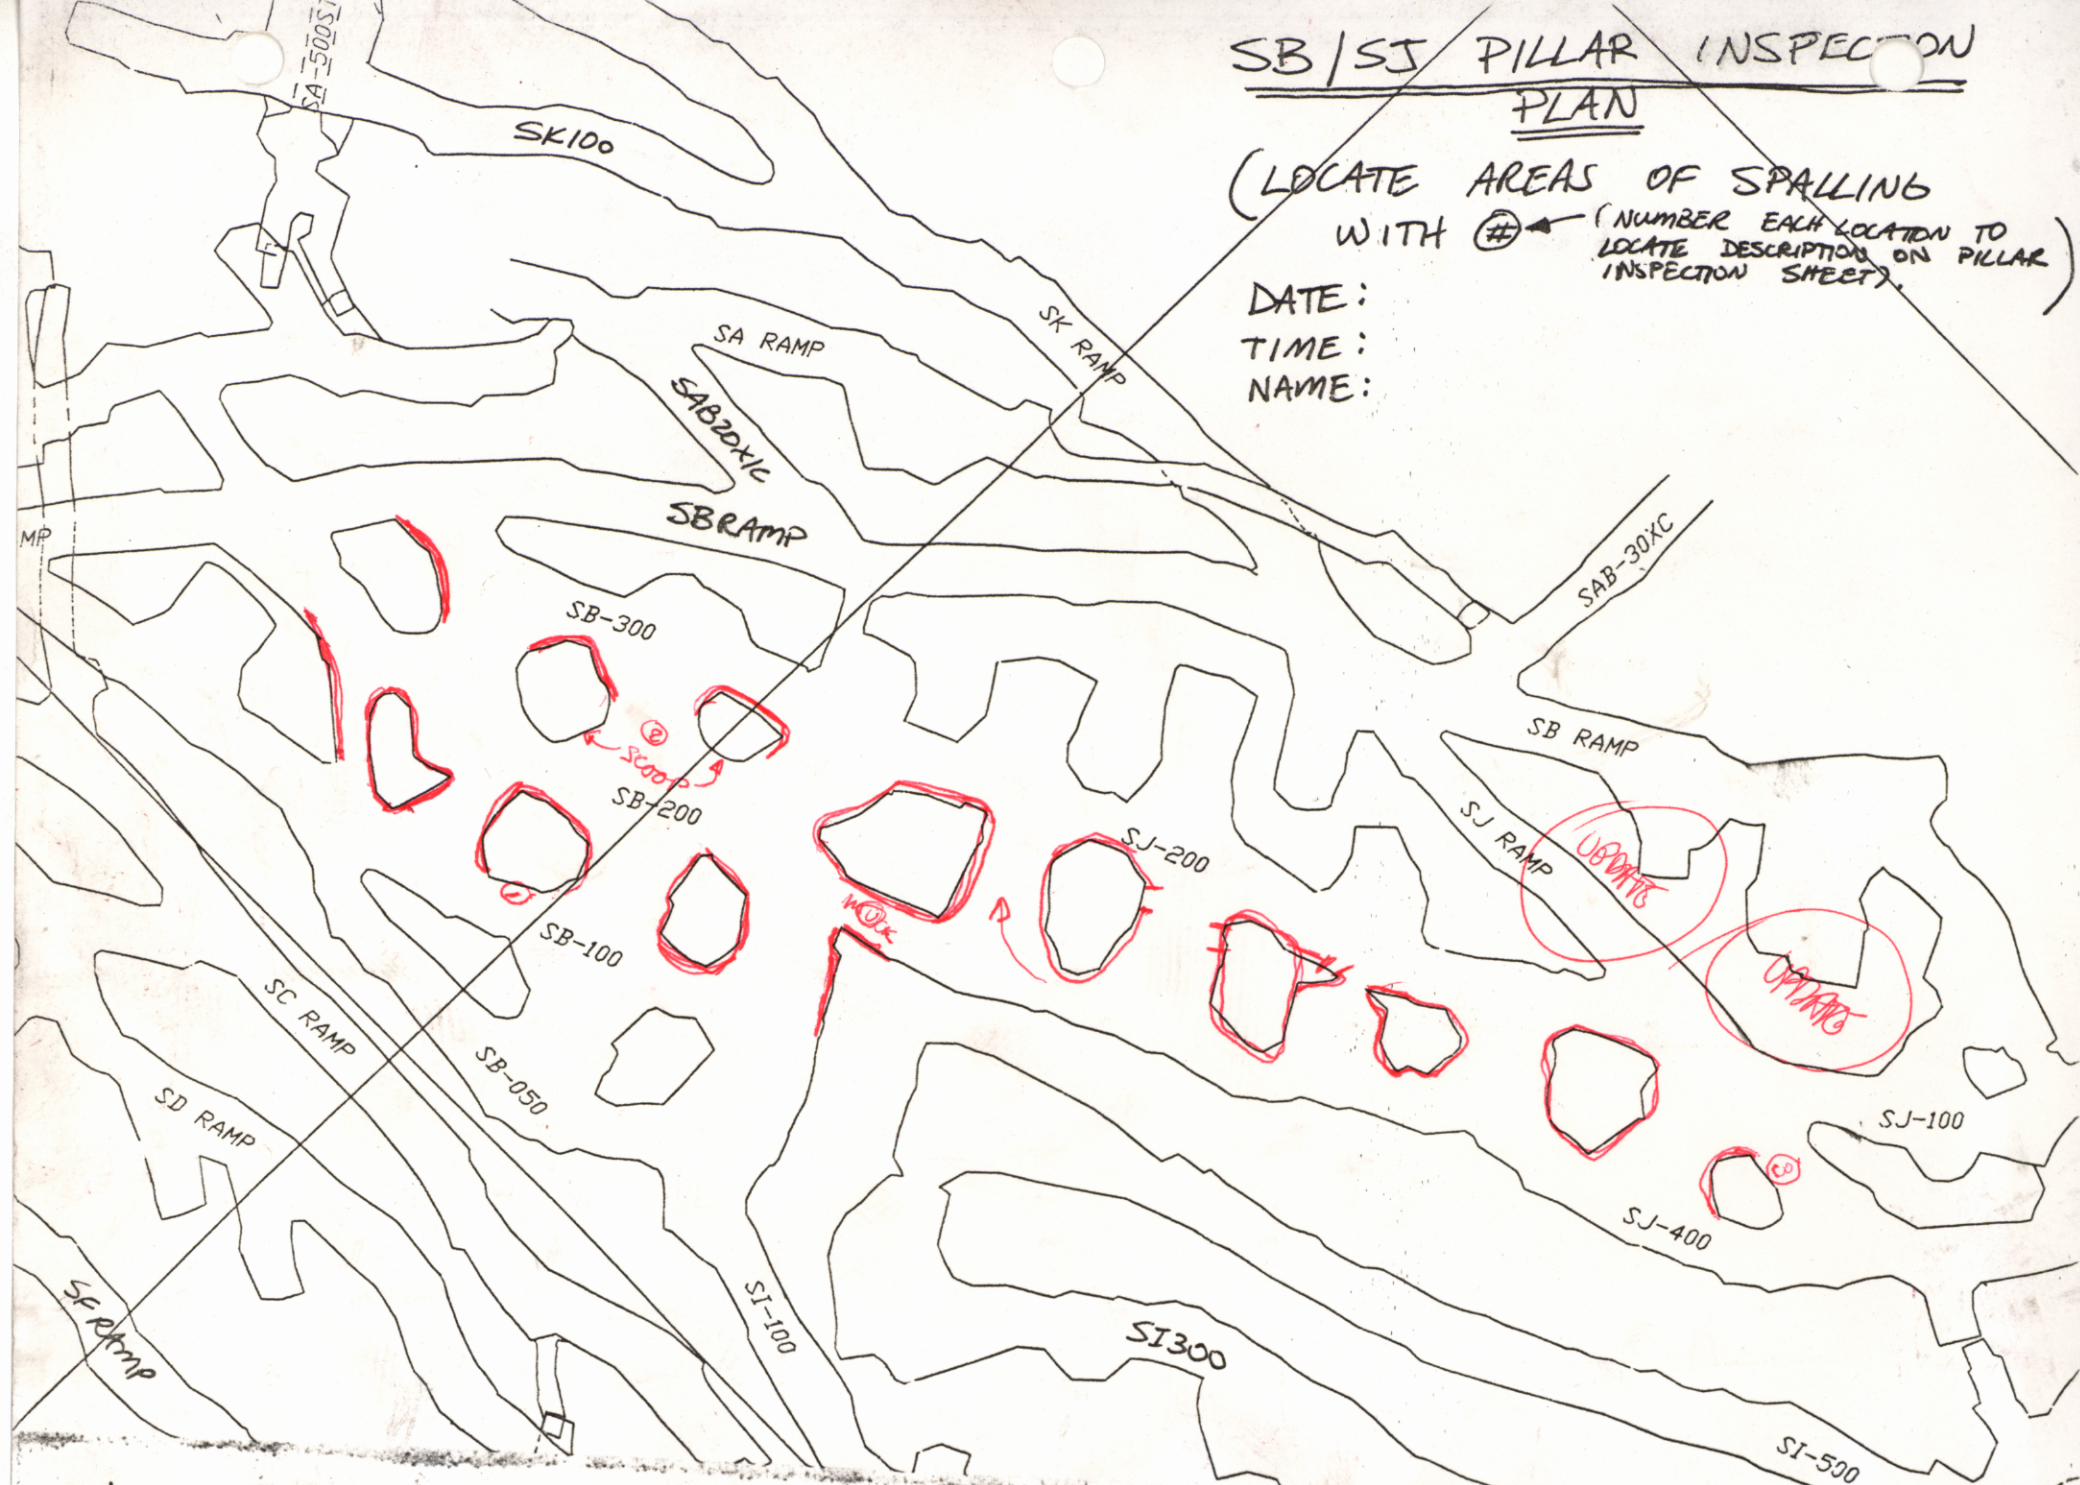
# SB/SJ PILLAR INSPECTION PLAN

A CURSORY VISUAL INSPECTION WAS PERFORMED ON THE SOUTH "B" & "J" STOPS. AS THE PIVARS WERE PAINTED, ONLY ONE PIVAR SHOWED SIGNS OF OPEN FRACTURES AND POTENTIAL SLABBING (#3 ON S3/SJ PIVAR INSPECTION PLAN). SEVERAL PIVARS HAVE YET TO BE PAINTED AND SHOULD BE MARKED ONCE BENCHING IS COMPLETED.

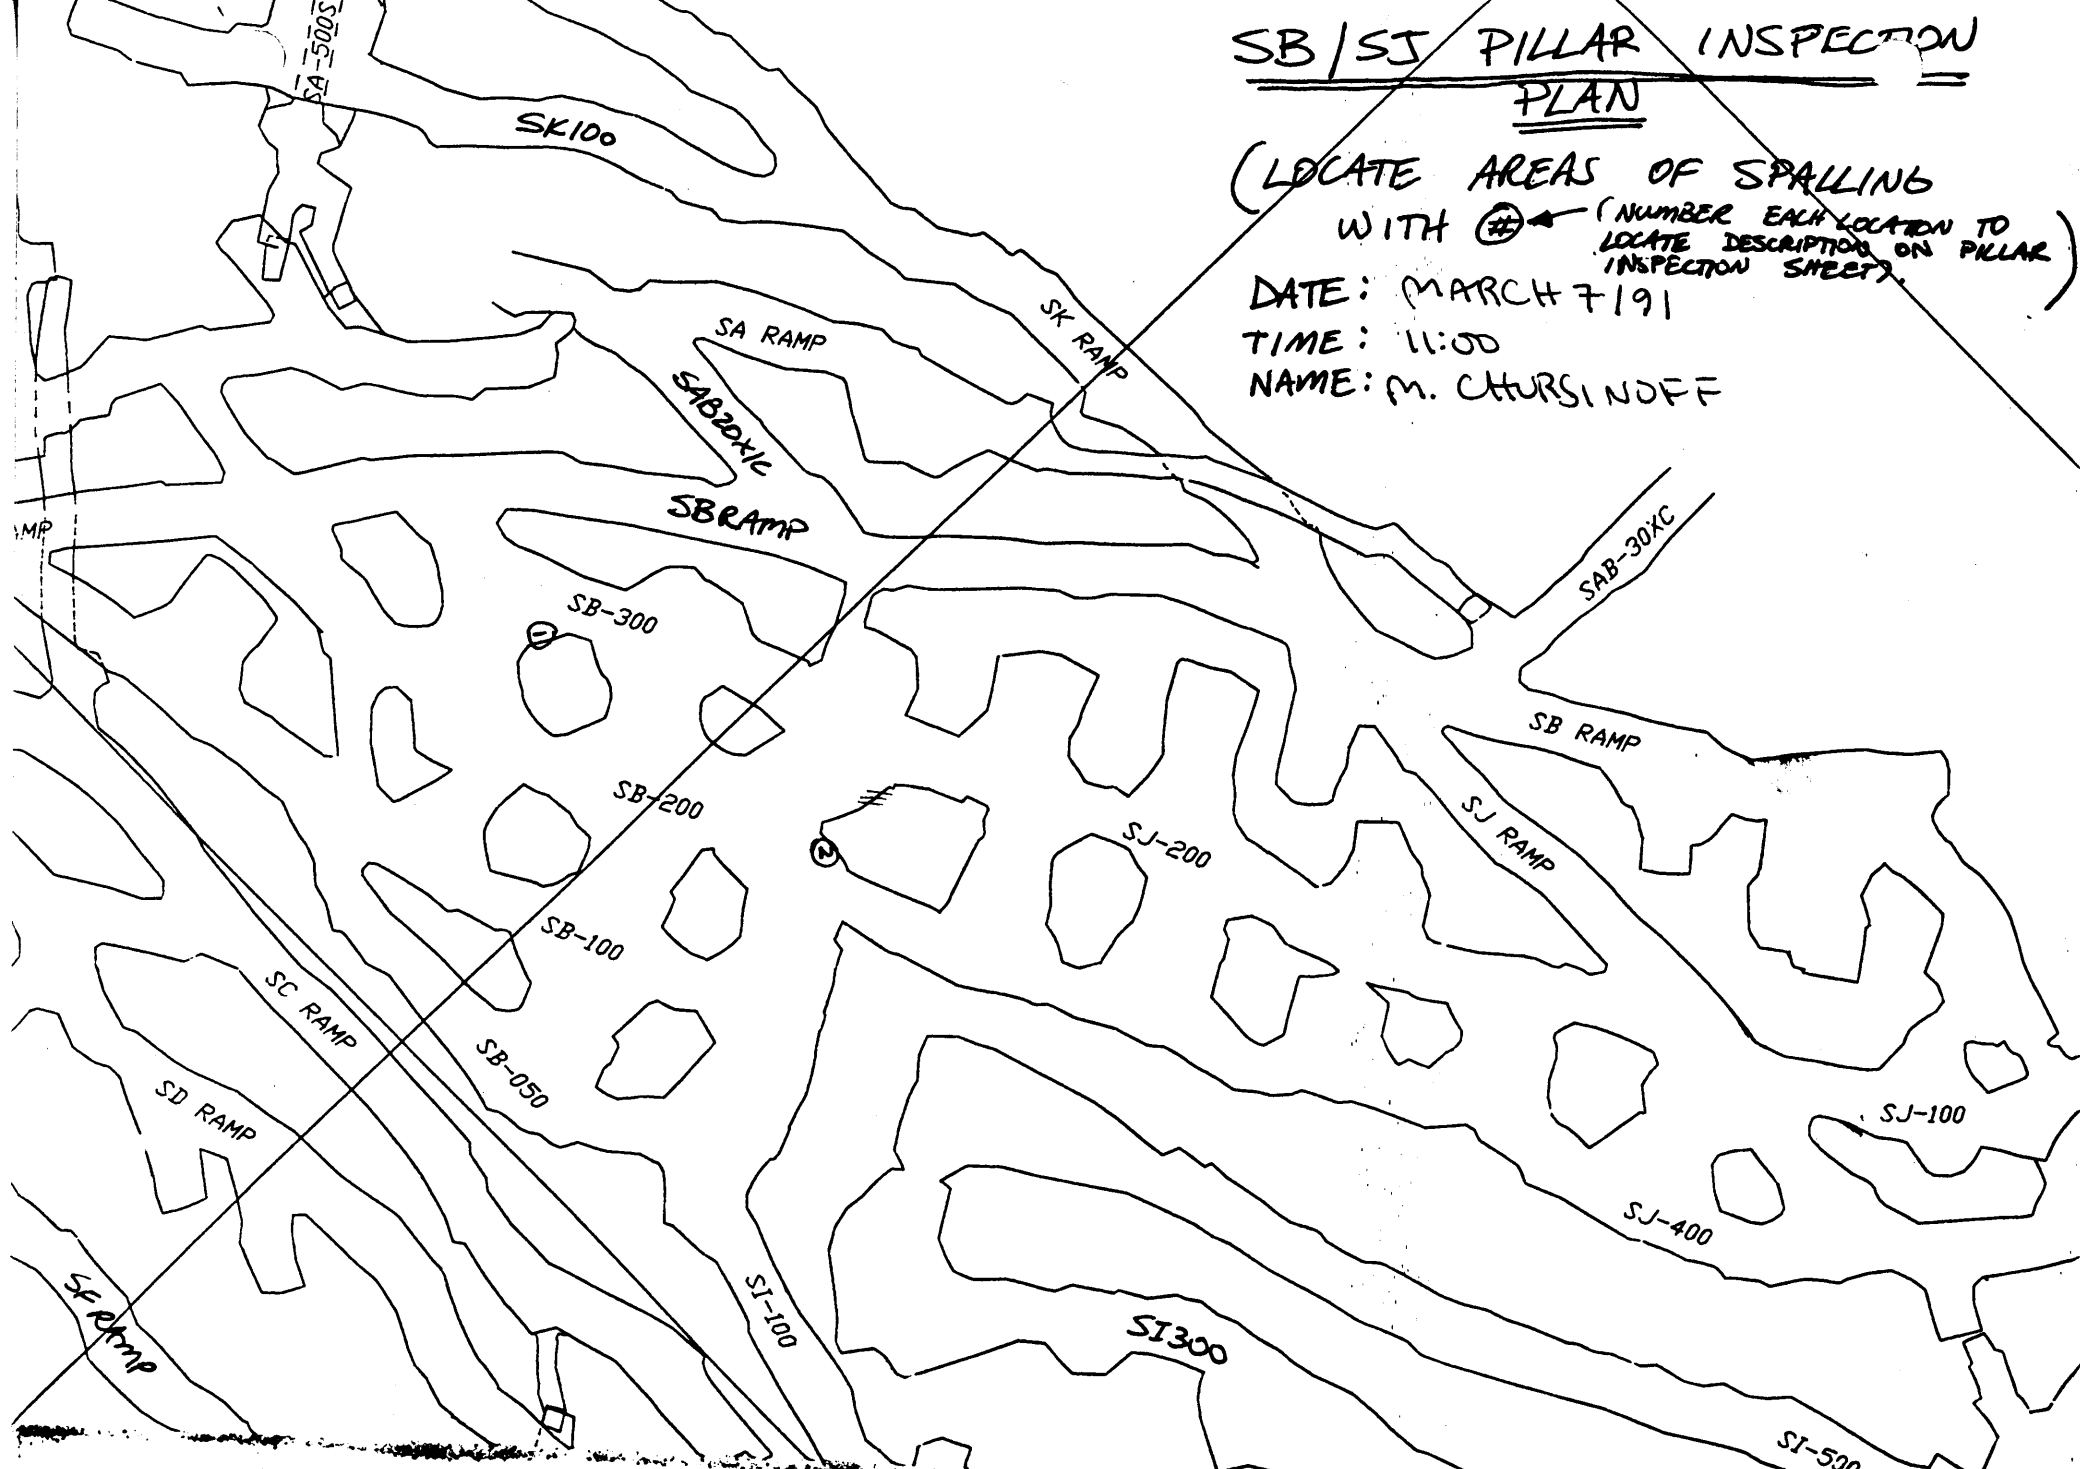
SB/SJ PILLAR INSPECTION  
PLAN

▶ A pillar inspection of the SB stope was conducted with Jim Mathis on March 7/91. #1 on the SB/SJ inspection plan show signs of minor slipping along HW contact. #2 has jointing / fractures, a potential for slabbing.

① Mine sloping along HW contact.  
Clear surface observed.

② Fractures & jointing observed. No fresh  
loose. Potential slabbing here.

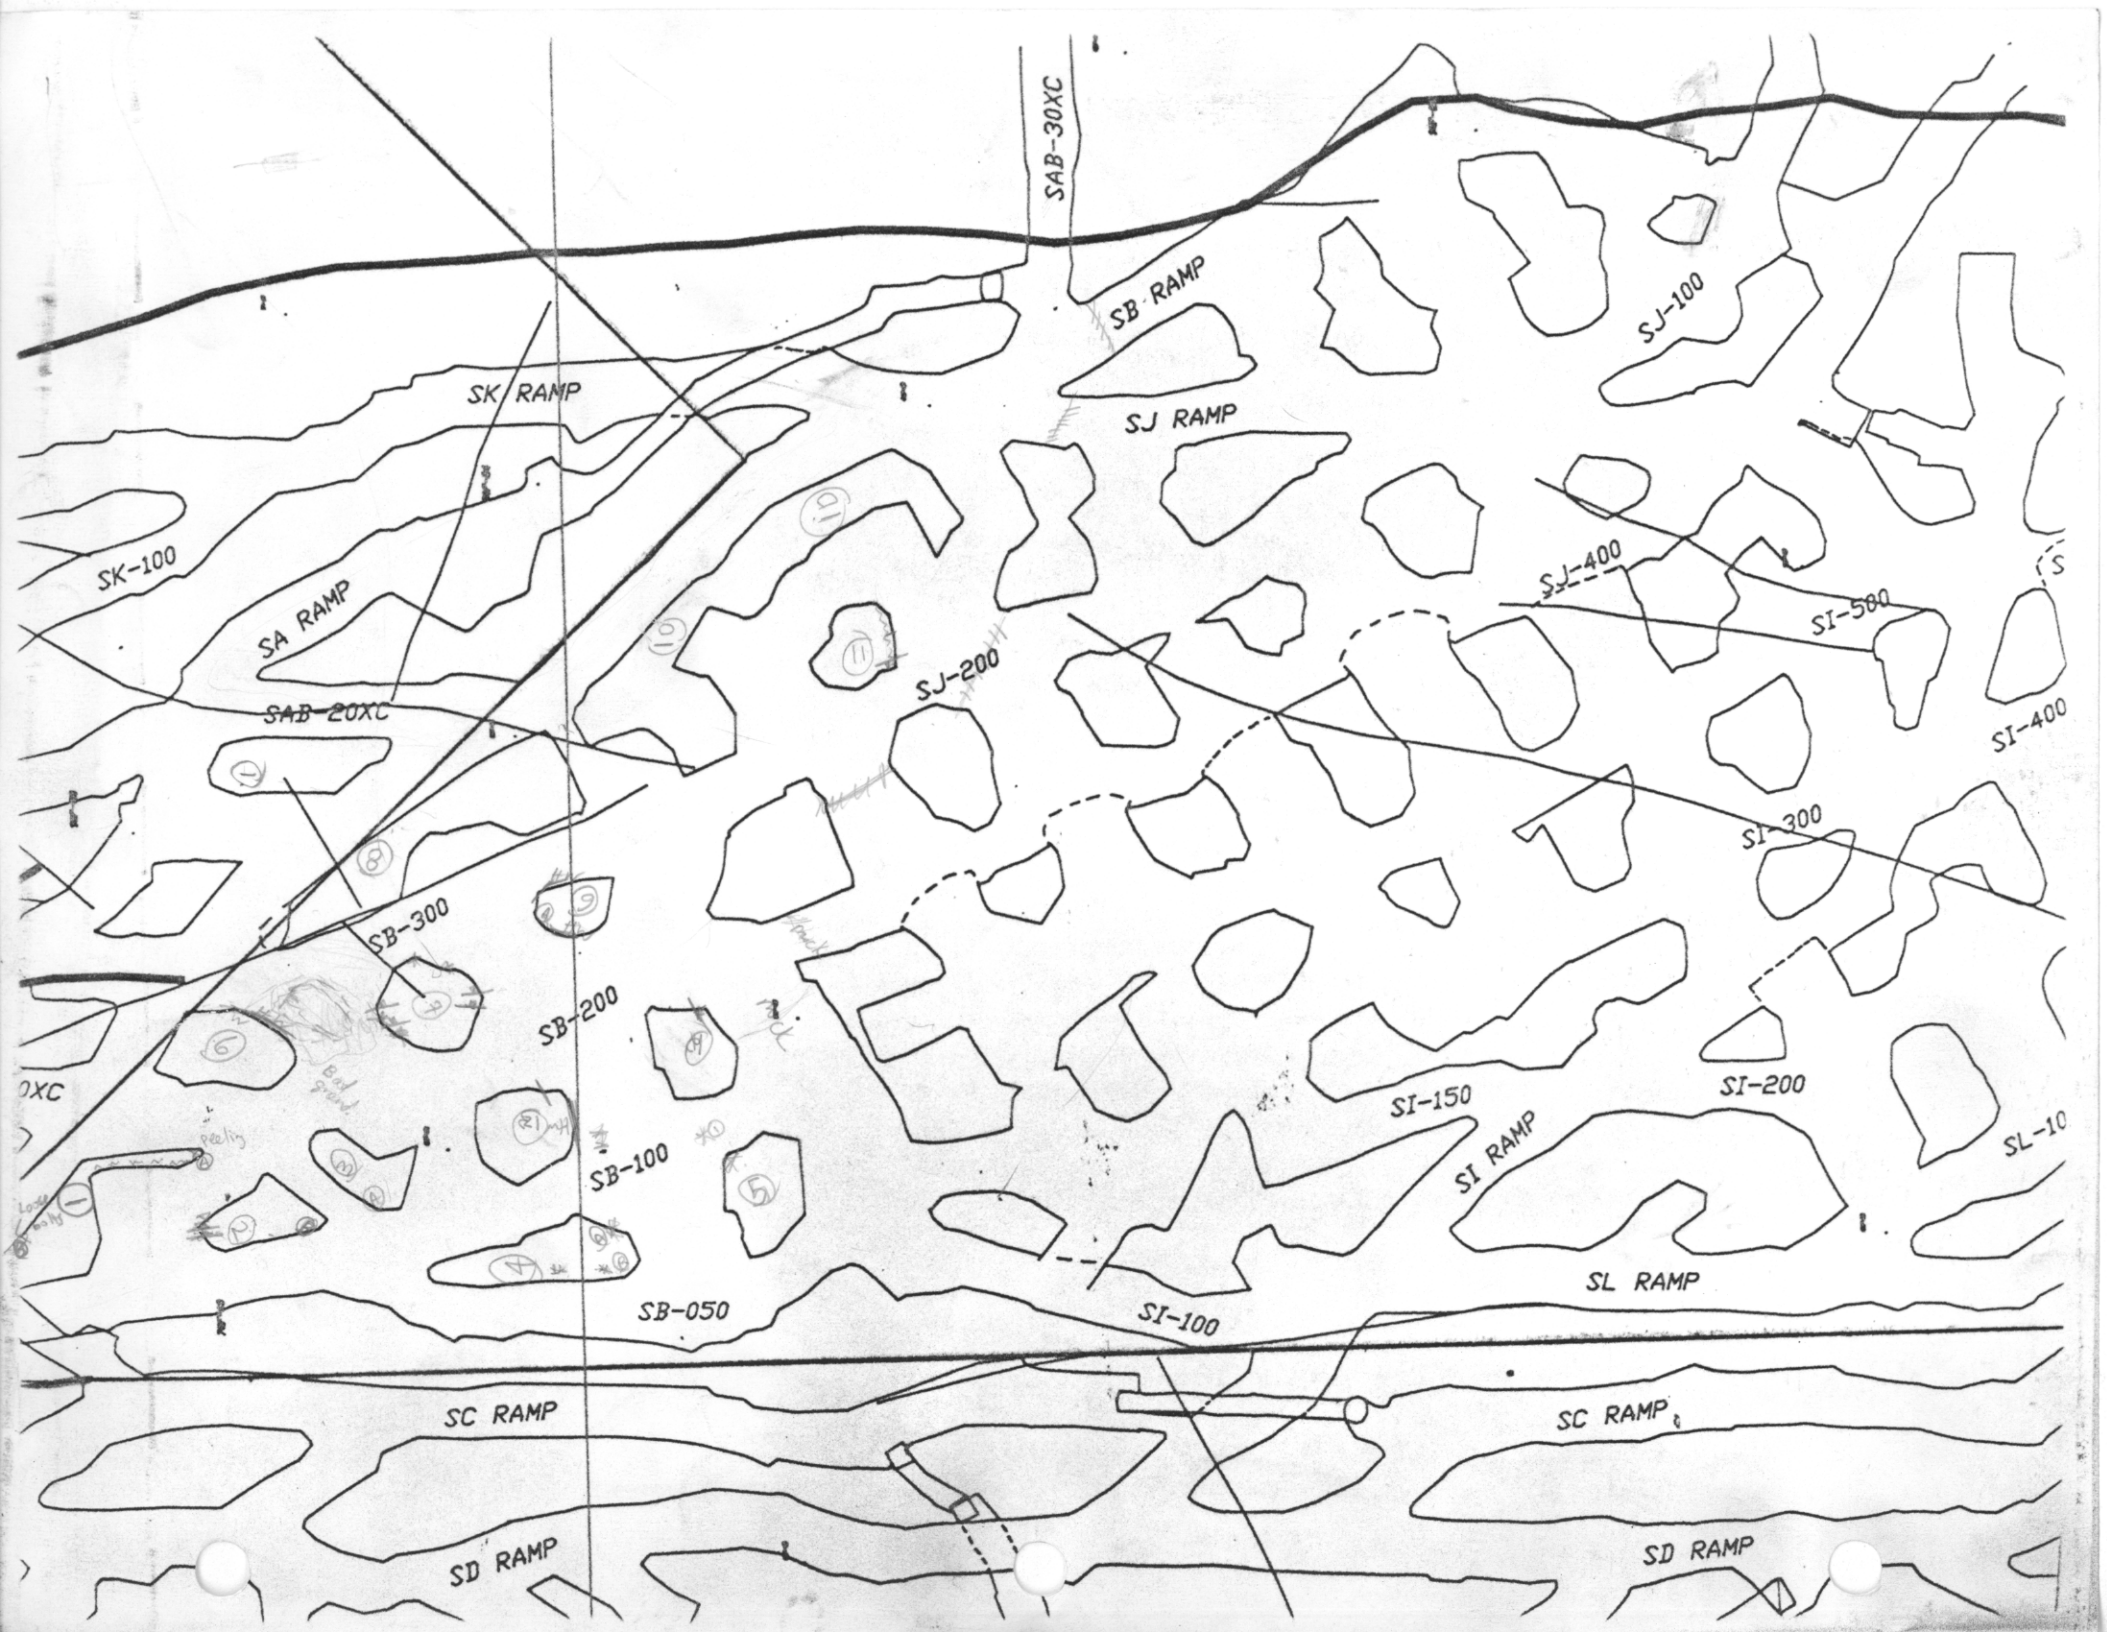
#1

Overall good condition of pillar.  
Peeling off of bolts <sup>(1 1/2")</sup> at base of pillar. See  
on indicates on map. All bolts ~~are~~ appear to  
provide support for pillar.

#2

Overall satisfactory condition. Minor small  
loose falling off sides.

#3

Good condition. Well distributed of bolts.  
Minor jointing. See map.

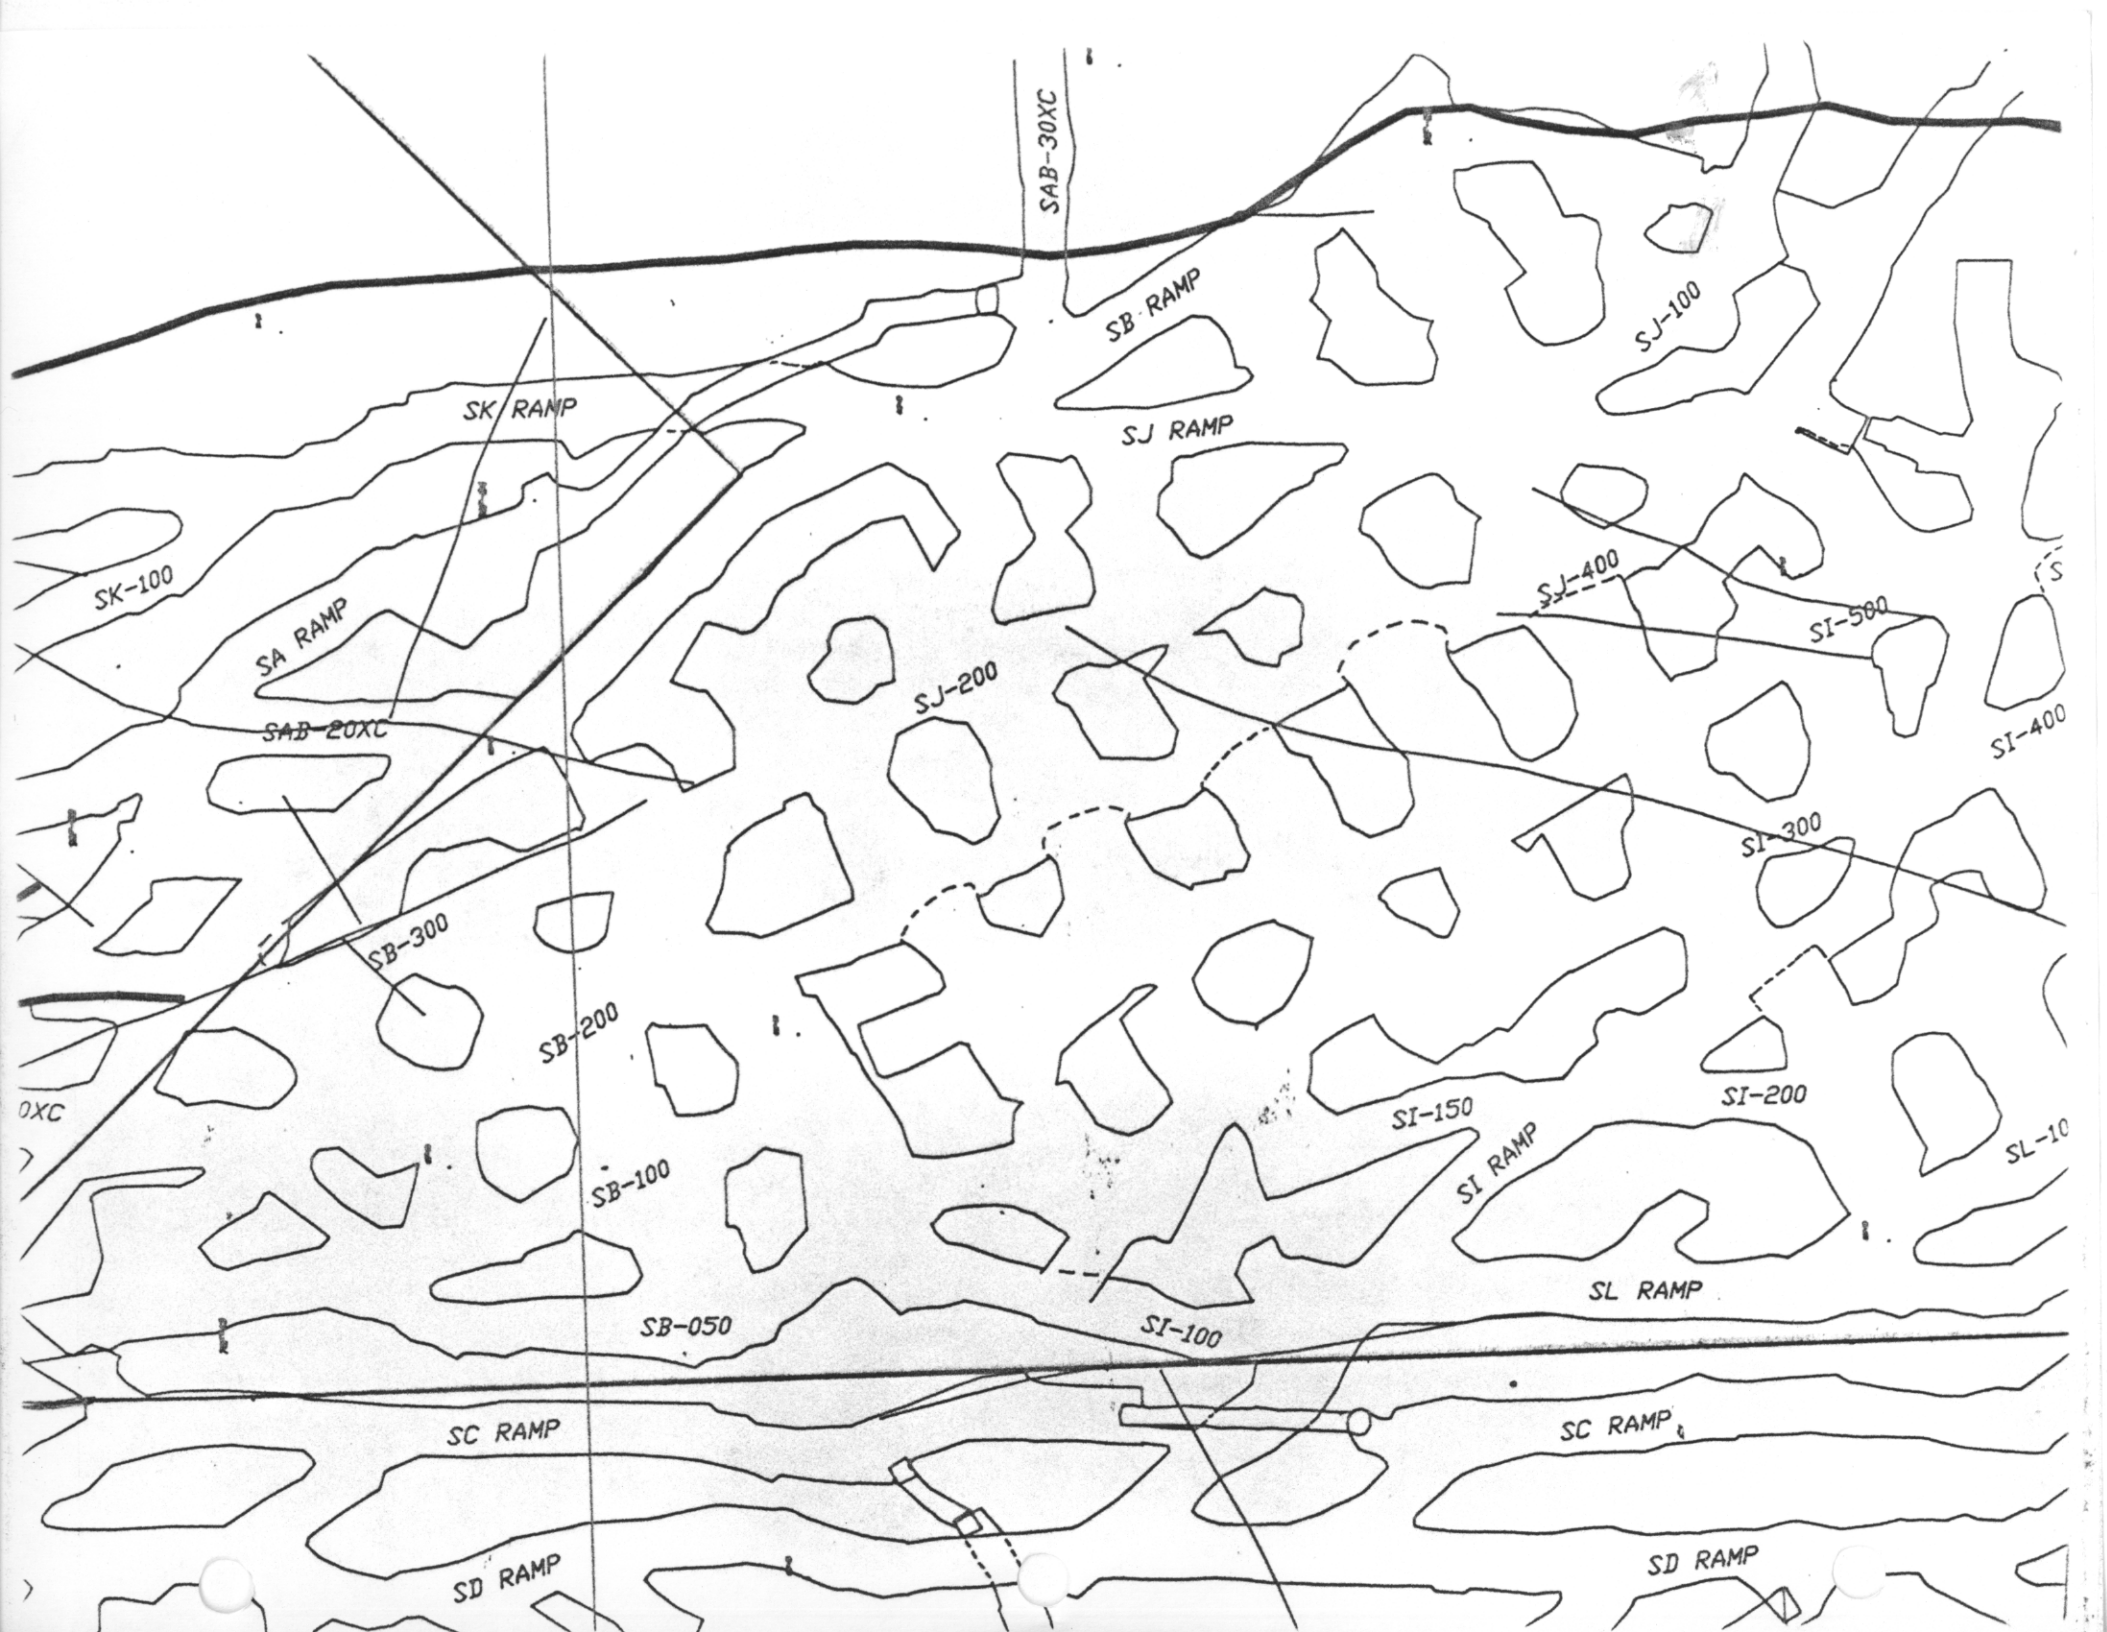
#1	See Map. A) Jagged edge, potential slab & peeling B) 2 loose bolts. Slip plane visible in wall.
#2	See Map. A) Jointly prominent 3 loose bolts. B) Loose bolts at edge/corner of pillar.

#3	A) HW CONTACT EXPOSED AT BACK. No visible slipping.
#4	Loose bolts indicated by #. A) HW CNT exposed. Some peeling. Back is narrower compared to base here.

#5	Overall satisfactory condition. HW cnt exposed. No visible peeling. A) in between pillar 5 & 7 peeling off hw. from back. loose bolts.
#6	HW contact visible on S-S side of pillar. no visible slipping. Between pillar #6 & 7 groove falls depth 3'

#7	HW contact exposed at back. visible slips of HW @ # marked on map. joints visible thru out pillar. Narrower at top than base. joints at base showing signs of stress.

#8	Satisfactory condition.
#9	HW exposed at back. Loose bolt & block @ A See map.
#10	Satisfactory condition.
#11	Slip plane visible in pillar. Overall satisfactory condition.

#12	Satisfactory condition. Minor jointing.
#13	HW cnt exposed. minor slippage of hw cnt. loose bolts as marked between #13 & #4.

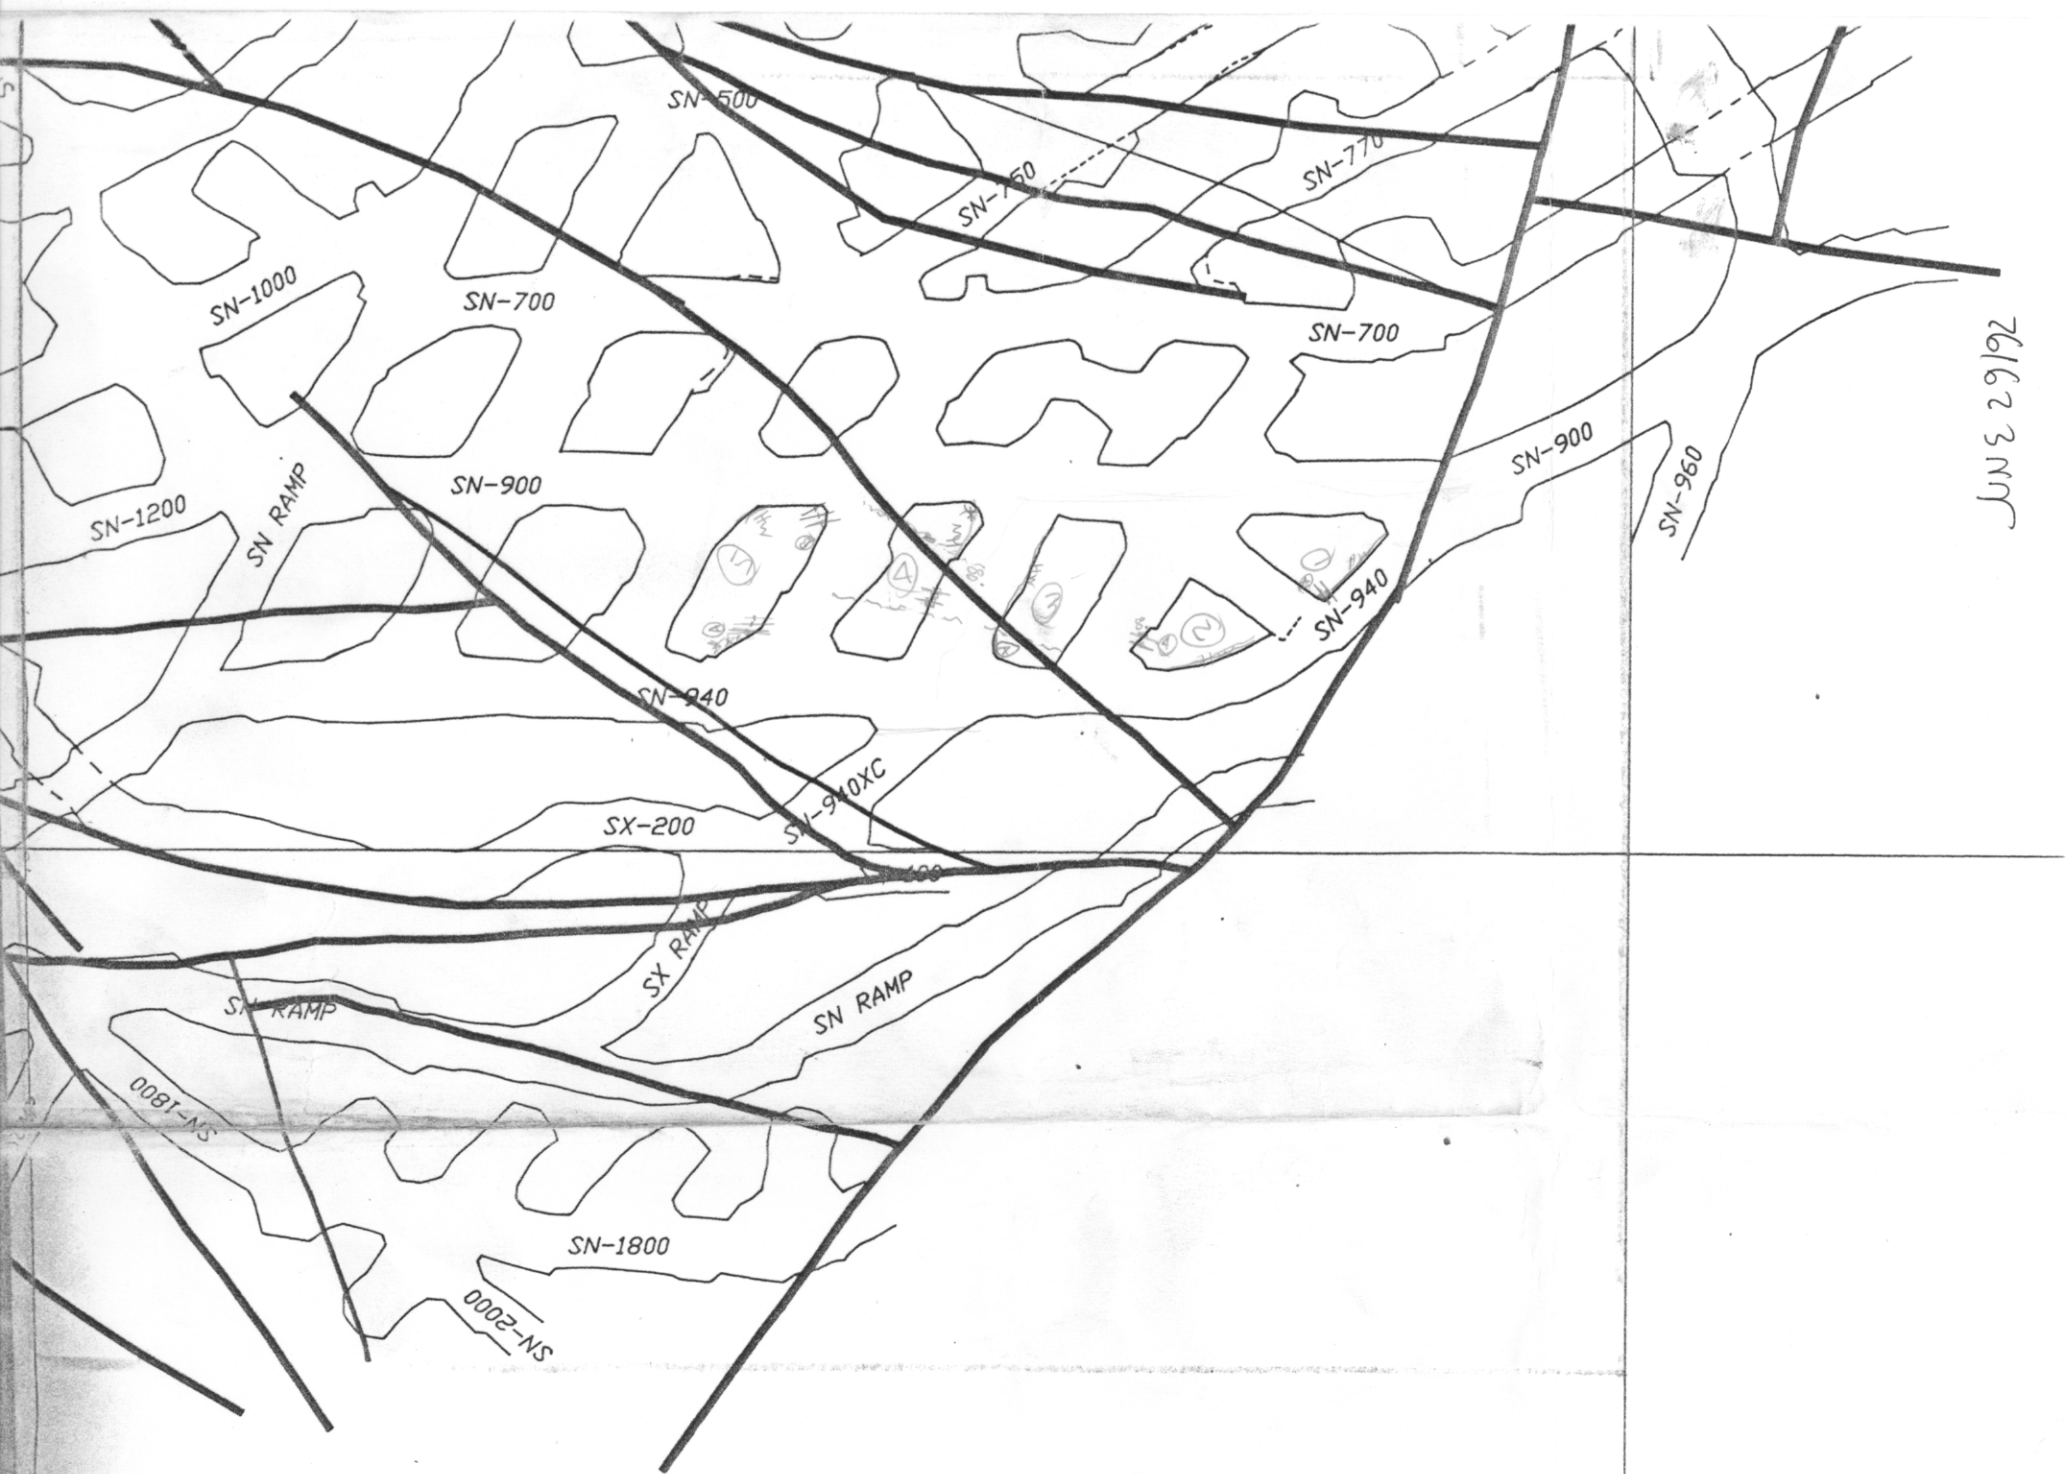
How cut exposed at back of pillar on SW side of pillar. @ Joints as marked on pillar. ② Jagged corner loose bolts. Overall satisfactory condition.

Overall satisfactory condition. How contact exposed on S-SW side of pillar. No visible movement along contact. @ Minor jointing ②

How cut of IDO exposed at back. Bolted & screened. Overall good condition. @ Loose bolts, bolts have peeled off. Good distribution of bolts.

W contact exposed on E side. No slippage. Well bolted & screened. x as marked on pillar. Loose bolts at top. No bolts on bottom of this corner. Prominent fault wrapped in.

@ Loose bolts & a loose blk. Overall satisfactory condition. Jointing present @ How contact exposed on NW corner. Good condition. ② Prominent jointing present. Jagged corner. Loose looking blk. on this jagged corner.
