U/G PILLAR  
INSPECTION

PIVAR INSPECTION

CURRAGH RESOURCES INC.  
file: PILLAR

FARO U/G PILLAR INSPECTION  
=====

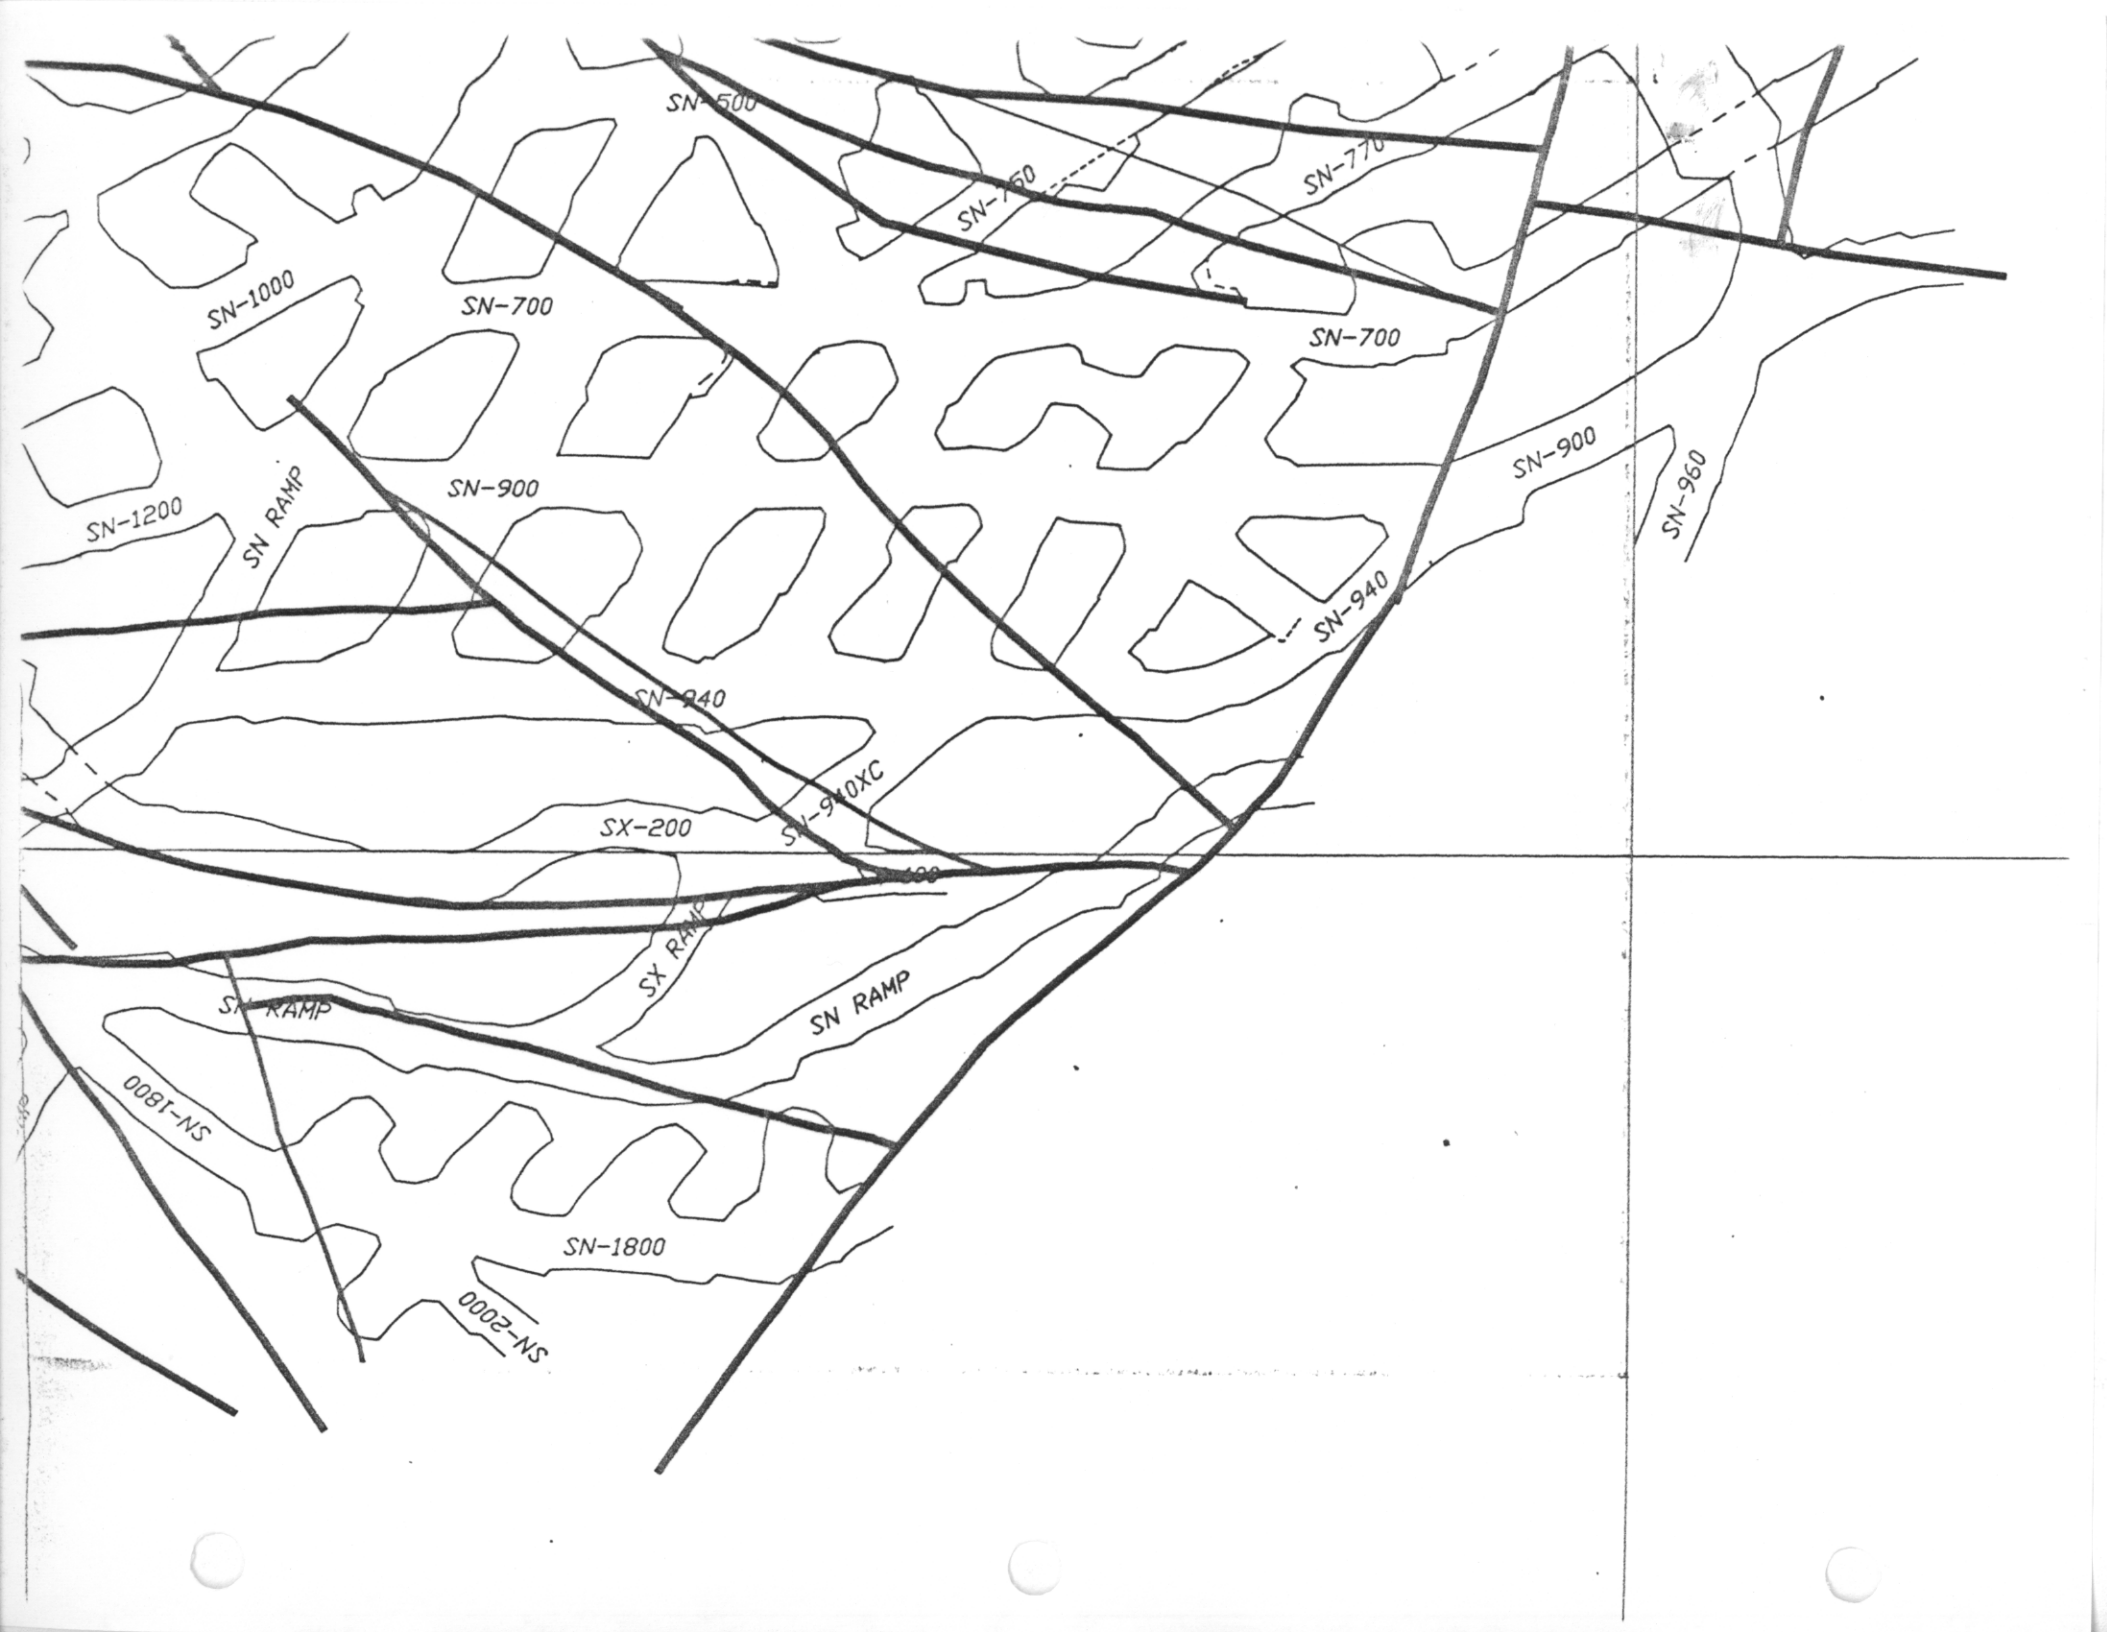
#(1) 940/900 overall condition of pillar satisfactory. few cuts exposed on some areas of pillar. No visible movement. Well bolted & screened. \* Slab appears to be loose. Needed scaling?

#2 Satisfactory condition. few cuts exposed. Screened & bolted. OK map. \* (3) Loose bolts on this corner. minor loose falling from sides.

#3 Heavily screened on south wall. <sup>loose enclosed by screening.</sup> Minor loose falling (due to blasting) \* Pieces of loose (3-4') 10' up on SE wall corner. How rock appears to show no signs of movement. Loose bolts (2) in SE corner. present.

#4. \* SW corner loose bolts. Crack also in SW corner. Possible slab forming. Overall good condition.

#5. NW/W corner. Loose bolts. Some showing no signs of support. Loose bolts visible (2-3 ft) overall ratty looking corner. FAULT well exposed in wall. \* Crack exposed in wall on SE corner.

#6. Overall good condition. No loose bolts visible. Minor pieces of loose. present around base of pillar.

#7. Good condition \* Loose bolt in a crack 2 inches on SW corner of pillar. Possible formation of a slab.

#8. Loose bolts on NW corner. Overall satisfactory condition.
