**PITEAU ASSOCIATES**  
TECHNICAL AND  
HYDROLOGICAL CONSULTANTS

June 23, 1995

Re: Current Groundwater Conditions in the Southeast Walls of the Grum Pit

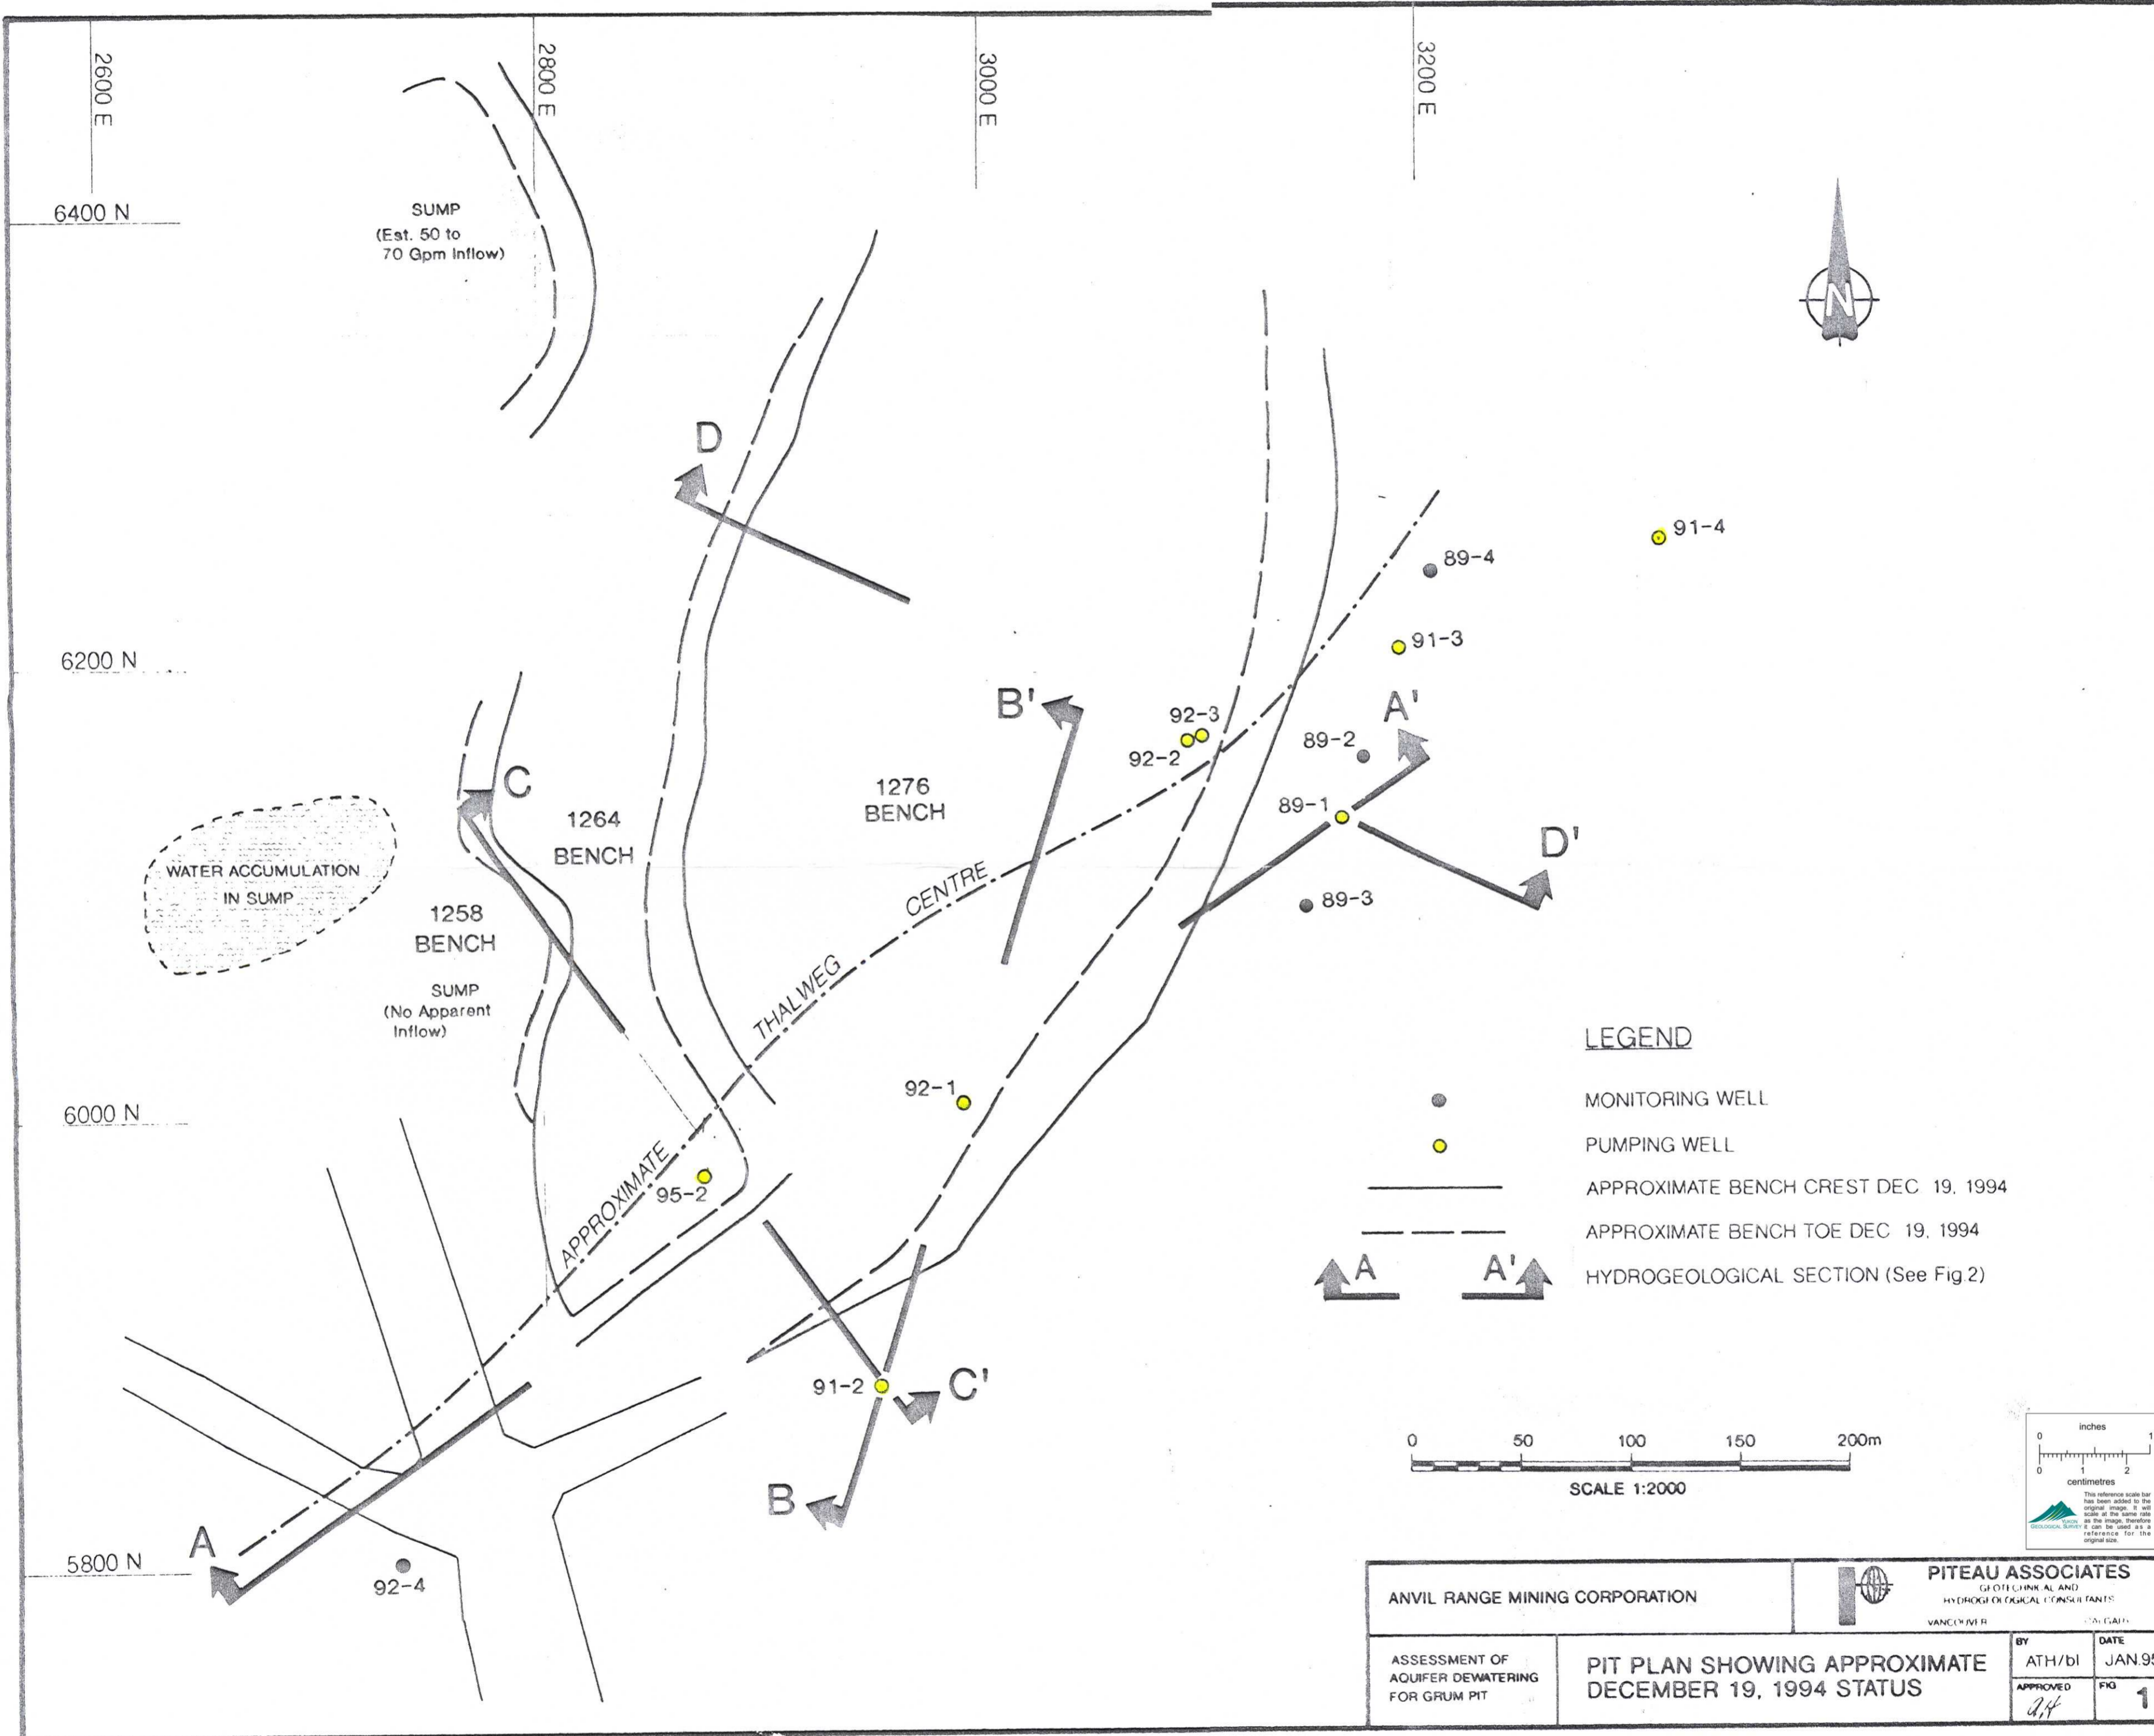
<b>PITEAU ASSOCIATES</b> GEOTECHNICAL AND HYDROGEOLOGICAL CONSULTANTS <small>VANCOUVER      CANADA</small>									
ASSESSMENT OF AQUIFER DEWATERING FOR GRUM PIT	PIT PLAN SHOWING APPROXIMATE DECEMBER 19, 1994 STATUS

Well 95-2 was designed to investigate the hydrogeology and groundwater conditions immediately north of where the thalweg intersects the south wall of the pit (Fig. 1). Sections presented in our report dated January 20, 1995 have been updated, to reflect information obtained from this new well, and current water level monitoring data.

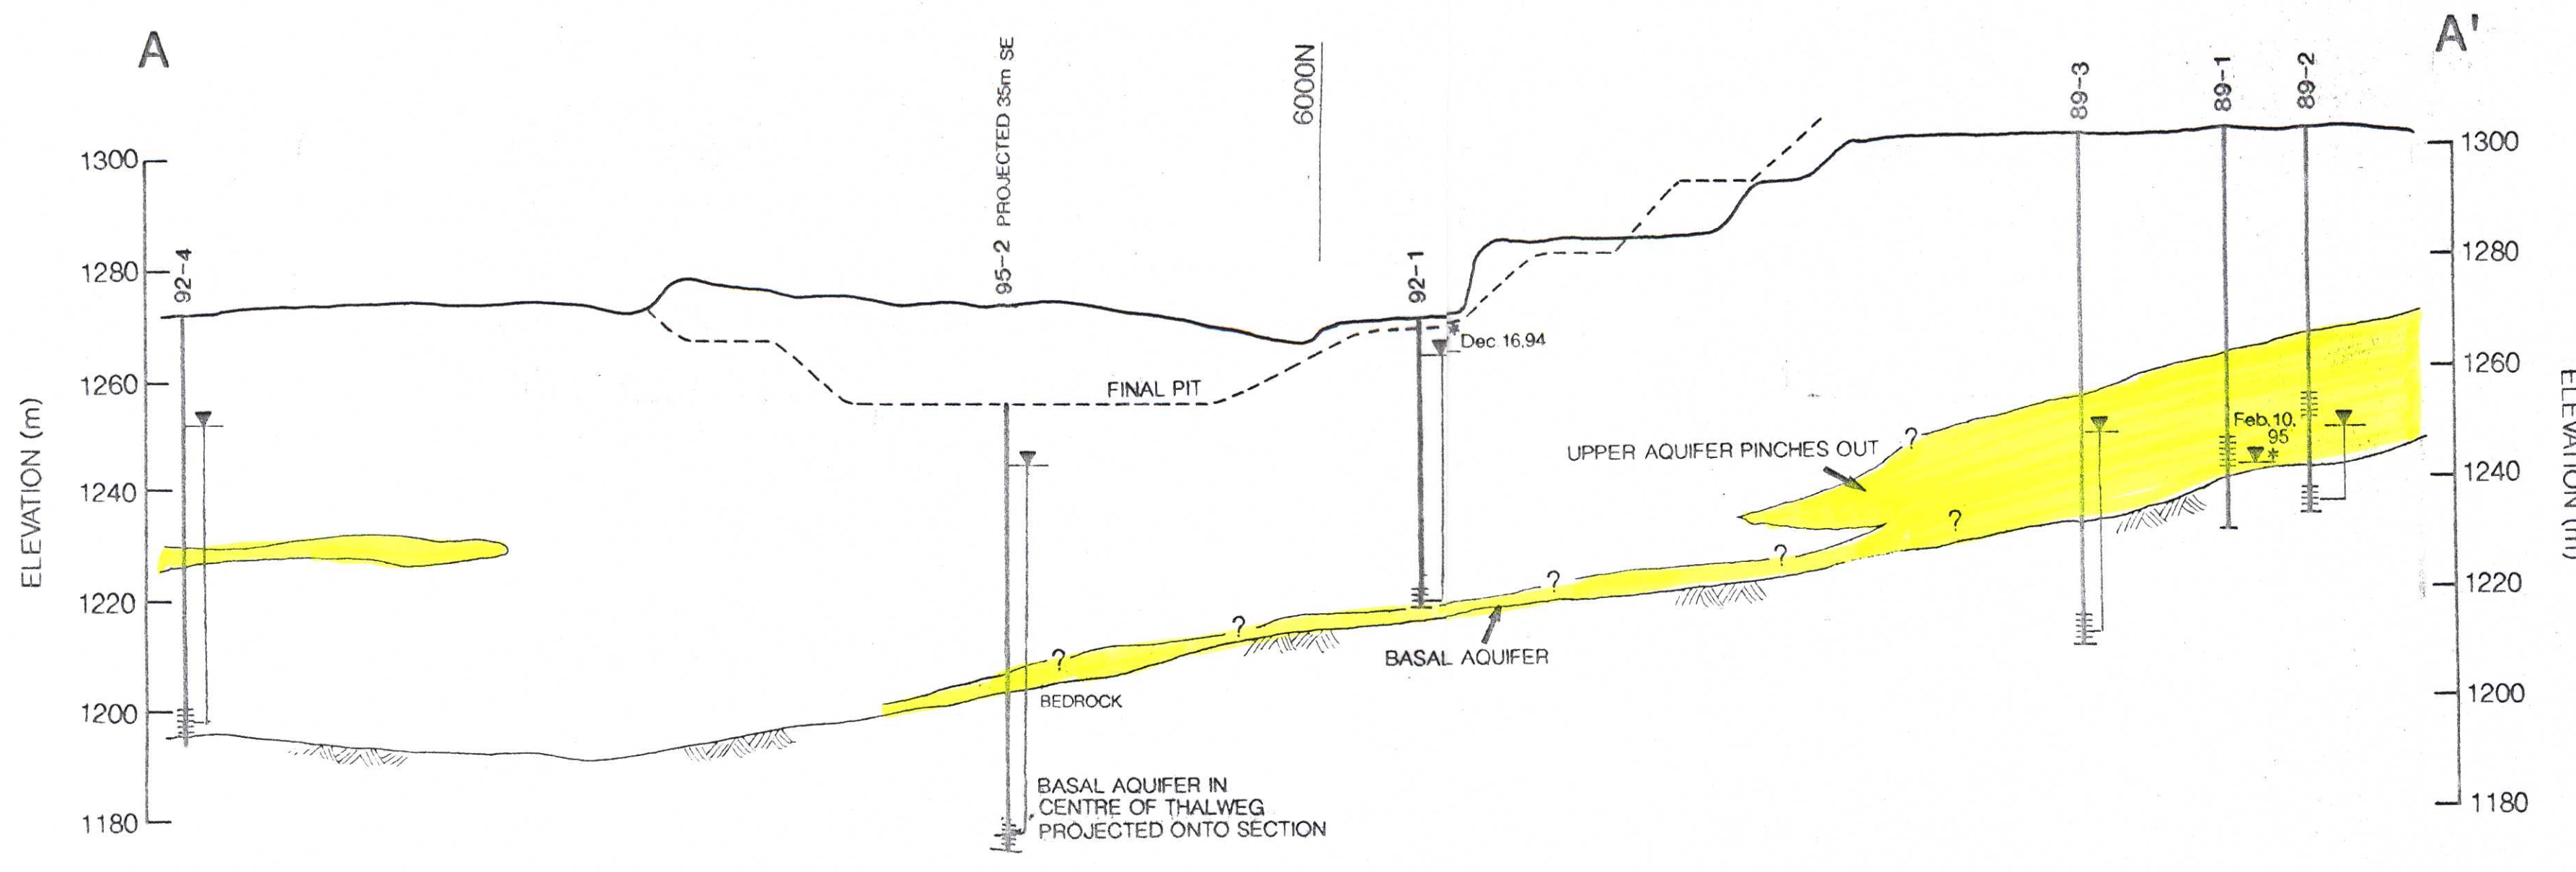
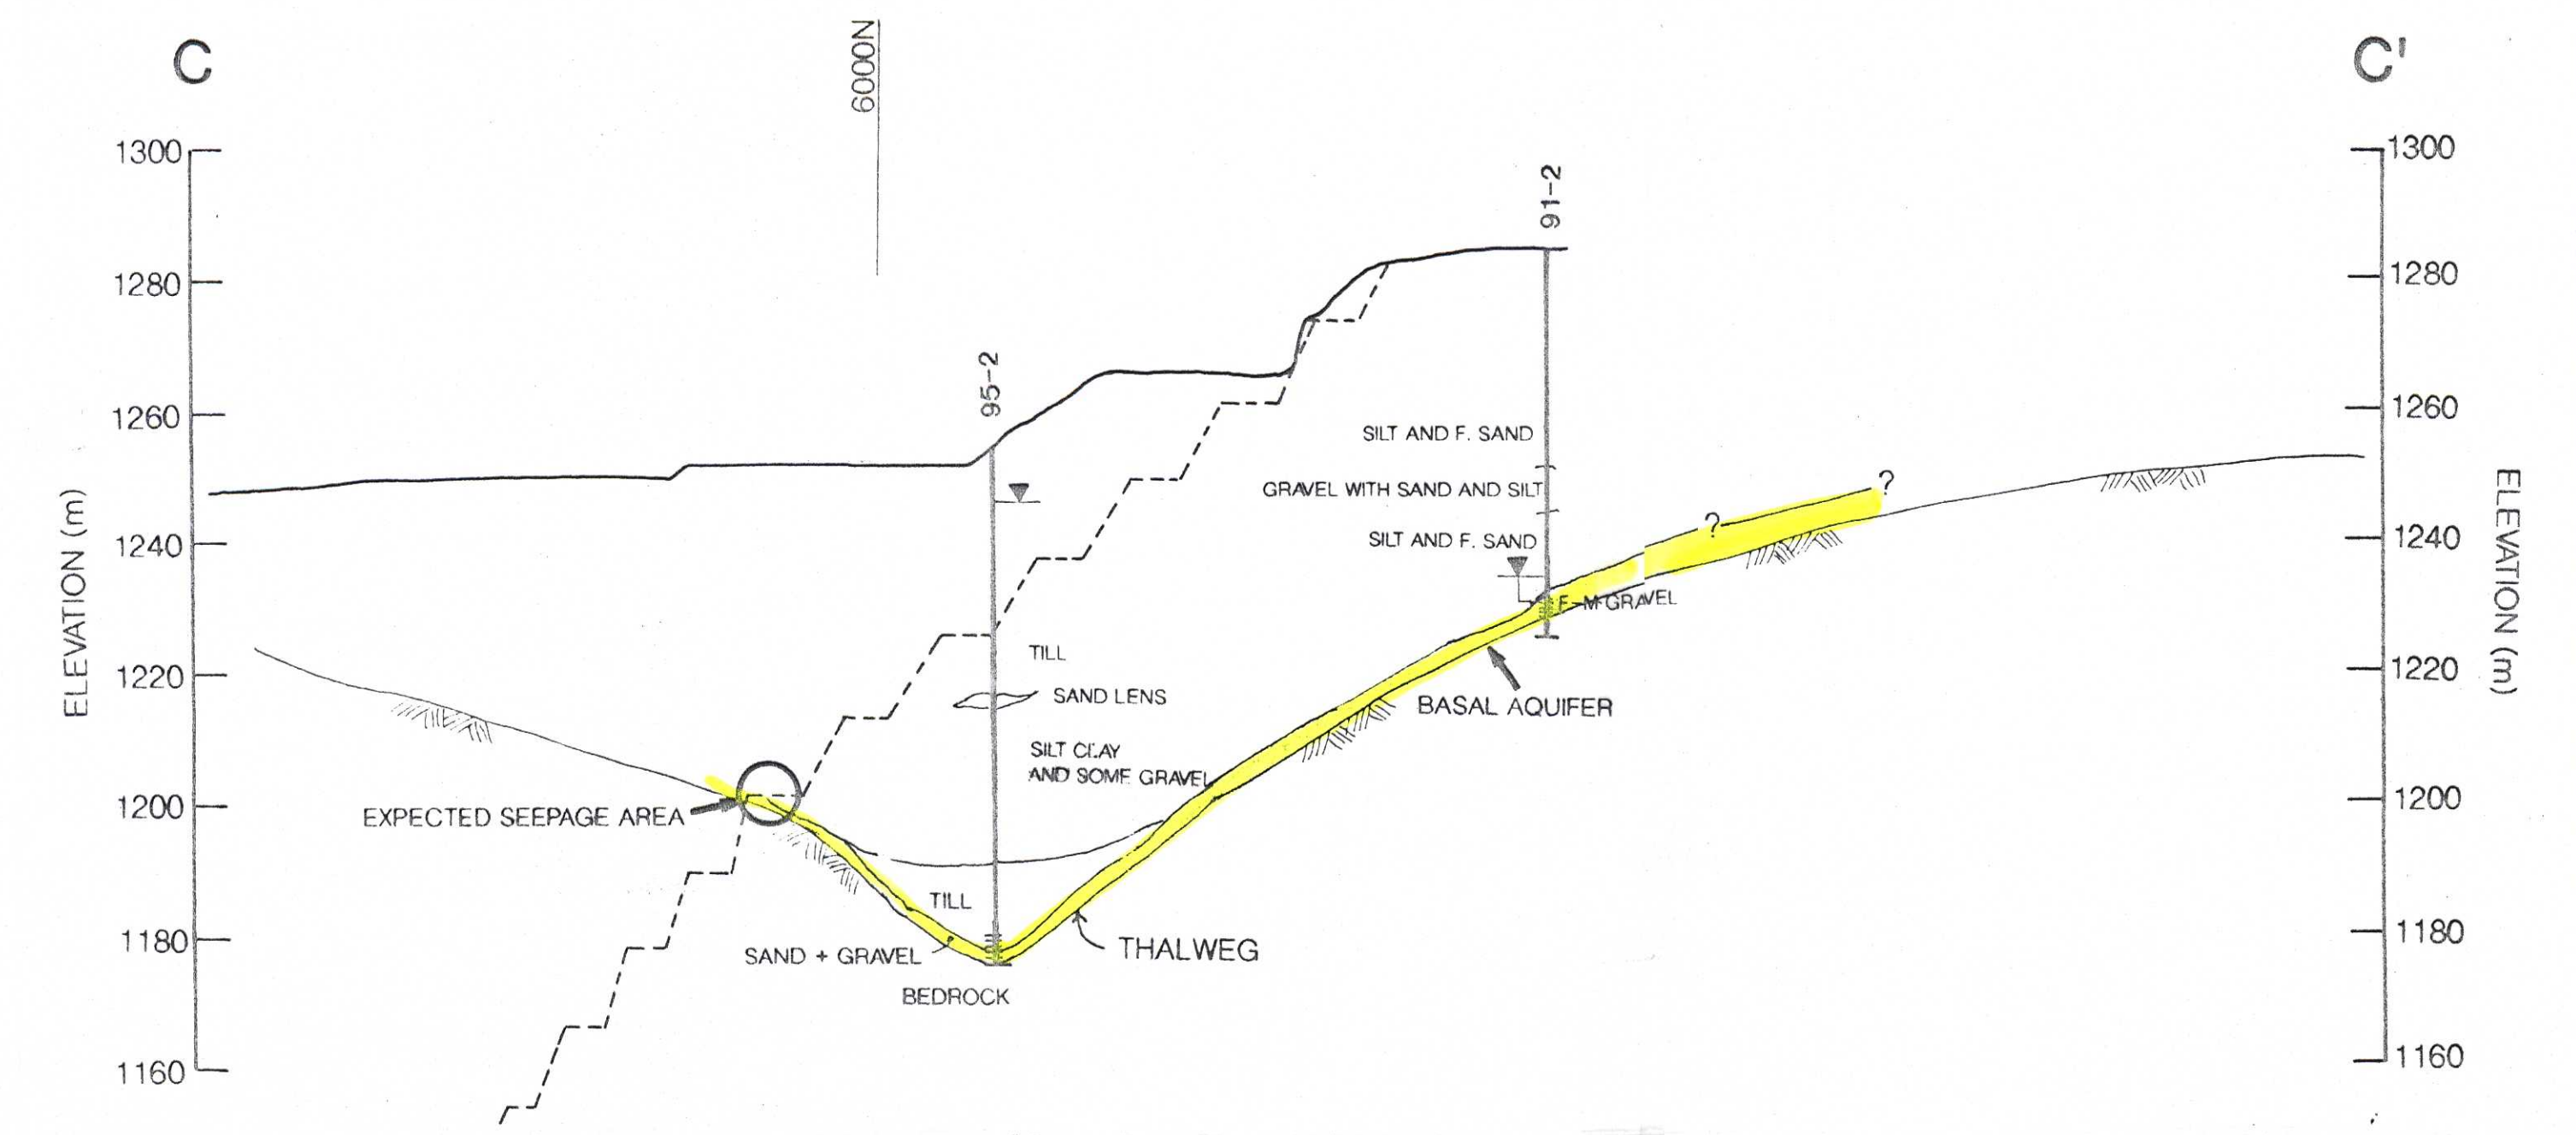
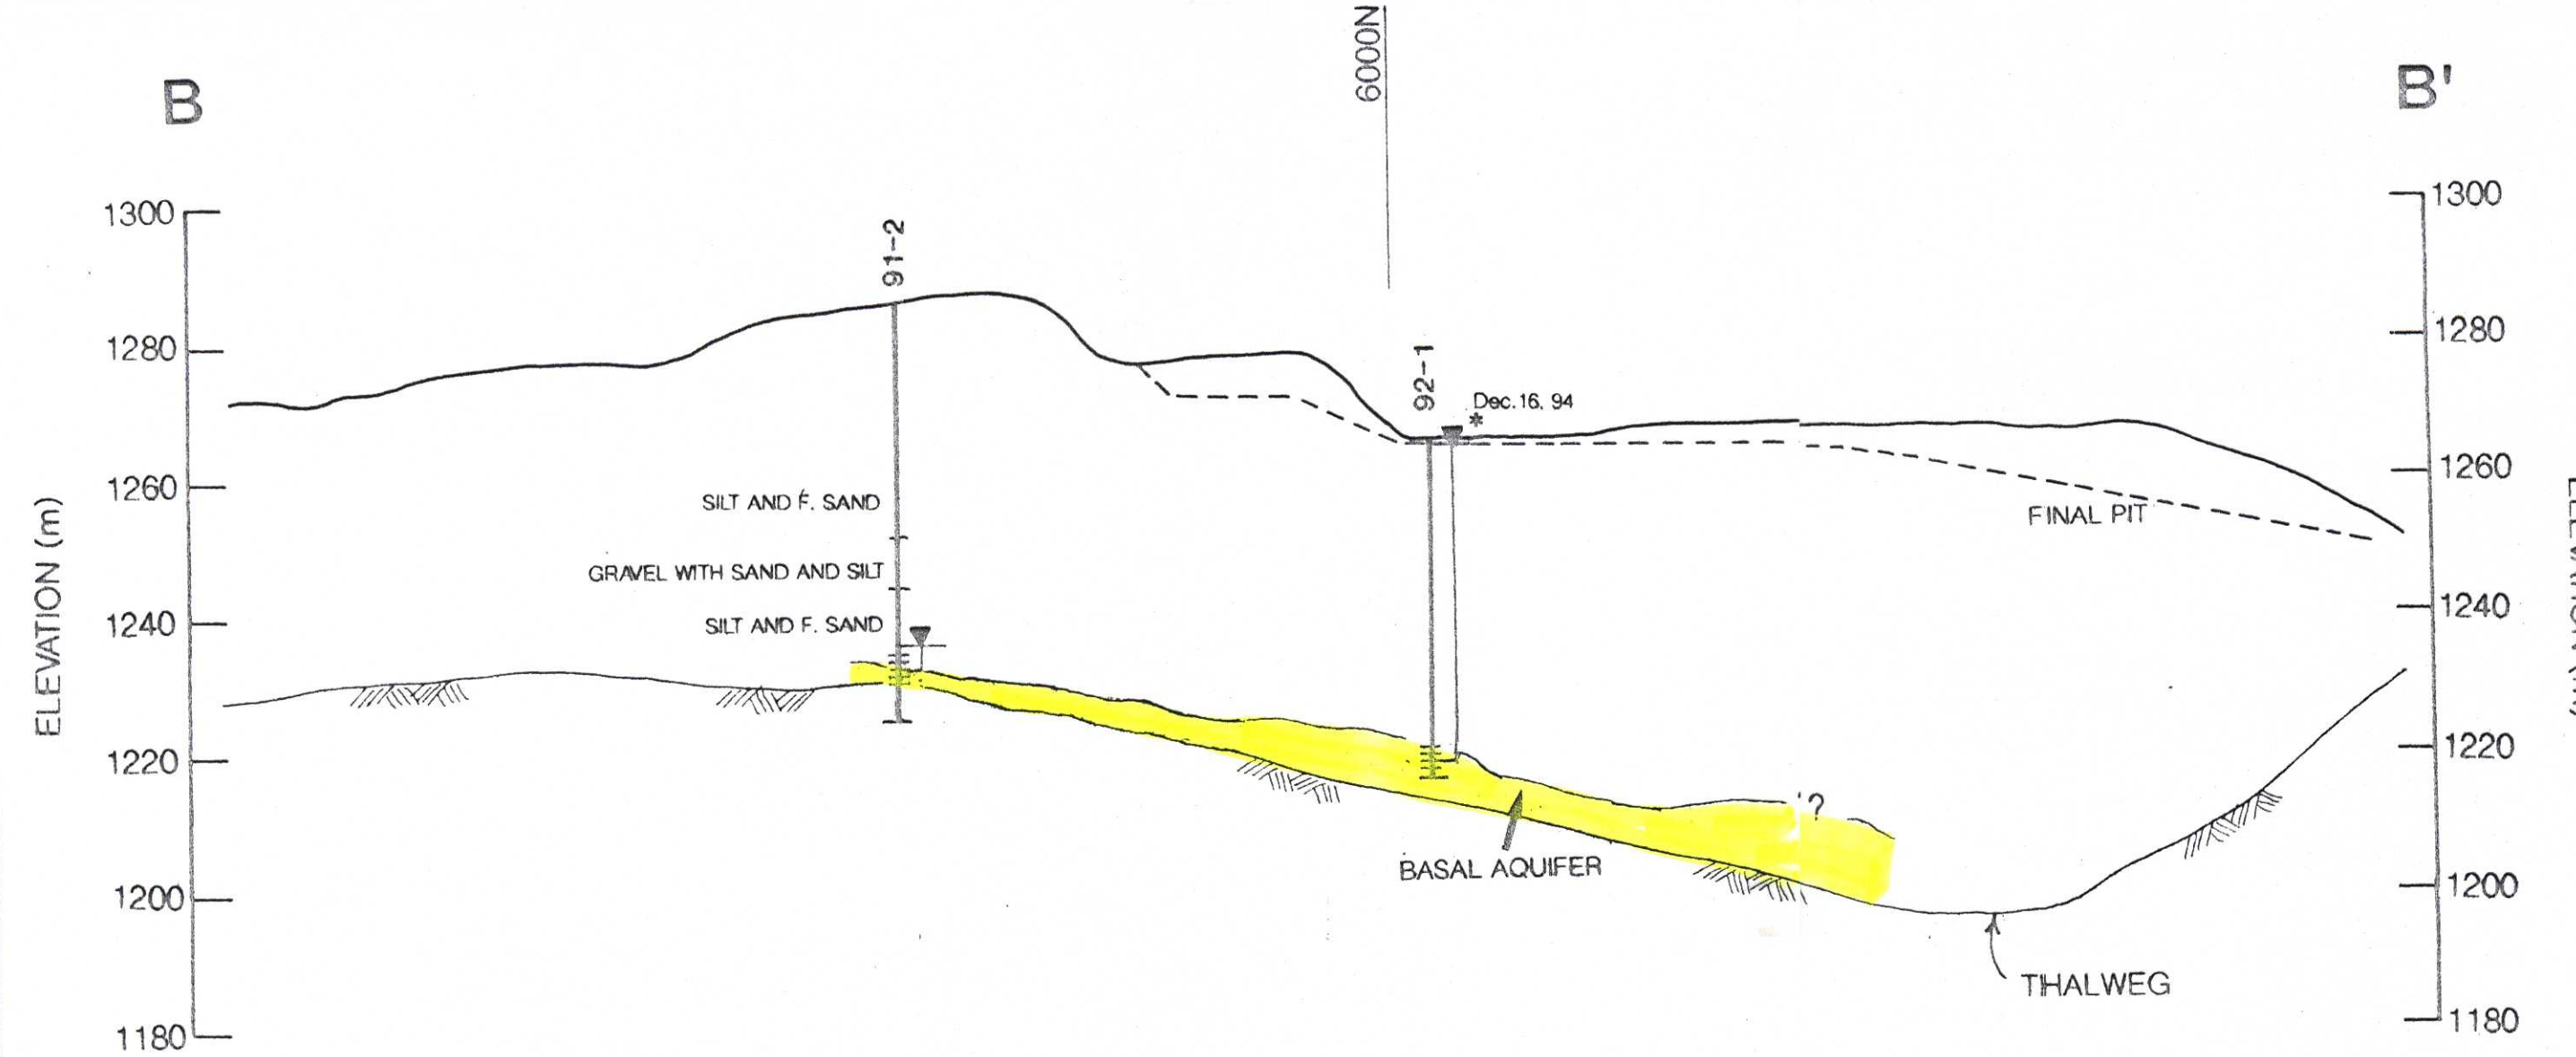
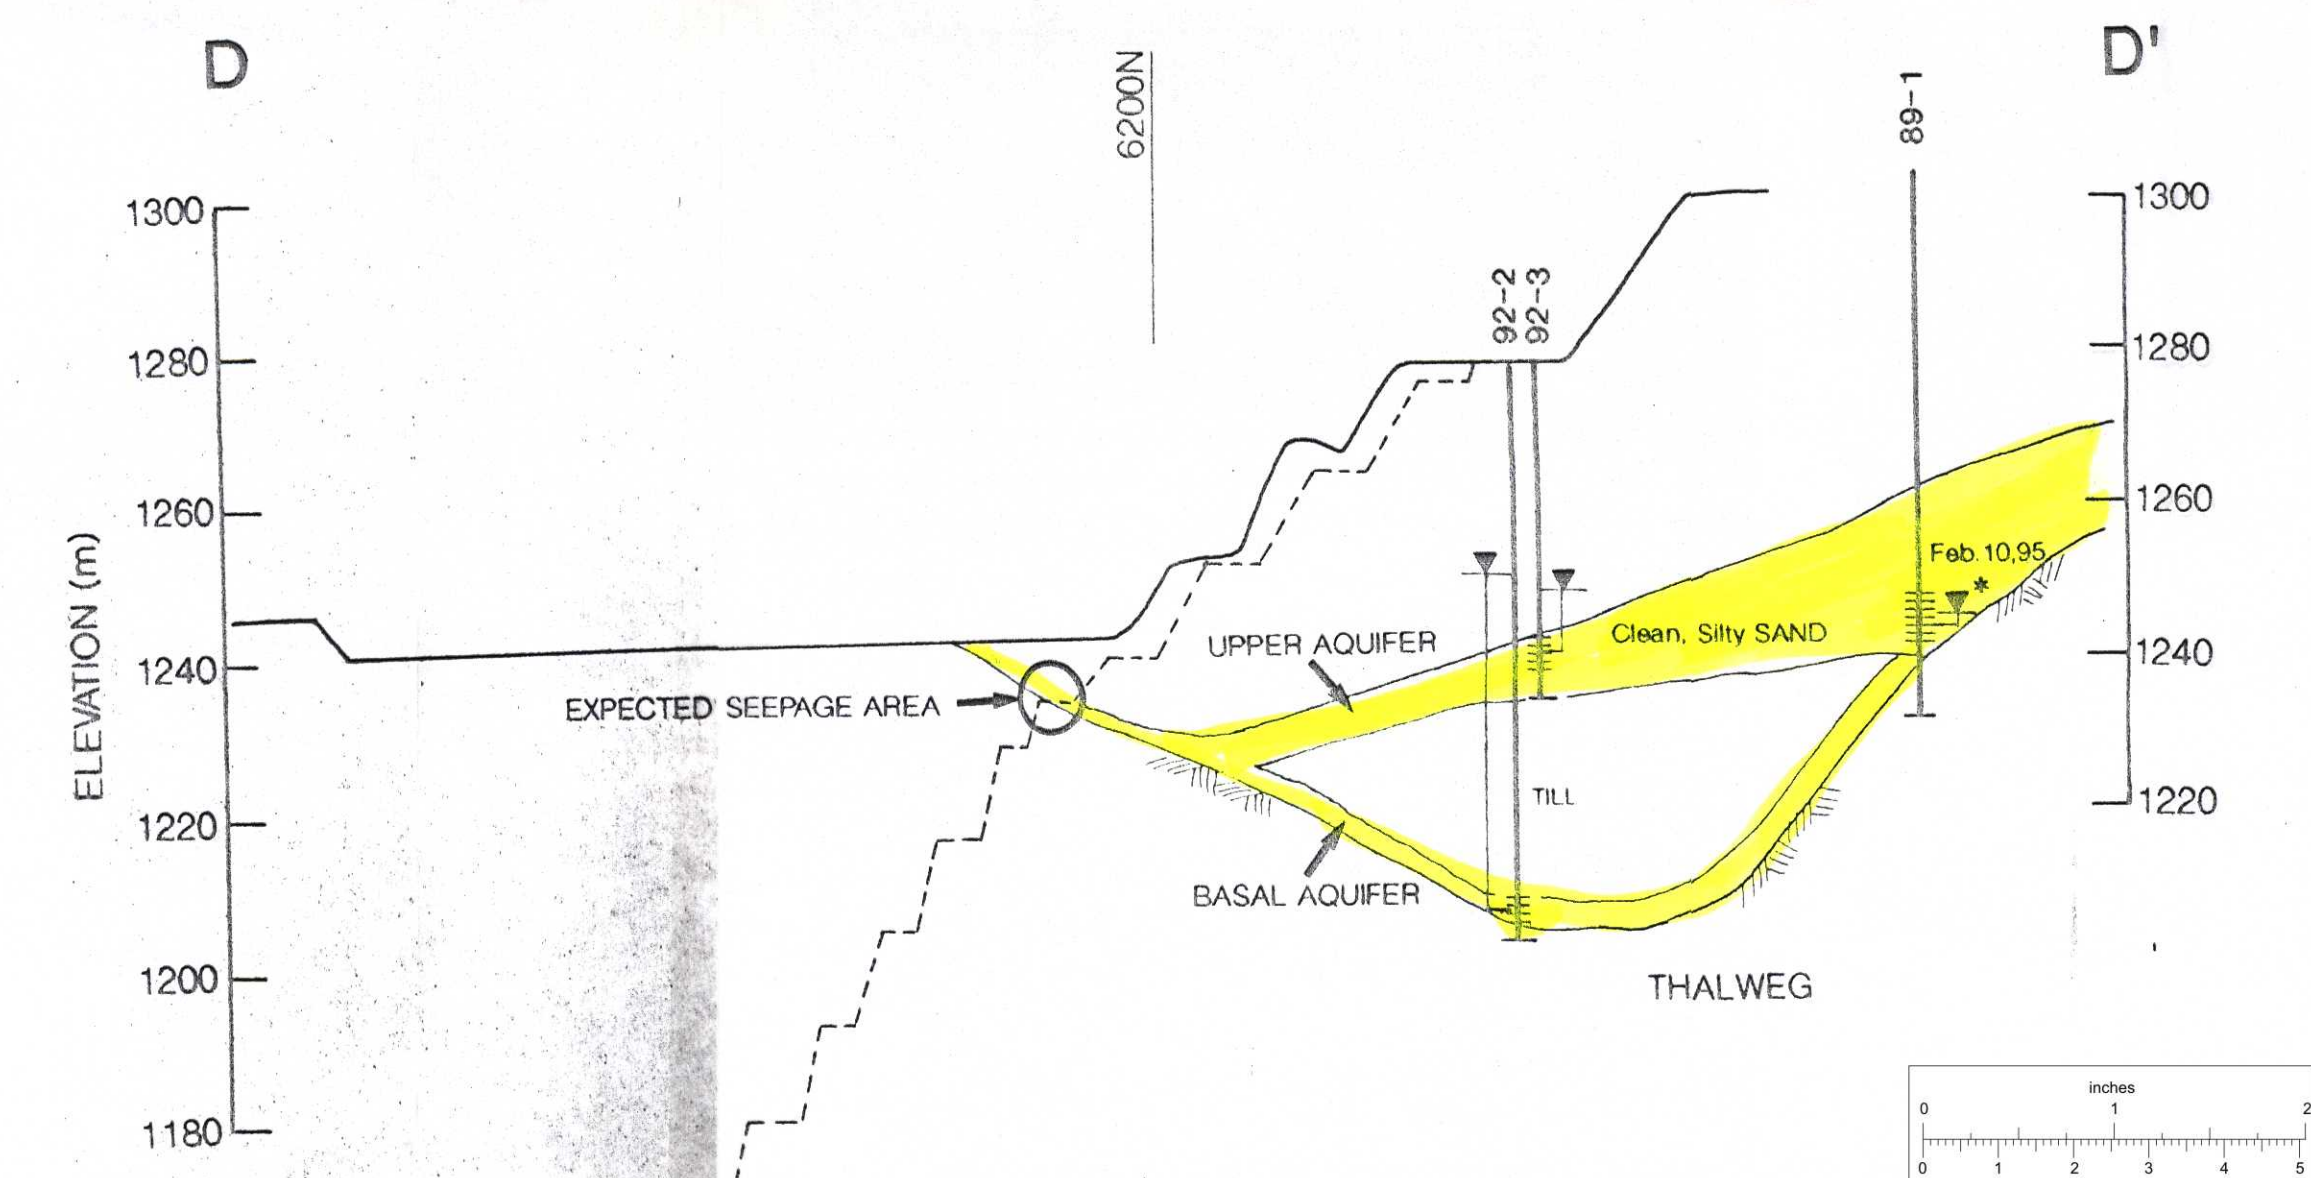
ANVIL RANGE MINING CORPORATION		<b>PITEAU ASSOCIATES</b> GEOTECHNICAL AND HYDROGEOLOGICAL CONSULTANTS VANCOUVER CALGARY	
ASSESSMENT OF AQUIFER DEWATERING GRUM PIT	HYDROGEOLOGICAL SECTIONS THROUGH SOUTHEAST PIT WALLS	BY: BDT DATE: JUN. 95	APPROVED: FIG: 2

Two aquifers are interpreted to underlie the east and southeast pit area. An upper aquifer appears to pinch out somewhere between wells 92-3 and 92-1, as indicated on Fig. 2. A basal aquifer, comprised of the bottom few feet of overburden and the weathered bedrock surface, is interpreted to extend throughout the thalweg and possibly the surrounding areas. There is a good hydraulic connection within the basal aquifer, as indicated by the approximate 6m of drawdown that occurred in well 95-2 after well 91-2 was put back into service sometime before May 18 (Table I and Fig. 3). There is likely a good hydraulic connection between the upper and lower aquifers near well 89-1, where the upper and basal aquifer appear to comprise a vertically contiguous aquifer approximately 20m thick. However, the upper and basal aquifers appear to become separated by till towards the centre of the thalweg, as indicated by the log for well 91-3 (see Piteau letter report to Jack Bowers dated April 4, 1991) and the screen installations in wells 92-2 and 92-3 (no logs available).

The upper aquifer may or may not daylight in the ultimate pit wall near well 92-2 (Fig. 2, Section D-D'). However, as the final wall is almost established in this area, a problem related to seepage from the upper aquifer would likely be apparent if it was going to occur. Dewatering achieved by wells 89-1, 91-3 and 92-3 has reduced the hydraulic head in this aquifer to about 1250m, which is apparently sufficient to prevent seepage related problems.

The basal aquifer will eventually be exposed along the east wall, but primarily on the west side of the thalweg (Fig. 2, Sections C-C' and D-D'). The effect of groundwater discharges from the basal aquifer can be minimized by pumping from wells 92-2 and 95-2, which are both located in the deep aquifer along the centre of the thalweg, and from 91-2 located above the east side of the thalweg. Pumping from these wells has currently reduced the heads in this aquifer to less than 1247m, and some additional dewatering will be achieved by continued pumping. However, as this aquifer will eventually be exposed below about 1240m, some seepage into the pit will occur, and the east and southeast walls of the pit should be closely inspected for signs of seepage near the bedrock interface, to determine if a sump should be established to collect groundwater discharge from the base of the overburden wall. If significant seepage does occur, it may also be necessary to construct a filtered buttress at those locations along the toe of the slope where erosion and slumping occur.

As the aquifer is gradually exposed by mining, seepage into the pit will increase and groundwater levels in the aquifer will drop. Well yields will fall off in response to a drop in groundwater levels. To continue the benefits provided by the wells, it may be necessary to install smaller capacity pumps that are compatible with the reduced well yields. If new pumps are to be installed, the potential for seasonal variations in flows should be recognized and allowed for in the pump selection.

Even though the aquifers appear to be depressurizing well in response to pumping and mining, the surrounding sediments are much lower in permeability and are expected to depressurize at a slow rate. Existing slope performance indicates that the soils have sufficient strength to stand in a saturated state. However, if a lens of loose soil is encountered within the generally dense soil mass, some localized slumping could occur. Slopes in the southeast corner of the pit should therefore be inspected frequently for any signs of seepage or slumping.
