CYPRUS ANVIL MINE GEOTECHNICAL EVALUATION  
JUNE, 1984 FIELD TRIP

84-07-05

BERZINS, B.

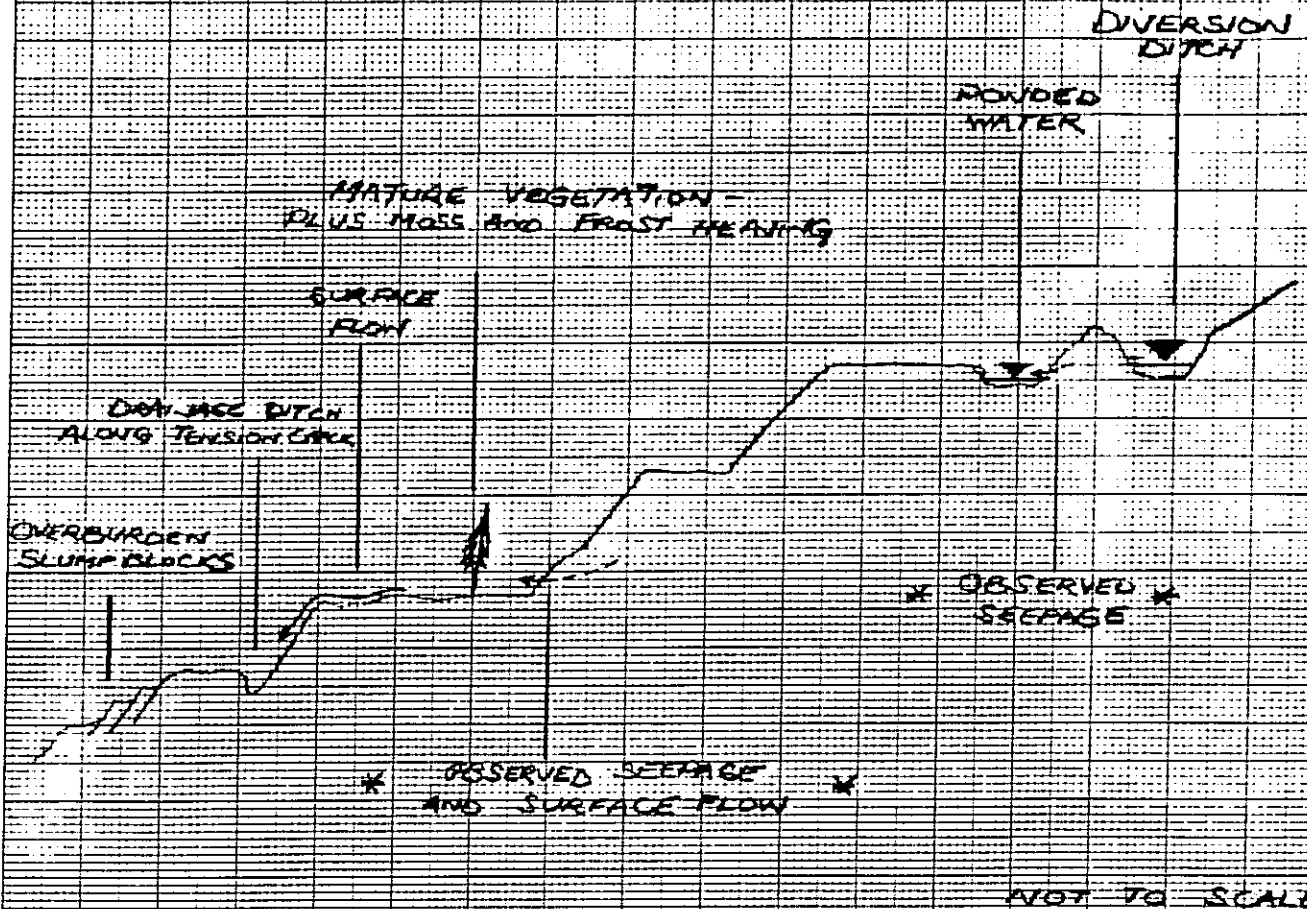
FIGURE 1 - CROSS SECTION VIEW ABOVE  
ZONE 2 AREA

High rates of flow upslope of the diversion ditch are evidenced in Photo 26. Seepage from the ditch is illustrated in Figure 1, and Photos 8 and the pan view opposite Photo 12.

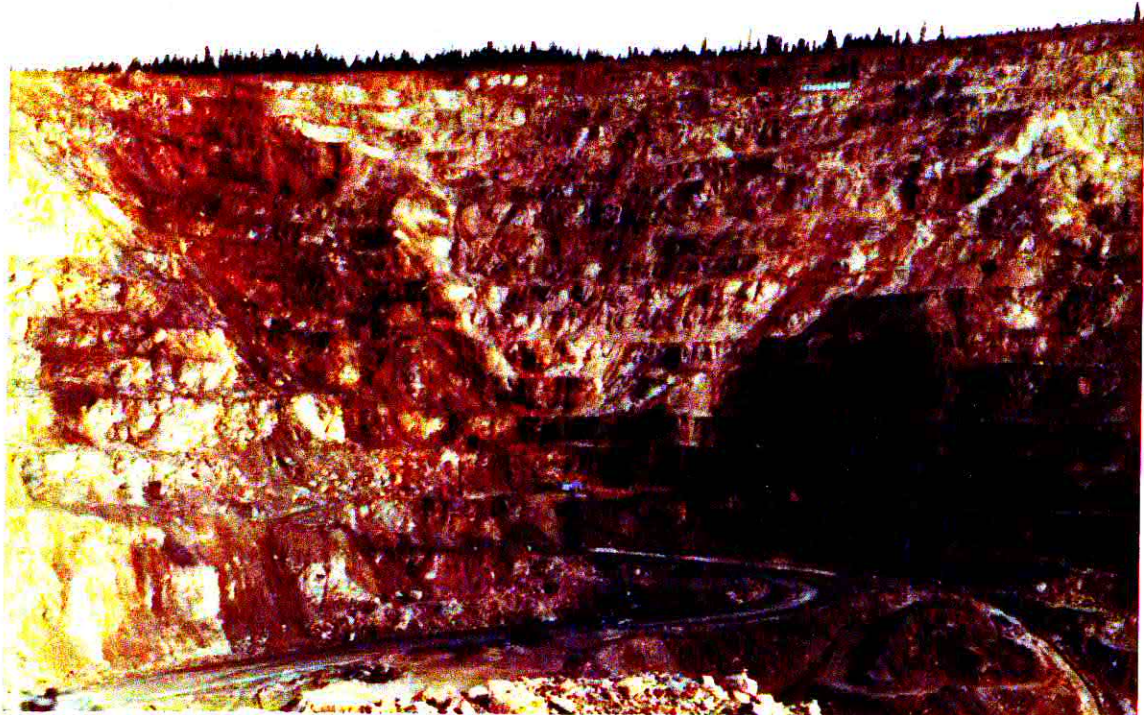
**Photo 1**  
**Evidence of seepage into Zone 1 pit**

A traverse of the Zone 1 pit walls was completed, and an inventory of visible seepages prepared. Conservatively, the estimated surface and near surface flow into this pit totals 30 to 40 l/s (400-550 IGPM), and originates from the sources documented in Appendix A. These sources are listed below in Table 2.1.

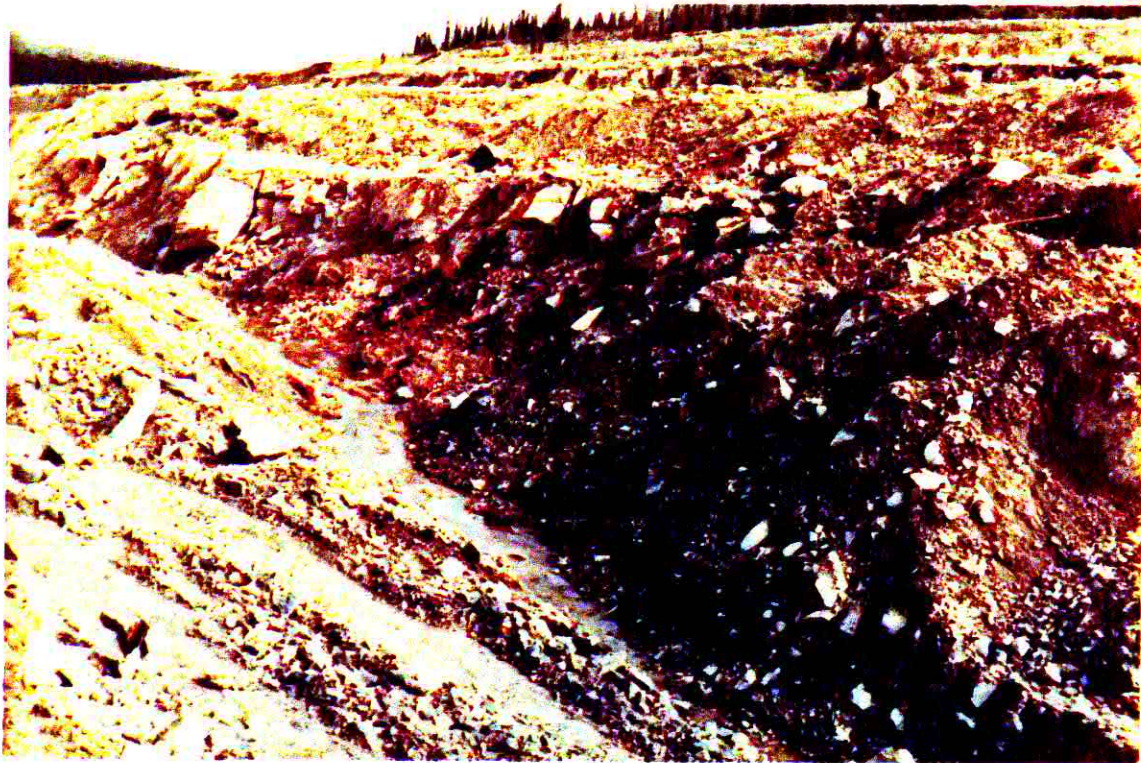
**Photo 4**  
**Surface flow on overburden into drainage ditches**

Seepage within the overburden and bedrock outcrop are currently collected in ditches which have been established at several levels along the wall. Flows within these ditches were approximately  $5 \text{ l}/\text{sec}$  in total. Perhaps the most significant concern related to these collection ditches is that they encourage ponding along tension cracks associated with overburden slumping. The consequences of this ponding on slope stability will be illustrated in Section 3.2.

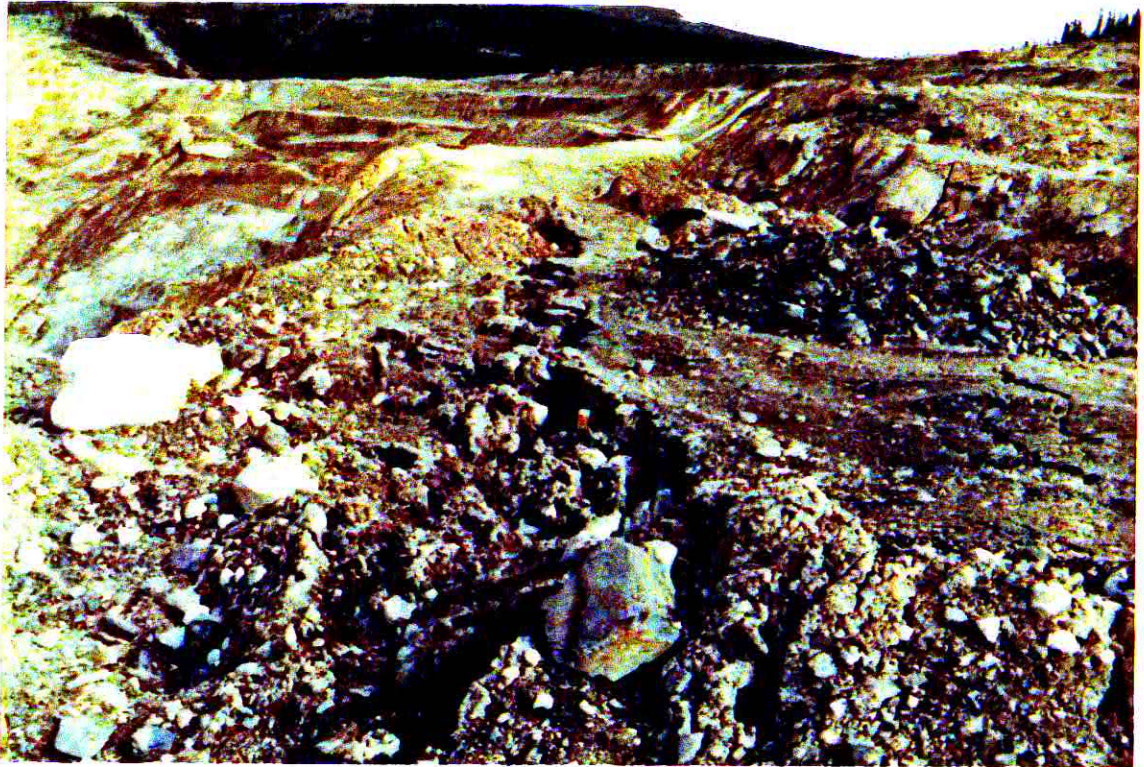
**Photo 6**  
**Slumping in overburden**

Large failures in the overburden are evidenced above the Zone 3 working face (Photos 6, 12, 19, 22). Preliminary calculations (Appendix D) and mine site observations support the contention that failure is occurring at the overburden/bedrock contact, (R. Lopaschuk, pers comm).

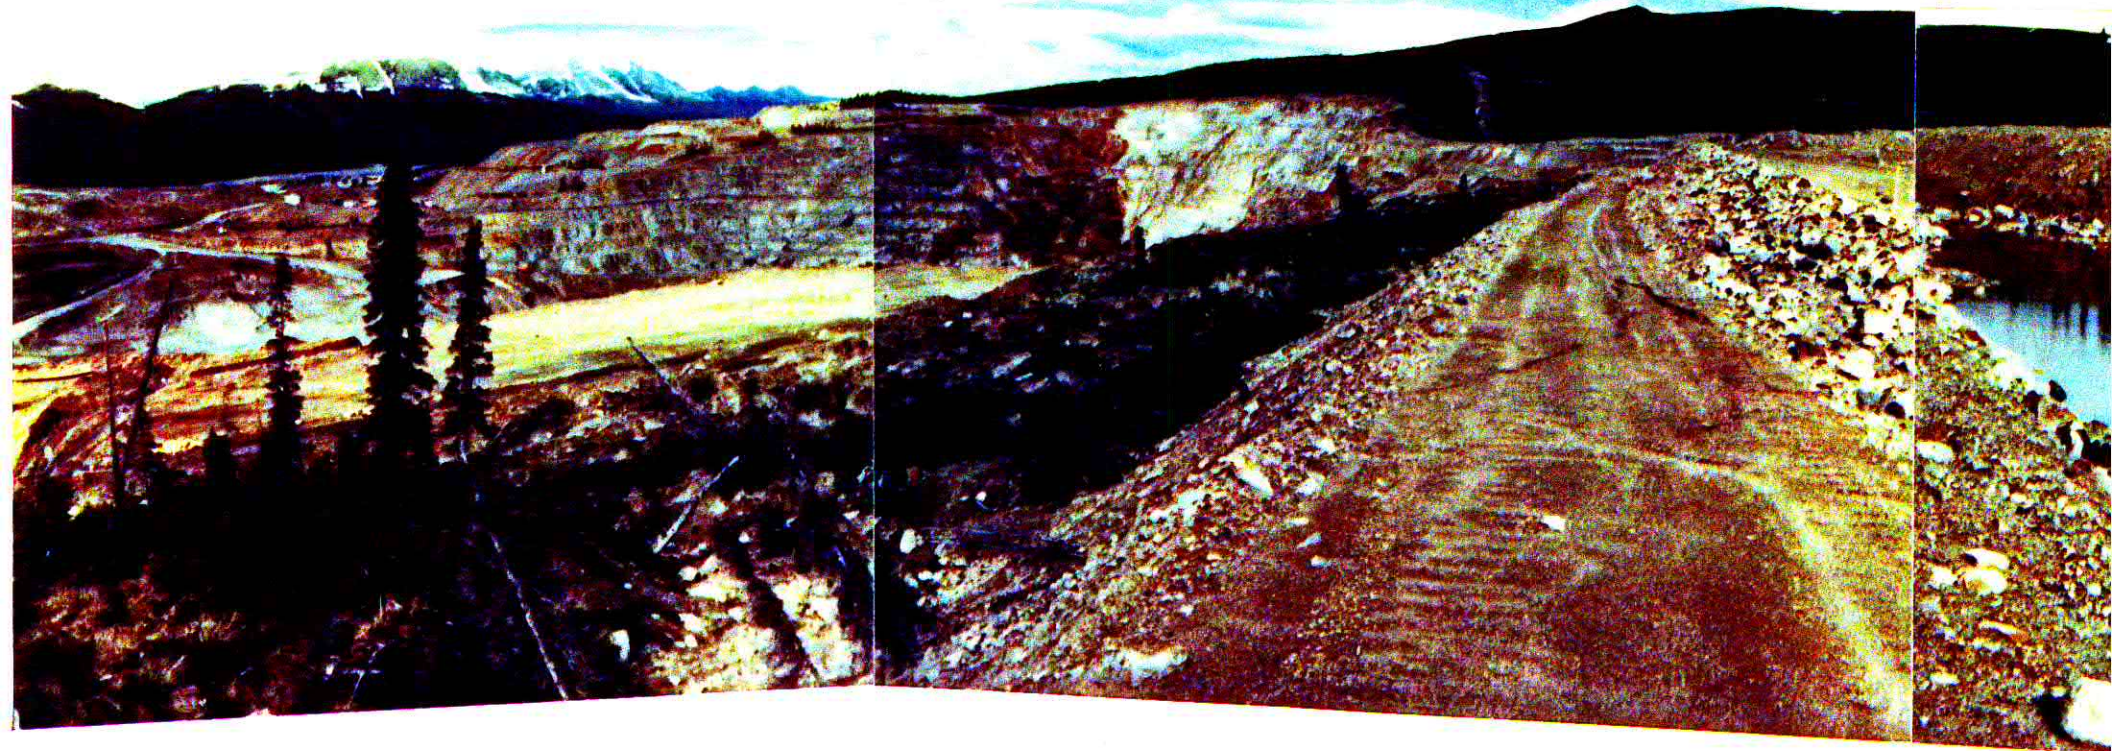
**Pan view of section through diversion ditch**

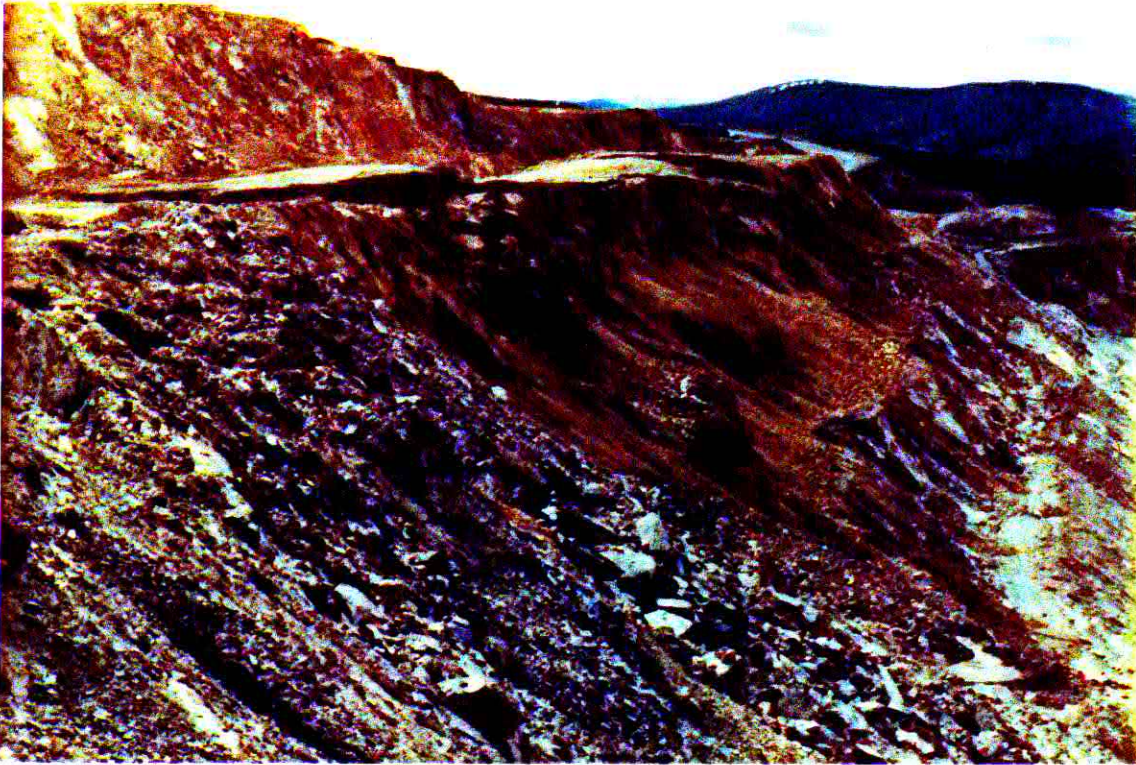
**Photo 22(a)**  
**Overburden slumping**

To date, there is no evidence that the failure is deepseated, however, the presence of splay faults associated with the Big Indian Faults may be contributing to the development of a failure surface in an undetermined fashion. As shown in Appendix D, however, water within the tension crack at the headscarp of the slump block contributes to a significant reduction in the safety factor. Consequently, continued emphasis must be placed upon the control and reduction in surface water flows in the vicinity of the Zone 3 face.

- (1) Redirect the discharge from Zone 1 and Zone 3 pit areas to a location where seepage into blast areas is eliminated.
- (2) Further grade the Zone 3 slope to eliminate ponding of water and flow into tension cracks.
- (3) Conduct studies into the correlation between historical blast-hole records and water problems.
- (4) Conduct aerial photography over the area to facilitate completion of up-to-date mapping of pit geometries and geotechnical features.

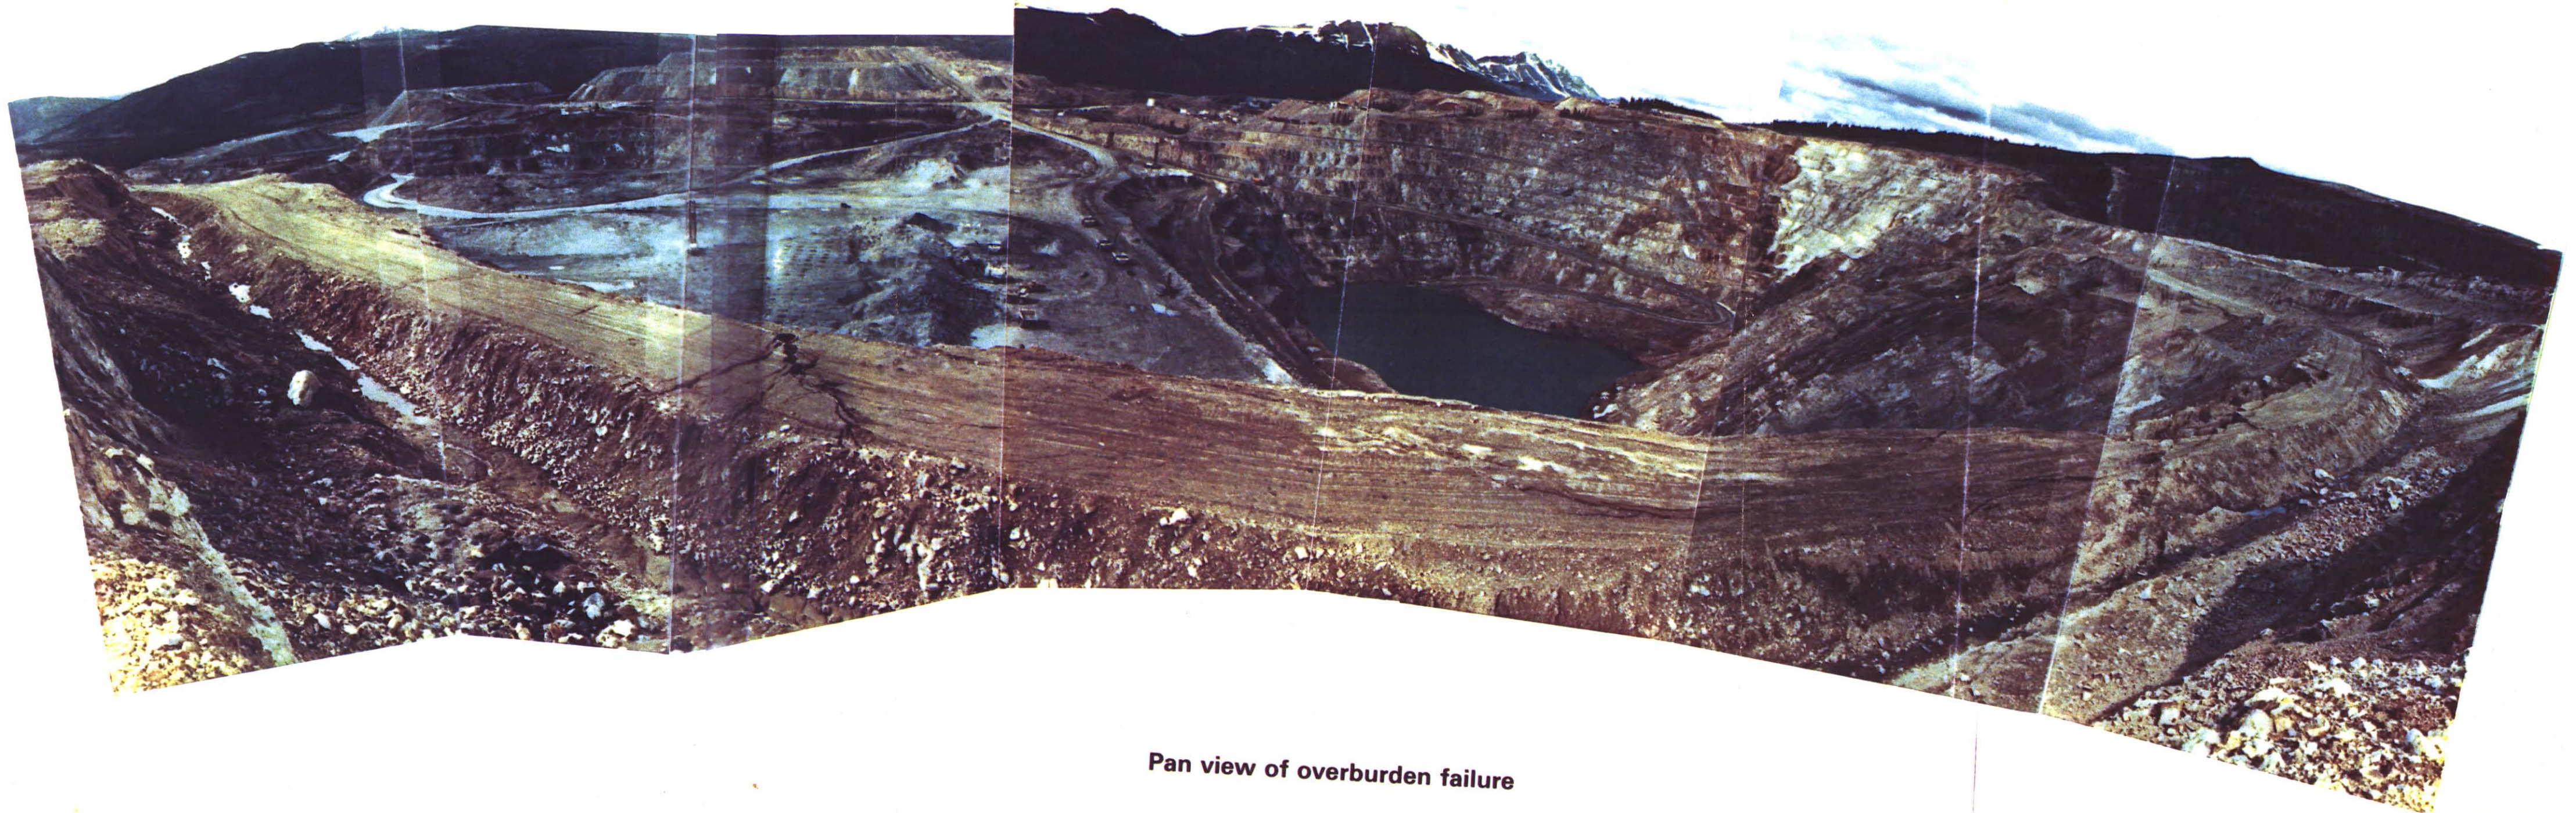
**Pan view of overburden failure**

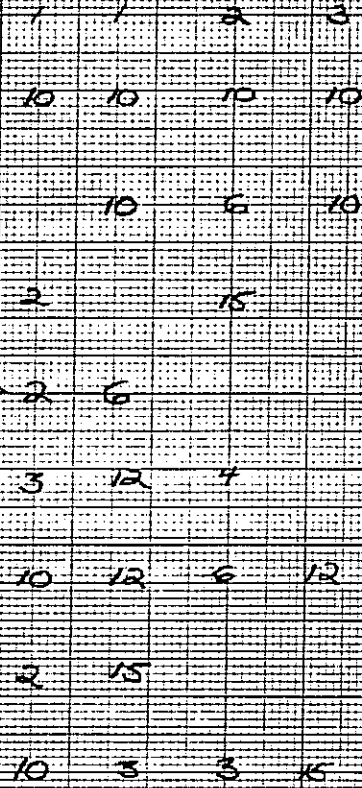
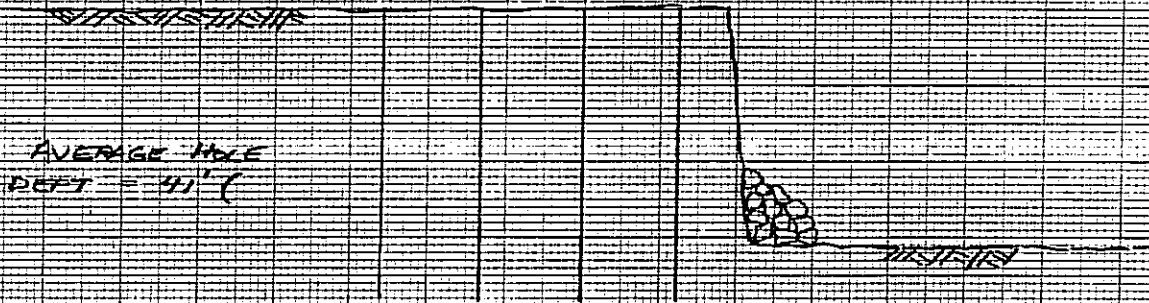
FIGURE B2 - WATER LEVELS IN BLAST HOLES

The lack of definite trends in water levels and the variability of levels in adjacent holes is consistent with the observation that groundwater flow through the waste rock is structurally-dominated (by joints and faults or alteration along dykes). As illustrated in Figure B2, water levels within 3 to 9 metres of the slope were still relatively high, even though blasting had taken place at least 48 hours before. These levels would seem to indicate a low
