CURRAGH RESOURCES - FARO MINE

REPORT  
ON  
1987 SITE VISIT

Prepared For:  
NORTHERN AFFAIRS PROGRAM  
Whitehorse, Y.T.

July, 1987  
G052-4

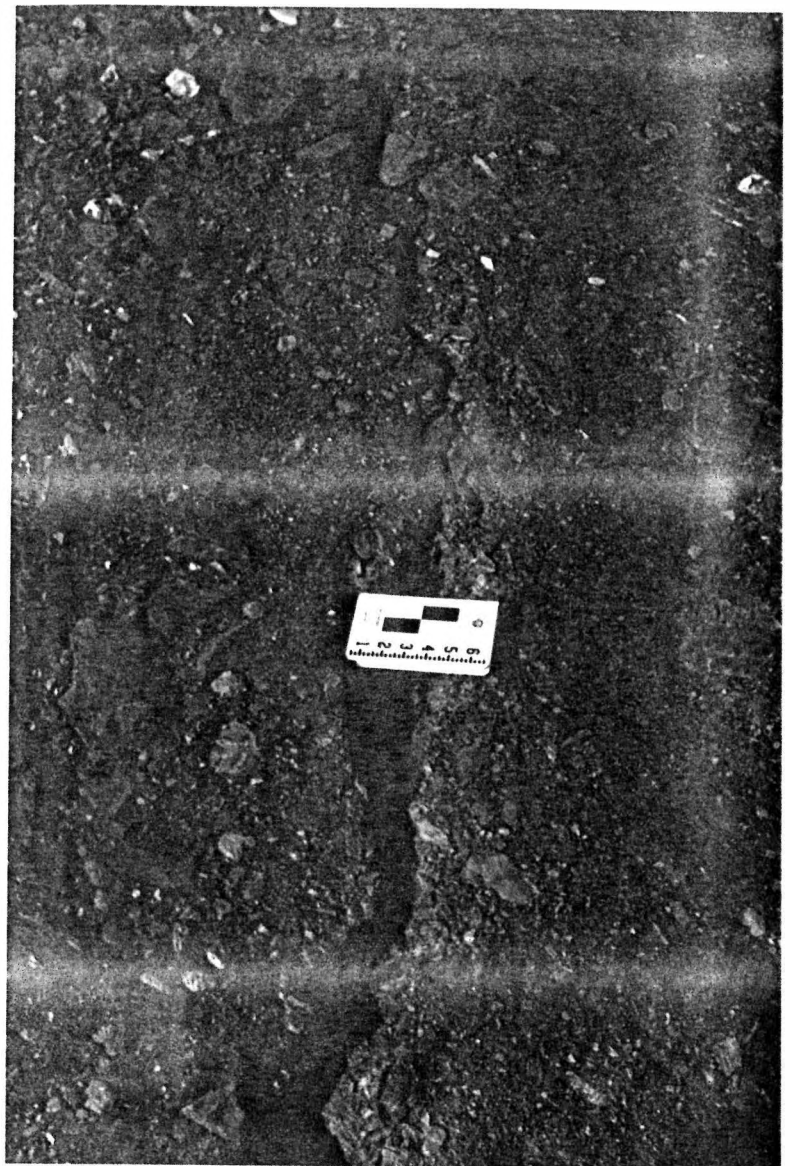
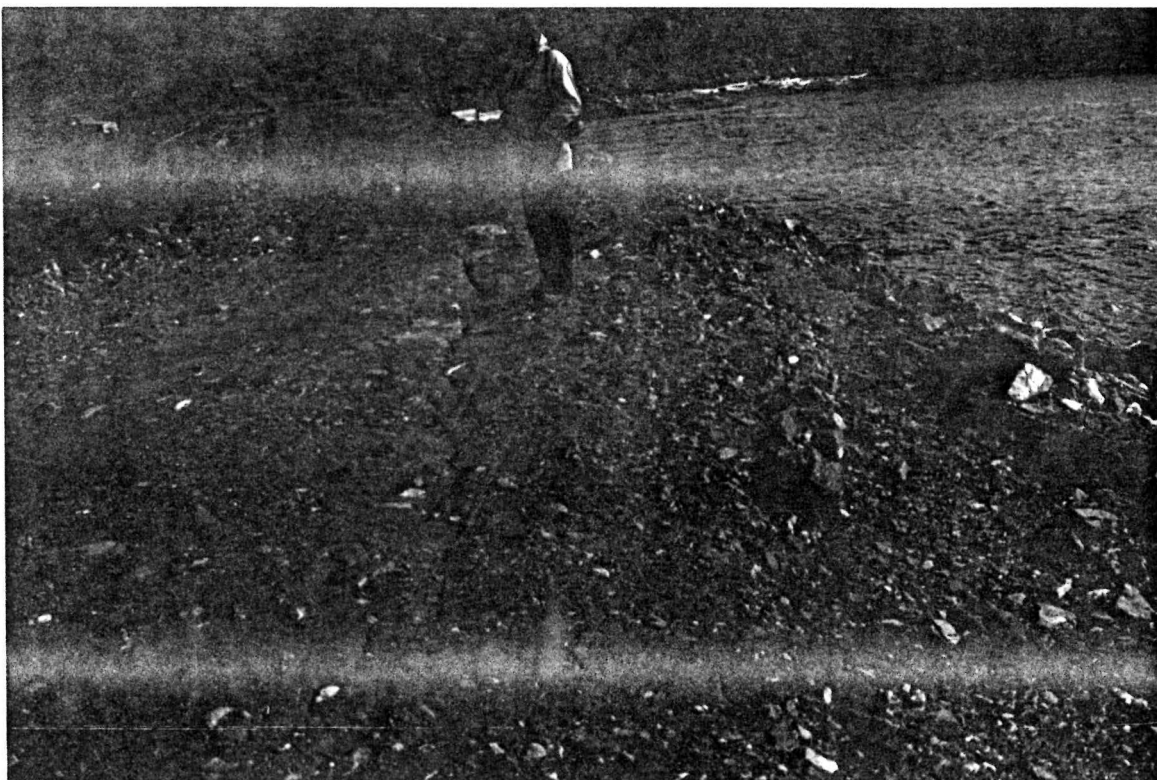
An almost continuous crack (and locally several subparallel arcuate cracks) traverse the top of the dam (Photo Nos. 1 and 2). In most instances, the crack is located approximately 1.0 to 2.0 m from the upstream dam face. In the middle of the dam (BH 85-4), where the crest is about 5 m wide, the crack reaches a point approximately 4 m away from the upstream edge (Photo 3).

The existence of extensive cracks in the crest of the dam indicates an unstable upstream slope. The extent of the instability is believed to be serious, especially with respect to known high pore pressure conditions in the dam and its foundation. Therefore, it is recommended that you consider the following actions:

Photos 1 and 2: Cracks encountered on the crest of the dam are fresh, up to 10 cm wide and mostly sub-parallel with the upstream face.

- ° Request that the owner undertakes an evaluation of the stability of the dam.
- ° When evaluating the stability of the dam and its segments, a realistic but most adverse combination of site and reservoir conditions should be considered.
- ° Request that the owner establishes a schedule of inspections and monitoring (including seepage pressures).
- ° Depending upon the results of the review, establish operation guidelines for the reservoir and, if necessary, request modifications of the structure to ensure a satisfactory Factor of Safety against foundation or dam failure.
- ° Institute a system of formal annual inspections and reporting with the objective to assess the dam and reservoir conditions from year to year.

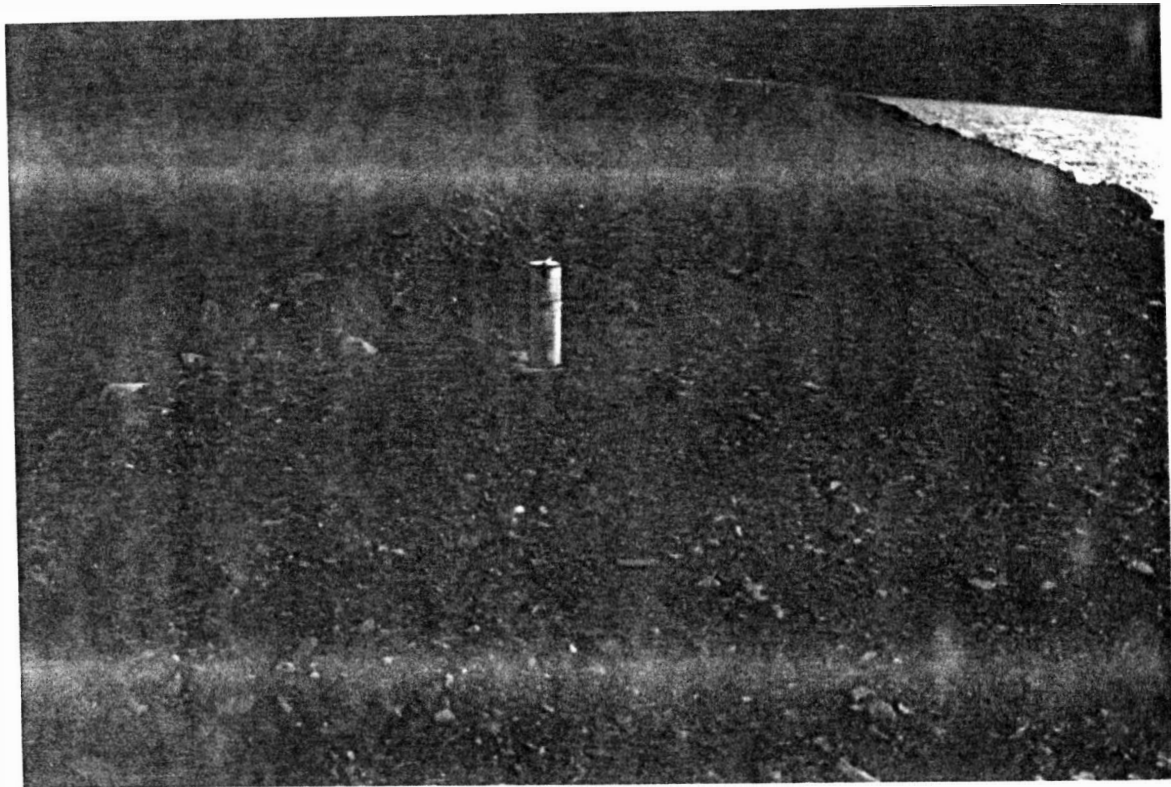
Photo 3: An arcuate crack is only 2 m away from the downstream edge of the the crest in the centre of the dam (at test hole BH 85-4).

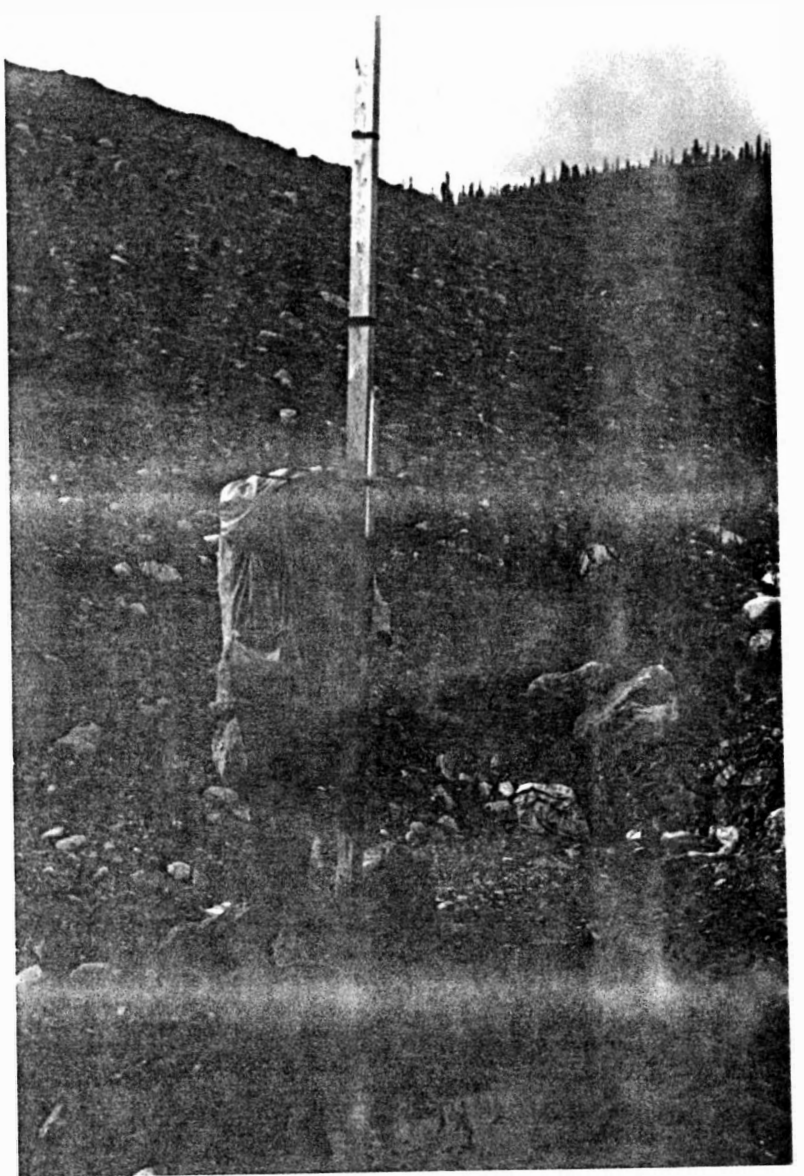
BH 85-2 measured 1.8 m pressure head above the surface of the toe support berm (Photo 4).

Photo 4: Standpipe BH 85-2  
measured 1.8 m pressure  
head above the toe berm.  
Note the seepage surfacing  
at the toe.

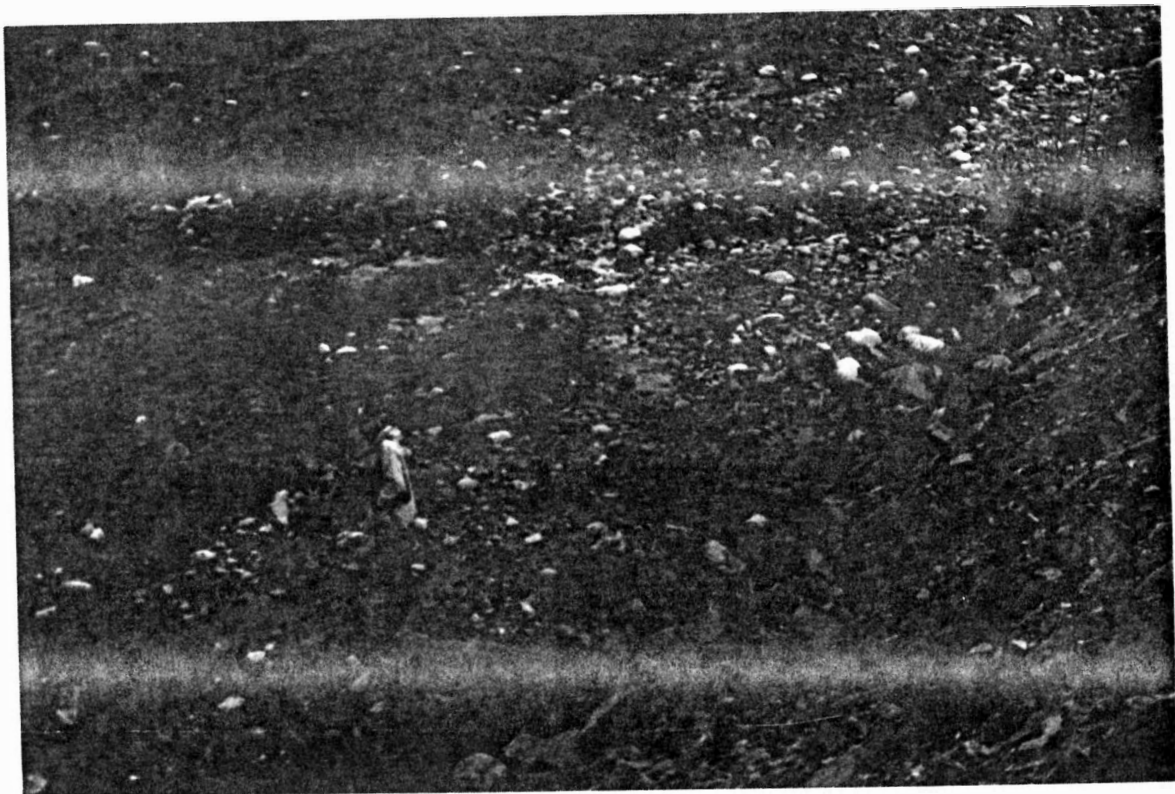
The ground immediately downstream from the toe berm is saturated and heavy seepage discharges exist throughout this area (Photo 5). The soil is in a loose (or in the case of localized cohesive materials in a soft) state of consistency, confirming existence of high pore pressures.

Photo 5: Heavy seepage along  
the toe berm.

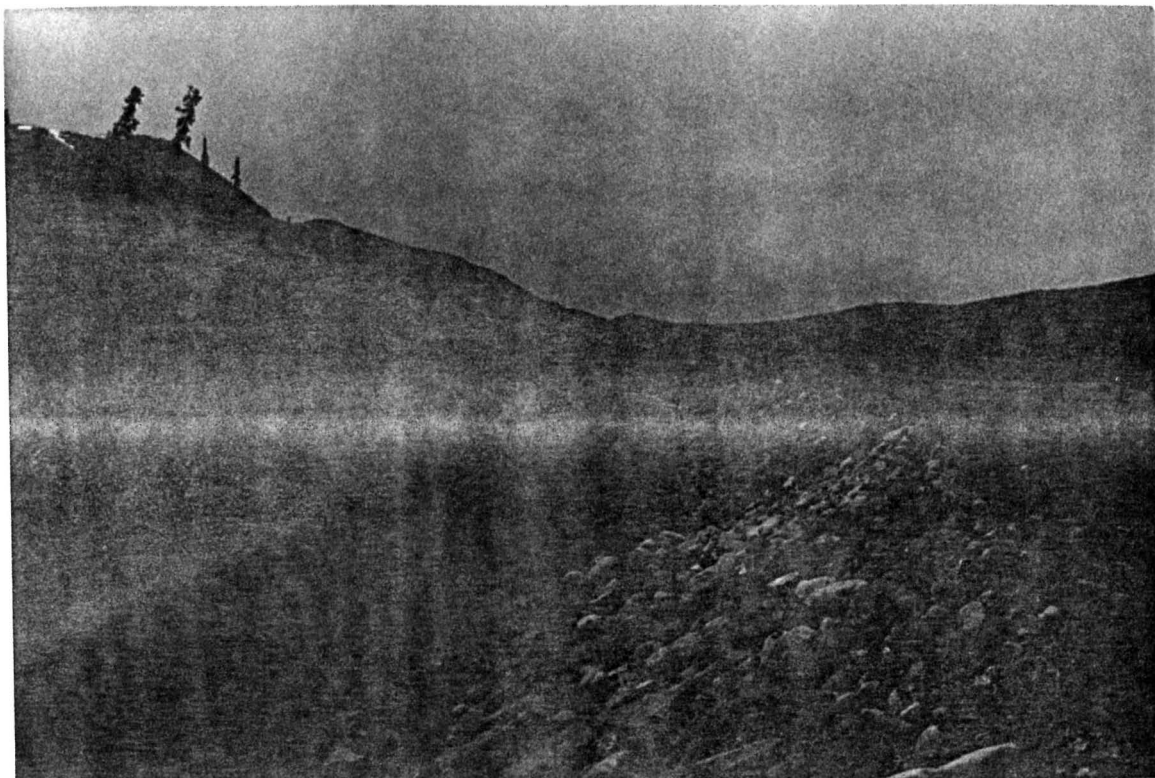
The diversion channel performs as designed and its overall appearance is good (Photo 6). The main deficiencies and deformations we have identified are similar to those detailed in 1986 Golder's report. These, in brief, include:

Photo 6: View of the diversion channel looking downstream. Note aggradation of material at a small tributary outfall.

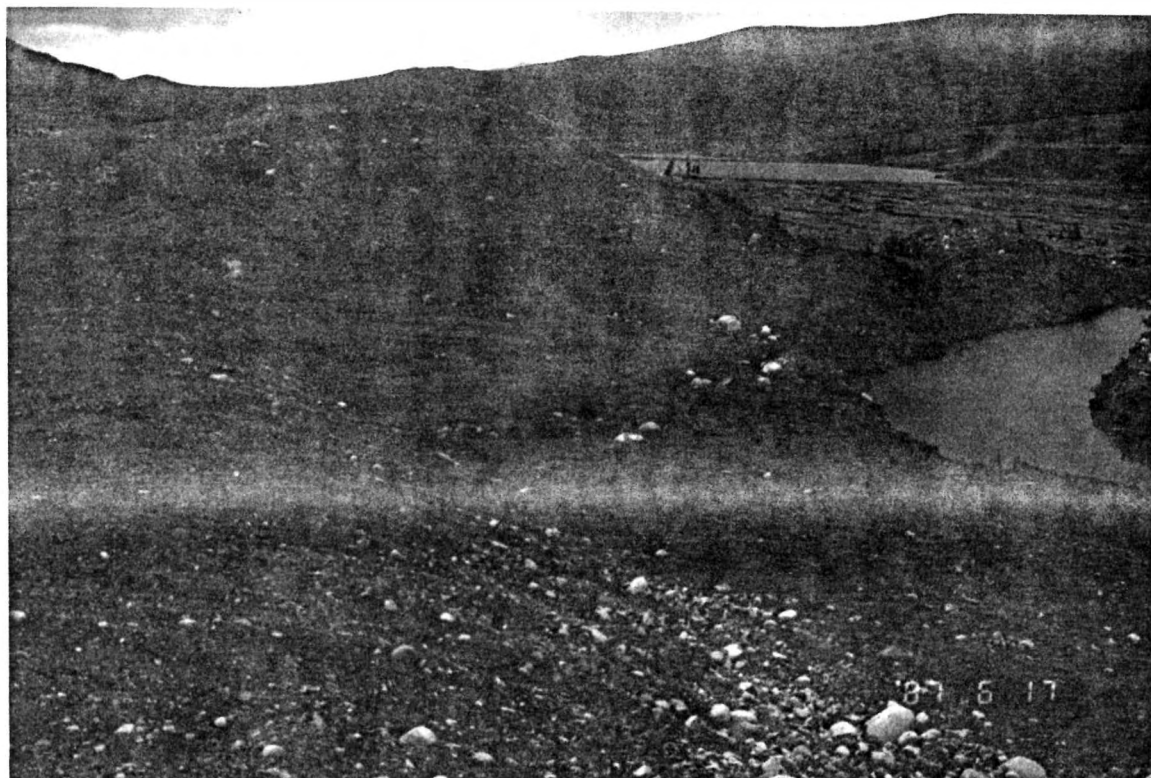
- ° Seepage discharges and ponding of water along or below the toe of the canal dyke, such as documented by Photo Nos. 7 and 9. This could adversely affect the stability of the dyke. Presently, the most critical situation is in the area adjacent to borrow pit "I" where a fresh mudflow (Photo 8) is retrogressing towards the dyke. Cracks, quite fresh and up to 10 mm wide, cut across the dyke toe area at this location. The volume of seepage is considerably larger than that experienced during the early stages of the canal operation.

Photo 7: Seepage discharges into borrow pit "I." The borrow pit slopes are unstable. There are fissures and cracks on the face of the dyke and along its toe.

- improvement of drainage and stability conditions in the borrow pit "I" area,
- regular (at least monthly during the warm season) visual monitoring of cracks and stability aspects of this area,
- development of stabilization measures should a retrogressive failure be indicated, and
- draining of the water ponded along the toe of the canal dyke at other locations as well.

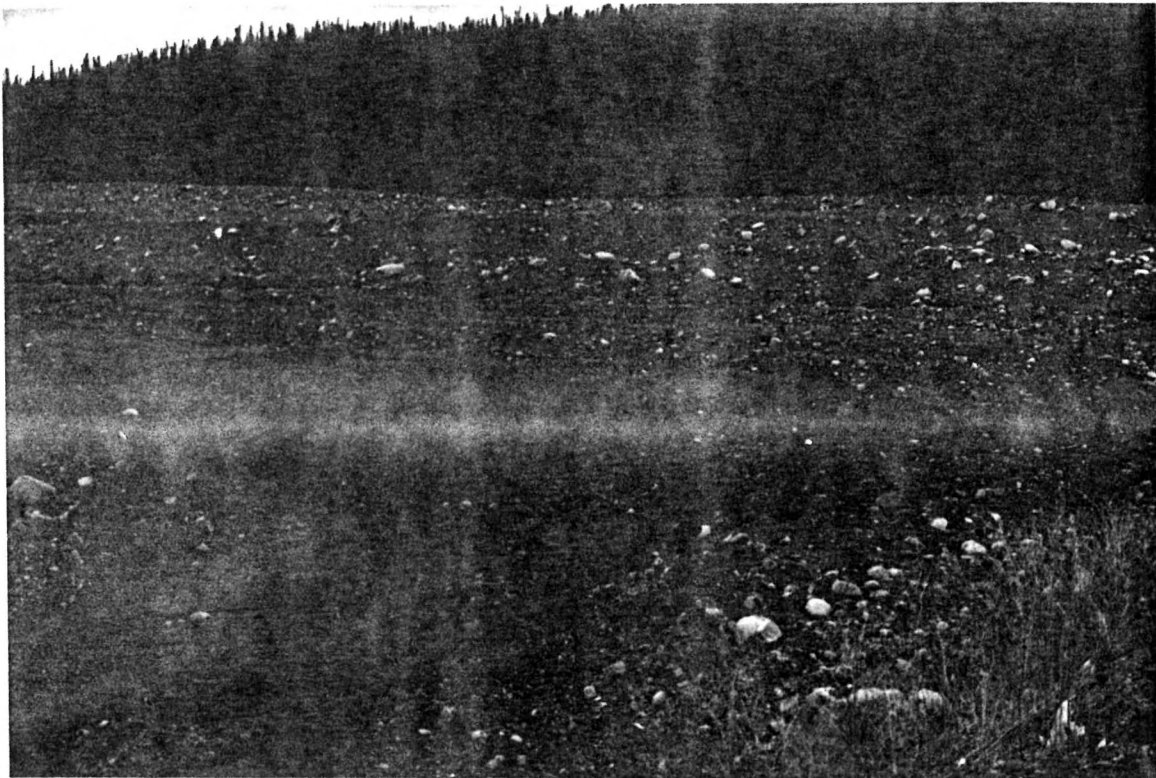
Photo 8: View of recent mudflow retrogressing towards the canal dyke.

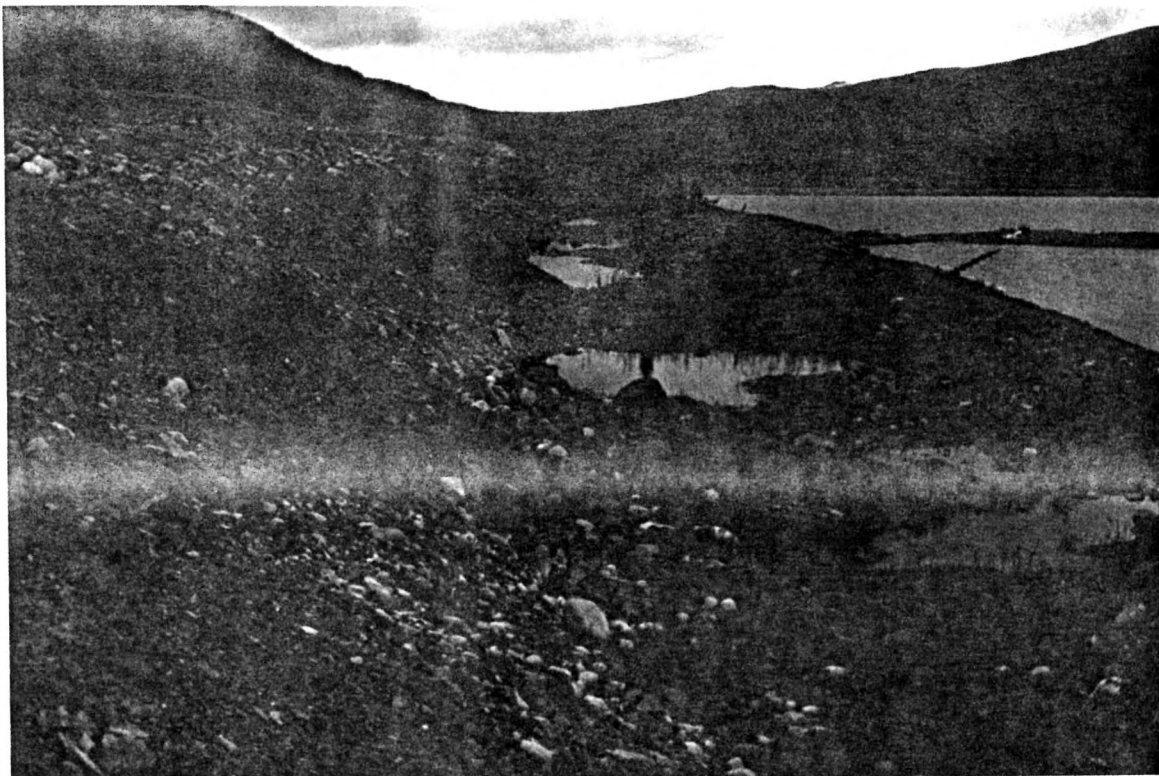
Photo 9: Seepage from the canal is ponded in localized depressions along the toe of the dyke.

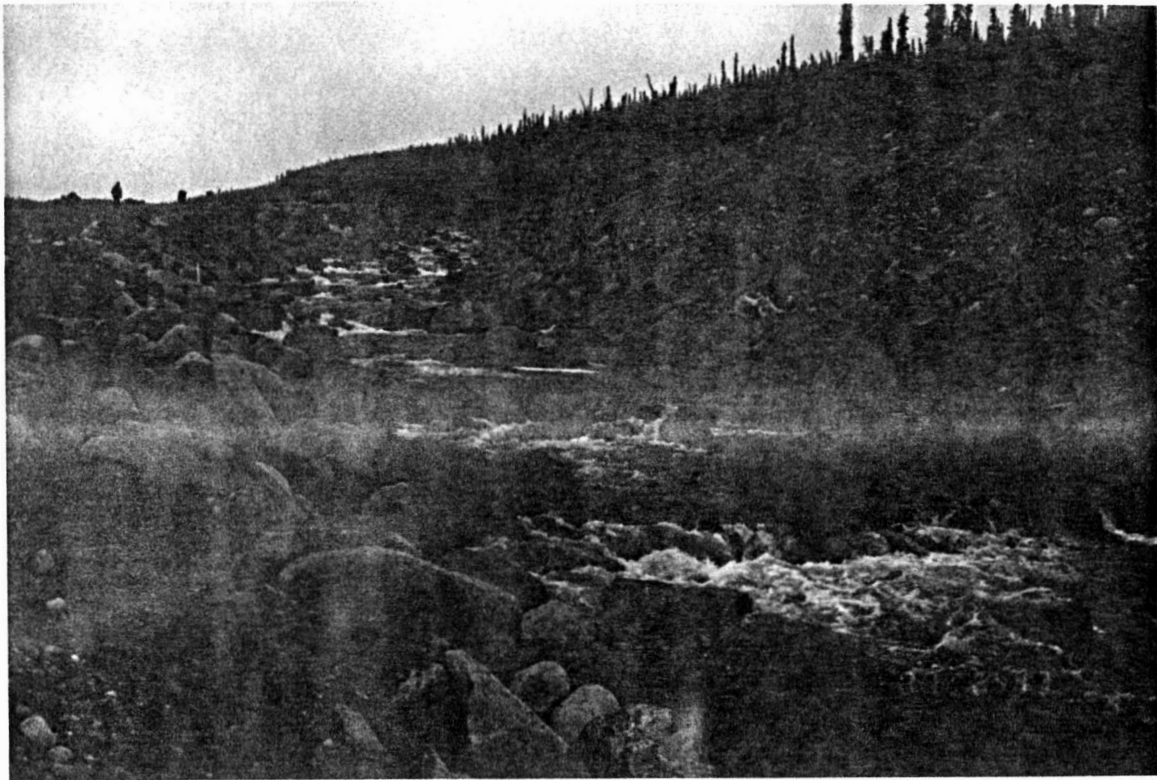
- ° Localized sloughing of waste piles, possibly due to continuing thaw of deposited materials and subgrade.
- ° Drop weir sections show localized dislocation of boulders, and in a few instances disturbance of the sidewall rip-rap (Photo 10).

Photo 10: Upper segment of drop weirs. Note individual blocks displaced from their original positions.

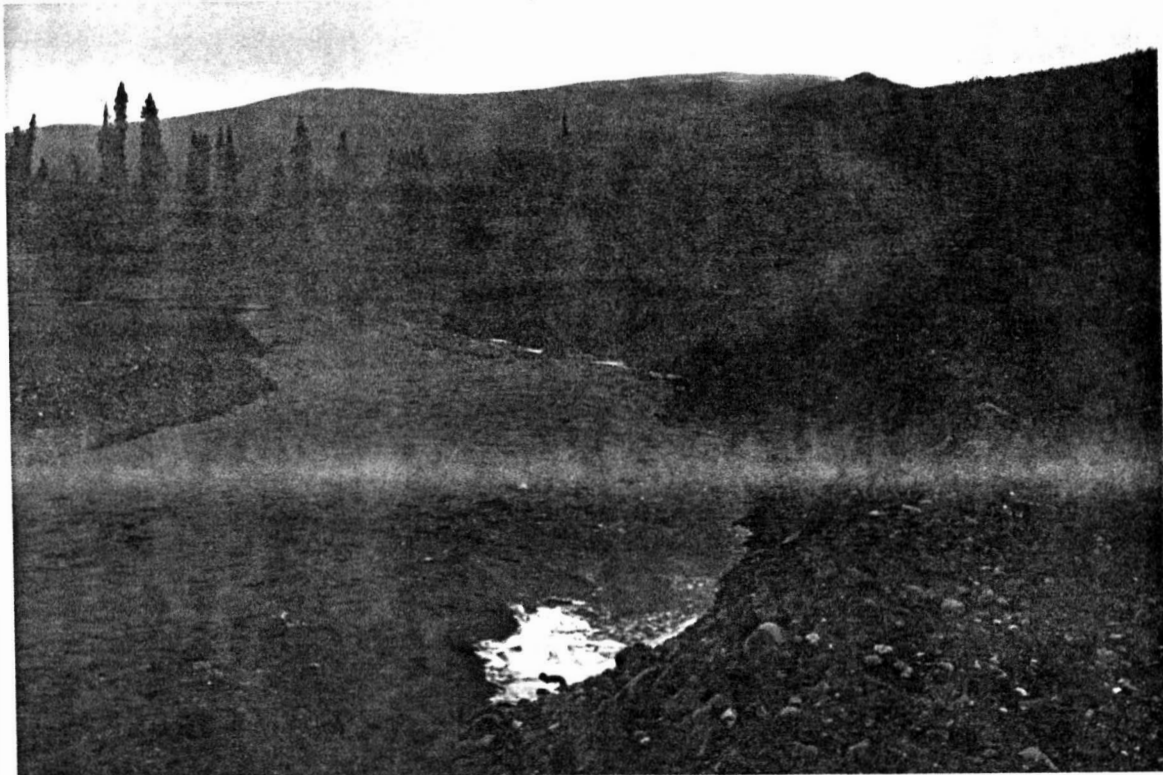
- ° Channel erosion and aggradation downstream from the last weir (Photo 11).

Photo 11: Diversion canal outfall. Note gravel bar on left and eroding bank on right side.

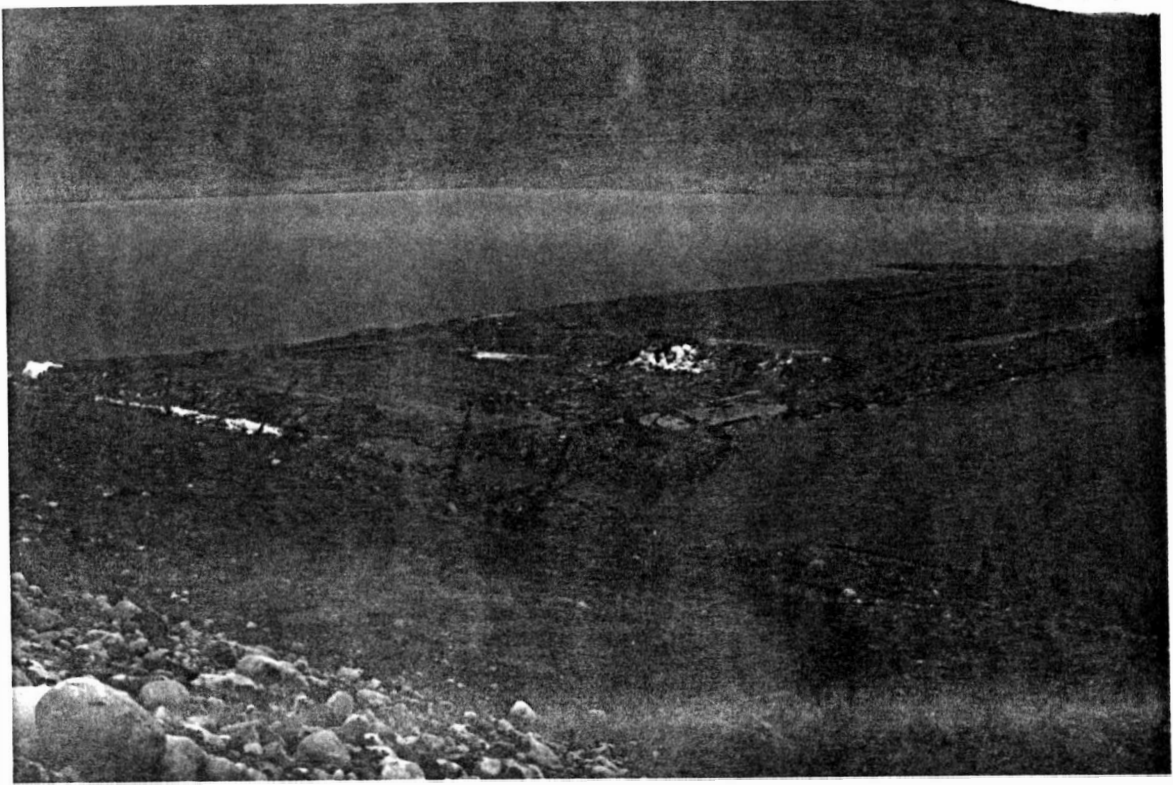
Water level in the tailings pond was only slightly below the sill elevation of the emergency spillway, controlled by the overflow through the decant channel (Photo 12).

Photo 12: View of the decant, emergency spillway and adjacent embankment of the Intermediate Dam. The integrity of this structure, at the present time, is governed by the stability of both spillways.

Clean-up of the emergency spillway is required. It would be prudent to grade the sill by selective placement of heavy rip-rap.

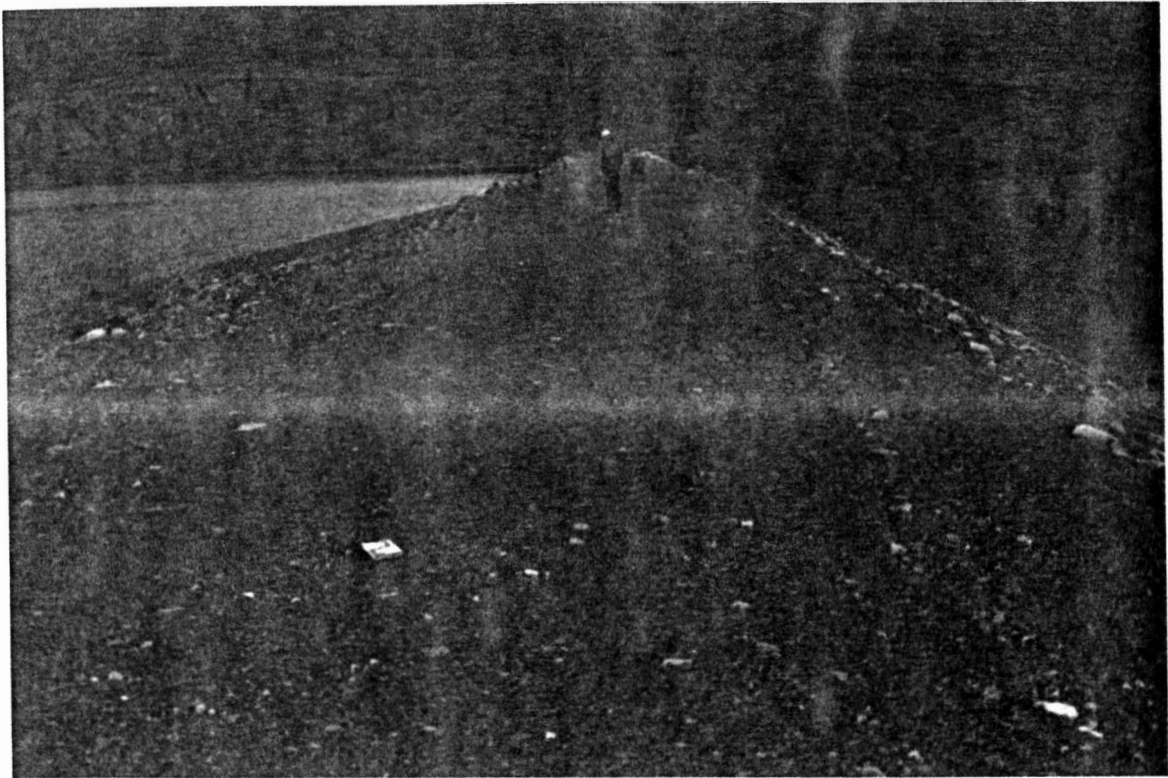
Our examination of the dam crest revealed existence of cracks which are locally arcuate and elsewhere subparallel with the upstream edge (Photo Nos. 13 and 14). The width of cracks range from 5 mm to 75 mm. They probably occurred relatively recently since they were not observed by Mr. H.G. Gilchrist during his October, 1986 site inspection. However, no major deformations have been identified on either slope of the dam.

Since the cracks are, in most instances, closer to the upstream edge (except the centre of the dam and at the south abutment where they are approximately in the middle of the crest) settlement or an instability of the upstream face of the dam is suspected. This deformation may be influenced by the reported increase in the piezometric levels beneath the upstream blanket (between October, 1984 and October, 1986 in the range of 1.4 to 2.8 m) as well as beneath the core (between 0.88 and 2.26 m). A detailed survey of the cracks and review and analysis of soil and pore pressure data should be undertaken in order to determine the probable causes and to evaluate the possible consequences of these deformations.

Photo 13: Crest of the Cross Valley dam looking south. An arcuate crack in front; further to the south the crack parallels the upstream edge of the crest.

It is our opinion that the extent of surface cracks observed on the dam and volume of seepage require a thorough evaluation. We recommend that the mining company be requested to undertake:

- ° detailed surveys of cracks and recent pore pressures,
- ° evaluation of the dam stability,
- ° regular and frequent (for example, monthly) monitoring of piezometers and seepage flows,
- ° frequent visual inspections of cracks (relative to installed reference points) and other surface features.

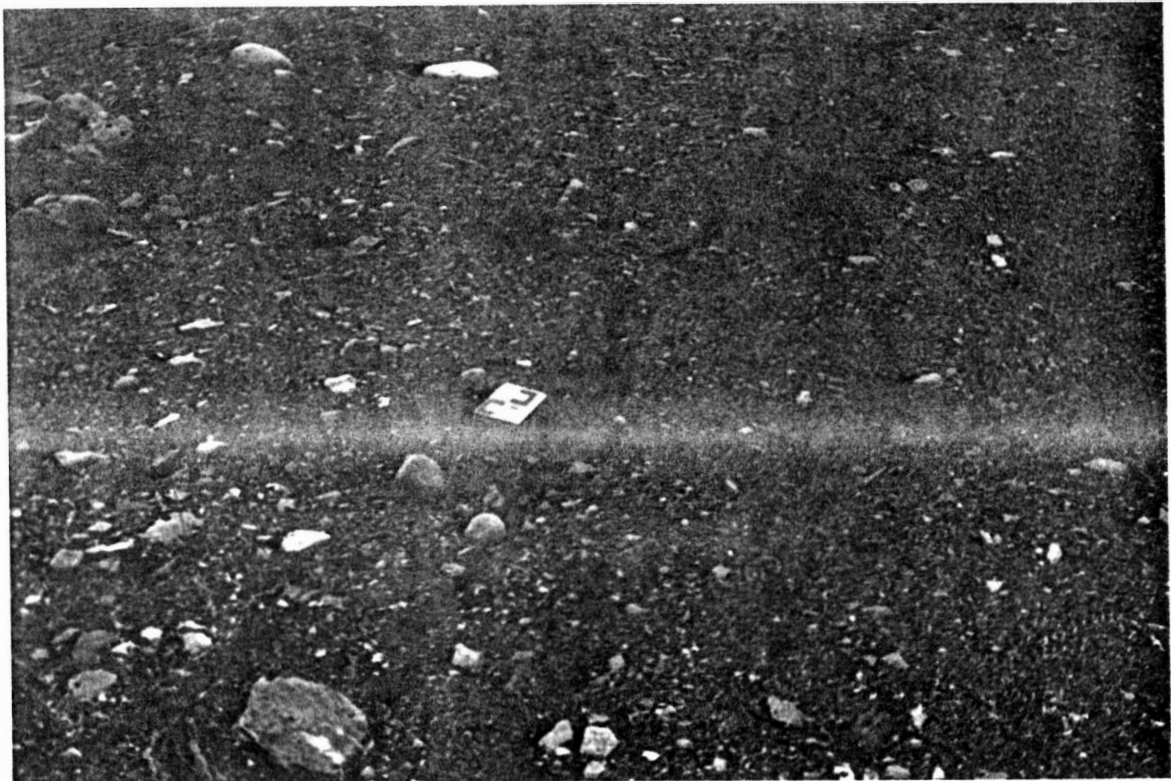
Photo 14: A wide open crack at the south abutment.

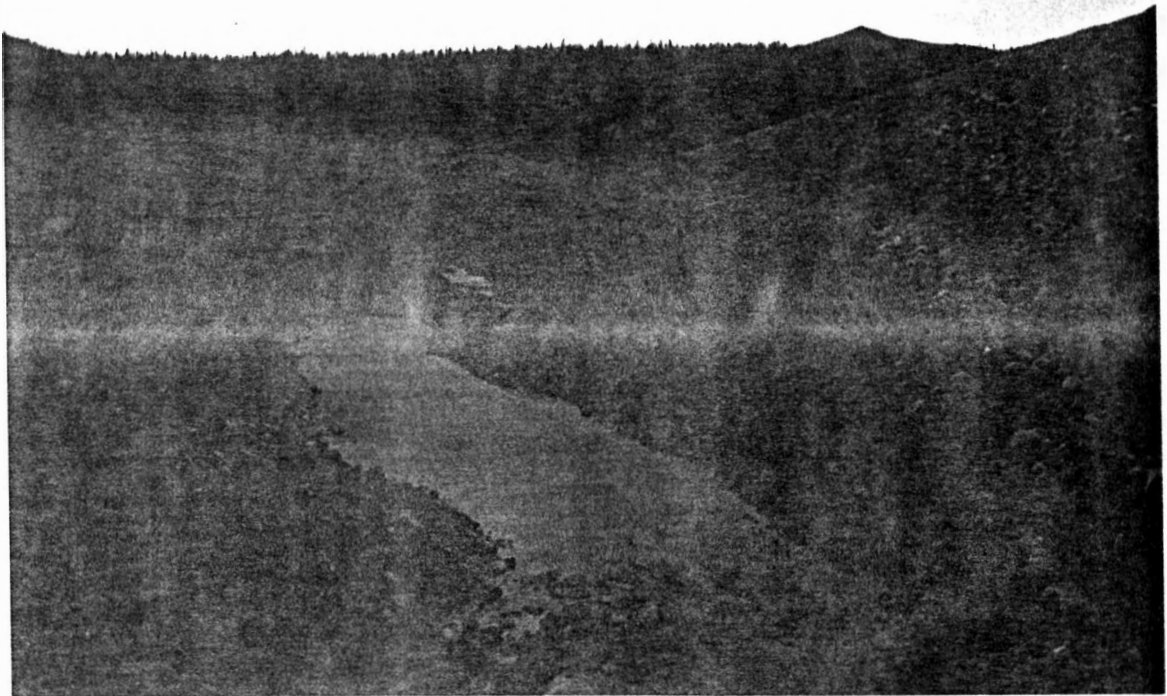
Heavy seepages occur at both dam abutments and along the dam toe (Photo Nos. 15 and 16). The total seepage flow (measured at weir W3) reached a peak volume of 128 l/sec (1685 igpm) in July and August, 1986. The volume of seepage discharged from both abutments is quite similar, approximately 18 l/sec (240 igpm) at each one. Consideration should be given to the fact that additional flow occurs below the ground surface and bypasses the measuring stations. It is our opinion that the

Photo 15: Seepage discharges from the south abutment and along the toe of the dam.

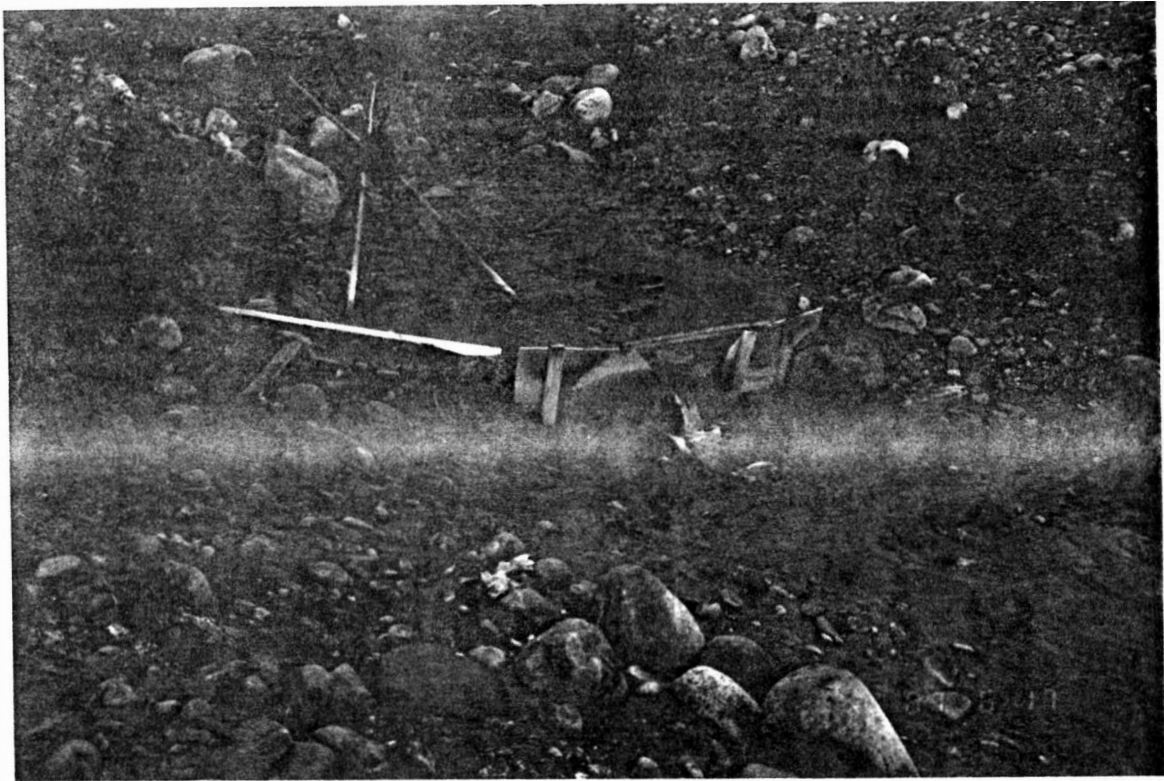
Photo 16: Heavy seepage from the north abutment.

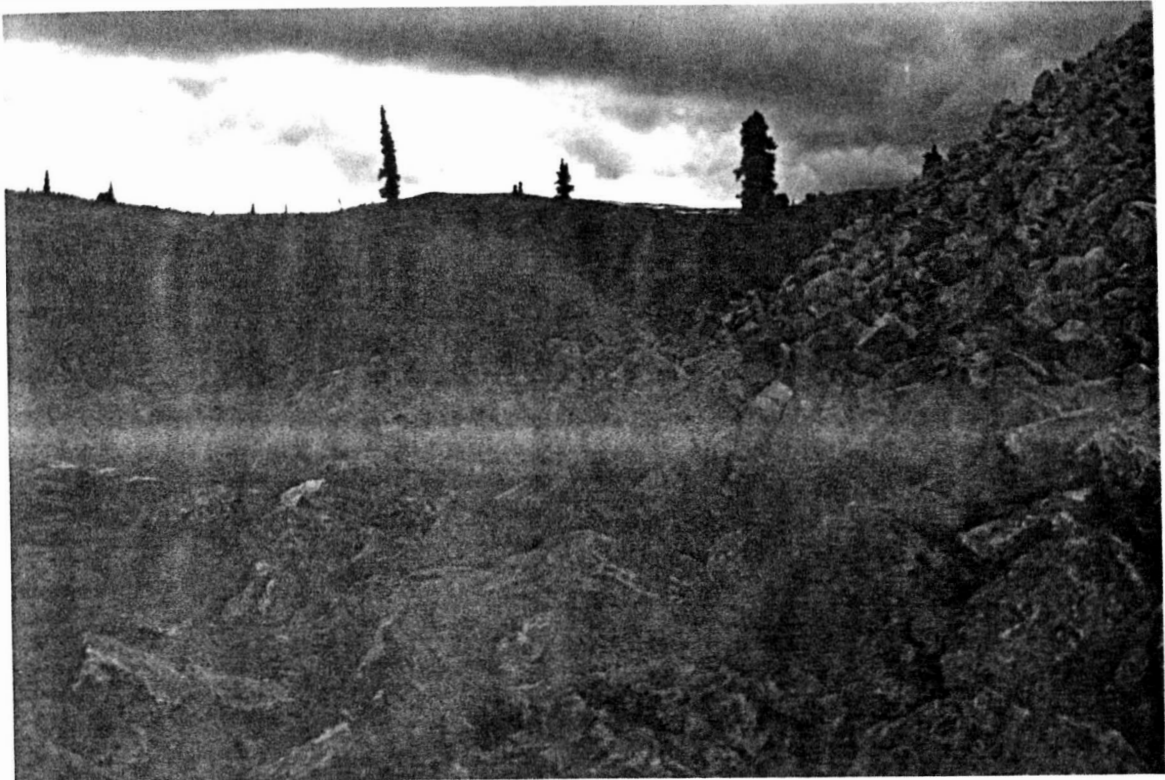
Photo 17: End-dumped boulders forming the base of the drain are 0.5 to 1.5 m in diameter and form a layer 2 to 3 m thick.

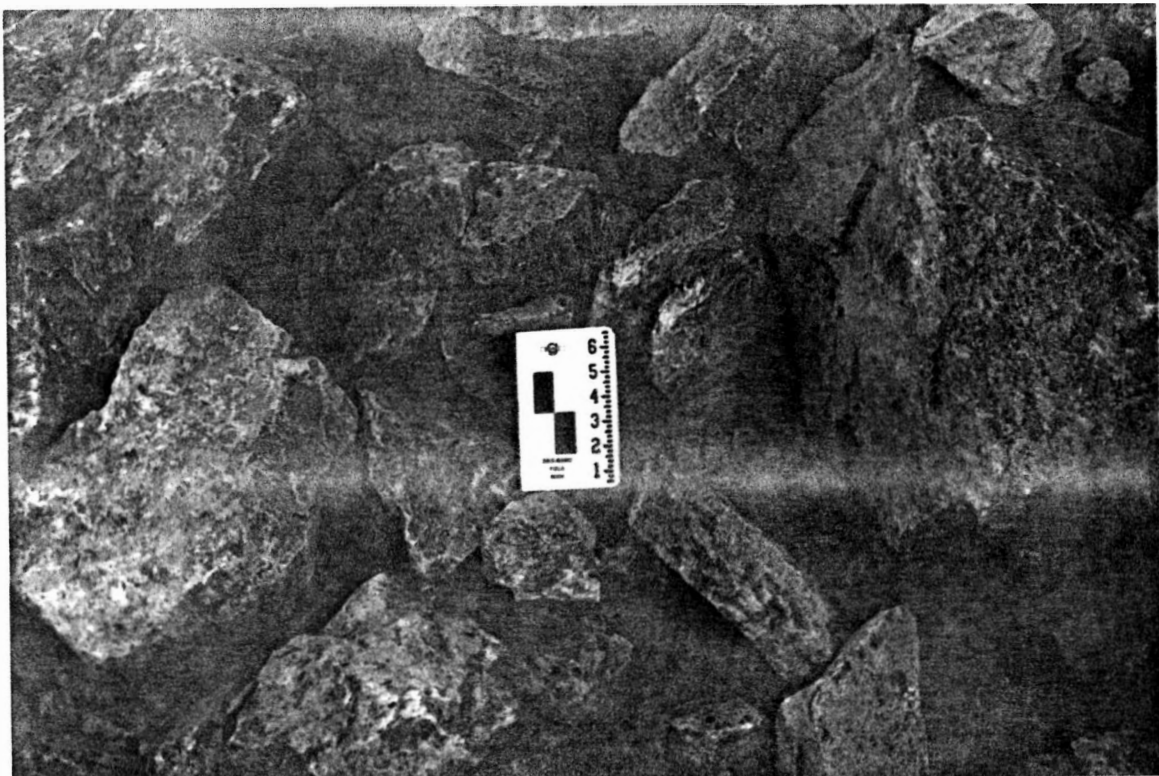
Photo 18: Typical rock sizes (0.2 to 0.6 m in diameter), approximately 5 m above the valley floor.

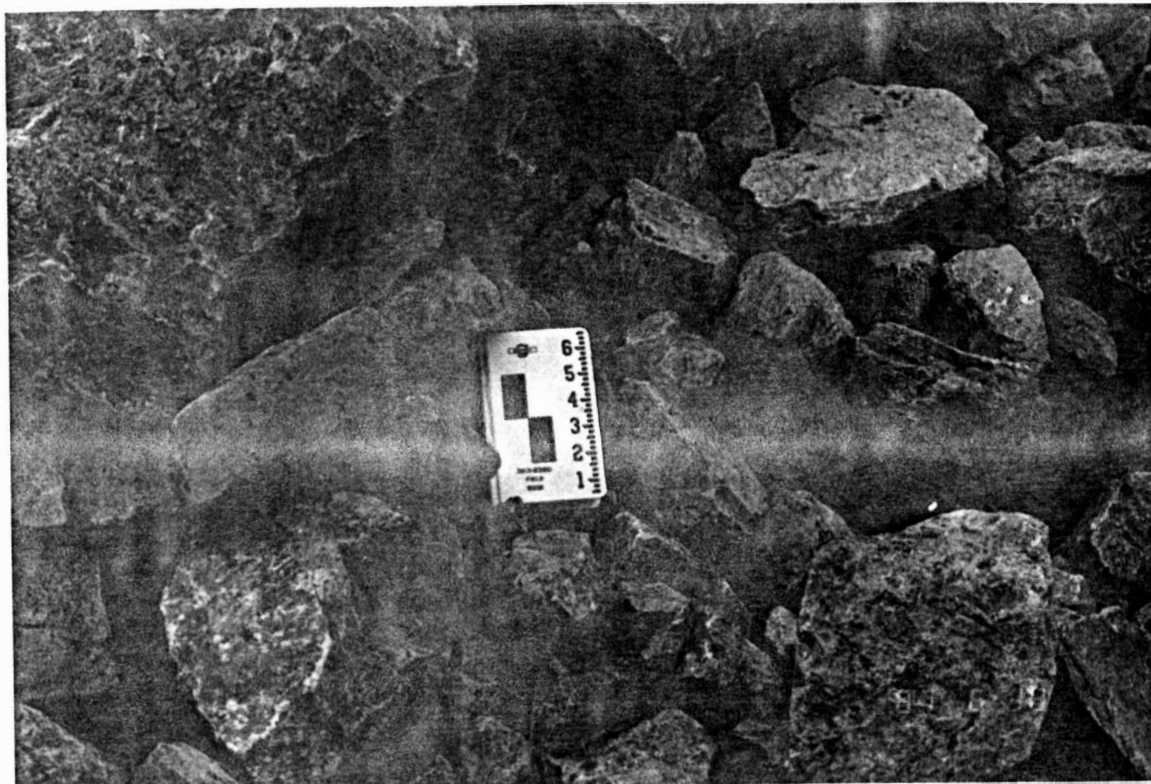
Photo 19: Smaller sized rock is locally encountered. Location - approximately 5 m above valley floor.

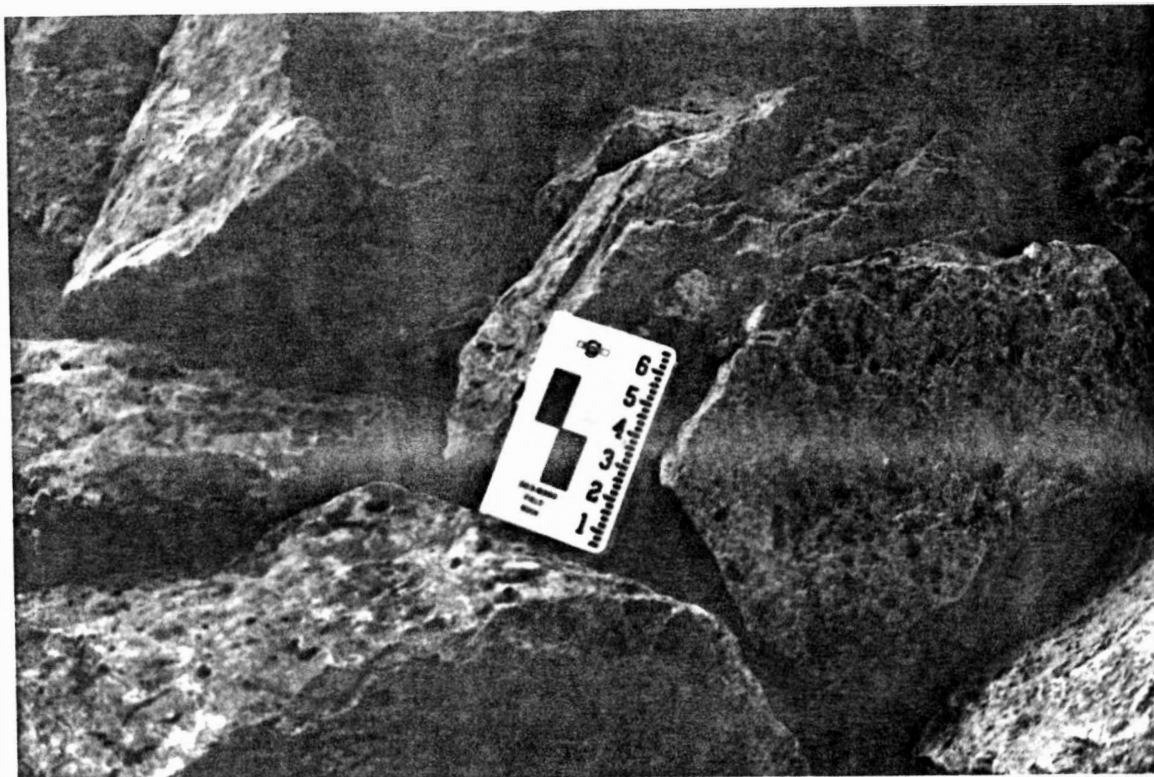
Photo 20: Accumulation of larger blocks 15 m above the valley floor.

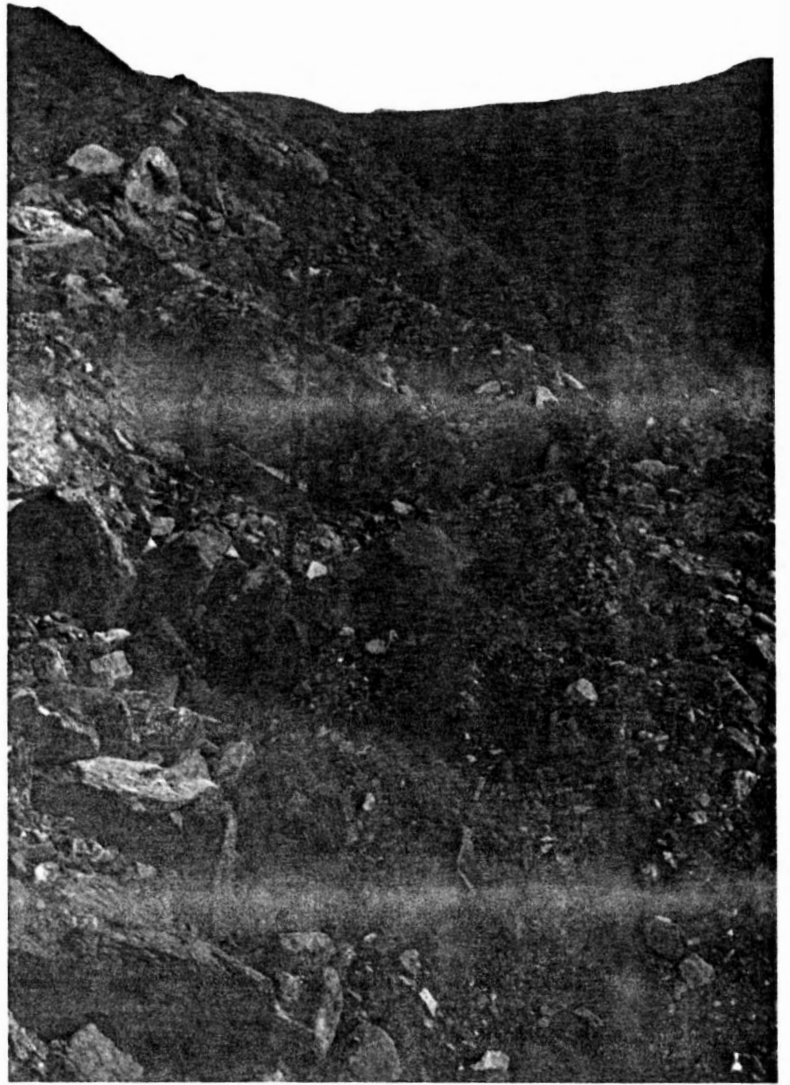
Photo 21: Unstable crest of  
a waste dump located  
immediately upstream from  
the North Fork Causeway.

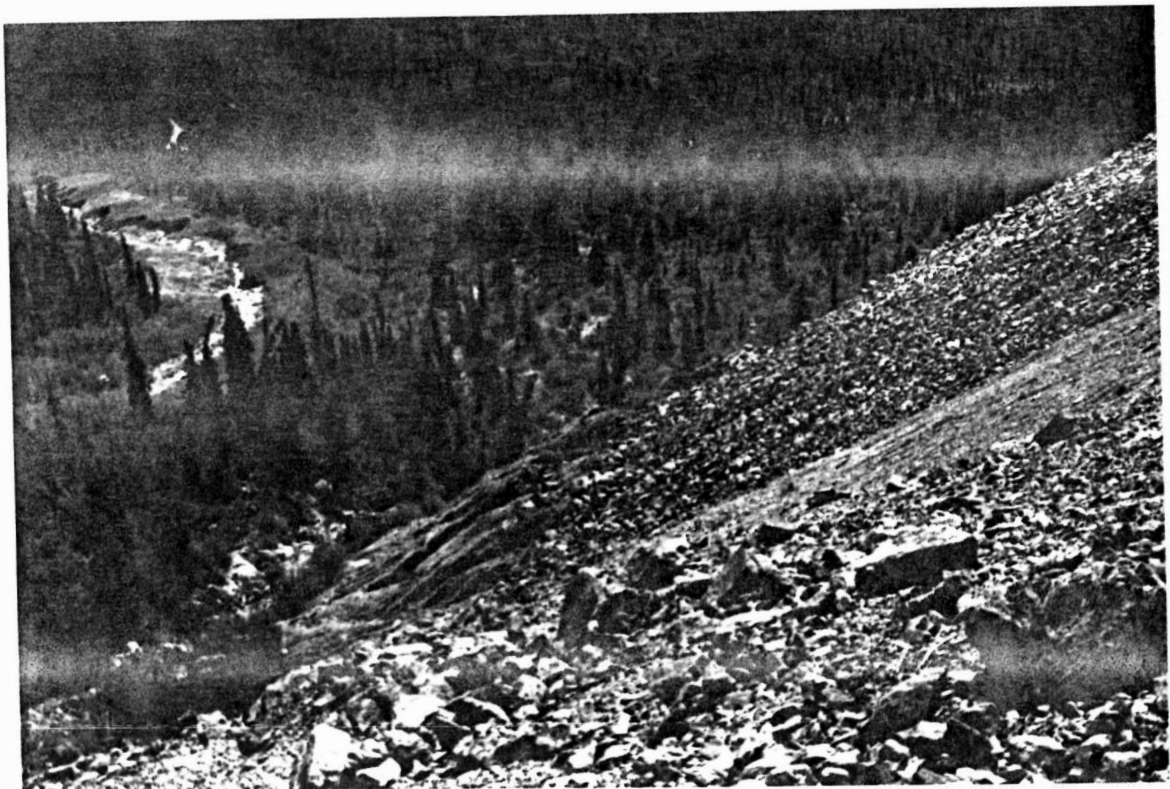
Photo 22: Unstable dump at  
the relocated Faro Creek.

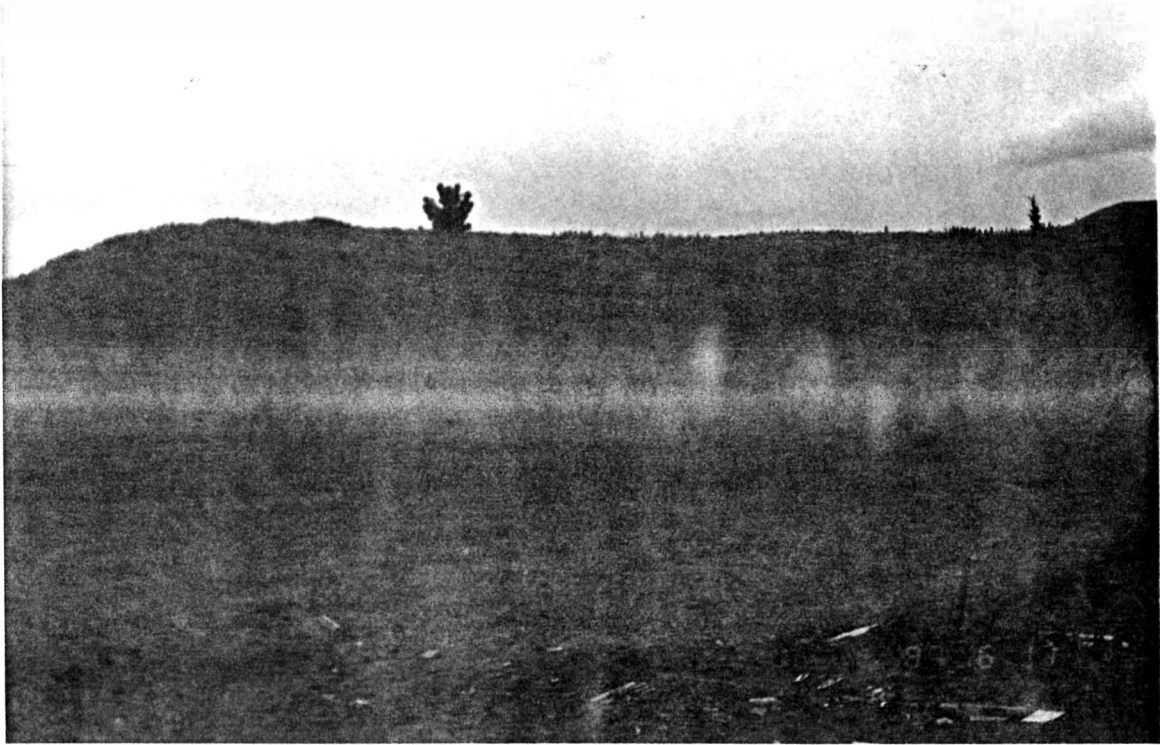
- ° While the overall terrain configuration of the area designated for the disposition of waste from the Grum pit appears to be suitable for the dump (Photo 23), there are localized zones comprising soft overburden and minor drainage courses (Photo 24). A detailed evaluation of the foundation conditions with the emphasis on the final dump configuration is required.

Photo 23: View of the proposed Grum Waste Dump area, looking across the Vangorda Creek valley.
