CURRAGH RESOURCES - FARO MINE

REPORT  
ON  
1987 SITE VISIT

Prepared For:  
NORTHERN AFFAIRS PROGRAM  
Whitehorse, Y.T.

July, 1987  
G052-4

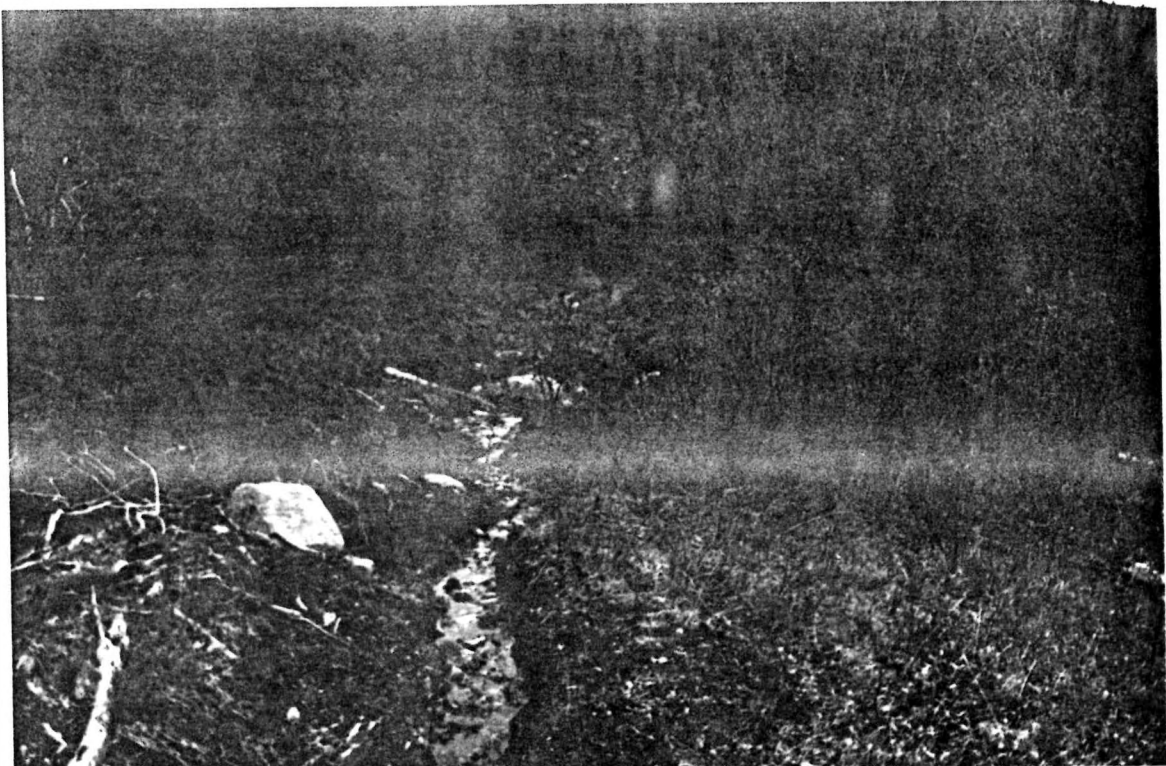
Photo 24: One of minor drainage courses traversing the proposed Grum waste pile area.

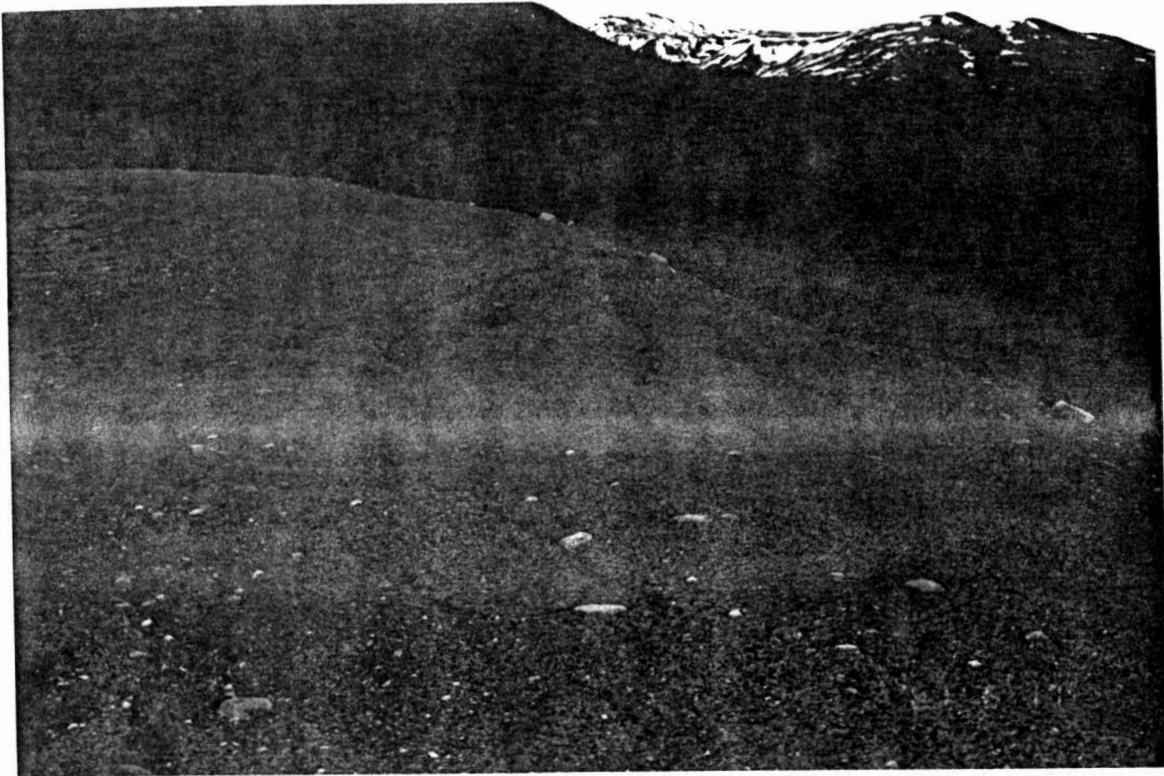
Photo 25: Glacial till waste dump at the existing Grum lagoon is unstable.

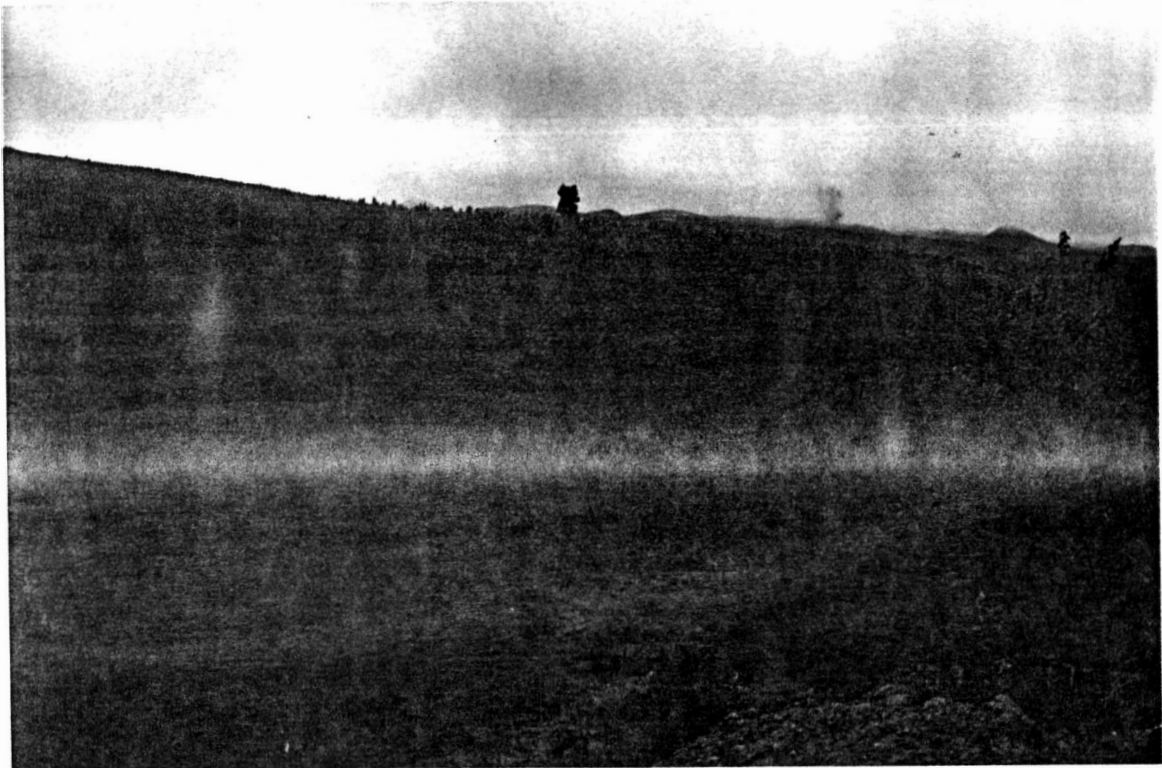
- ° There appears to be a more suitable location for this waste dump, within a terrain depression adjacent to the south side of the pit (Photo 28). Two small streams currently flowing into this depression will be cut away from their drainage basins by the pit.

Photo 28: Terrain depression immediately east of the proposed Vangorda waste dump.
