**C.O. BRAWNER ENGINEERING LTD.**

Re: Geotechnical and Hydrological Inspection  
Curragh Resources

I inspected the Curragh Resources mine project near Faro, Yukon on June 2, 1988 with Ken Nordin of the Water Board.

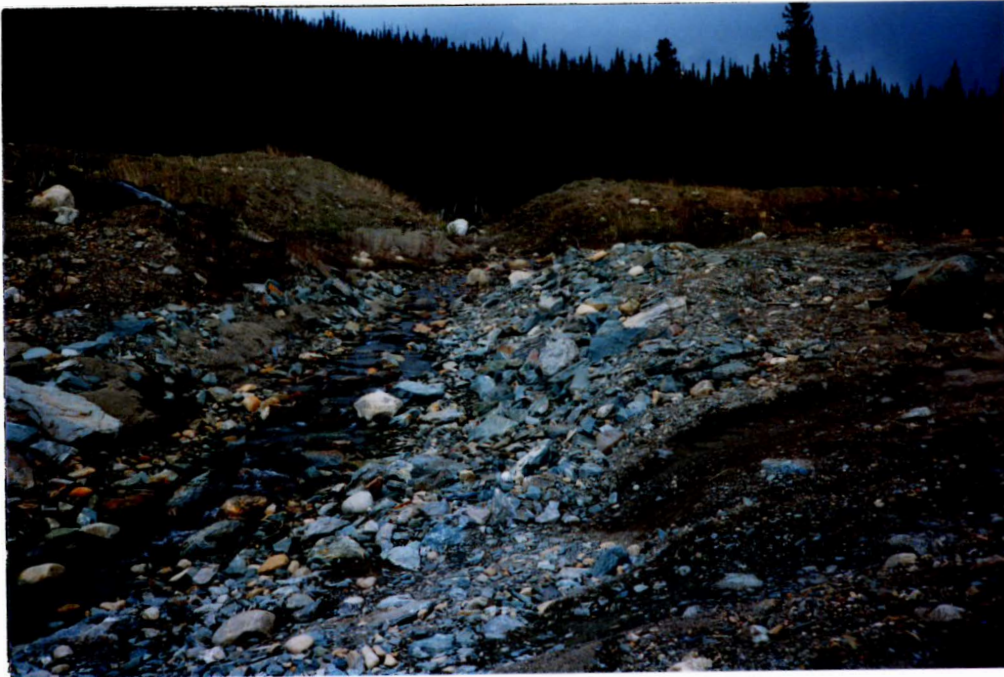
This trench (photo 1) extends from beyond the mill along the N.W. side of the project to intercept seepage and surface water. Portions of this trench have scour protection where the slope is steeper. Scour has occurred along some portions of this channel.

Photo 1 - N.W. interception trench. Limited scour has taken place. Some maintenance desirable to upgrade ditch to carry flood flow.

It is important that a maintenance program be carried out each year to ensure the required channel section and scour protection is adequate to carry the design flood flow.

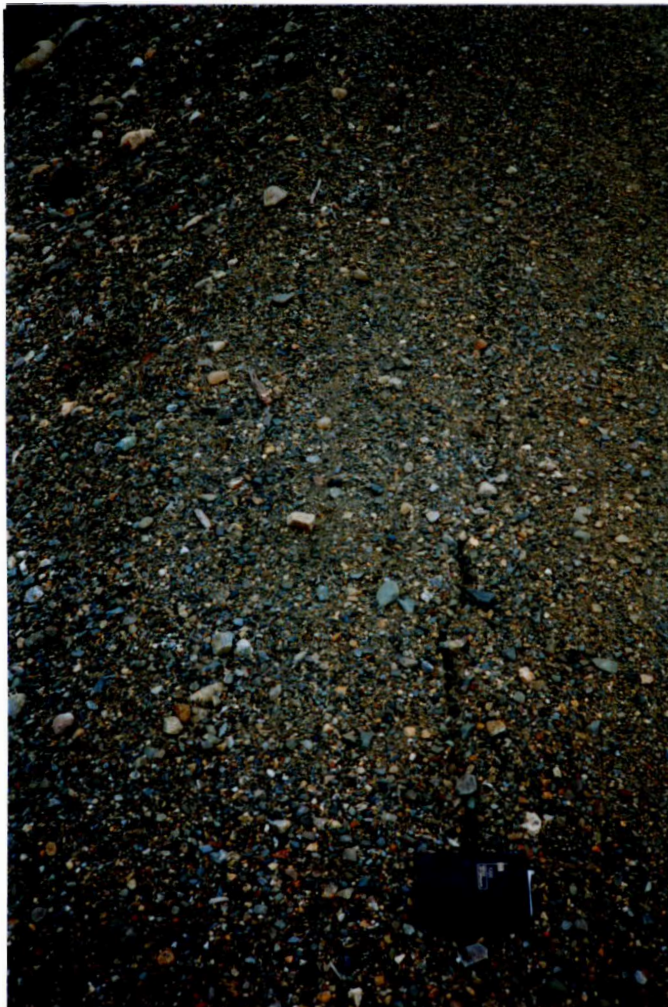
Cracks were observed on the crest of the dam. These are generally parallel to the centerline and more common in the south half of the dam. Golder Associates have postulated that frost heave in the dam is the cause of these and that there is no danger to stability of dam.

I agree that these pose no serious stability problems at this time. However, if the cracks remain open at depth and the dam elevation is raised they could influence stability later.

Photo 2 - Longitudinal crack on top of intermediate dam. Golder Associates consider these are due to frost heave. Note the water table is likely well below the surface. It is possible the dam foundation is spreading over thawed permafrost. The installation of movement monitors and thermistors is recommended.

I consider it necessary to determine the cause of the failure so it can be remedied before any further construction is performed. The cracks could also, for example, be caused by permafrost thawing in the foundation and the dam spreading as a result. Thermistors and lateral and vertical movement monitors should be installed.

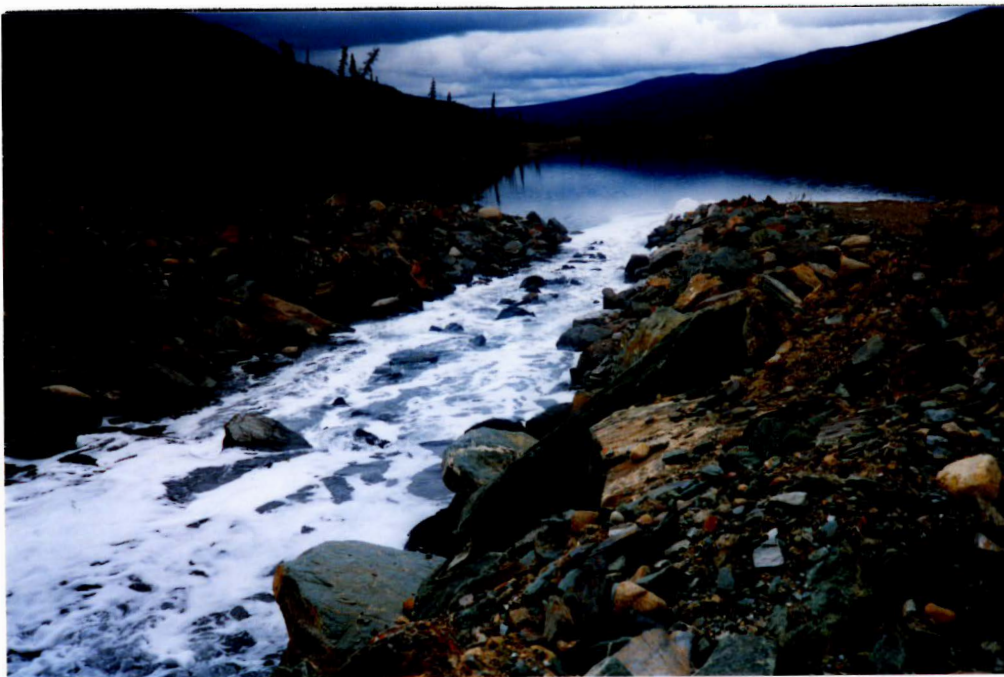
The intermediate dam was constructed to standard engineering specifications. A spillway allowing flow into the sedimentation pond above the Cross Valley dam, lined with rip rap is operating efficiently (photo 3).

Photo 3 - Overflow rip rap spillway at the south end of the intermediate dam. This spillway is operating efficiently.

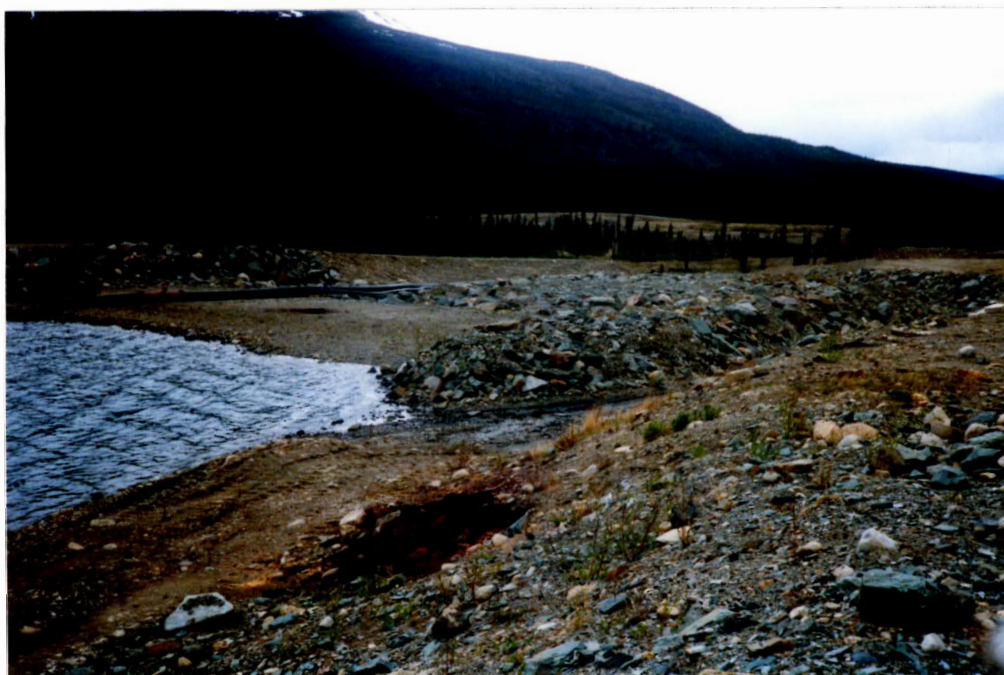
Photo 4 - Pipe siphon carrying water from lower pond over spillway location. North end Cross Valley dam.

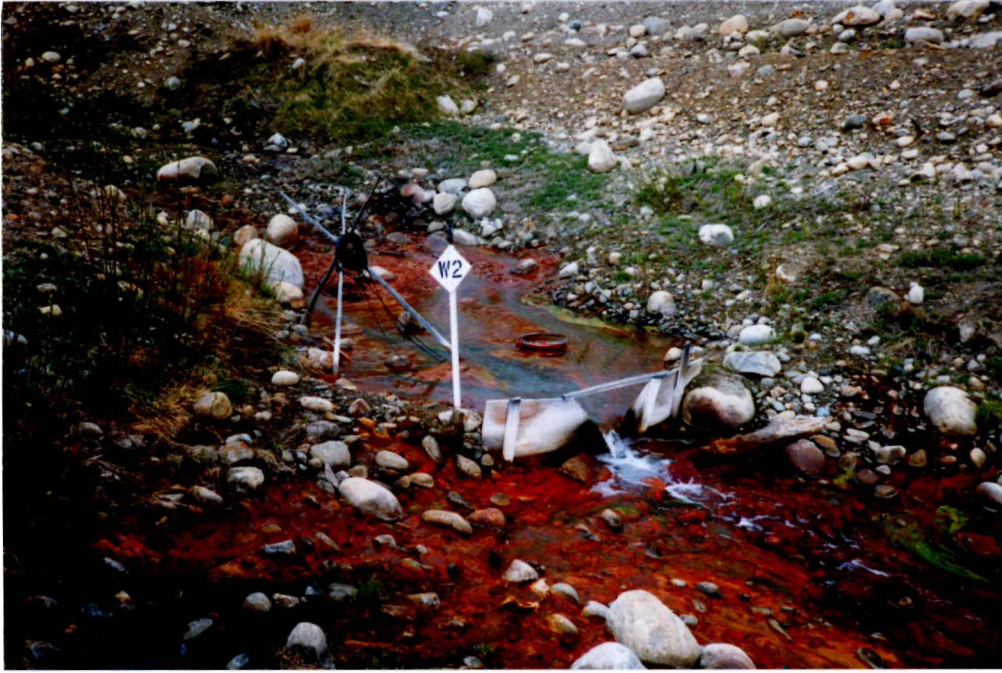
This dam was constructed to standard engineering specifications. A siphon is used to carry overflow from the pond (photo 4). An emergency spillway with coarse rock in the channel has been developed. Heavy seepage was observed issuing from several locations near the toe of the dam (photo 5 and 6). The volumes are greater than desirable. Steffin Robertson and Kirsten have referred to some evidence of piping (water carrying fines with the seepage indicating cavities are developing). I saw no evidence of this. However, I consider the seepage is excessive and recommend Curragh be instructed to develop a toe drain pipe within a sandy gravel toe berm designed to filter requirements.

Photo 5 - Seepage exiting below the north end of the Cross Valley dam. A V notch gauge installed to measure seepage. W2 is a water sampling station for metals and chemical analysis. The volume of seepage is considerable. The water must be monitored closely to evaluate if any piping (loss of soil) is occurring. If it is a collection pipe and granular toe term are recommended.

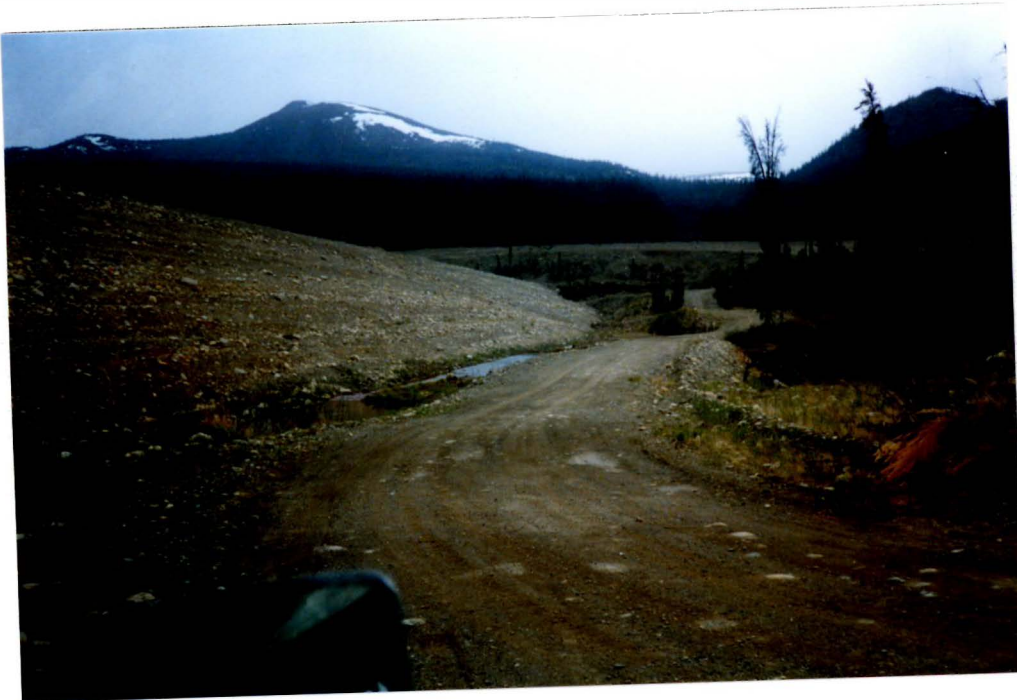
Photo 6 - Downslope area of Cross Valley dam. Note seepage at left.

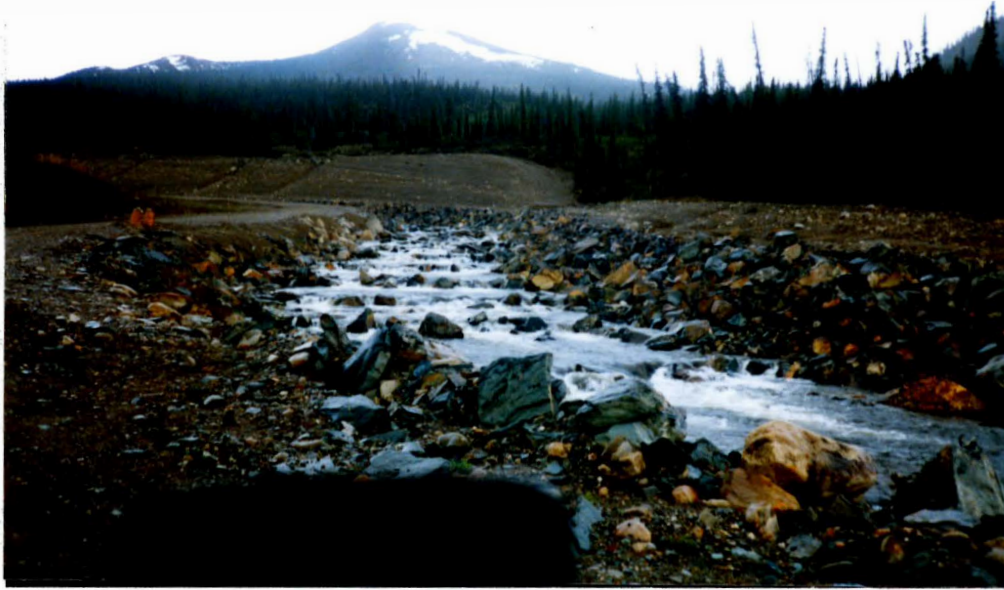
The steep portion of the channel has been developed with side channel rip rap and velocity checks (photo 7). This channel is working well under normal flow conditions. Some of the rip rap in the velocity checks has moved. During low water the rip rap should be replaced.

Photo 7 - Rose Creek diversion. Rip rapped section with heavier rap rapped velocity checks. This channel is in reasonable condition. Some of the large rip rap has moved. They should be moved back to original position.

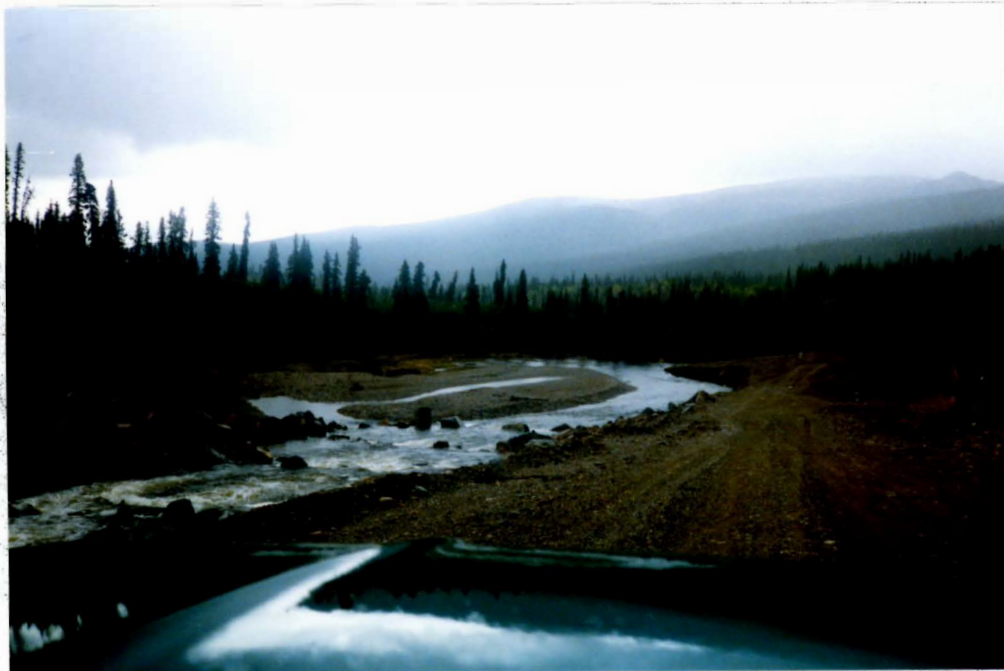
The lower portion of Rose Creek is scouring and has developed a meander pattern (photo 8). It is recommended that scour protection along the north creek bank be extended for about 400 feet.

Photo 8 - The run out area of the Rose Creek diversion is developing scour and building a delta. This area should be stabilized.

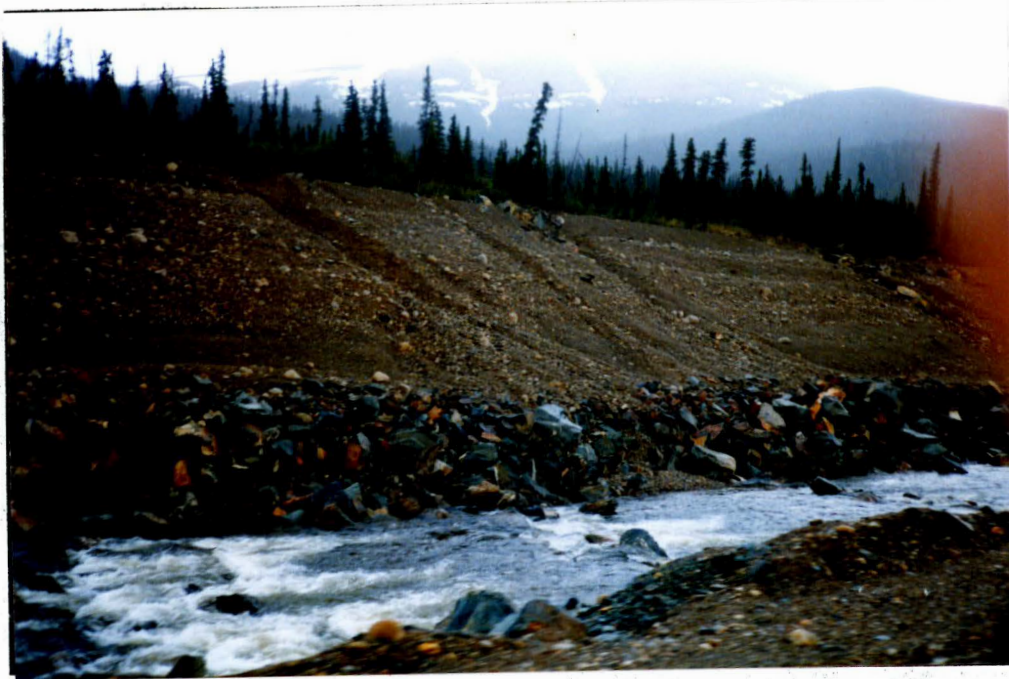
Slope erosion on the south channel slope has occurred at several locations (photo 9 and 14). These should be filled with erosion resistant material to stop the scour. In photo 14 the channel section has been reduced. Heavier rip rap will be required here.

Photo 9 - Cut slope erosion above Rose Creek diversion. If the erosion becomes excessive these channels should be filled with small waste rock.

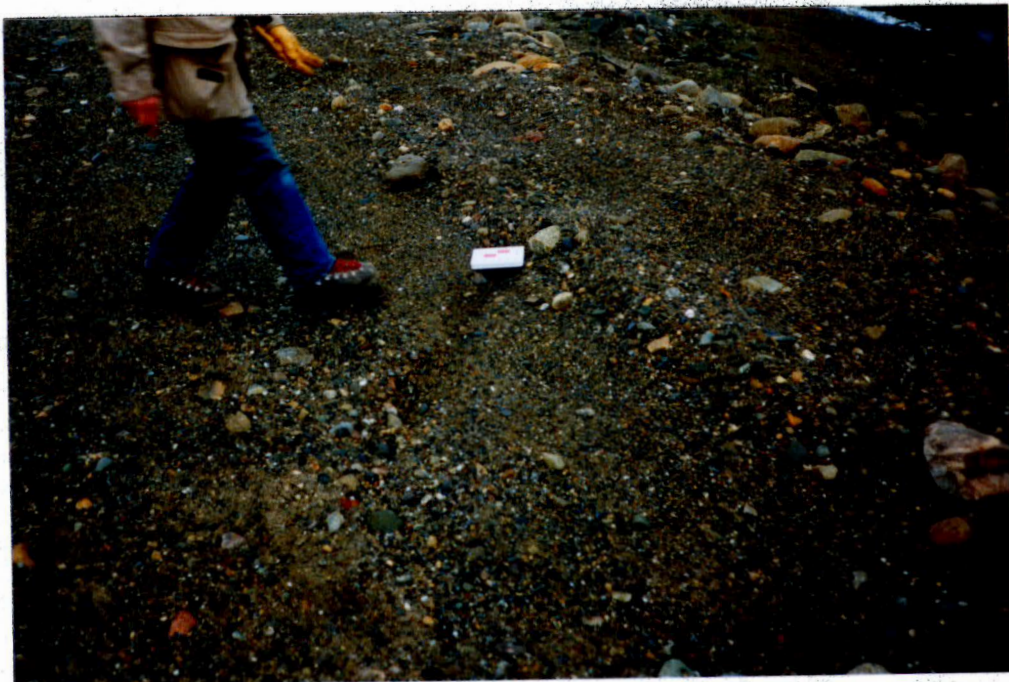
Two slides are occurring which involve the stability of the diversion dyke (photo 10 and 12). At several locations heavy seepage and piping is occurring from the dyke toward the pond (photo 11 and 13). These conditions are serious and must be rectified. A failure of the dyke could allow Rose Creek to flow into the tailings pond. It is recommended that the slides be stabilized and the piping be controlled this summer. This is considered urgent.

Photo 10 - Crack across the Rose Creek diversion dyke. This slope has moved toward the tailings pond. The slope should be stabilized. Horizontal drains are a low cost stabilization procedure.

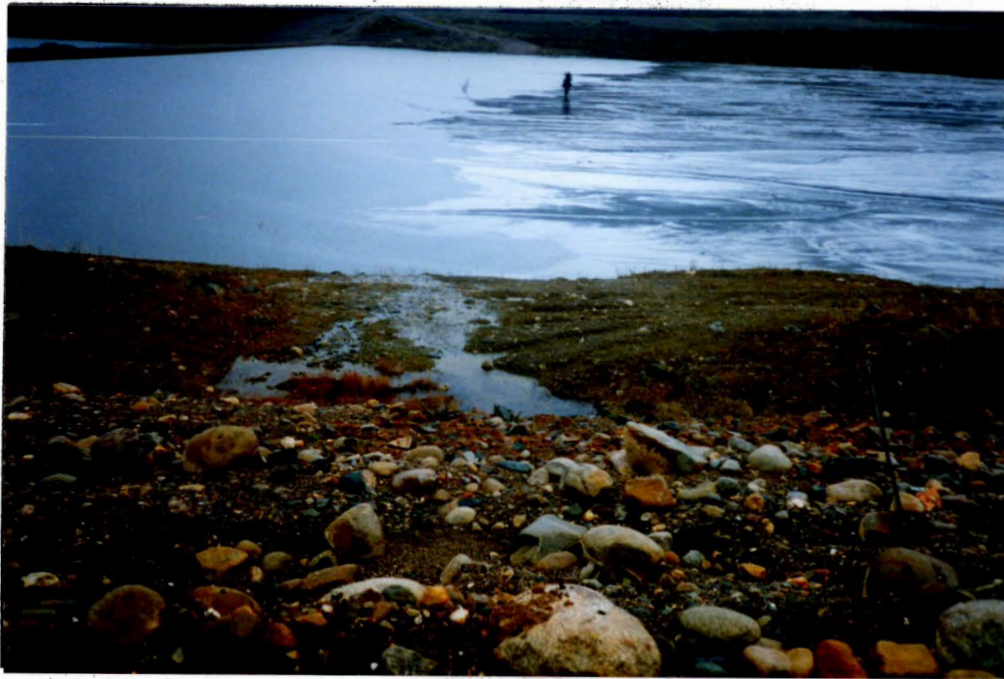
Photo 11 - Seepage through the Rose Creek diversion dyke. Some piping is also occurring. A sandy gravel filter cover and horizontal drains are recommended.

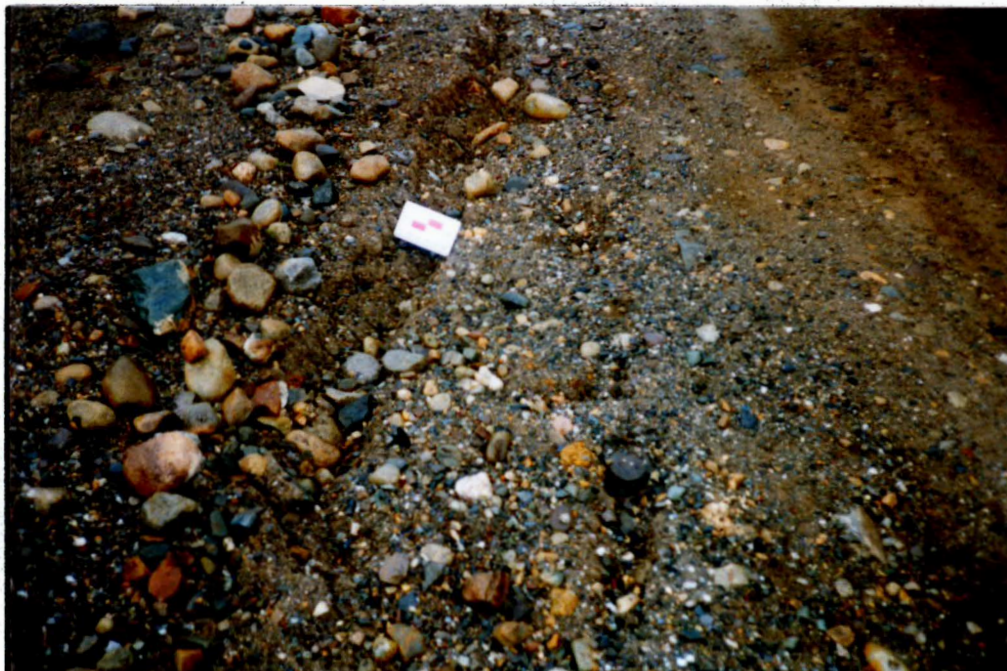
Photo 12 - A second crack with vertical displacement on the Rose Creek diversion dyke. This slide must be stabilized. If a major failure occurred Rose Creek could flow into the tailings pond.

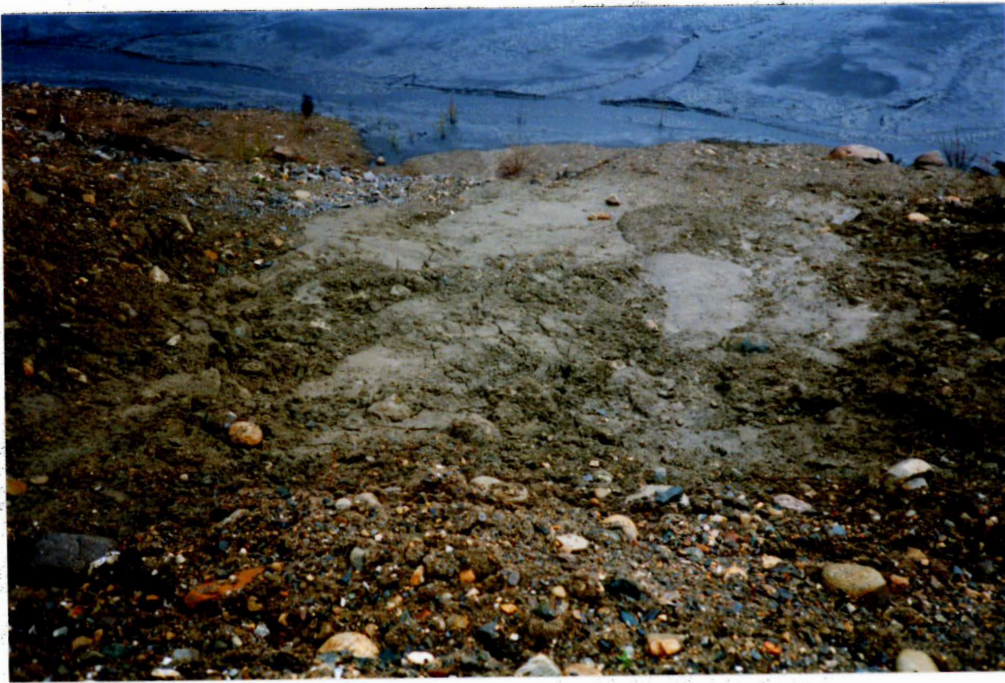
Photo.13 - Seepage and piping through Rose Creek dyke slope. This must be stabilized and controlled. This is occurring at several locations along the slope below the Rose Creek diversion.

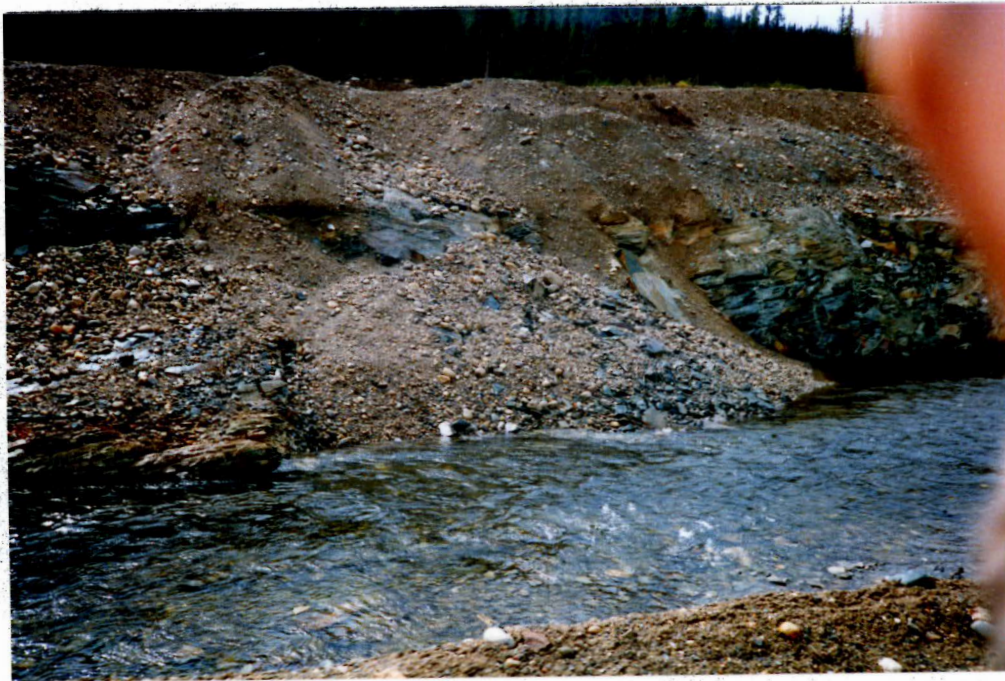
Photo 14 - Slope erosion partially filling in Rose Creek diversion. This material should be removed.

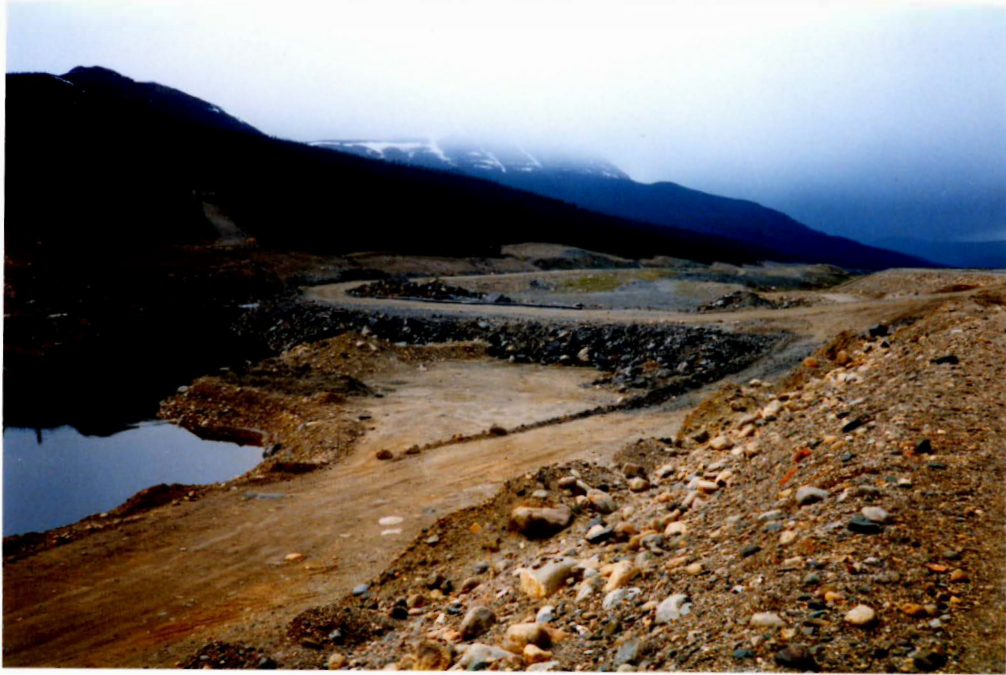
Photo 15 - Rose Creek diversion. The road elevation is lower than the dyke. It is recommended the several rip rap piles be positioned along the dyke in case emergency repairs are required quickly.

In the event of very high flood flow there will be some scour develop. In order to be prepared for adverse scour it is recommended that about 2000 cu. yds. of rip rap be stockpiled along the dyke for emergency use.

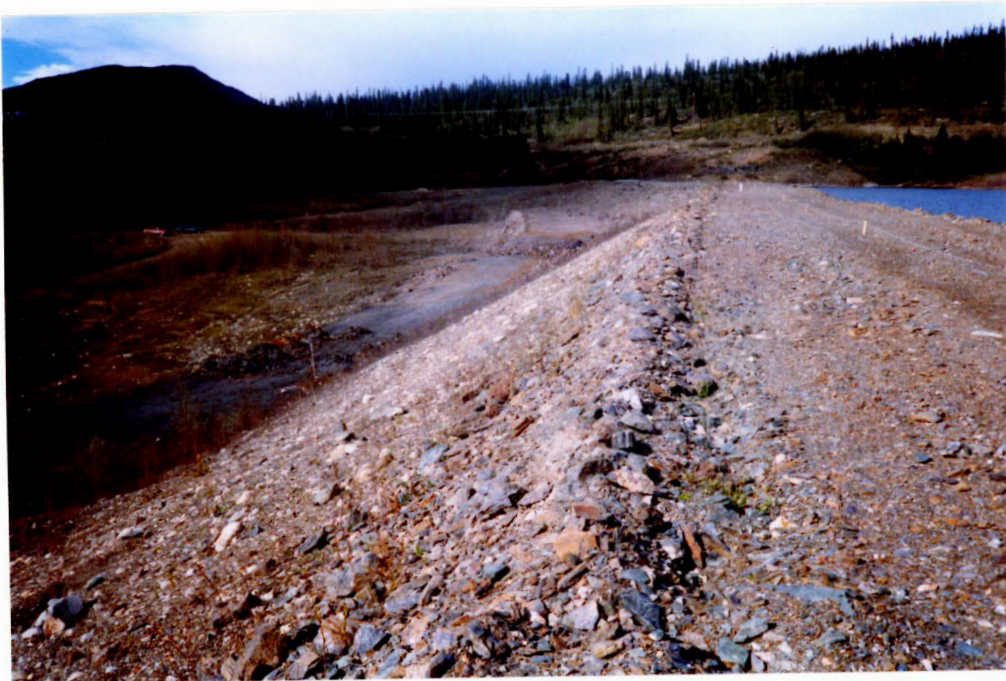
The Fresh water dam is about 50 feet high (photo 16). A toe berm was constructed some years ago to improve stability.

Photo 16 - Fresh water dam about 50 feet high.

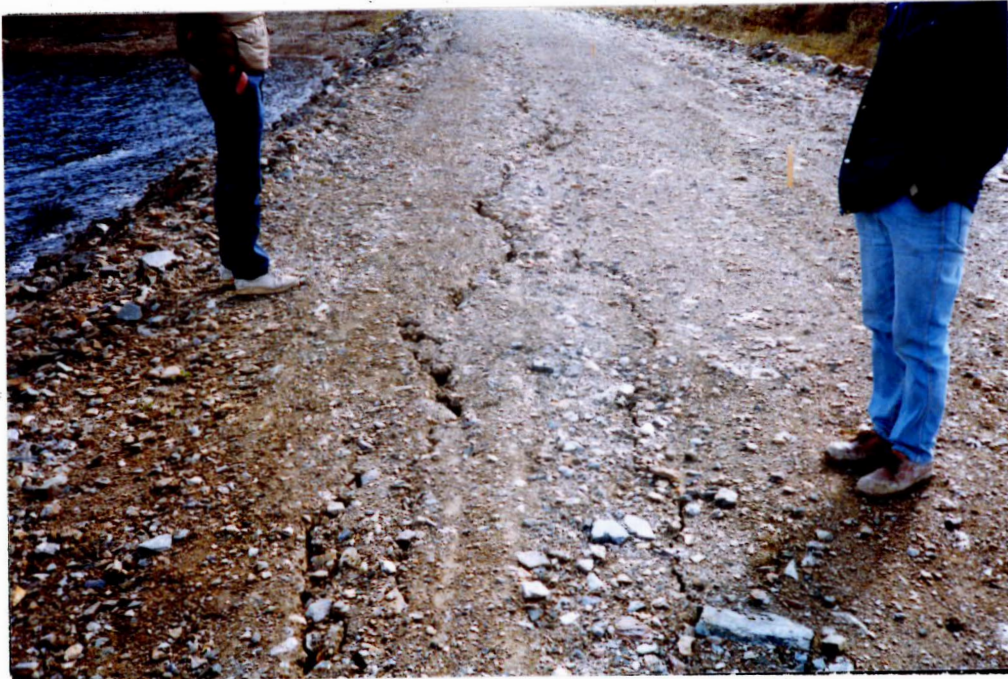
Photo 17 - Crack on top of fresh water dam. The cause must be definitely determined and corrected.

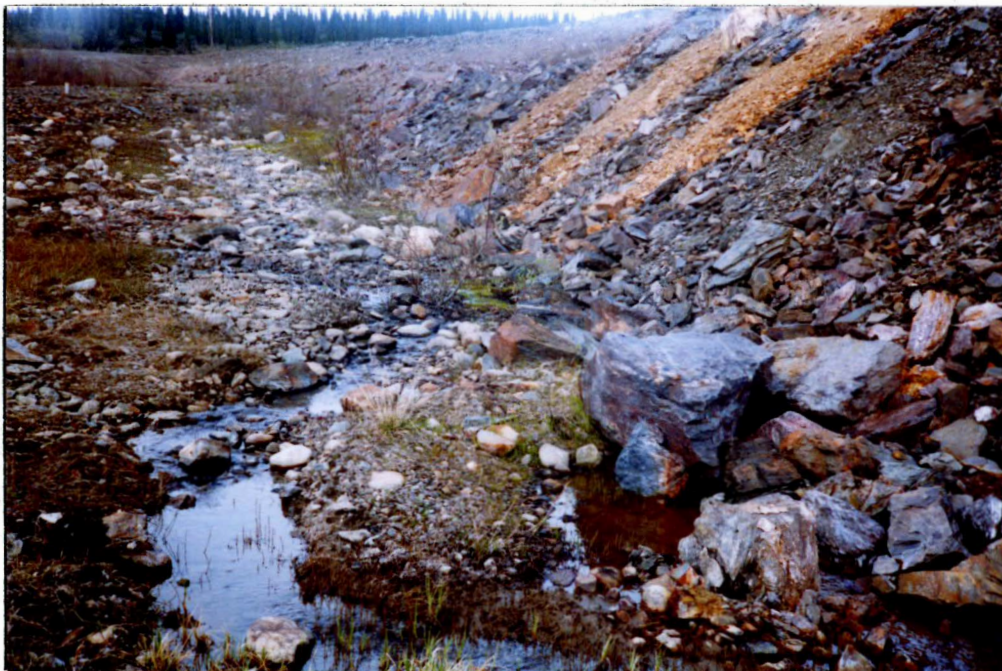
Very high pore water pressures existed recently below the toe berm. I was advised that the water level in a piezometer rose about 6 feet above the toe berm. I also observed seepage from the toe of the dam (photo 18). Severe cracks were observed along the dam (photo 17).

The ground below the toe of the berm was very spongy to walk over, suggesting high pore water pressures and a near 'quick' condition (water pressure equals weight of the soil).

Photo 18 - Seepage at the toe of the berm below the fresh water dam. Several weeks prior to this inspection artesian pressures were monitored in a piezometer on the berm. The soil is spongy. The stability of this dam must be evaluated. It appears to have low stability.

The condition of the dam and pore water pressures suggest to me the dam may not meet adequate stability standards. Accordingly I recommend a stability evaluation by a specialist geotechnical engineer, including installation of piezometers, thermistors, slope indicators, lateral movement gages etc. be made this summer. If the stability is low I recommend the necessary stabilization this fall. In addition the condition of the pipe under the dam should be inspected to determine if it is intact.

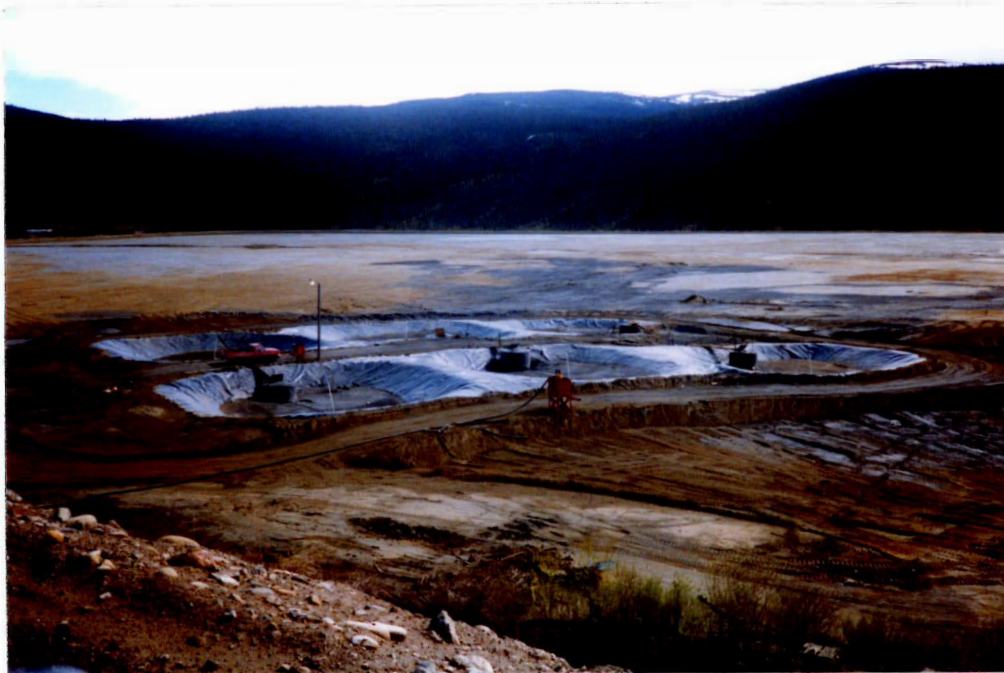
The Acid Generation Test Program is underway as part of the 4 year program. Photo 19 shows the test site.

Photo 19 - Test plots in the old tailings pond to evaluate acid generation under various conditions.

An interim report on the progress of the test program is required.

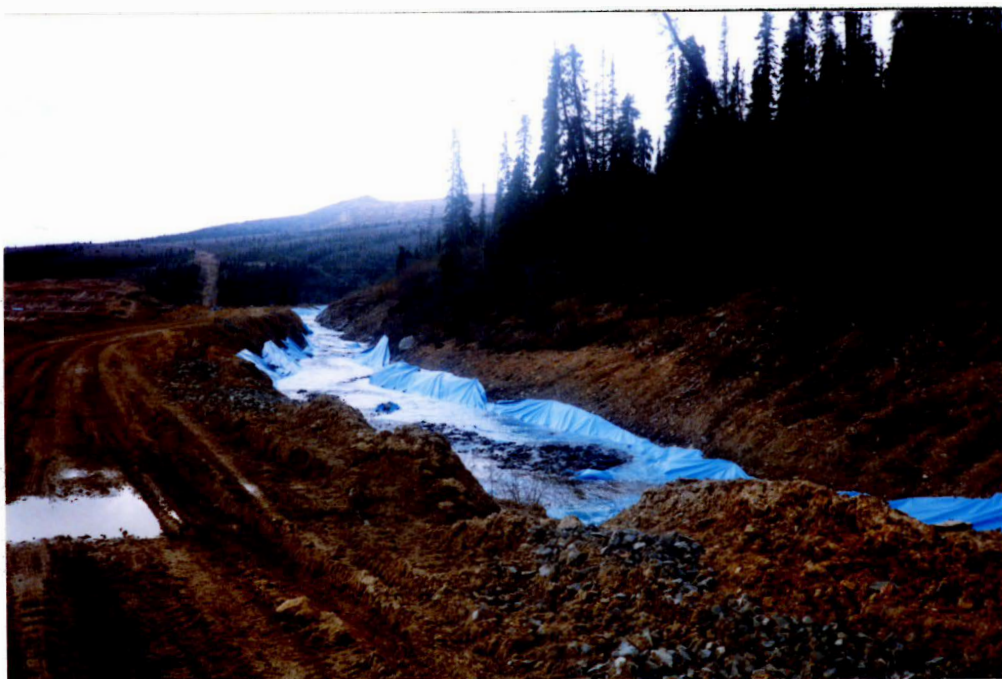
Considerable seepage from the creek into the pit has resulted in slope stability problems. Attempts to reduce this seepage using a plastic liner has been partially successful (photo 20). It is noted that this is a temporary procedure.

Photo 20 - Diversion of N. Fork around the open pit. Plastic lining has been placed to reduce seepage and pumping from the pit. This is a temporary program until the pit is mined out and the water will likely be diverted into and through the pit.

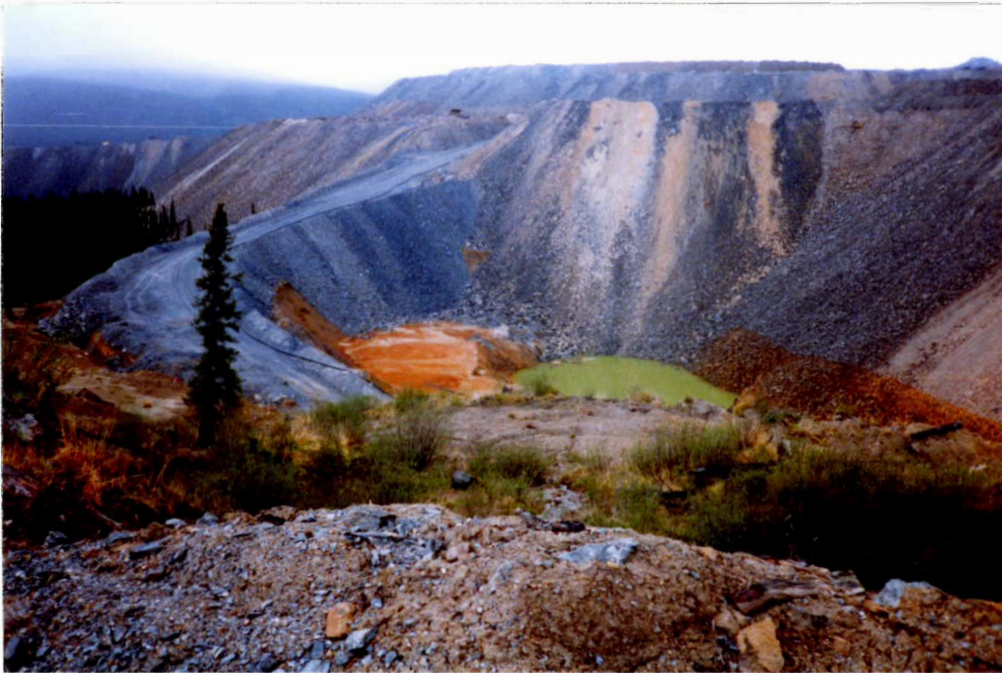
Some runoff and seepage is presently being drained into Pit 2 (photo 21). The water quality should be monitored to determine if any special precautions are required.

Photo 21 - Seepage ponded in the remainder of pit 2 that has not been completely filled.

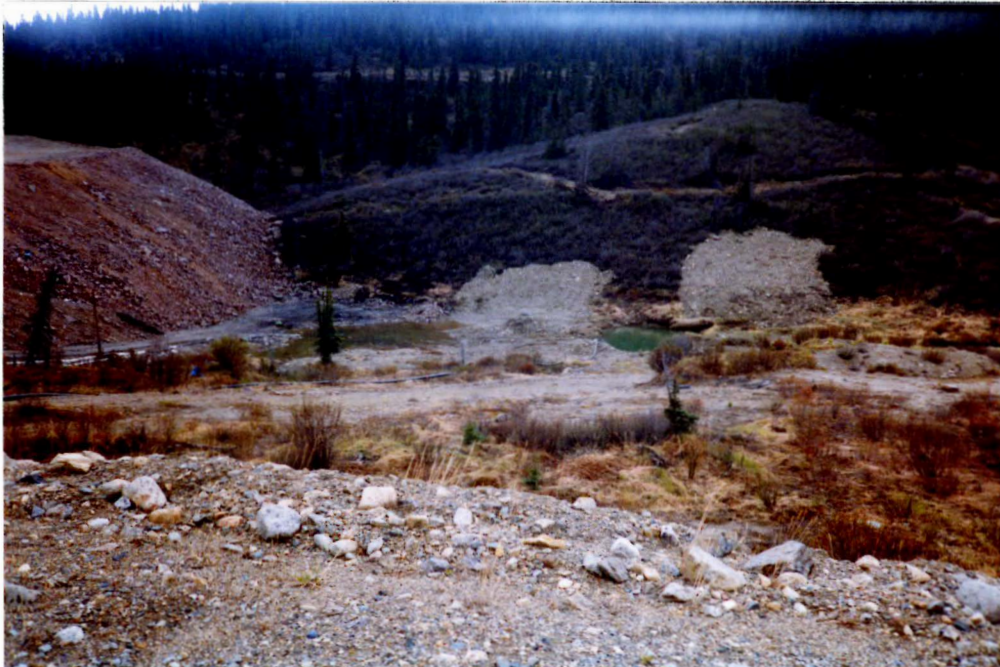
The northern most spoil pile (photo 22) is confining water which is high in zinc content. The option of placing a low permeability clay till on the upstream slope to reduce seepage flow and fill the valley with waste rock is recommended for consideration.

Photo 22 - North Fork seepage with excess zinc concentration ponded. I consider the upper waste pile slope can be covered with low permeability clay till and the valley be filled with waste rock.

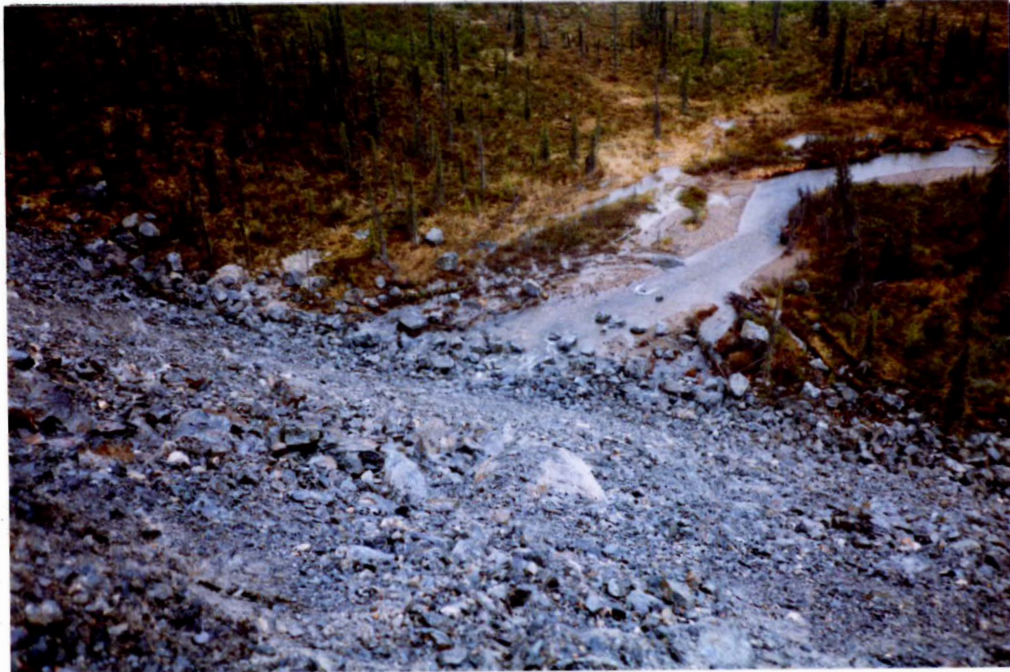
The new road being constructed to the Vangorda deposit crosses the North Fork Creek. Instead of placing a culvert, very coarse durable rock was placed in the channel which allows the water to flow through.

I am not aware of approval from Water Resources or the Water Board for this type of construction.

Photo 23 - North Fork flowing through a rock drain under the road being constructed to the Vangorda property. Properly constructed rock drains will operate effectively for short to moderate term. On abandonment the fill must be excavated and the creek channel redeveloped.

This rock drain must be inspected periodically to ensure it is operating efficiently.

I also recommend a water chemistry sampling station be established directly below the fill to monitor water quality.
