January 14, 1992  
Project Number 60642

Curragh Resources  
117, Range Road  
Whitehorse, Yukon  
Y1A 2T8

**RE: FURTHER REVIEW OF THE POTENTIAL FOR SEEPAGE FROM THE FARO PIT AND CONTAMINATION OF THE NORTH FORK OF ROSE CREEK**

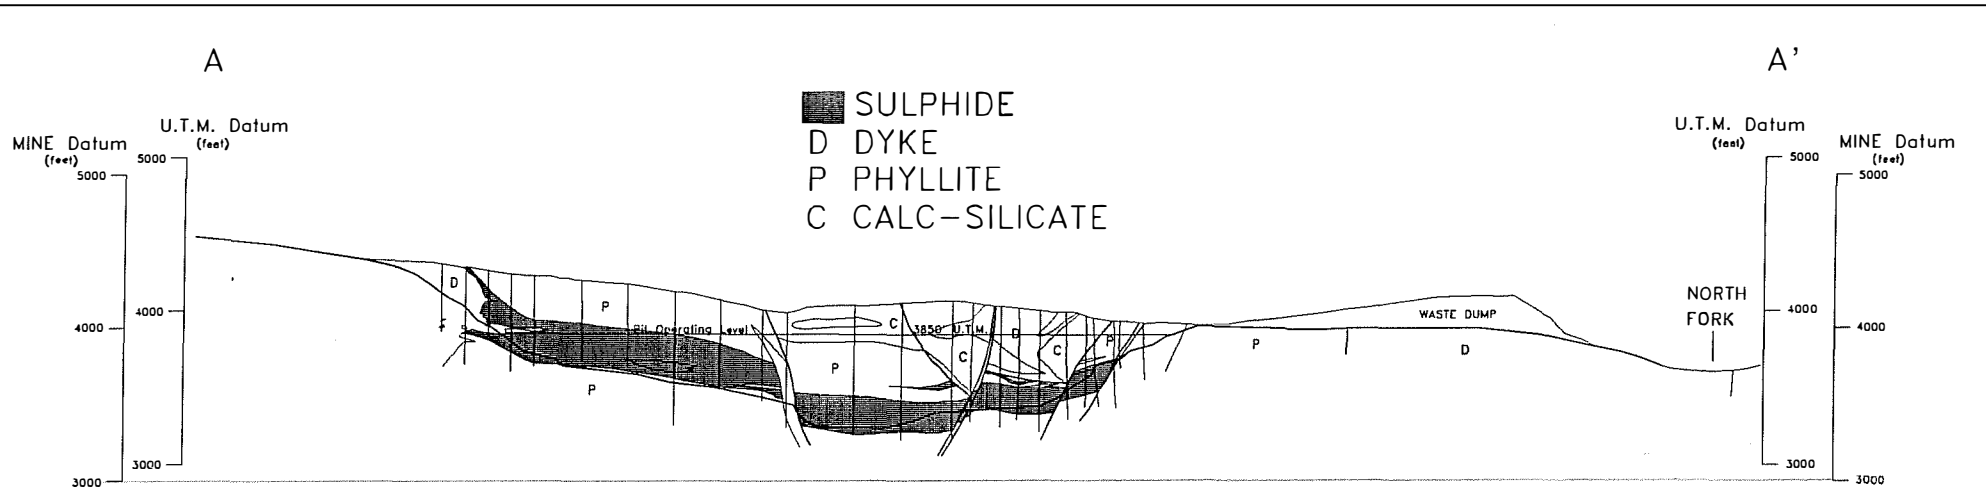
Figure 1A: Cross-Section through Main Pit to North Fork

It has been suggested that an extensive investigation program should be undertaken to determine the potential for seepage loss from the Main Pit through the east wall. This is because EP believe there is a risk of poor quality water migration to the North Fork. Potential water quality is addressed below. The nature of the program recommended is similar to the study performed by Piteau and Associates, presented in their report 86-804 of October 1986. The Piteau report has been further reviewed and has been correlated with Curragh's geological data and opinions supplied by Dr Lee Pigage, senior geologist at Curragh. This has enabled a classification of the Faro rock types in terms of their ability to transmit seepage. The rock types are illustrated on geological section A-A' drawn through the Main Pit and extended to the North Fork (see Figure 1A). The locations of the section and the Piteau boreholes are shown on Figure 2.

Competent rocks are generally massive and may host open fractures. Incompetent rocks generally will not sustain fractures. Dr Pigage classifies the calc-silicate, sulphide, quartzite and dike rocks at Faro as falling into the competent category, while the schists and phyllites fall into the incompetent category. Figure 1A shows that, east of the Main Pit, the rocks are predominantly schists or phyllites, and therefore the lower of the hydraulic conductivity values given above are relevant. Dike intrusives can be found between the pit and the North Fork. The dike rock was found to be massive and low in permeability, with some permeability along the contacts. In conclusion, it would appear that the more permeable rock units identified above (although these are by no means high in permeability) are restricted to the vicinity of the pit, while the units east of the pit are low in permeability even accounting for the occurrence of fractures. The values are also only relevant to the immediate area of the test. The extent and connectivity of fractures is also expected to be low, thus further lowering the bulk permeability for a long flowpath.

Comment has been made regarding the presence of major faults between the Main Pit and the North Fork. Certainly the Big Indian fault system consists of a series of significant faults. However, these have been found to be mostly healed with either mineral deposits or fault gouge (Dr Pigage). The Piteau study was conducted in order to assess the potential for dewatering in the vicinity of the fault zones for pressure relief. Apart from the massive sulphides, very little water was found. Also, the southern extension of the fault zone strikes towards the Zone II Pit (see Figure 4.2 in Appendix A of Kilborn report #350928). Any significant flow along the faults would be expected to flow through the Zone II area.

To put the Main Pit seepage potential into perspective, one can calculate an approximate seepage rate by applying Darcy's Law. If we assume a pit wall dimension of 150 m deep by 300 m long, a hydraulic conductivity of  $1 \times 10^6$  cm/sec, and a relatively high hydraulic gradient of 0.5 (1 is vertical, 0 horizontal), we obtain a seepage rate of  $19 \text{ m}^3/\text{day}$ . For this volume to migrate from the pit to the North Fork, the individual fractures responsible for the permeability must be interconnected and extensive. This seepage estimate should therefore be considered conservative.

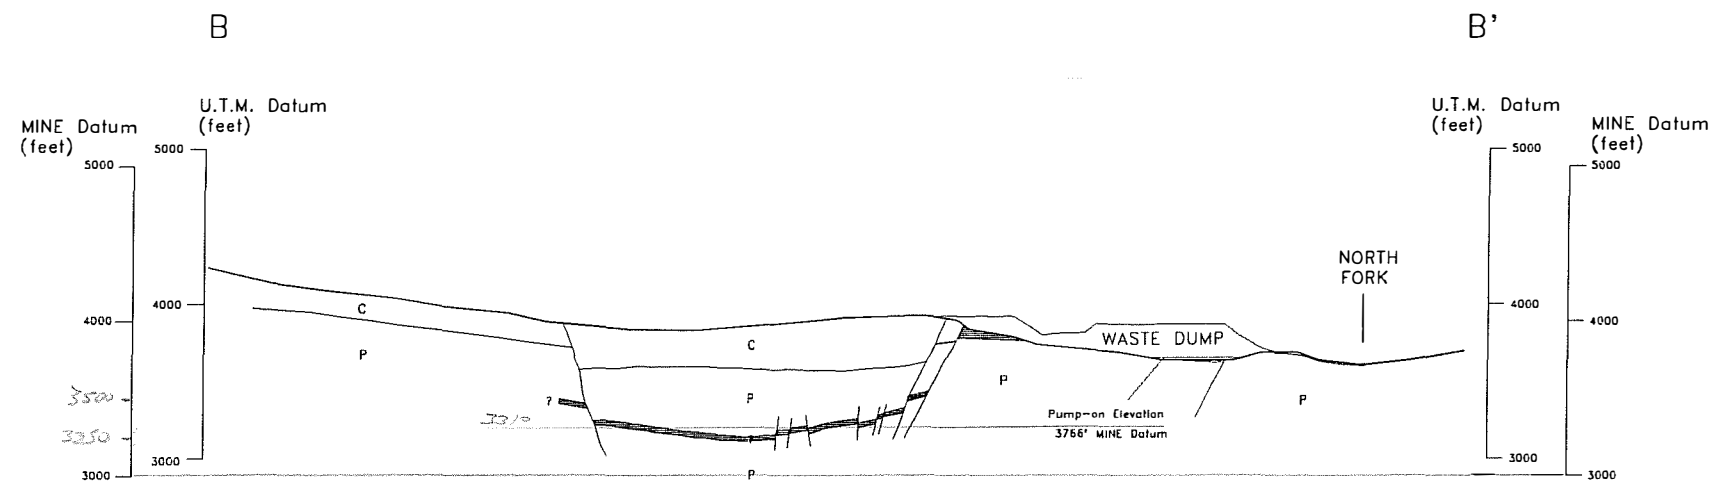
Figure 1B: Cross-Section through Zone II Pit to North Fork

Figure 1B shows geological section B-B' drawn through the pit to the North Fork. The wallrocks on the down-gradient side of the pit are schists or phyllites, and these extend east below the North Fork. Phyllite bedrock was intersected at between 15 - 20 feet in the BH series holes adjacent to the North Fork. These same boreholes recorded groundwater at the base of a silty profile resting on bedrock, with water-levels below the elevation of the adjacent creek. The seepage potential of the schists/phyllites is expected to be low based on the study and interpretation described above. However, the condition of the wallrocks around the rim of the Zone II Pit is not known. Given that the rim is 700 m from the creek, and that the pit is to be used for

contaminated drainage storage, it would be prudent to investigate wallrock conditions and provide monitoring facilities.

Zone II Pit - The wallrocks of the pit require investigation. This will not be an easy task given the waste rock cover which will make borehole location and drilling difficult. Three rotary drilled boreholes should be inserted around the down-gradient rim to a depth of approximately 150 feet, roughly equal to the elevation of the rock surface below the North Fork. The holes should be packer tested and then equipped with two monitoring piezometers each. Hydraulic and water quality data will form the basis for an assessment of seepage potential.

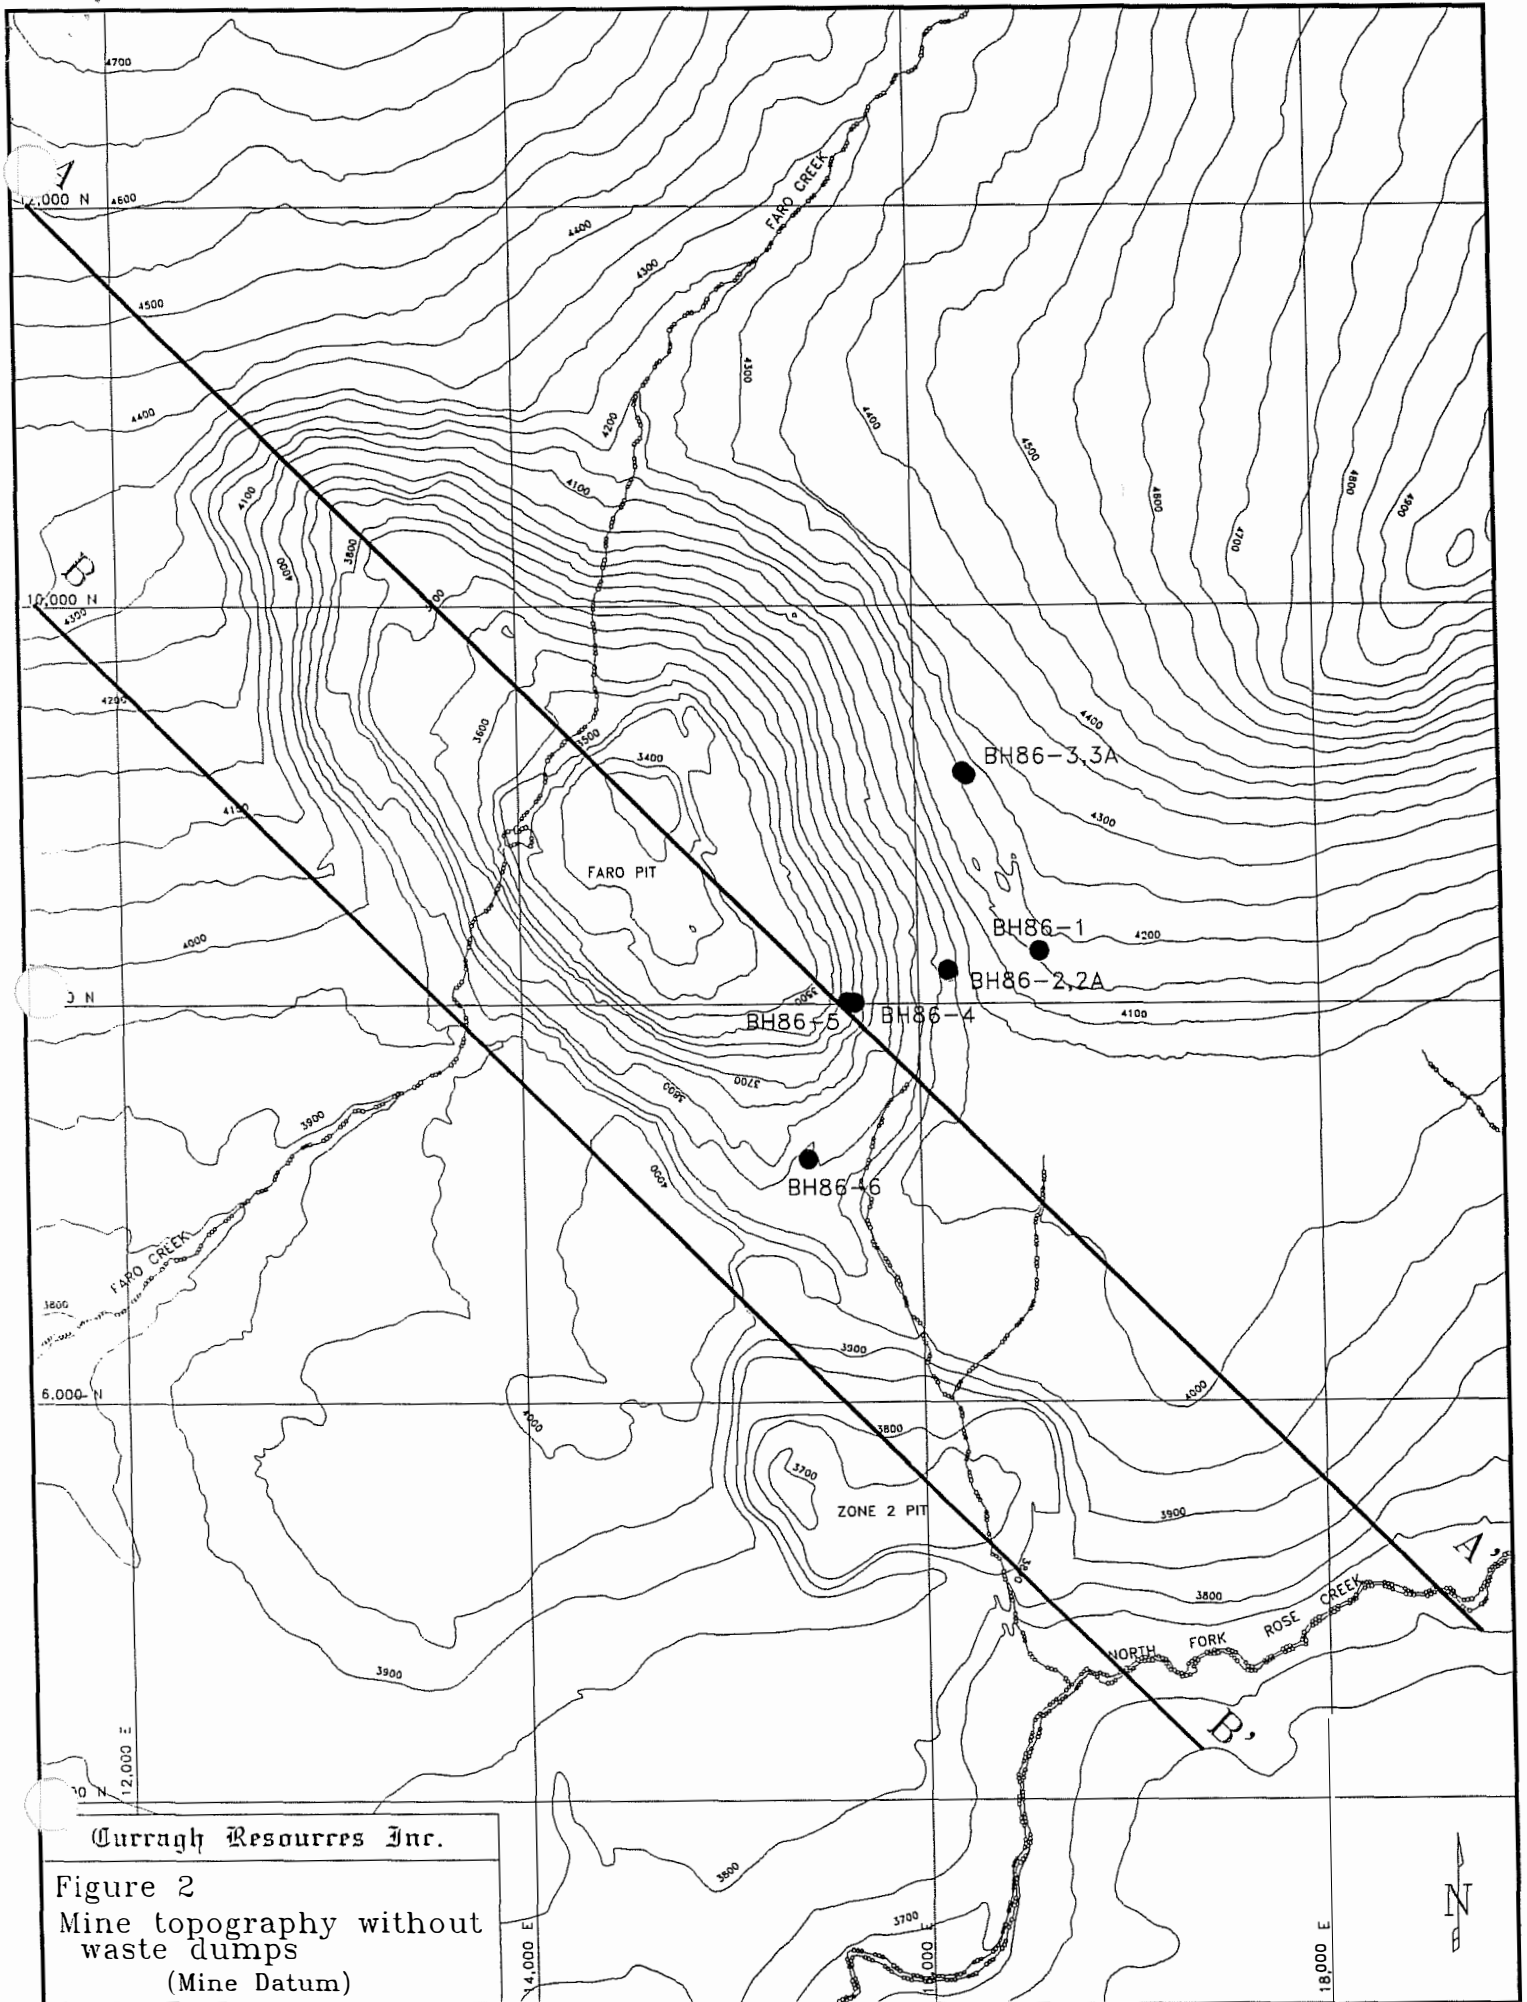
Figure 2  
 Mine topography without  
 waste dumps  
 (Mine Datum)

Waste rock dumps line the western side of the North Fork valley, which includes the filling of the Zone II Pit. Figure 2 shows the natural topography below the waste rock. Precipitation is infiltrating through these dumps, and has the potential for leaching soluble salts. Once this infiltration reaches the base of the dumps, part will infiltrate into the natural soils, and part will run-off through the dump and probably flow onto and infiltrate into the alluvial silty sediments of the North Fork valley. This is probably significant to the north of the Zone II Pit, although the waste rock deposited over the rim of the pit also has potential for contributing run-off. The unit mean annual run-off calculated for the Faro site is 260 mm (SRK report 60635). An estimate of infiltration through the North Fork dumps and subsequent run-off can be made by assuming a dump area of 360,000m<sup>2</sup>, and infiltration rate of 150 mm. This derives a flow of approximately 150 m<sup>3</sup>/day, greater than an order of magnitude larger than the Main Pit seepage estimate. The water quality of this flow is not easily estimated. Visible seeps have not been recorded at the toe of the dumps. However, the seepage is probably migrating into the valley sediments just below the surface. A shallow groundwater survey conducted by Curragh personnel in 1990 in the valley area provided a number of water samples. These had sulphate concentrations indicative of neutralized acid drainage (up to between 1200 and 2250 mg/L), although metal concentrations were low with an average zinc concentration of 0.07 mg/L, and a peak of 0.4 mg/L.
