C.O. BRAWNER ENGINEERING LTD.
Consulting Geotechnical Engineers

August 9, 1991

Mr. John Hogg
General Manager
Curragh Resources, Inc.
P.O. Box 1000
Faro, Yukon Y0B 1K0

Re: Evaluation of East Pit Wall Stability

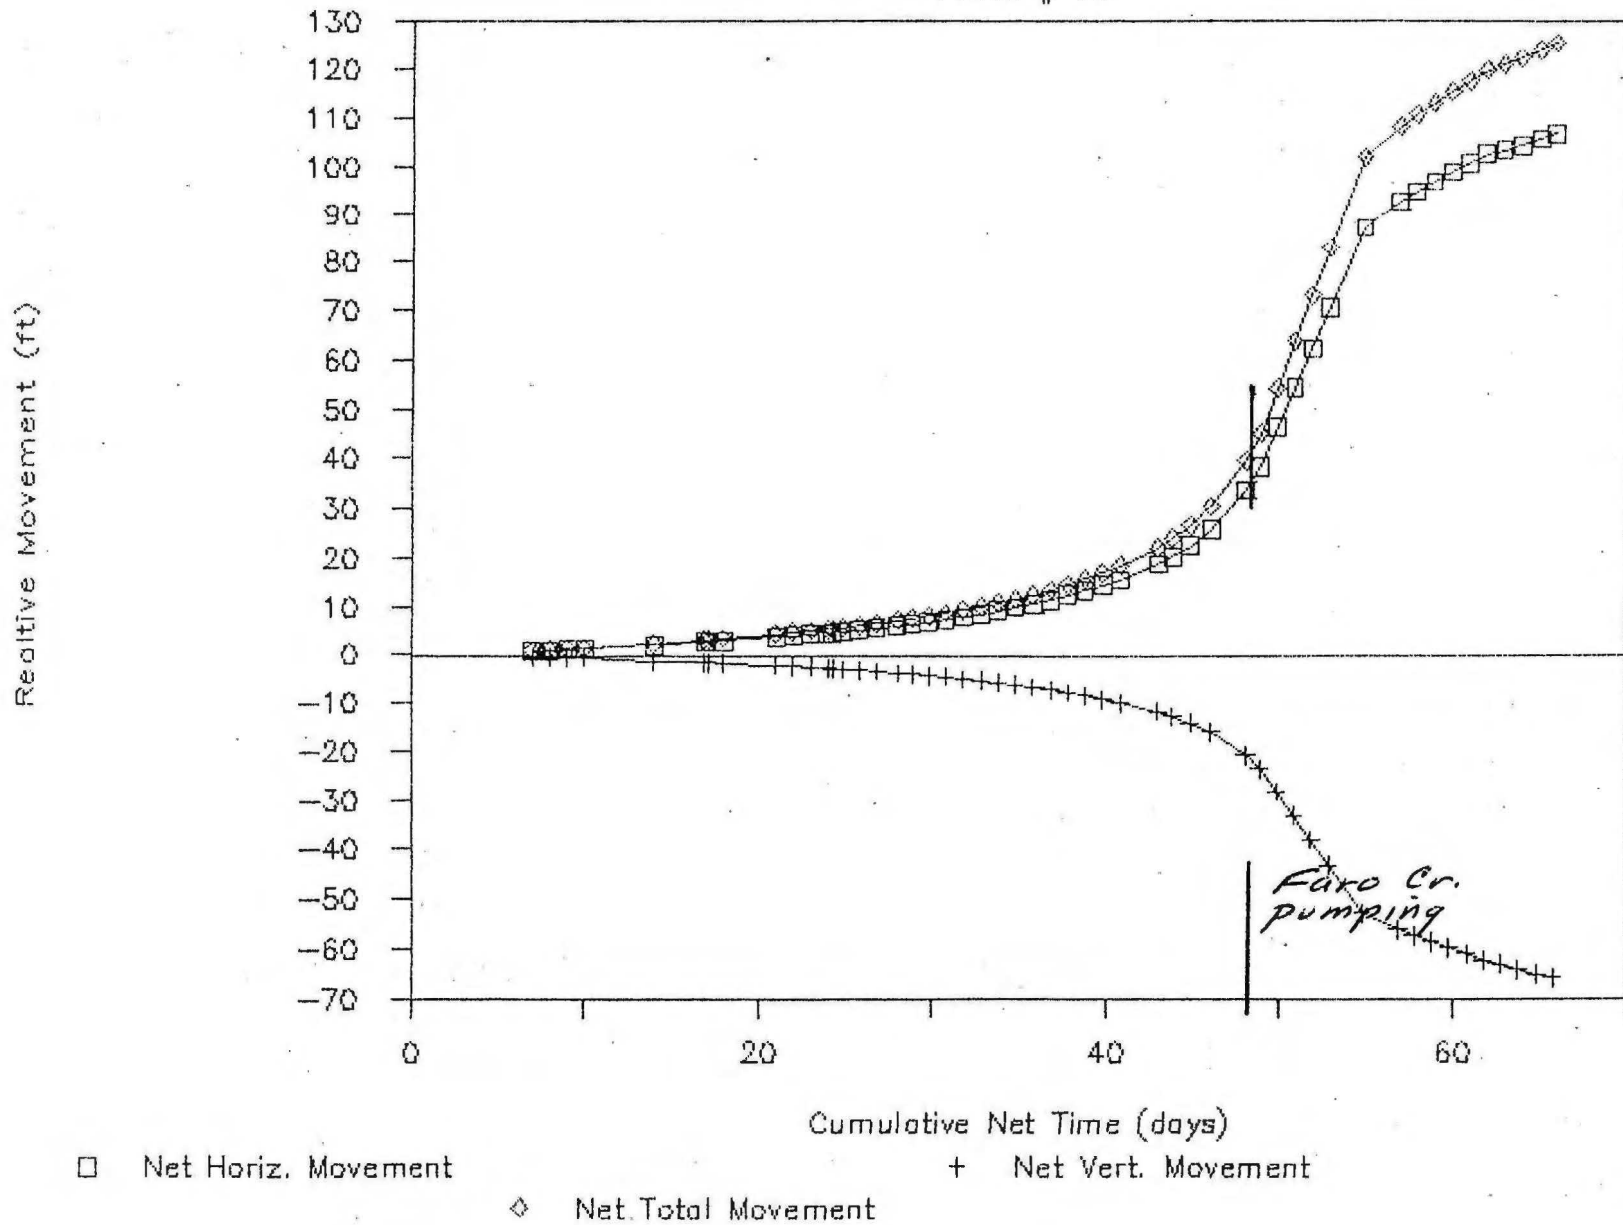
Prism # 15

Extensive slope monitoring has been performed. Figures 1 and 2 show movement results for hubs 15 and 16 about mid-height on the slope. Horizontal movement sectors are generally much larger than vertical sectors. This indicates toppling type failure. Observation from the south end of the east slope clearly indicates toppling failure with material moving in behind as a graben, which continues to apply lateral pressure.

FIG. 1 - RELATIVE MOVEMENT VS TIME - PRISM

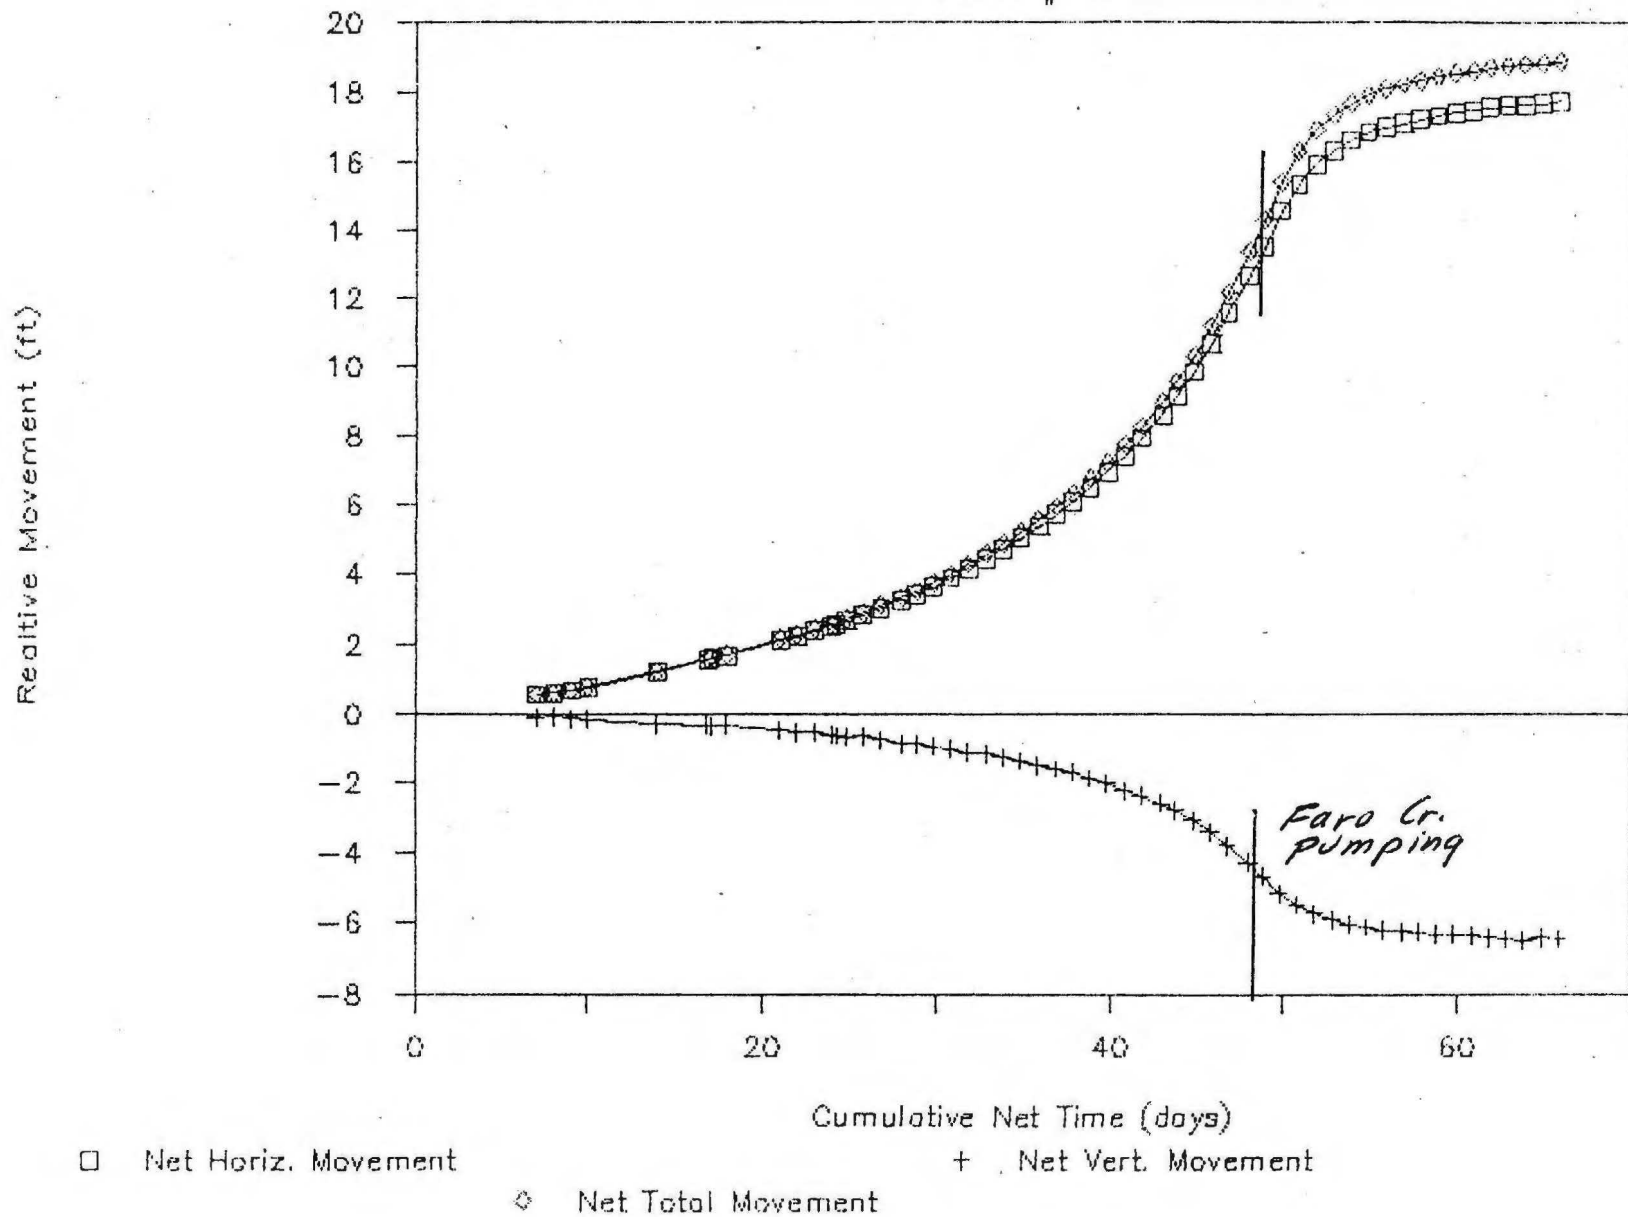
Prism # 16

FIG. 2 - RELATIVE MOVEMENT VS TIME -- PRISM

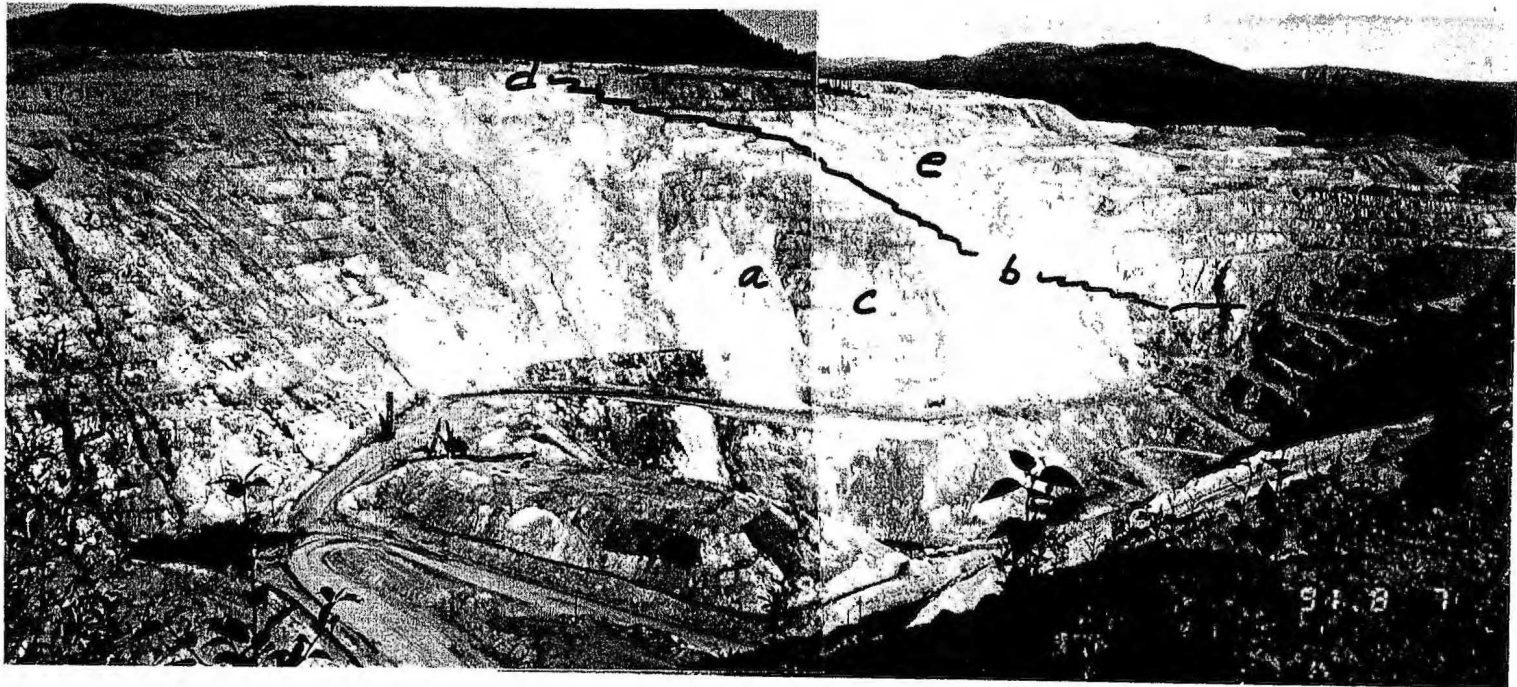
A harder nose exists about midway along the east pit wall which is described as calc silicate rock. This rock is much more competent and is tending to act as a retaining wall to the slope.

The phyllites both north and south of the calc silicate is moving and ravelling. These zones are referred to as the north slump and south slump.

The major Big Indian Fault intersects the east wall at a small angle to the face and dips about 75 - 80° toward the pit. Prior to extensive movement, this fault was likely a low permeability barrier to water seeping toward the pit. This fault is about 100 feet wide.

PHOTO 1: East wall of pit. The north slump and talus area (a), south slump and talus area (b) and calc silicate rock zone (c). Note negligible talus below zone c. The Big Indian Fault is behind the major talus zone (d). Upper broken moving zone behind the fault (e).

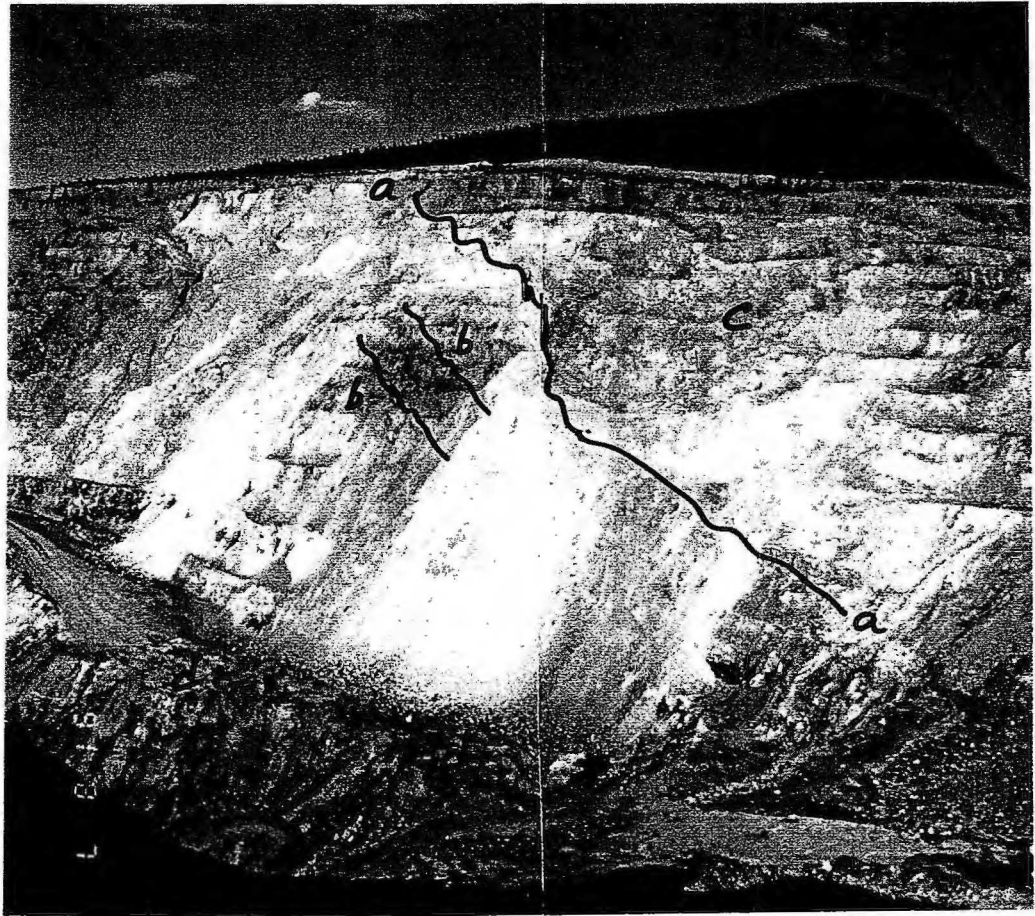
Secondary shears have recently been observed which dip into the slope at about 65 - 70°. Recent toppling movement has occurred along these shears.

PHOTO 2: Angled view of the east slope from the south end of the pit. Note the Big Indian Fault (a) and secondary shears which dip about 70° into the pit (b) and the upper slump area (c). Note the previously blasted area on the bench (d). Greater movement has taken place in the south slump area.

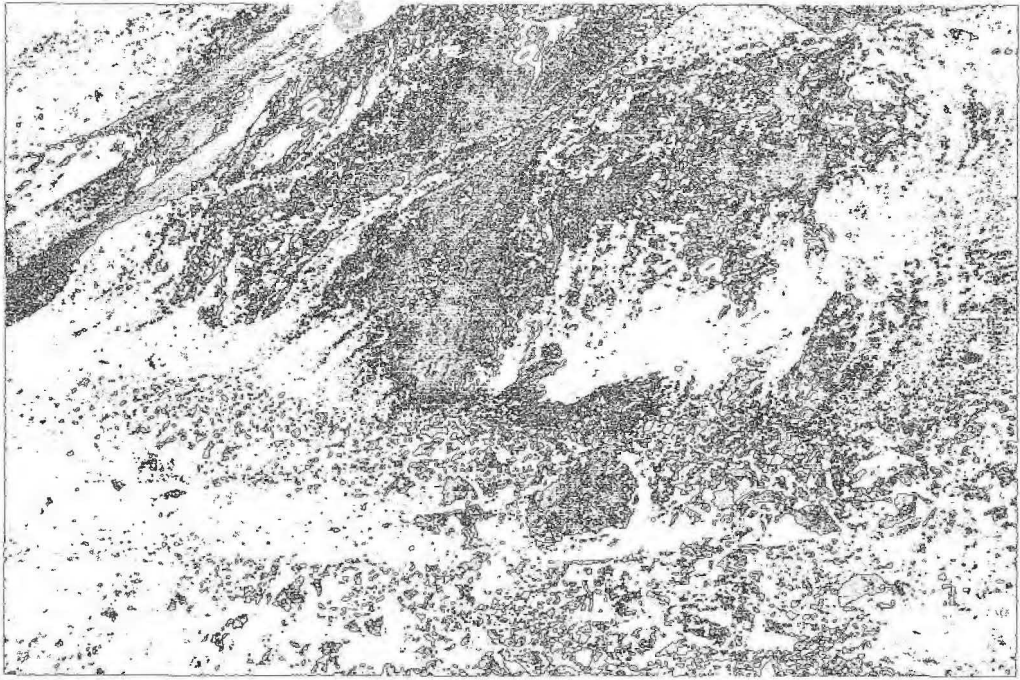
Considerable wet areas still exist in the lower slope area. Further effort to reduce water pressures in the slope is recommended.

PHOTO 4: Note the numerous wet areas indicating extensive seepage (a).

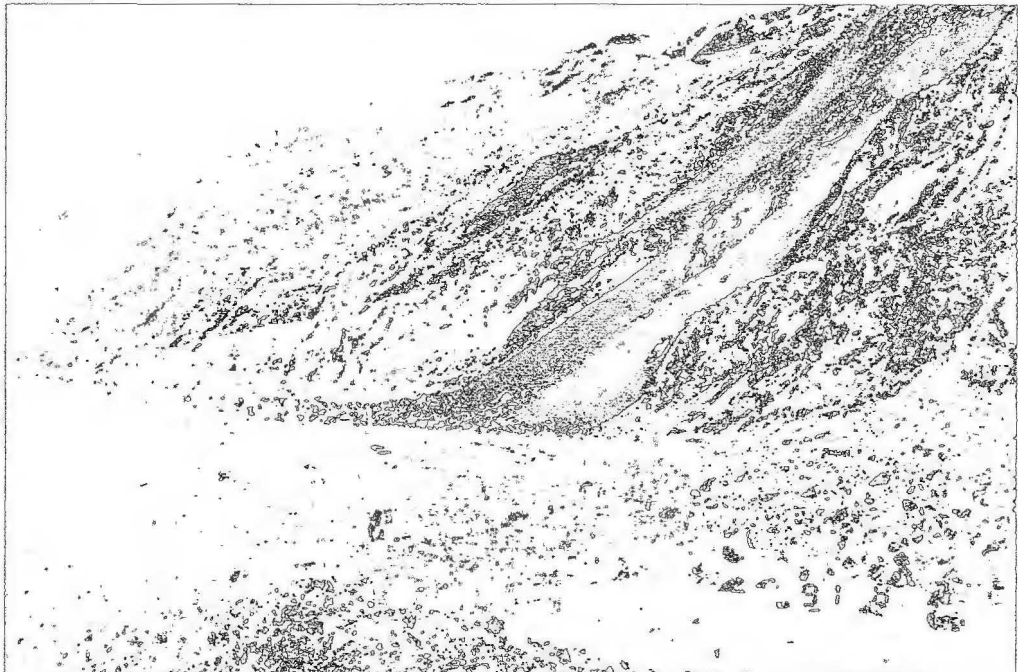
PHOTO 5: Note the zone below the calc silicate with no ravelled boulders.
Six fanned horizontal drains to be installed into the slope on plus 3% grade.

1. Install six vacuum assist horizontal drains. There is still considerable seepage issuing from the wall so water pressures are still influencing the movement. In addition, mining is proposed to go considerably deeper. This will increase stresses in the slope. Maximum drainage effort is therefore strongly recommended.

The drains should be installed from the safest location available at the toe into the calc silicate. Some form of shield or wire mesh frame to protect from ravel may be required for the drill. Drains are to be fanned from one location with the first two drains to be perpendicular to this slope $+7\ 1/2^\circ$ and $-7\ 1/2^\circ$. Other drains should be fanned 15° apart.

The drains are to be 200 feet long, at a 3%+ gradient. Standard P.V.C. 1 1/2 inch diameter drain pipe is to be inserted in each hole. The inner 170 feet to be perforated with 0.02 inch slots, the outer 30 feet unperforated.

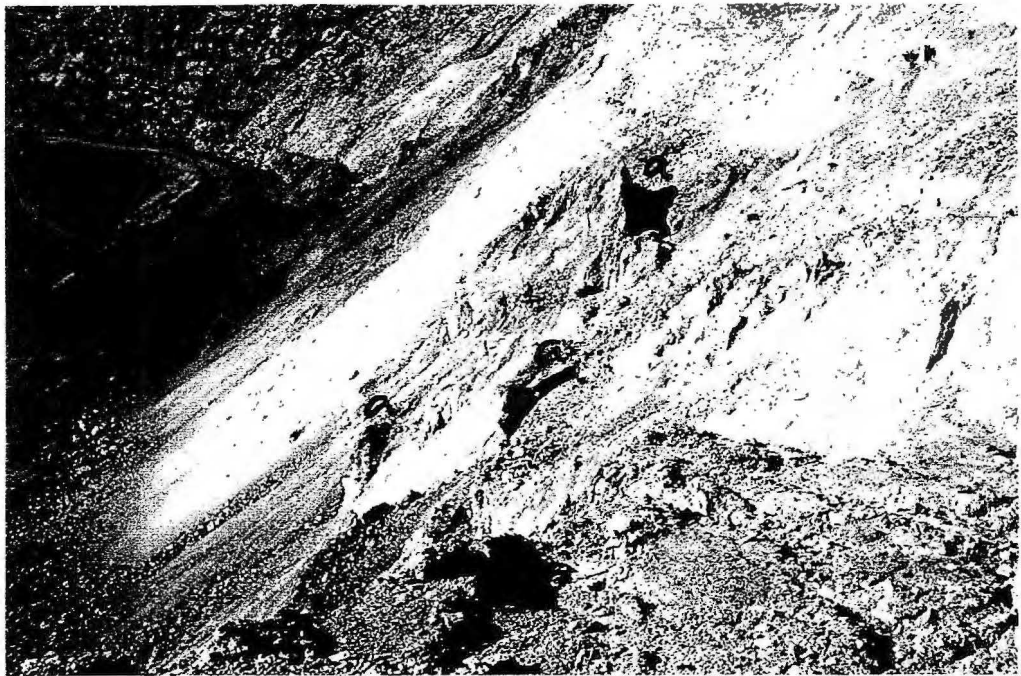
PHOTO 6: Side view of the lower east slope. Note the protruding blocks which have obviously moved in a toppling mode (a).

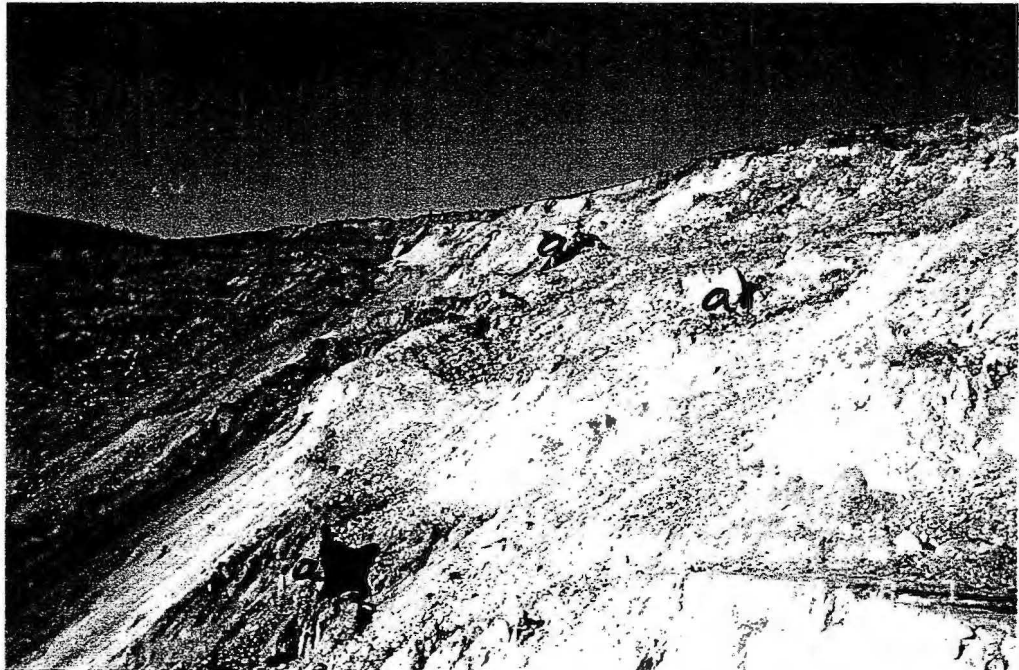
PHOTO 7: Side view of the upper slope. Note the protruding blocks which are evidence of toppling (a).
