**Curragh  
Resources Inc.**

**SUBJECT:** Dy Pilot Hole

DY  
Drilling  
Pilot Hole

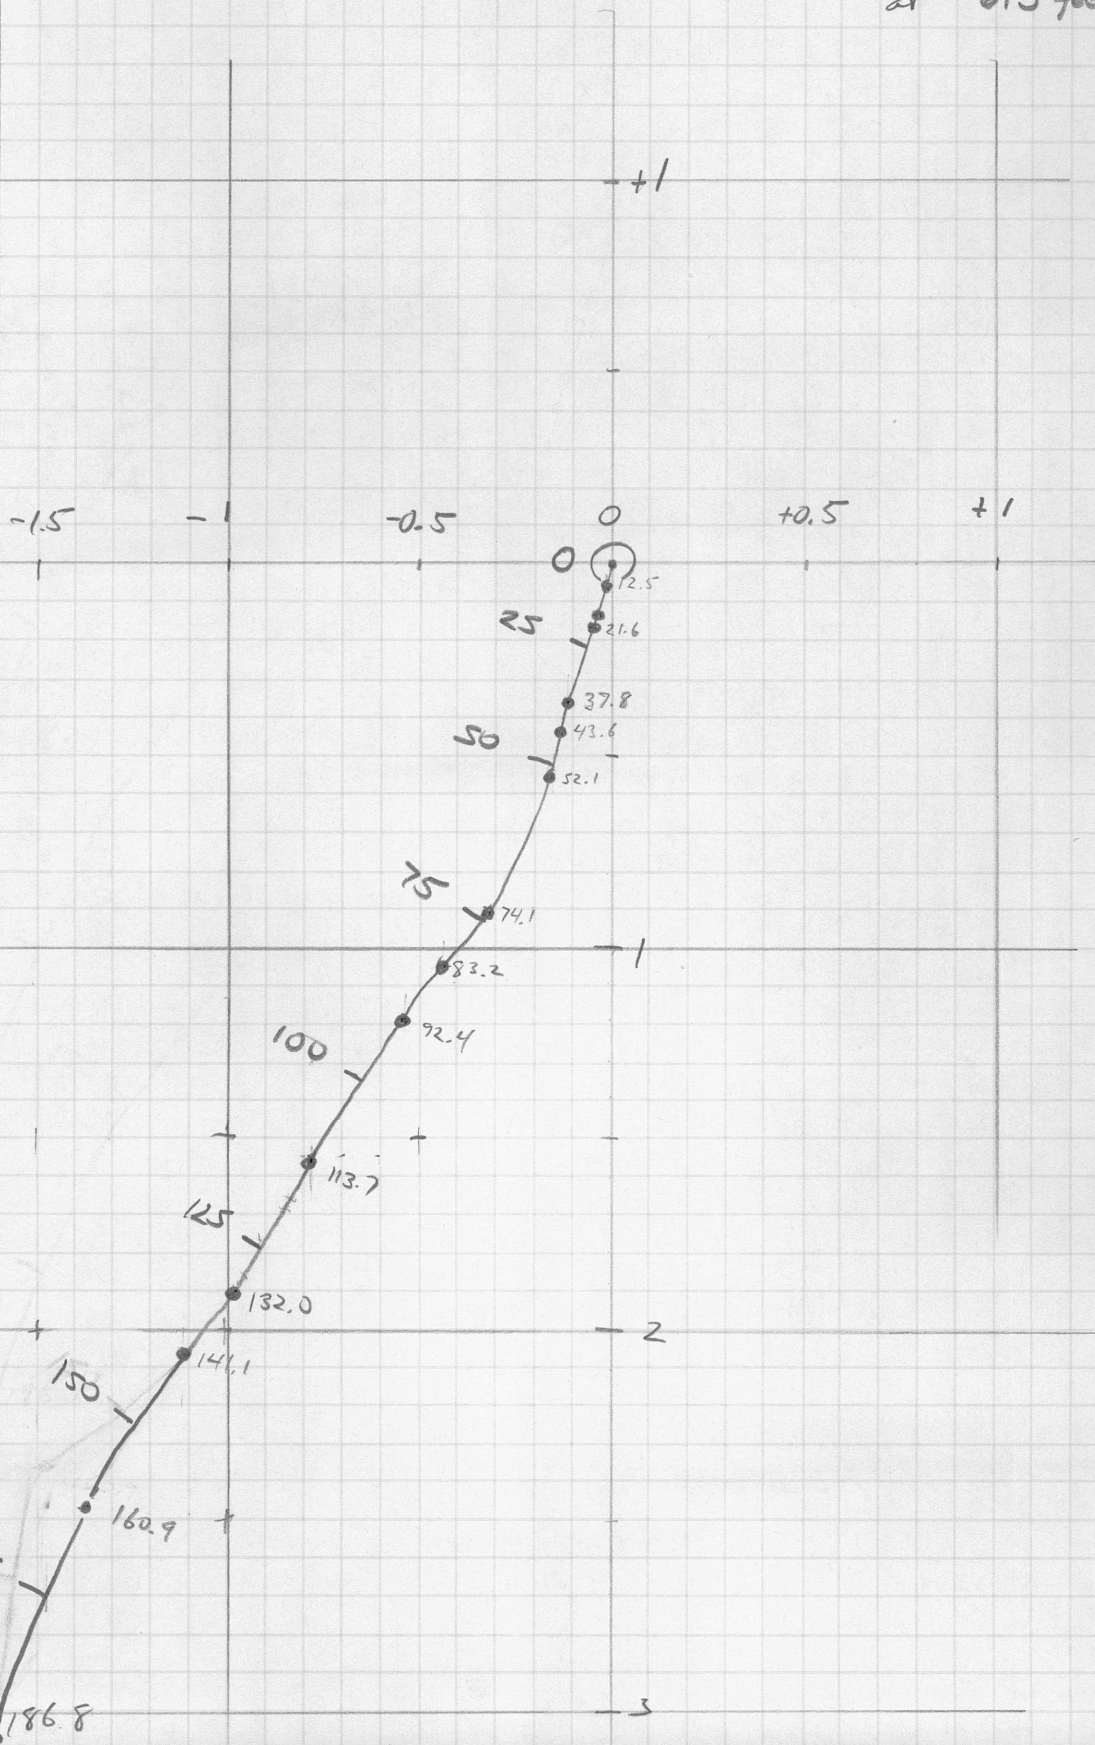
Attached is a plot of the Dy hole - As you can see it is straight below 75m but heading in the wrong direction - kink at bottom of hole was an error thus go back to bot up hole to find homogenous soft spot and place cement plug - steer hole back into the shaft volume and then deflect back into vertical. - make sure you get enough straight hole after bend to get

the stabilizers re established

off by 3.47 metres = 11.4 feet from collar  
at 613 feet
