PITEAU ASSOCIATES

Our file: 91-804B

July 18, 1991

Re: Geotechnical Review of East Wall of Faro Pit

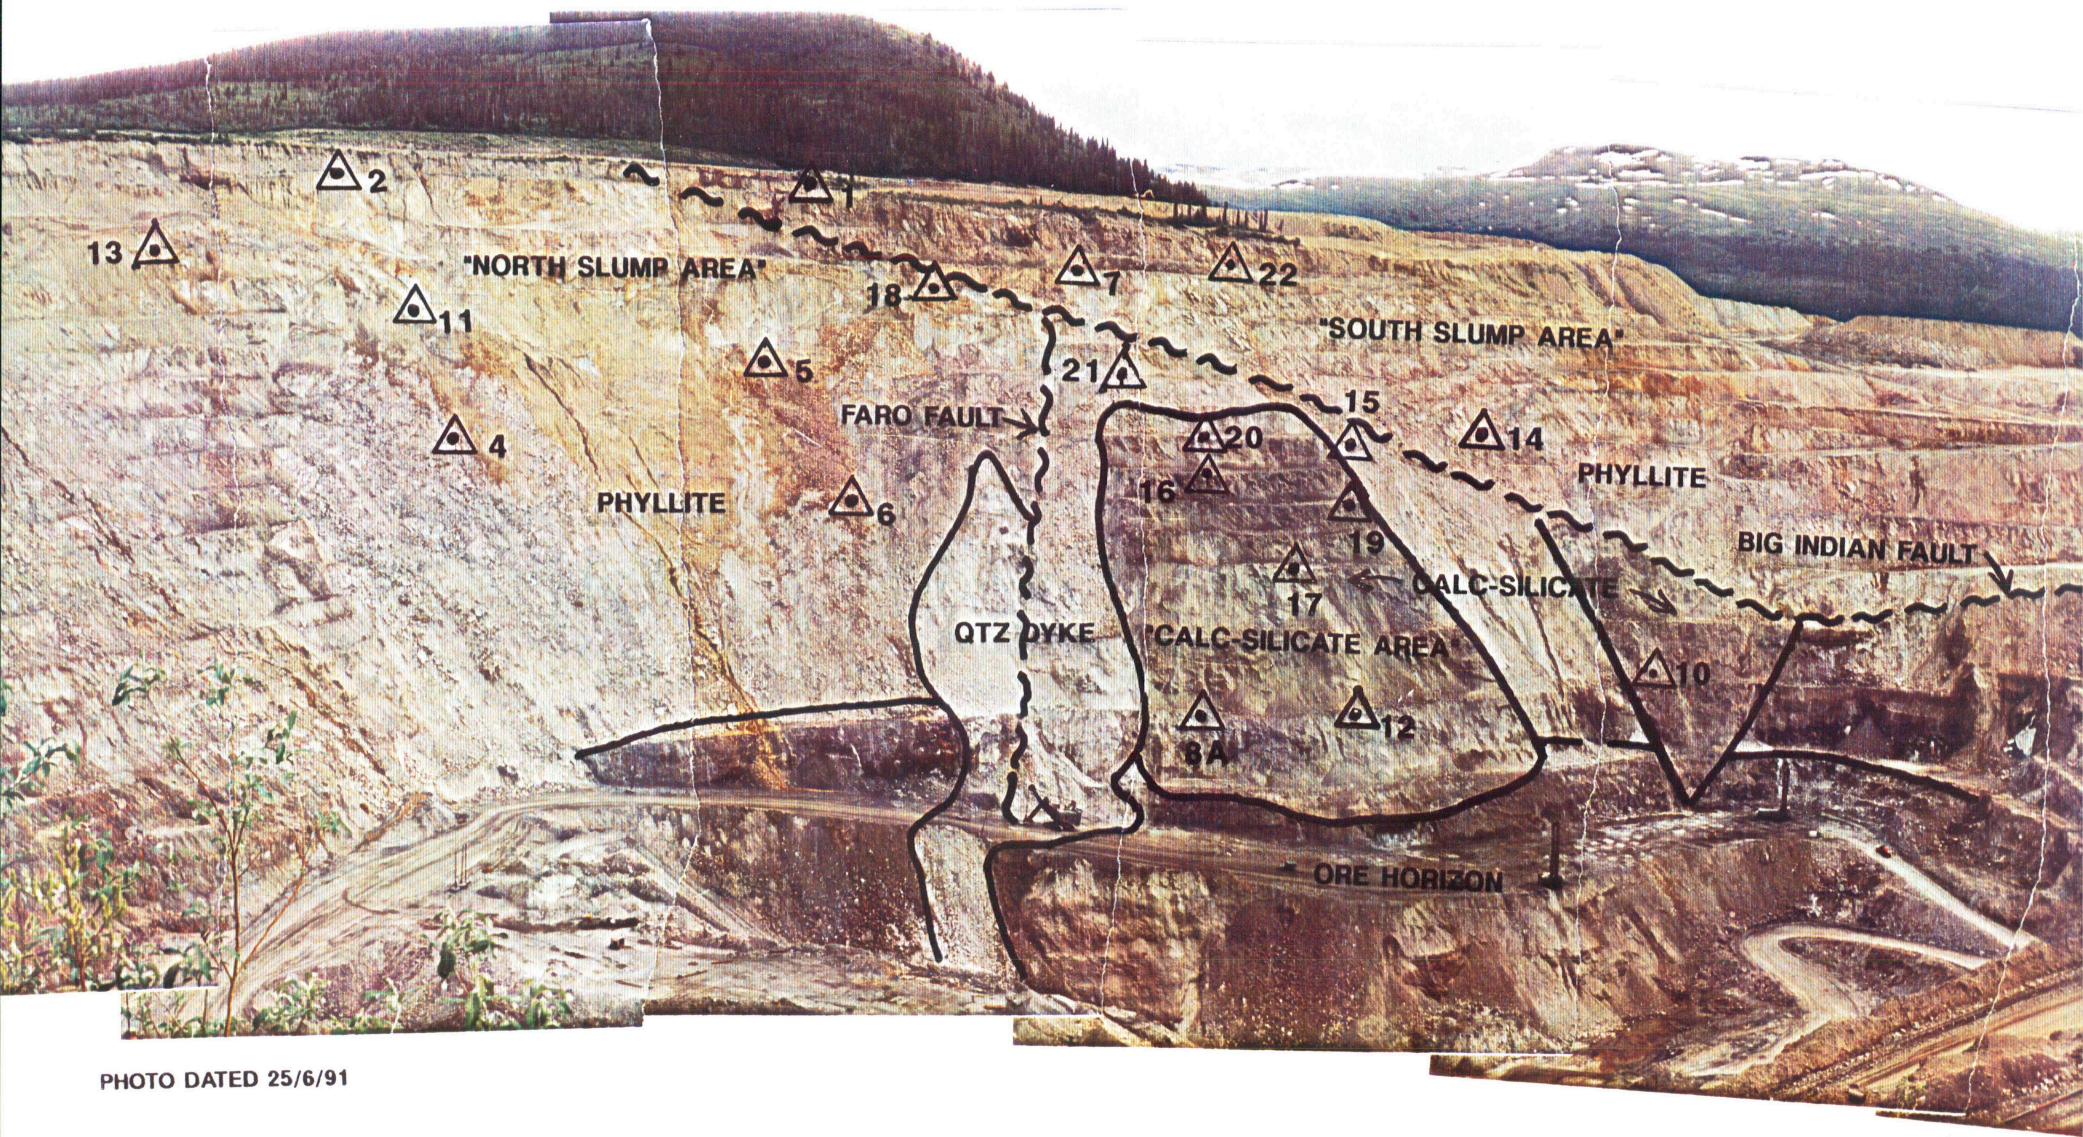
FIG. 1

The end result of the gradual degradation of the phyllite has been the creation of a pit wall at an overall angle of about 35° to 37°, with the slope essentially consisting of rubble with no well defined berms. While monitoring records for slope movements of this nature do not exist prior to September 1990, it would appear that the movements have been of a gradual creeping nature, with no sudden or large scale catastrophic slope failures. Examples of this type of slope degradation and movement can be seen in what are referred to as the "north slump" and "south slump" areas of the present east wall (see Fig. 1).

The rock types exposed on and present behind the east wall are illustrated in Fig. 1, where it can be seen that the northern portion of the wall (i.e. what is referred to as the north slump area) is excavated in the weak and relatively incompetent phyllite discussed above. Similarly, the southern portion of the wall, east of the Big Indian Fault (referred to as the south slump area), is excavated in phyllite. Below the south slump area, calc-silicate breccia and a quartz diorite dyke are exposed in the slope. These rocks are expected to extend to the pit bottom in this area (i.e. about the 3450 ft elevation).

Prism monitoring of the south slump area began on June 3, 1991. During that time, movement rates have accelerated from about 50mm/day to as much as about 300mm/day for Prisms 14 and 15, located essentially in the middle of the slump area (see Fig. 1). The movement is directly downslope at a plunge of about 20 to 30°. A recently installed prism at the top of the south slump area (i.e. Prism 22) has not experienced any movement to date. However, the presence of cracks and settlement just south of this prism indicate that movement is likely to occur.

PHOTO DATED 25/6/91
