Re: AY Zone Slope Failure in Faro Pit

As requested, Piteau Associates Engineering Ltd. has completed a geotechnical assessment of the AY Zone slope failure in the Faro Pit. Mr. A. Stewart, P.Eng. visited the site on December 16 to 18, 1992. During that time, the geology was reviewed and an inspection of the area was made with Messrs. M. Wasel, W. Dunn and J. Deforest of Curragh Inc. Subsequent to this, discussions were held with Mr. J. Hogg and Mr. R. Mason. A preliminary report was issued on December 18, 1992 before Mr. Stewart left the mine.

AY TARGET DIG MAP

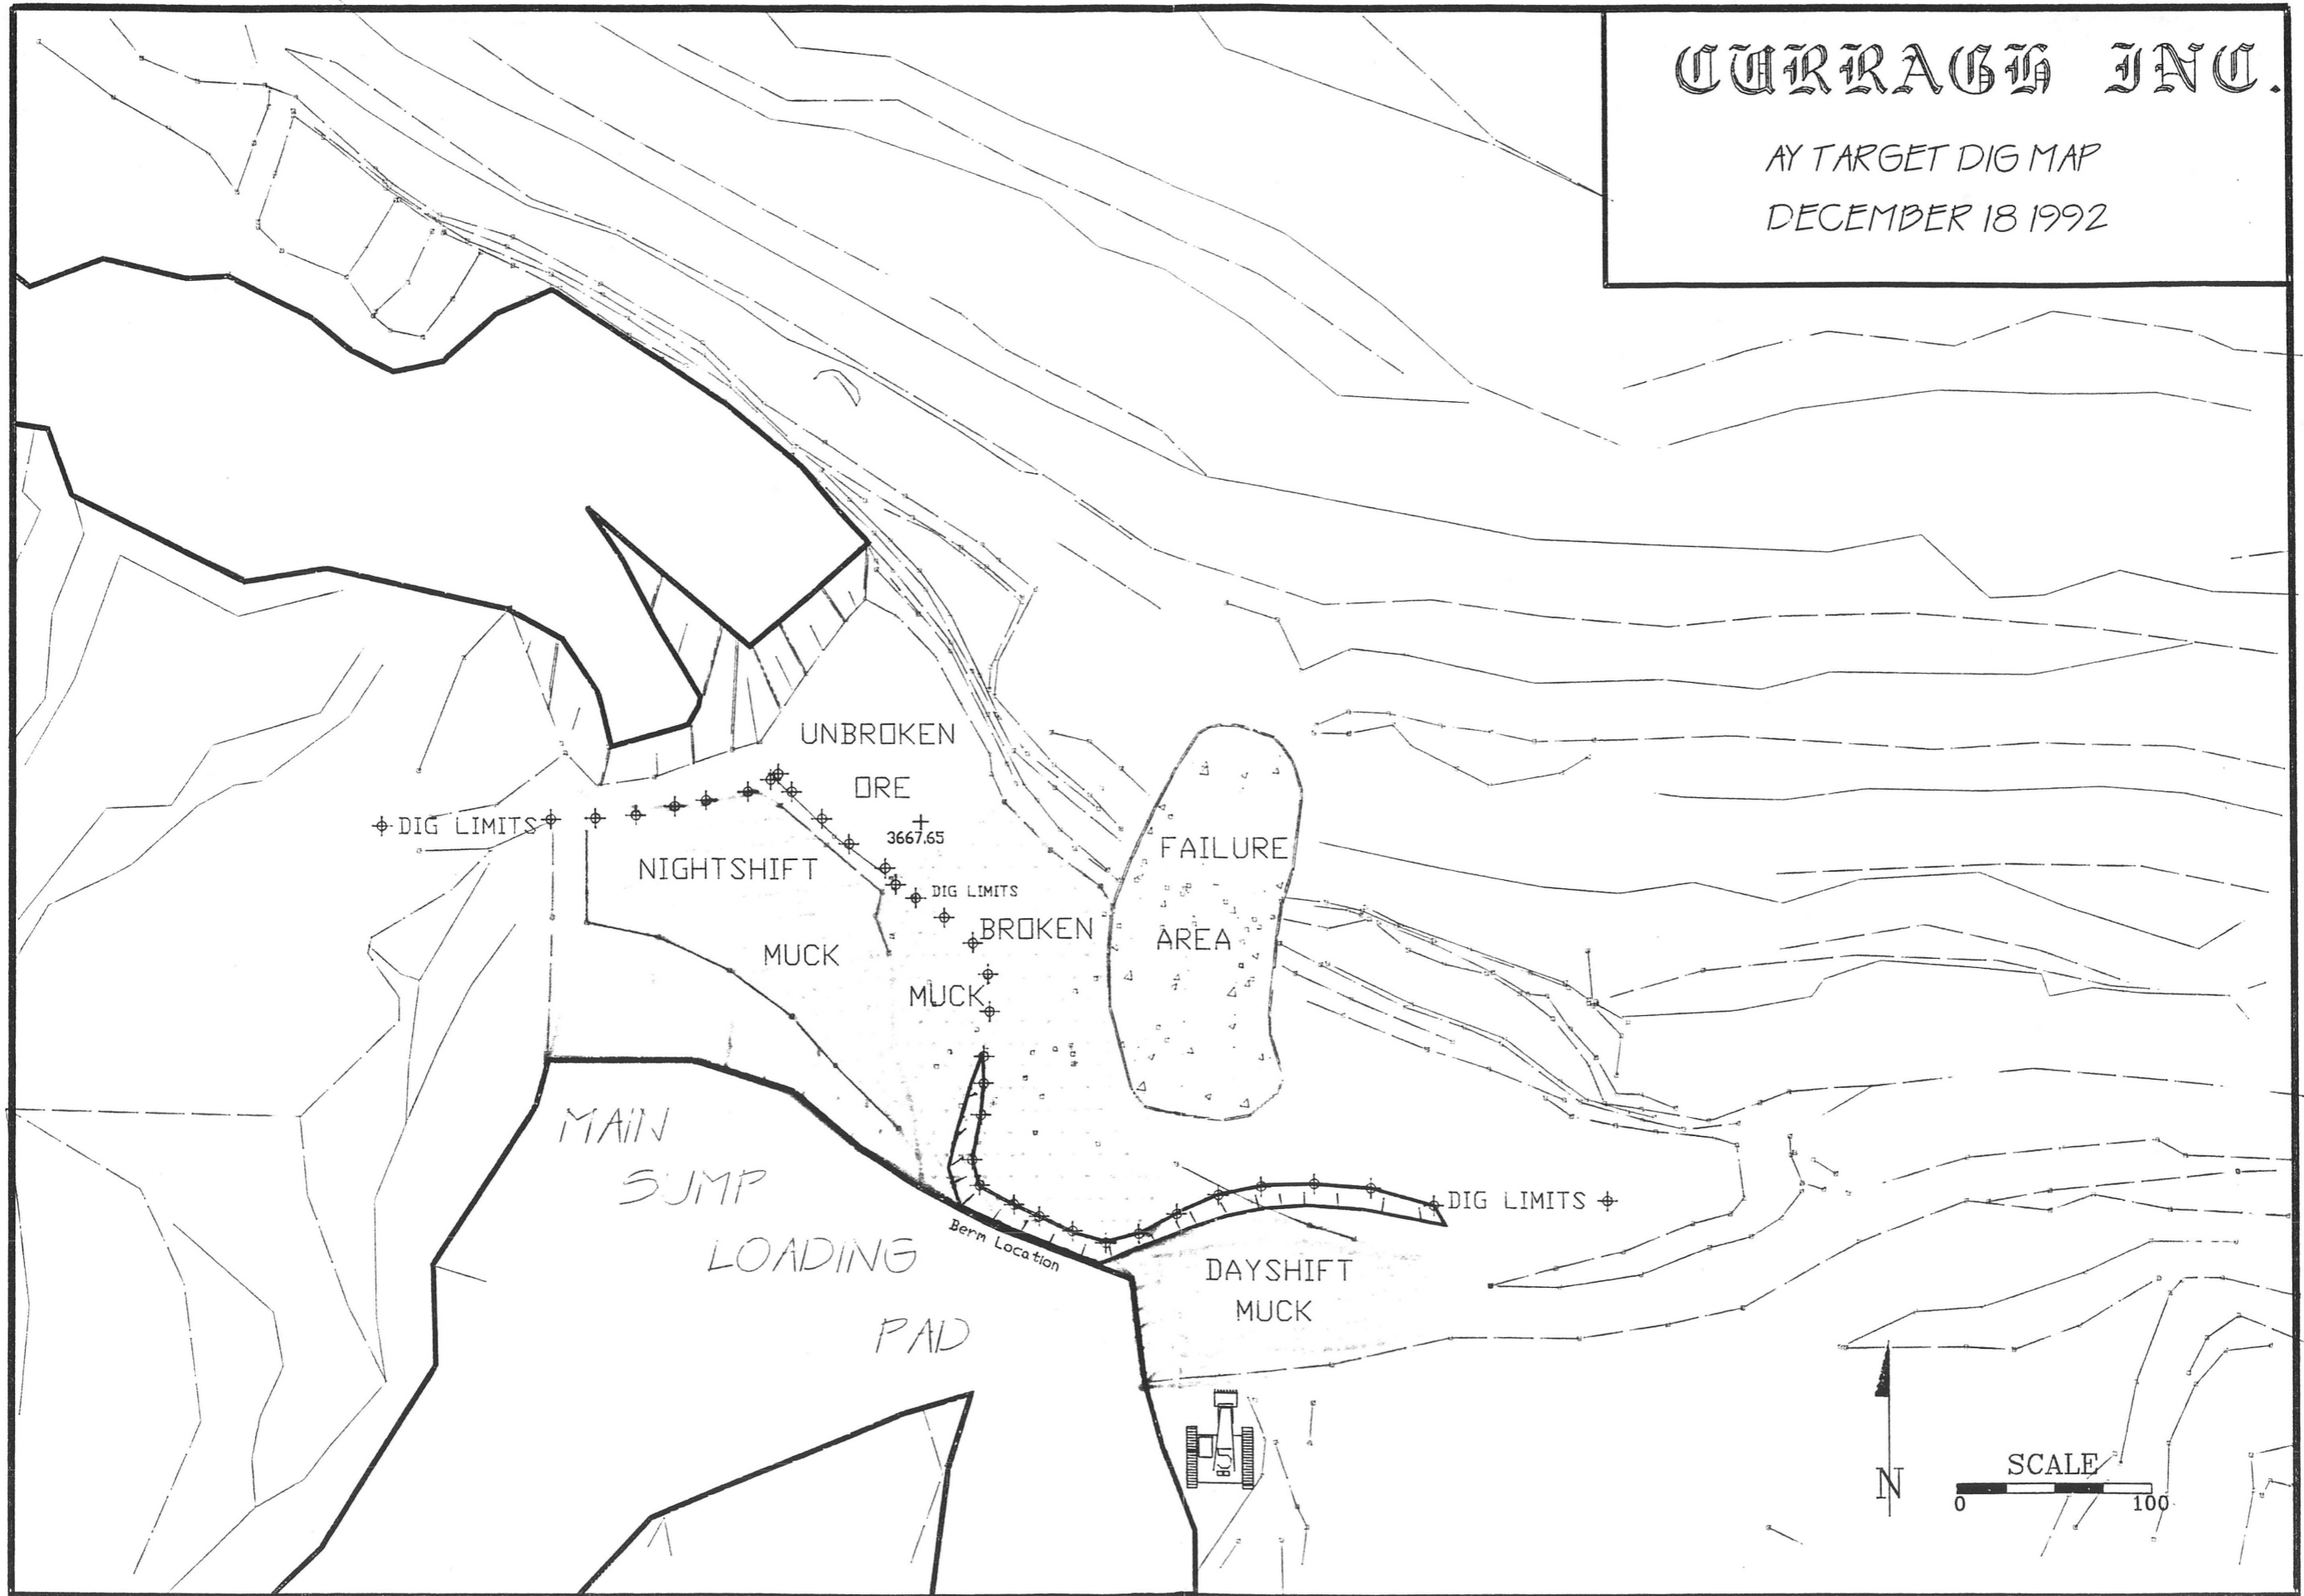
Based on the inspection of the AY Zone and a review of the sequence of events surrounding the recent slope failure, it is concluded that further sliding, particularly from the area immediately west of the failure, is likely. Sloughing of frozen rubble from the crest area of the recent failure could also occur, most likely when this material begins to thaw. However, as discussed with yourself and Messrs. M. Wasel and J. Deforest, it is also concluded that a portion of the presently broken ore can be safely mined at the present time. In this regard, a consensus was reached by the writer and the above personnel as to the location of a safe dig limit. The location of this limit, which was outlined in the pit with a line of survey stakes, is illustrated approximately on the attached plan.

In general, two areas of the muck pile may be mined; west of the cracks that are just west of the failure, and east of the recent failure in front of Shovel #5. While it should be possible to mine the western area at any time of the night or day, it is recommended that the eastern area, in front of Shovel #5, be mined only during daylight hours. However, before any mining begins, it is strongly recommended that an impact berm be established along the southern edge of the muck pile between the western and eastern mining areas.
